## GEOENVIRONMENTAL GROUND INVESTIGATION

### Barugh Green Road Roundabout Barnsley West

Reference	4848-JPG-BG-XX-RP-G-0603-S2-P02
Date	October 2020
Version	P02

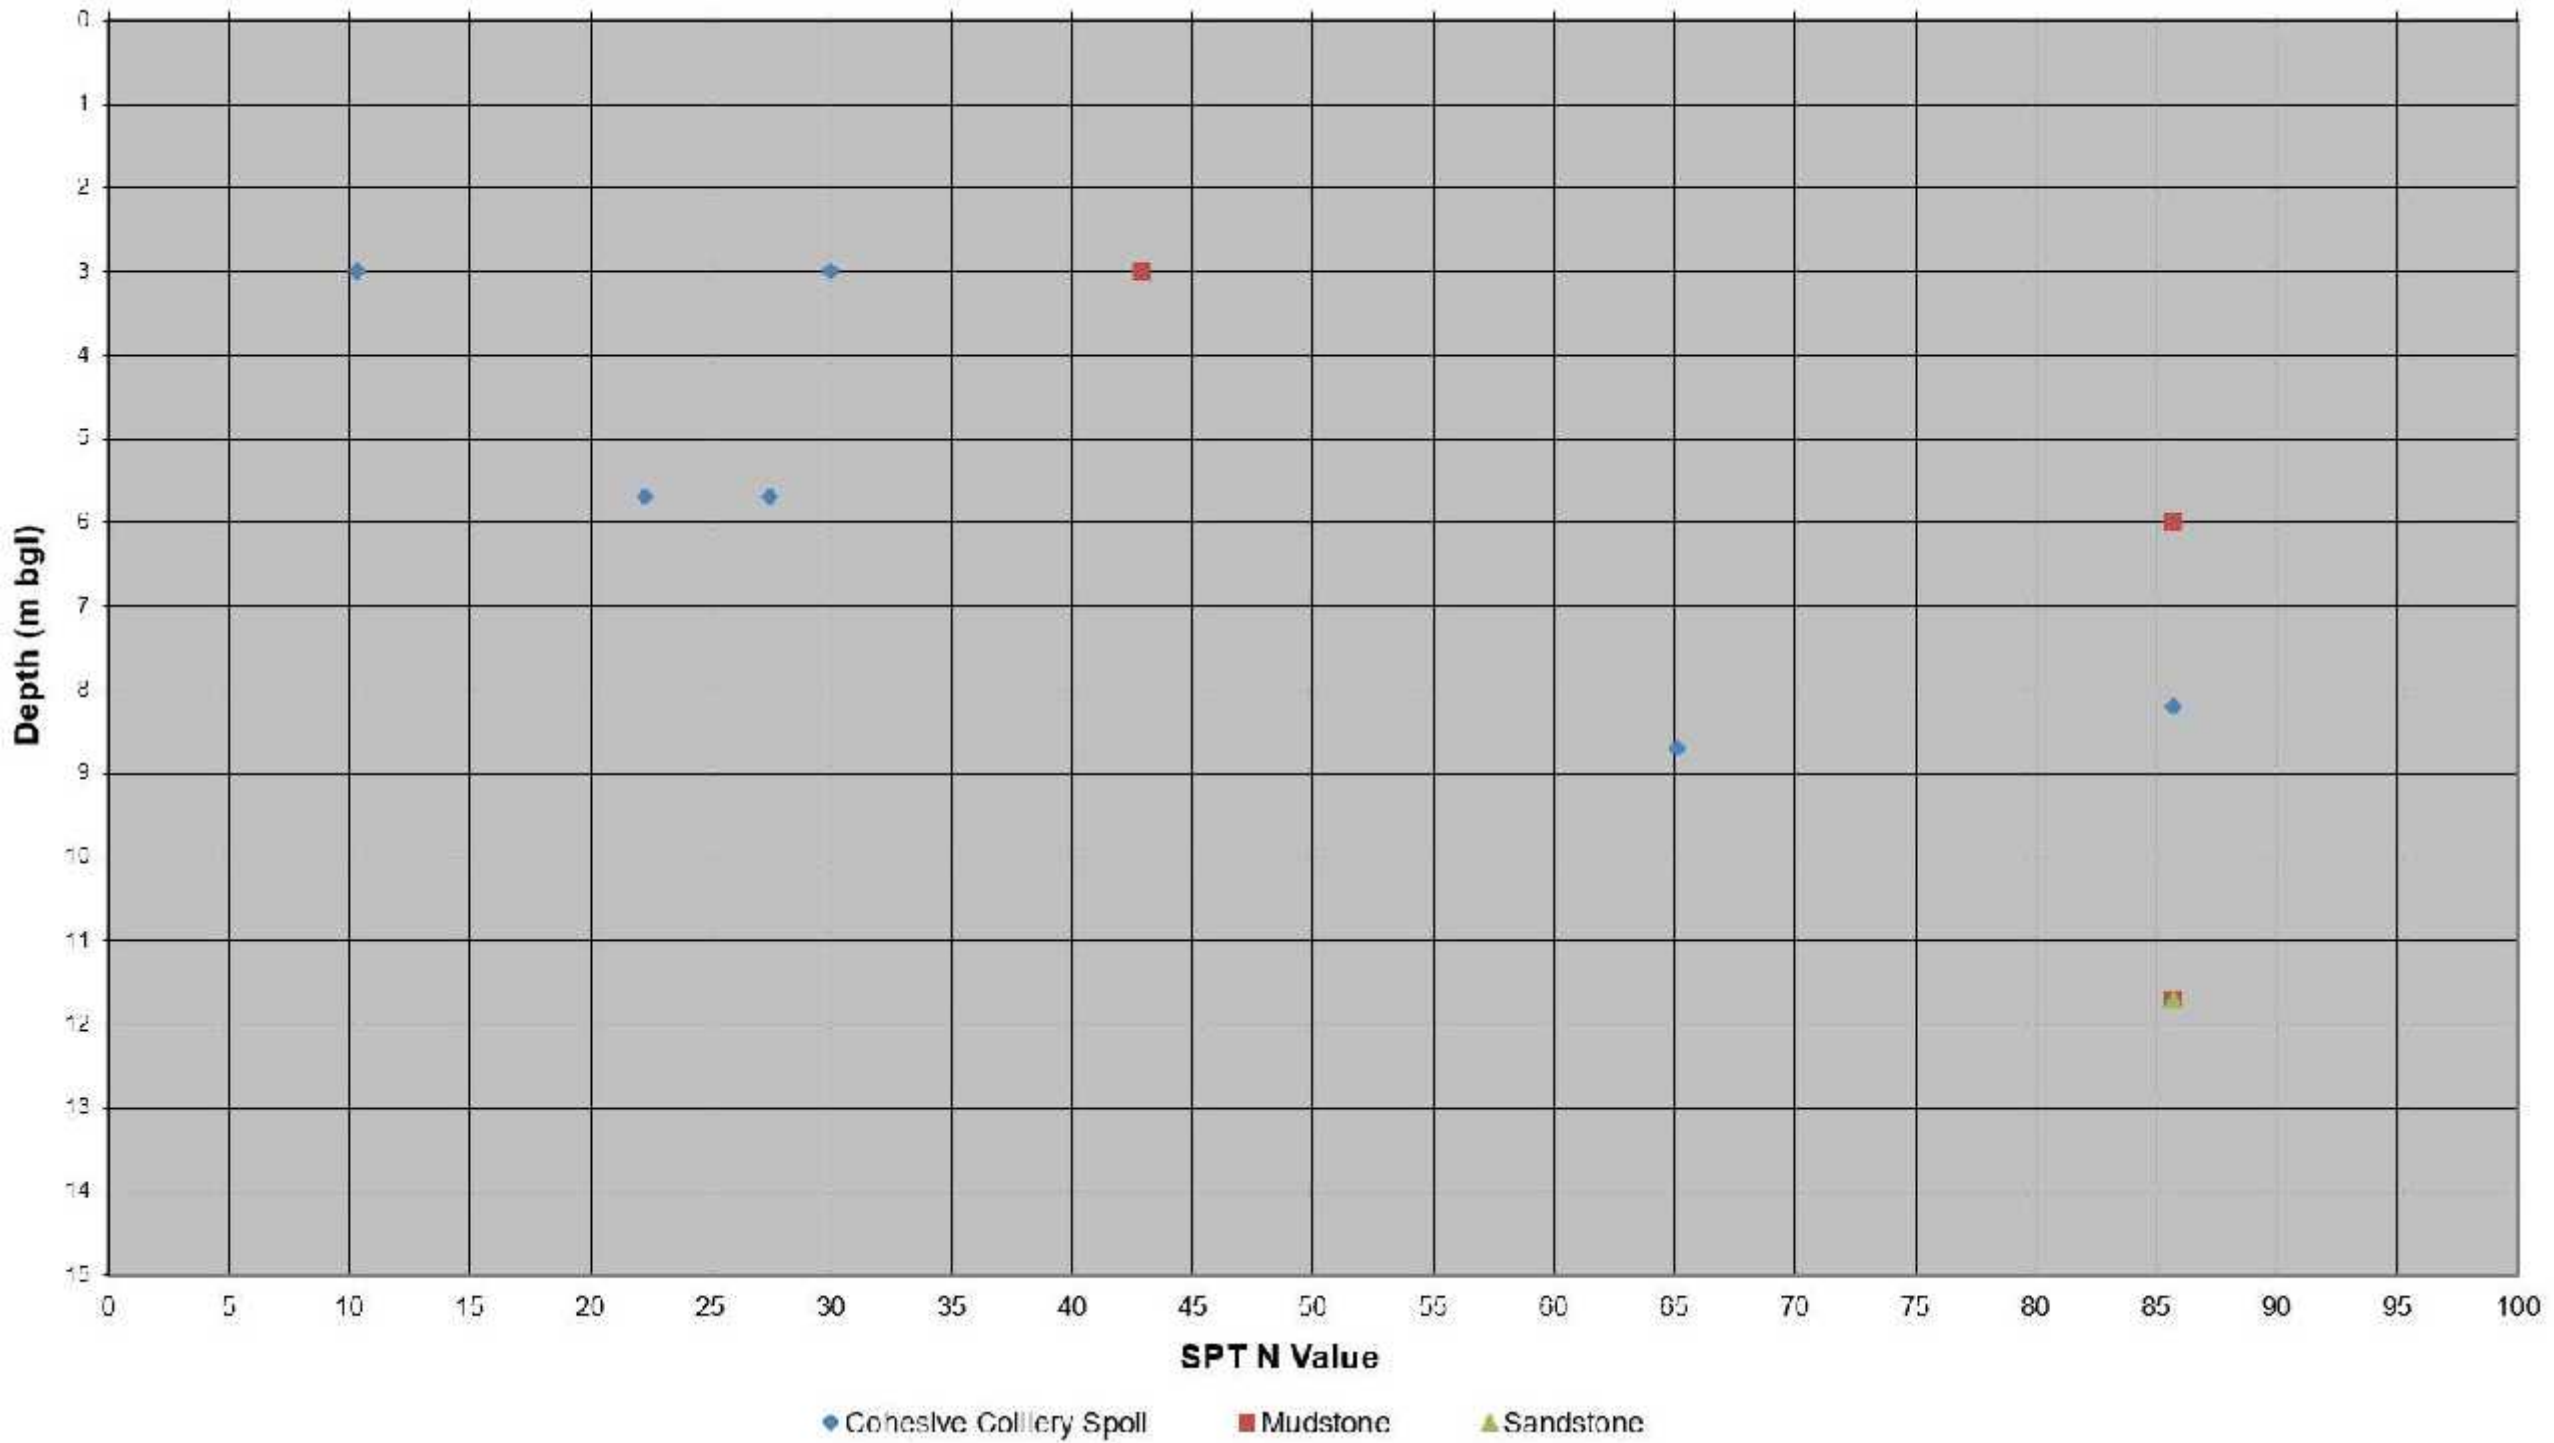
Figure 2: SPT N Value vs Depth (m bgl)

The SPT data shows a spread of N-values which indicate the colliery spoil has medium dense to very dense/ medium to very high strength conditions. The SPT N-values show an increase with depth. SPT N-values within the shallow natural strata, mudstone and sandstone, indicate dense to very dense conditions.

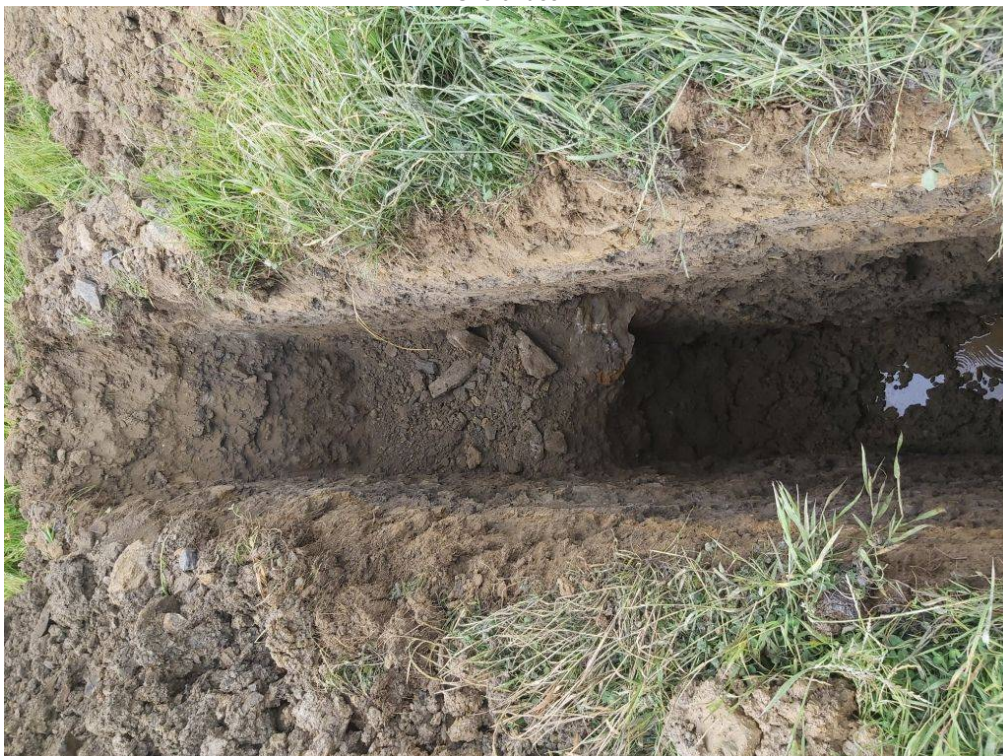
**Figure BGR\_TP101.2  
Short Face**

1.00 1.20 1.50	J4 ES5 LB6			85.08		MADE GROUND (Soft and firm grey slightly sandy slightly gravelly clay with cobbles. Sand is fine to coarse. Gravel is fine to coarse subangular to angular and includes sandstone, mudstone, coal and brick. Cobbles are subangular and include mudstone and sandstone). between c.0.50-3.40m BGL ... no suitable sized material for HSV. at c.1.50m BGL ... with interbeds of clayey sandy gravel sized mudstone. at c.1.90m BGL ... sandstone boulder in Face D and A of pit.
Terminated at 3.40m BGL - due to boulder obstruction.

**GROUNDWATER**  
 Water strike at 3.30m BGL (Moderate Inflow). Water level at 3.30mBGL at end of excavation.

**STABILITY**  
 Pit sides and base moderately stable throughout excavation.

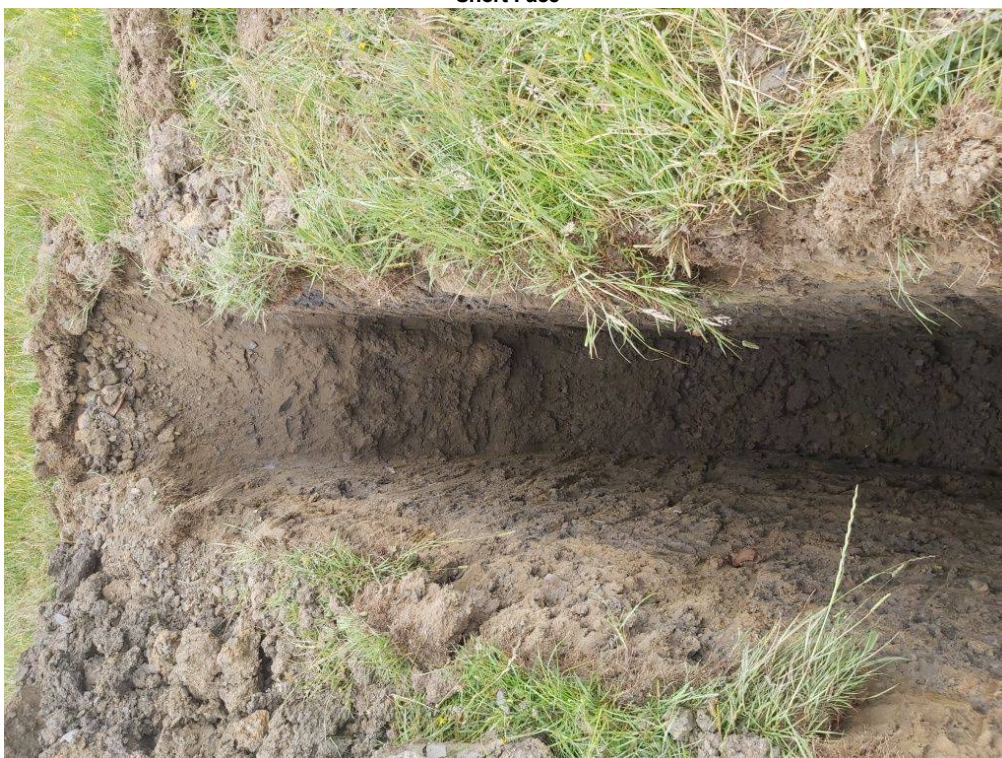
**Figure BGR\_TP102.2  
Short Face**

SAMPLES & TESTS			STRATA			
Depth	Type No	Test Result	Water	Reduced Level	Legend	Description
0.10 0.20 0.30	J1 ES2 LB3		↓ Water	87.06	(0.40)	MADE GROUND (Topsoil consisting of soft light brown sandy slightly gravelly clay with many rootlets. Sand is fine to medium. Gravel is fine subangular and includes tile, brick, sandstone and mudstone). between c.0.00-0.40m BGL ... too gravelly for HSV.
2.00	J4				(3.00)	MADE GROUND (Soft and firm grey slightly sandy gravelly clay with low cobble content. Sand is fine to coarse. Gravel is fine to coarse subangular to angular and includes sandstone, mudstone, coal and brick. Cobbles are subangular and include mudstone and sandstone). between c.0.40-3.40m BGL ... no suitable sized material for HSV.
2.50	ES5					
3.00	LB6				84.06	(3.40)

**GROUNDWATER**  
 Water strike at 3.10m BGL (Slight Inflow). Water level at base at end of excavation.

**STABILITY**  
 Pit sides and base moderately stable throughout excavation.

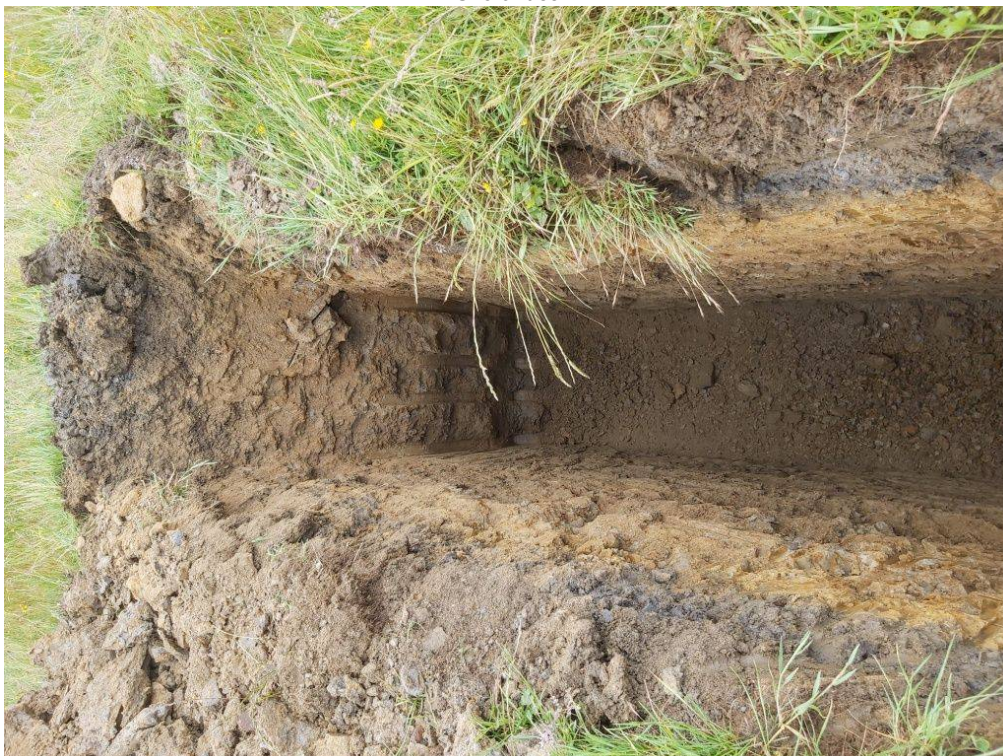
**Figure BGR\_TP103.2  
Short Face**

84.17		(0.50) 2.50	Extremely weak grey and black thinly laminated MUDSTONE residual. (Recovered as clayey fine to coarse gravel. Gravel is fine to coarse angular). <i>Complete at 2.50m BGL.</i>

**GROUNDWATER**  
No groundwater inflow observed.

**STABILITY**  
Pit sides and base moderately stable throughout excavation.
