**CUDWORTH SOCIAL CLUB.**

**BAT AND BIODIVERSITY NET GAIN  
REPORT.**

**Ref No: 251145.**

**Date: 4<sup>th</sup> December 2025.**

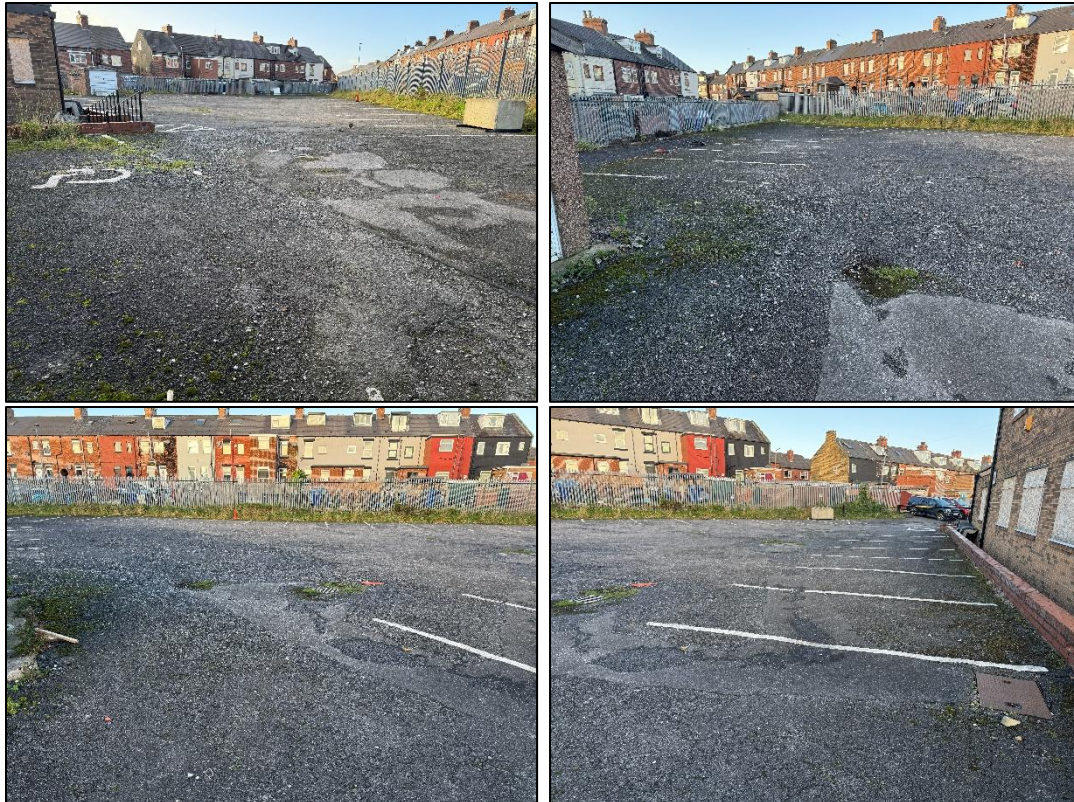
3.2.2.1. There is a large car parking area around the west side of the existing building.

3.2.2.2. There is no condition assessment for this habitat.

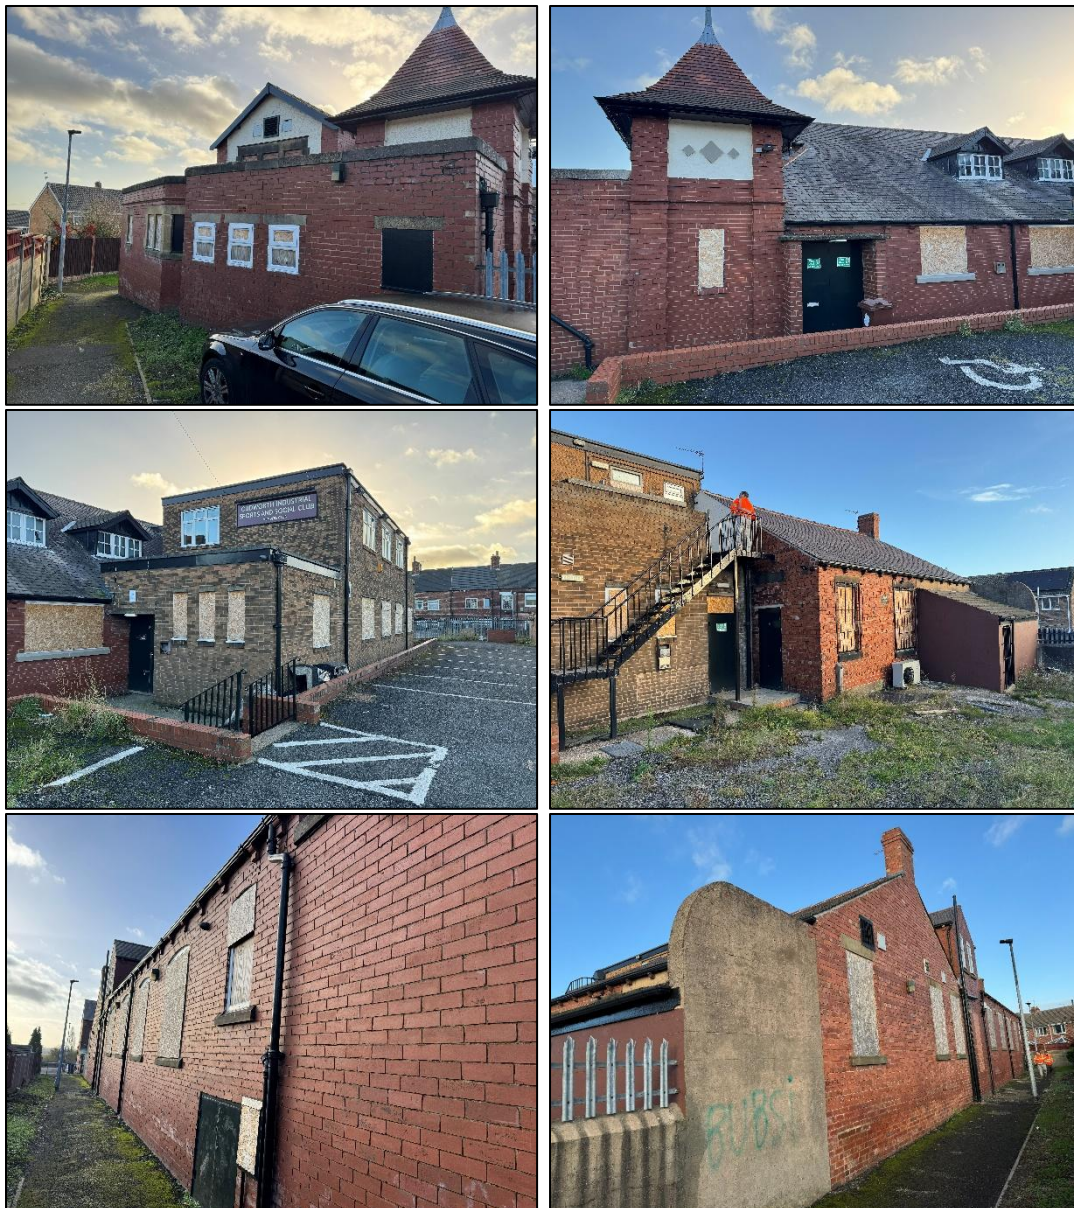
3.2.3.1. The first is the main Social club building that is to be demolished. That building is shown below.

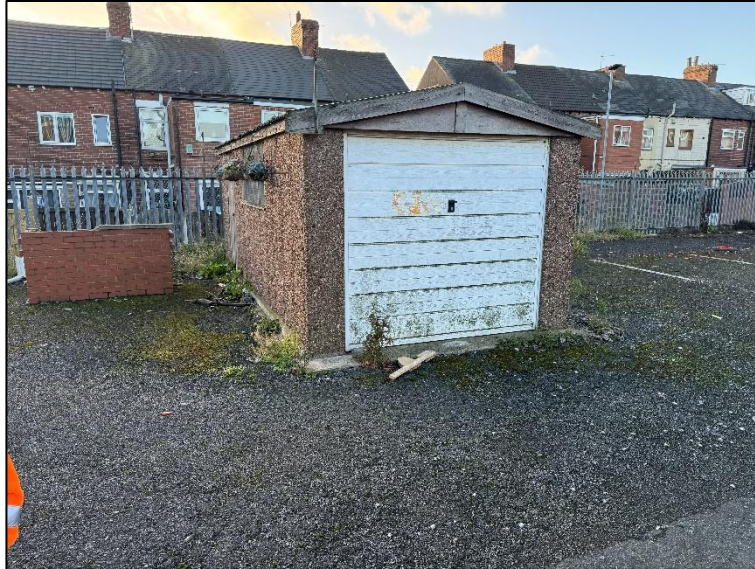
3.2.3.2. The second is a prefabricated garage in the car park.

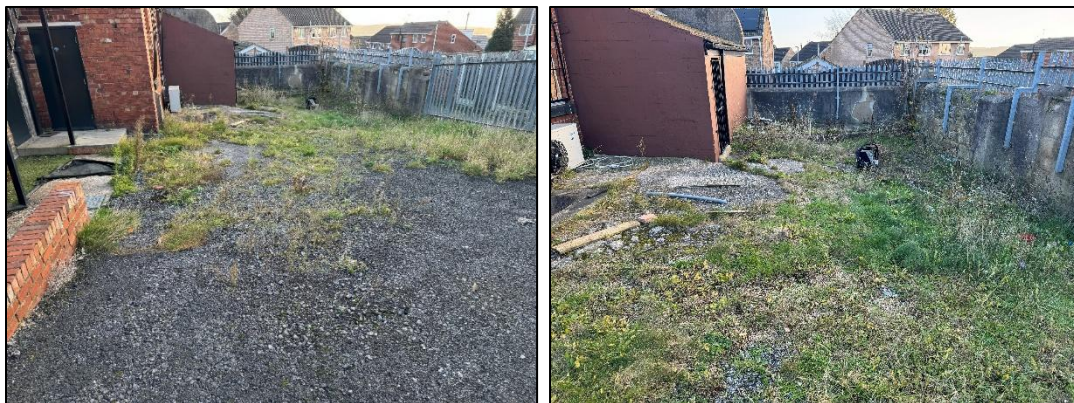
3.2.4.1. Grass and weeds have become established in the southwest corner of the car park as shown below. Vegetation cover is between 10% and 50% and therefore the habitat is assessed to fall within the sparsely vegetated land category.

3.2.4.2. Species present include perennial ryegrass (*Lolium perenne*), cocksfoot (*Dactylis glomerata*), dandelion (*Taraxacum officinale*), white clover (*Trifolium repens*), greater plantain (*Plantago major*), thistle (*Cirsium* sp(p)) and dock (*Rumex* sp.) with one sycamore (*Acer pseudoplatanus*) sapling.

3.2.4.3. The condition assessment for this habitat is within the Statutory BNG Condition Assessment document that accompanies this report. The condition of the sparsely vegetated urban land is poor, passing only one of the criteria.

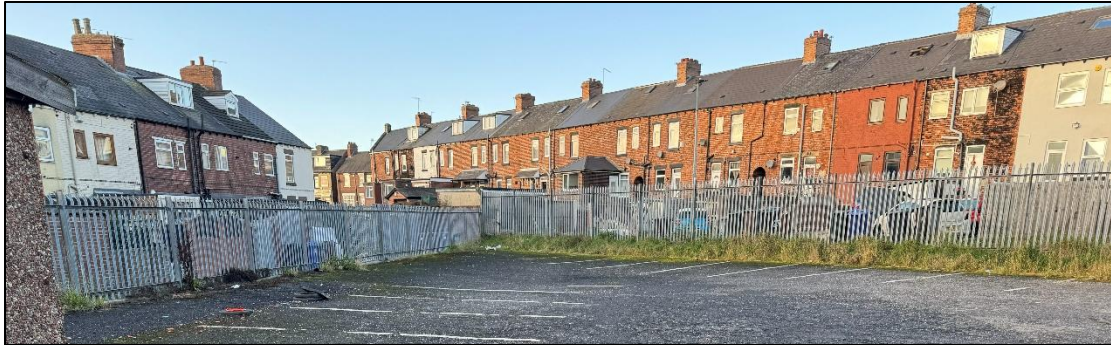
3.2.5.1. There is a palisade fence around the car park.

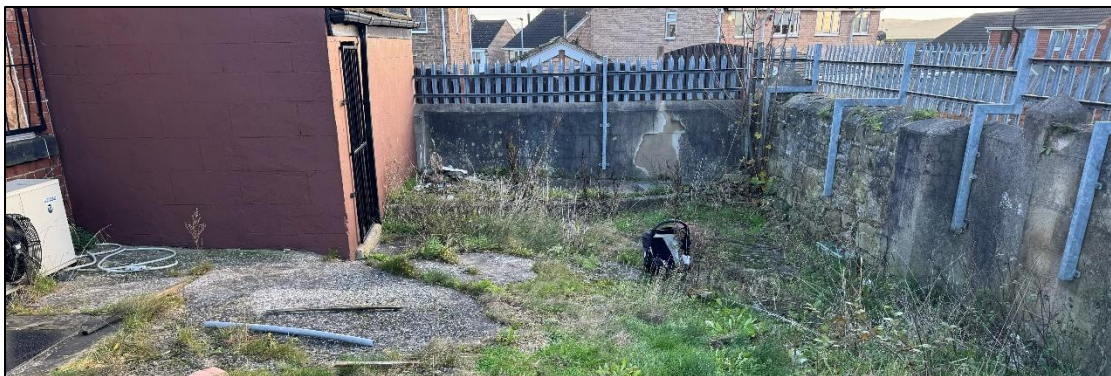
3.2.6.1. There is a mortared stone wall around the southwest corner of the site.

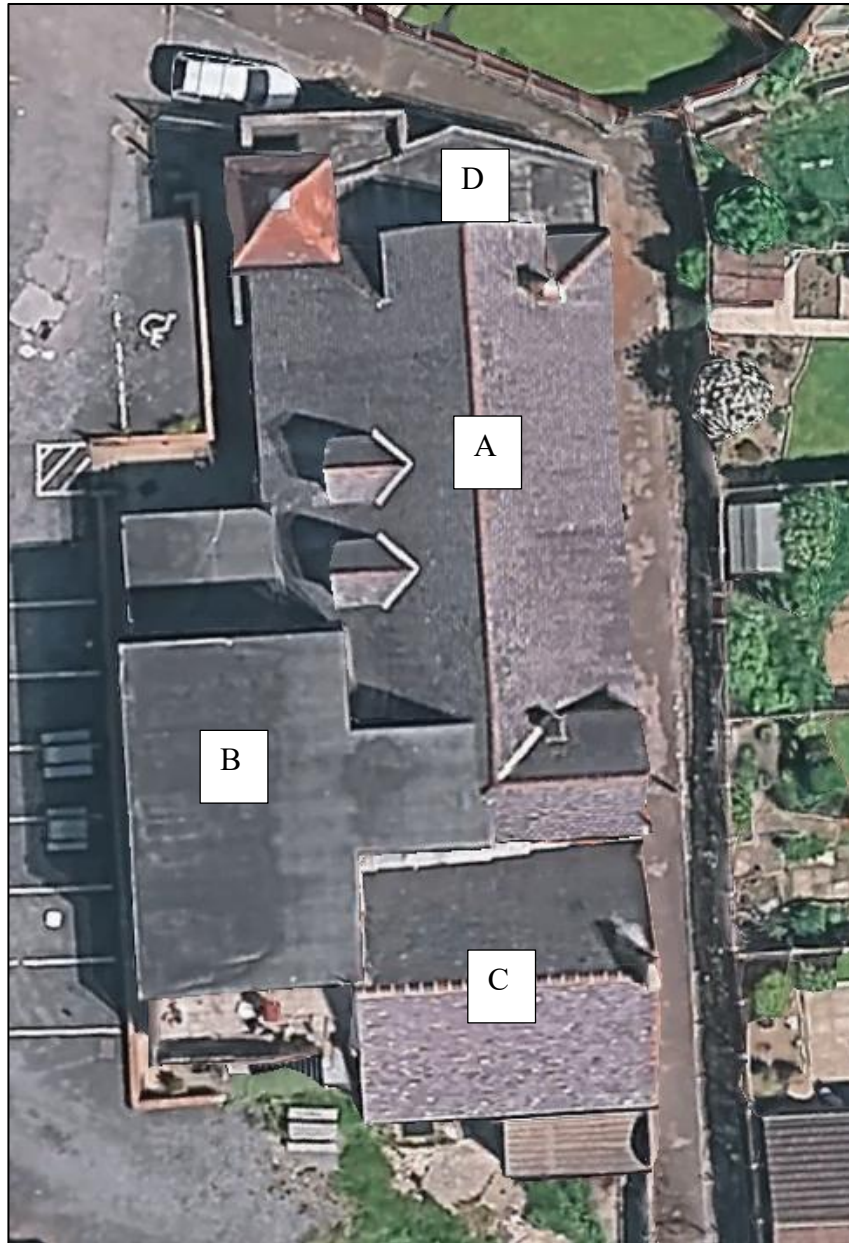
The roof layout of the existing Social Club is shown below. The building logically breaks down into four main sections and each is labelled on the aerial view below and each is dealt with separately below.

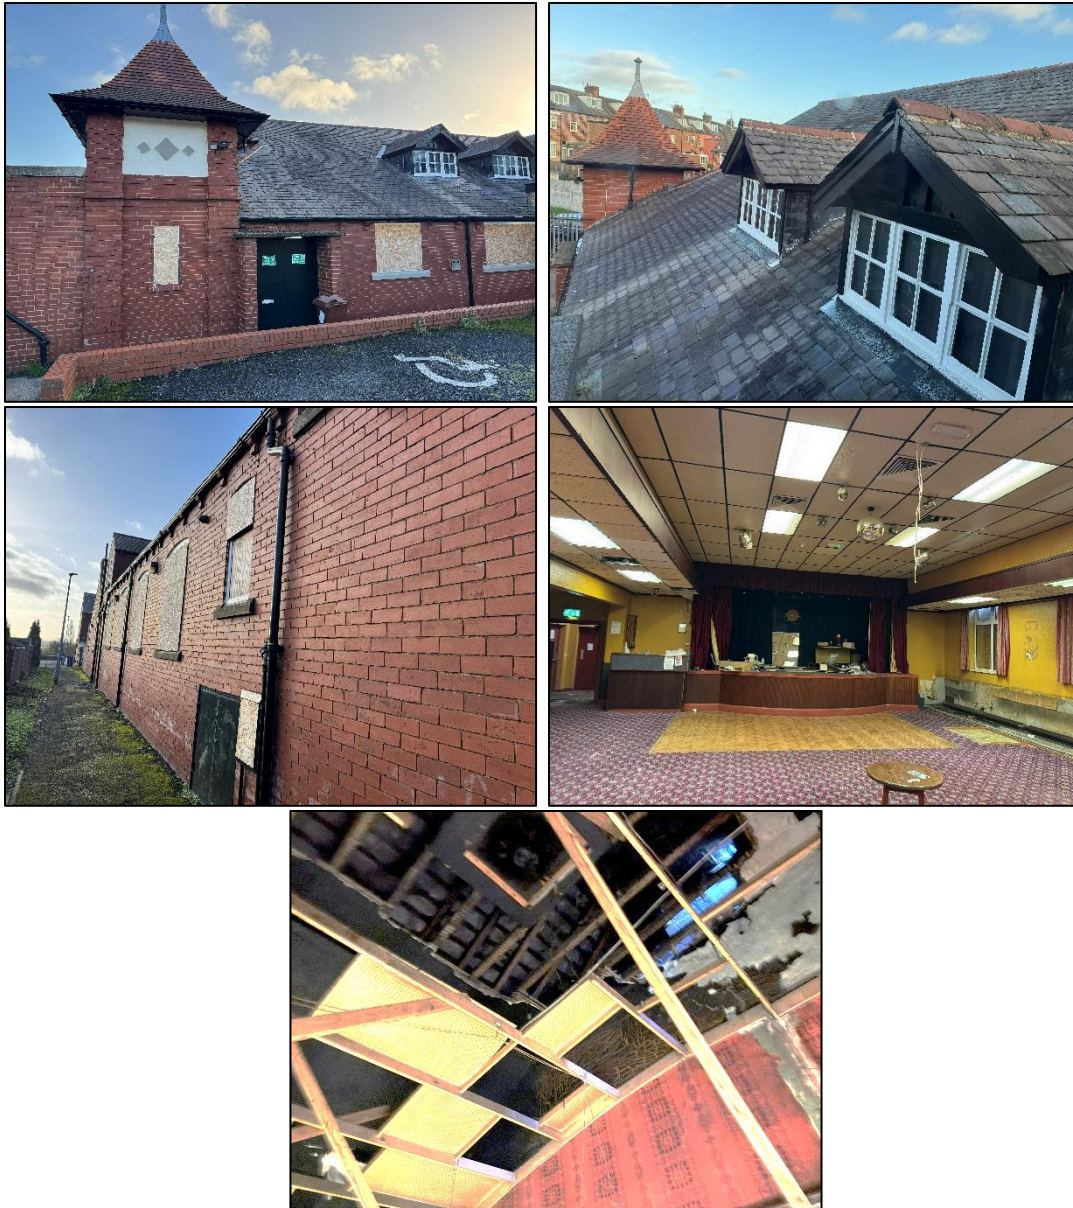
3.3.1.1. This is the main hall of the building and is shown in the photographs below.

3.3.1.2. It comprises solid brick walls with a pitched roof covered with Welsh slates and with decorative dormer windows.

3.3.1.3. The roof is in good condition with all slates in place. The slates are thin and close fitting providing no gaps suitable for roosting bats.

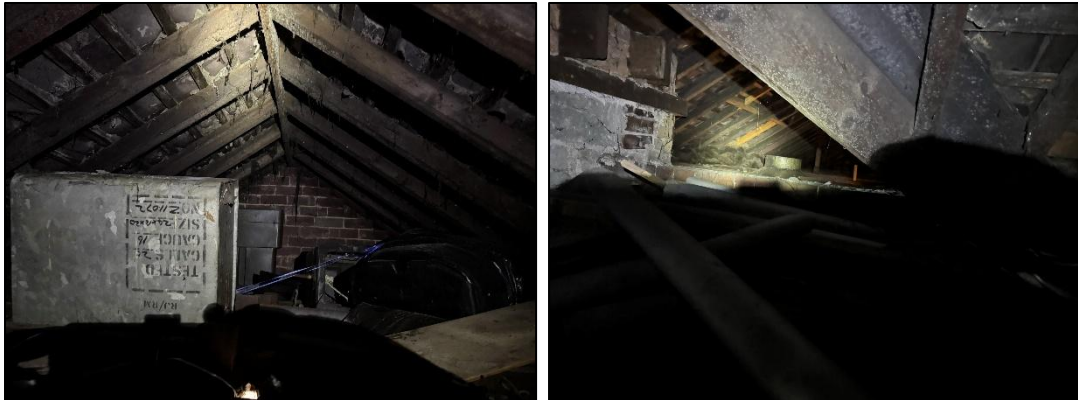
3.3.1.6. There is one loft space south of the concert hall. This is a shallow loft space with no lining beneath the roof slates, an abundance of cobwebs and no bat field signs.

3.3.1.7. No bat field signs were found anywhere within this section of the building.

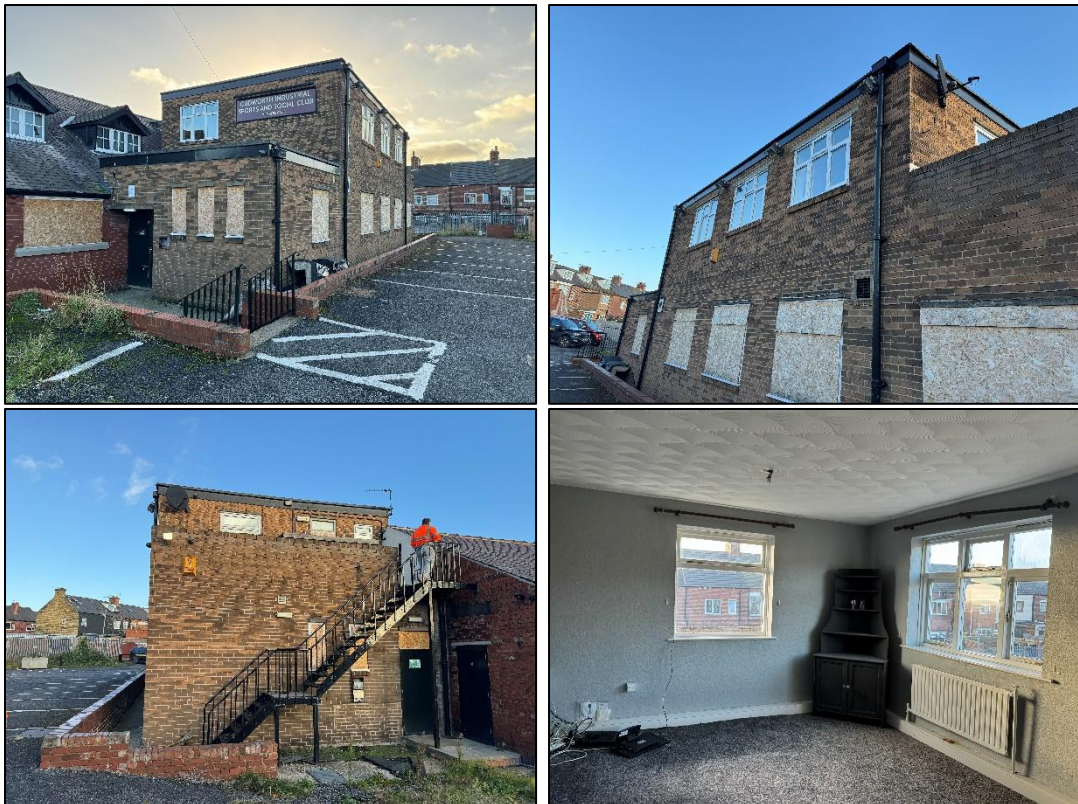
3.3.2.1. This is a more modern extension built with brick cavity walls and a flat, felt covered roof.

3.3.2.2. The windows of this section have been boarded up with plywood sheets. These are close fitting with no gaps around them for roosting bats.

3.3.2.3. This section of the building is in good condition and provides no opportunities for roosting bats.

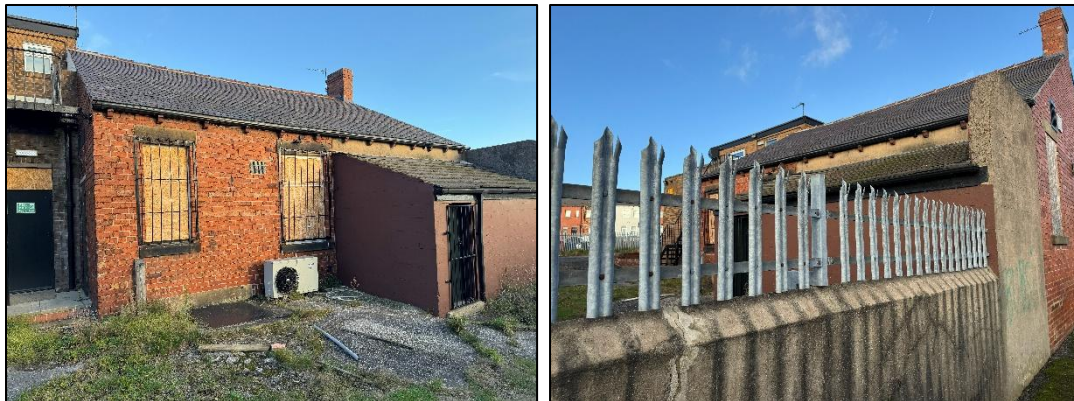
3.3.3.2. The walls of the building are solid brick and are in good condition with boarded up windows.

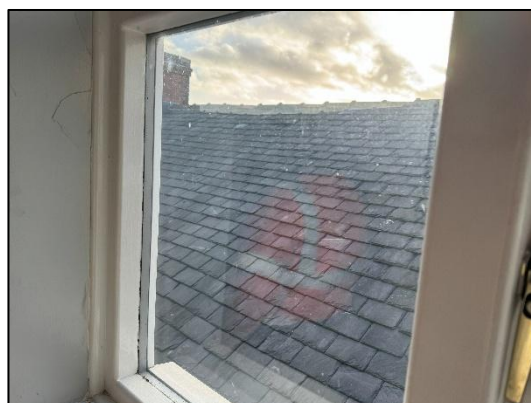
3.3.3.3. The roof is in very good condition and is reported to have been replaced recently. The photograph below shows the roof viewed from an adjacent window.

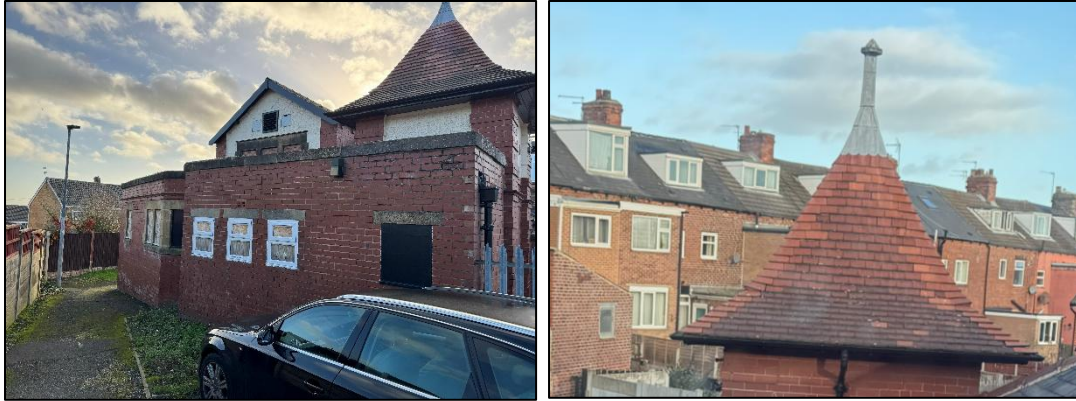
3.3.4.1. At the northern end of the building there is a flat roofed toilet block with an ornamental two storey, square tower, shown below.

3.3.4.2. The solid brick walls are sound and provide no opportunities for roosting bats. The flat roof also provides no opportunities for roosting bats.

3.3.4.3. All of the roof tiles on the pyramid section are in place and sound and these also provide no opportunities for roosting bats.

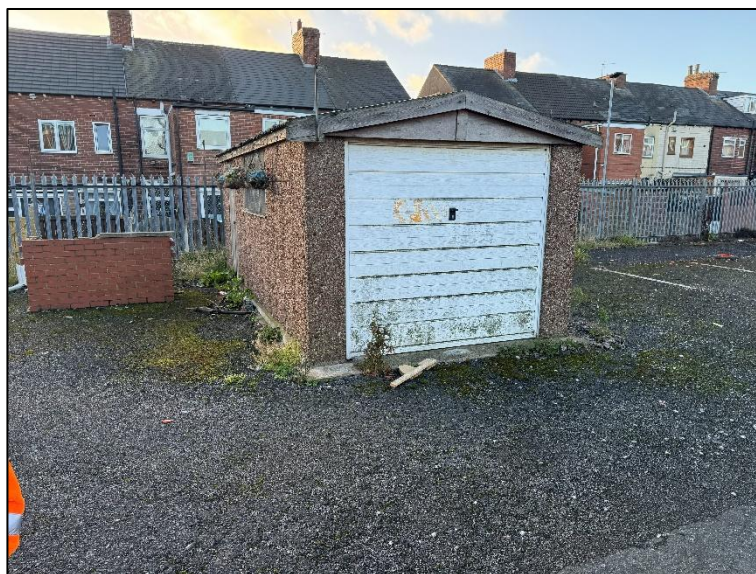
The garage outbuilding is a prefabricated structure, a design that provides no potential for roosting bats.
