BRAMPTON ROAD, WOMBWELL

Preliminary Bat Roost Assessment Report

April 2026

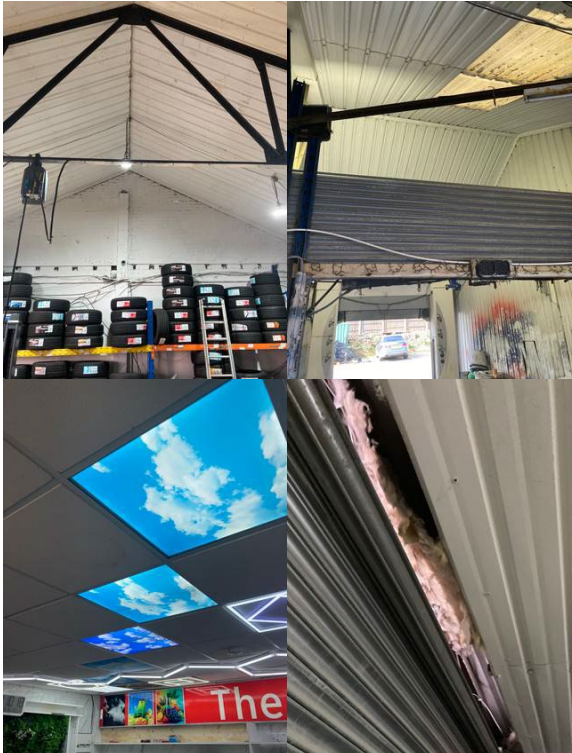
Table 3.2.1 PRA Details

Description	Photographs
	External Aspect
<p>The corrugated metal roof was in good condition throughout with no lifted panels identified to provide features or access points for bats. The redbrick walls were also in an overall good condition although a few gaps within the brickwork were noted on the northern aspect of the building. There were small gaps at the top of the wall on two points on the northern aspect where the fascia board met the brickwork, this was identified as a PRF (Potential Roosting Feature) and/or potential access point.</p> <p>A final gap was also identified on the northern aspect on the flat roof section of the building associated with a gap between the brickwork and metal shutter. This was not identified as a PRF as it is anticipated to be frequently used but was identified as a potential access point into the building.</p> <p>A gap was identified on the southeastern aspect of the building associated with the signage of the commercial unit where the signs had become loose, this was identified as a</p>

Description	Photographs
<p>PRF.</p> <p>A gap was located at the top of a pebble dashed wall on the southern aspect of the building where it meets the flat roof. This was identified as a PRF and/or access point into the building. A sign made up of cladding was also located on the southern aspect of the building where a small crevice was identified, this was identified as a PRF.</p> <p>Finally, on the western aspect a gap between the metal fascia and redbrick wall was identified. This was identified as a sub-optimal PRF for roosting bats as it is anticipated to fluctuate in temperatures.</p> <p>A roadside vehicle service facility was connected to the building on the eastern aspect; this was a large, flat roofed canopy supported by vertical steel columns. The roof was made up of corrugated metal with signage made up of cladding running along the front. This feature was found to be fully exposed; there were no gaps or crevices identified along this aspect of the building that could support roosting bats.</p>

Description	Photographs
<p>The internal aspect of the corrugated metal roof was found to be single layered which is exposed internally with no void present that could be used by local bats. The flat roof section of the building has vaulted and metal ceilings both of which are not anticipated to be of value for bats with no loft void present within the building.</p> <p>One crevice between the wall and metal shutter was identified internally, this was made up of insulation. This was identified as a sub-optimal feature for roosting bats with the fibres of the insulation anticipated to deter roosting individuals.</p> <p>The gaps in the brickwork on the northern aspect were not visible from the internal inspection, with exposed painted red brickwork only. This was discounted as an access point and provided suboptimal roosting opportunities for roosting bats due to the exposure of the feature.</p> <p>There was no evidence of roosting bats identified within the building.</p>

3.2.2. Overall, the building was assessed as having **low bat roosting potential** due to the presence of multiple potential roosting features providing suitability for individual roosting bats and habitat suitability within the local area. The building did not have any features that could be utilised by roosts of higher conservation value due to the lack of voids suitable to support roosts of higher conservation value.

- 4.1.1. The building was found to have **low bat roosting potential** and therefore in accordance with best practice guidance (Collins, 2023), **one nocturnal bat survey** should be undertaken between May-August (inclusive) to determine usage by roosting bats.
- 4.1.2. The results of the further surveys will determine if any mitigation is required for roosting bats. If roosting bats are located within any of the buildings, a Natural England Mitigation Licence may be required for development to proceed. The Licence can only be obtained once planning permission has been granted and all wildlife conditions discharged. However, the bat emergence surveys must be undertaken prior to planning permission being applied for as they are a material consideration
