# Bat Survey DVSA Weighbridge Barnsley

Preliminary Roost Assessment for Bats

2486947

FEBRUARY 2024

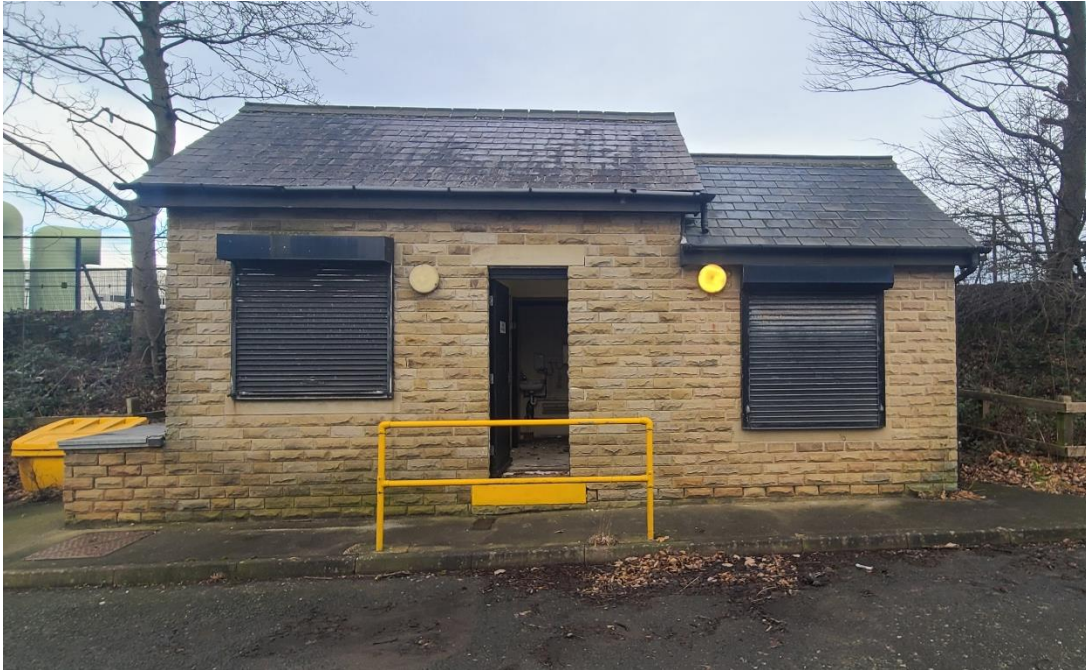
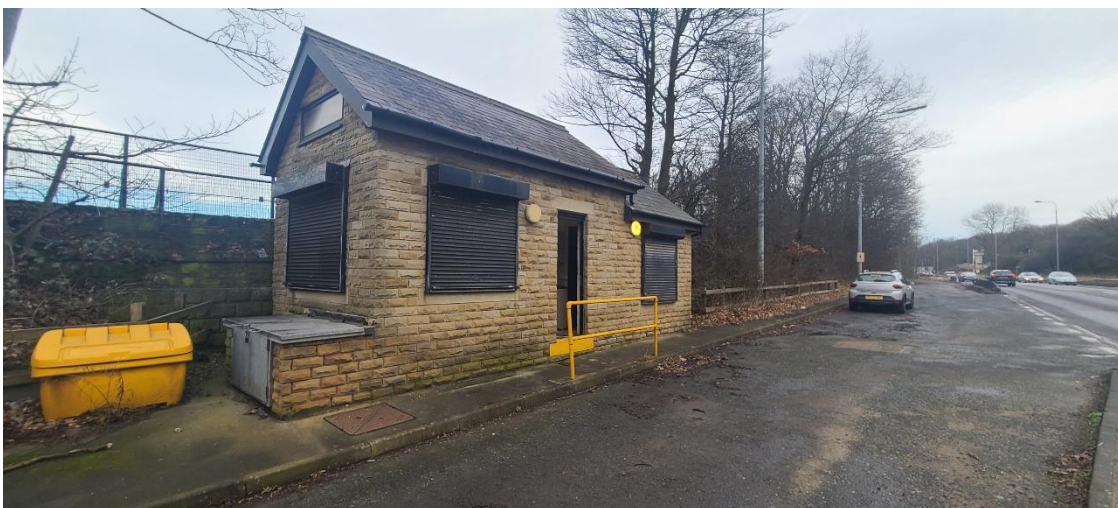
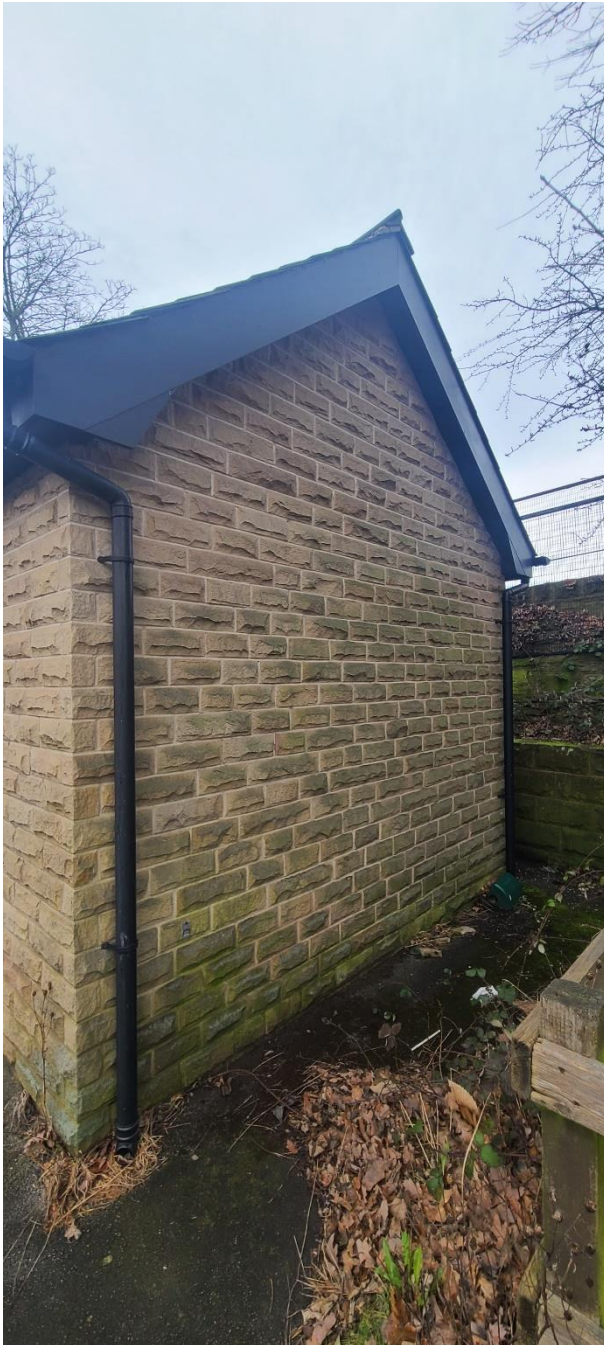
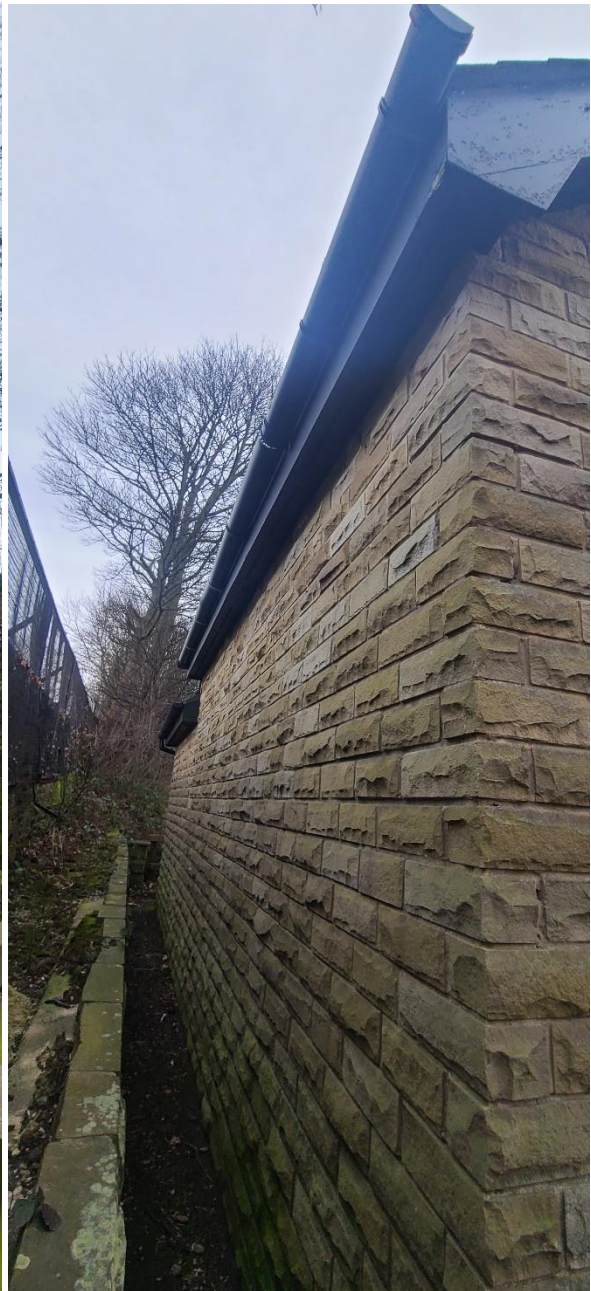
- 3.1.1 The surveyed building is a stand-alone, brick built, single-story construction with a pitched slate tile roof, with gable ends facing north east and south west. The structure was split into two sections with separated loft voids. The buildings windows were affixed with metal security shutters (Plates 1-4). The structure was in good condition.

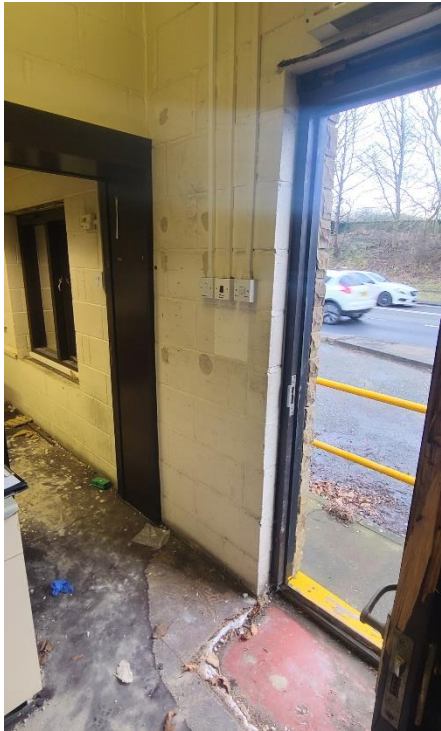
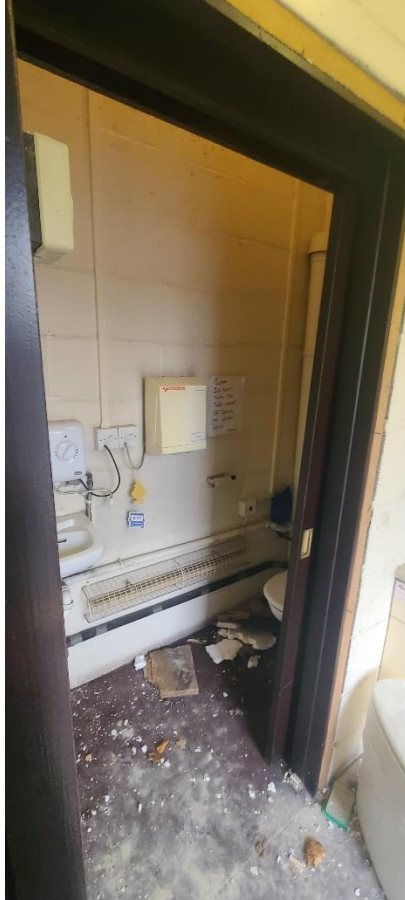
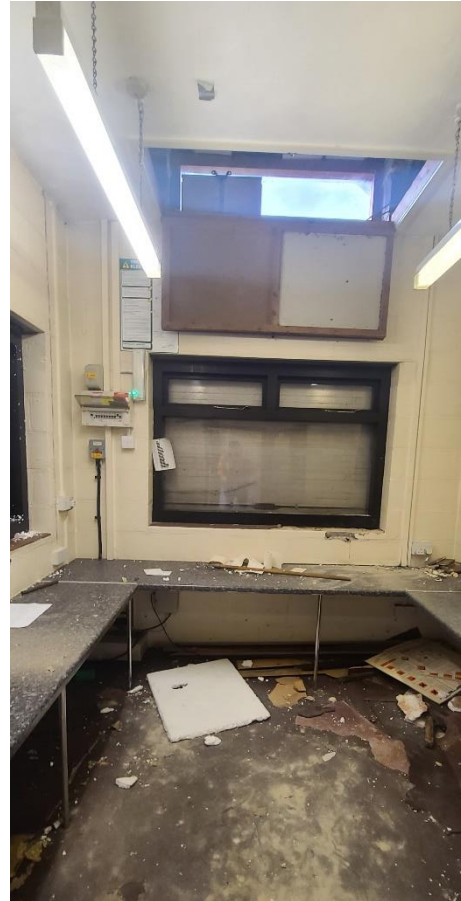
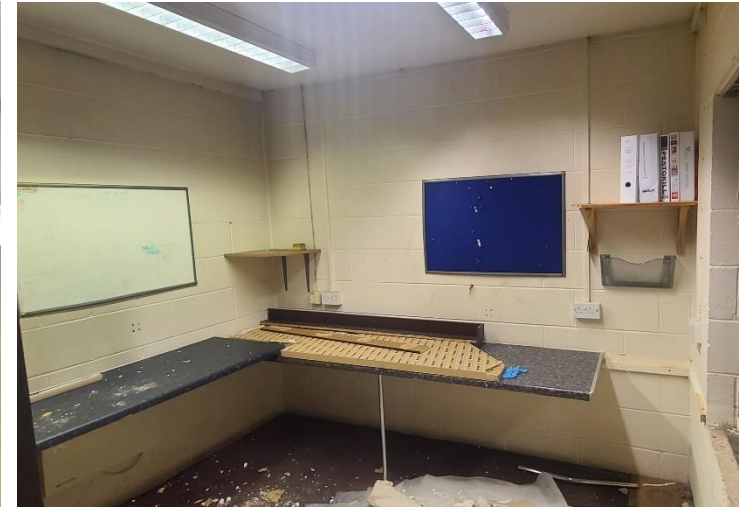
- 3.1.2 The interior of the building was separated into four separate rooms: the entry hall (Plate 5), toilet (Plate 6), south west office (Plate 7) and north east office (Plate 8). The two offices had open loft hatches into the separated insulated loft voids (Plate 9, 10).
- 3.1.3 No bat droppings, grease marks, feeding debris or other signs of bat habitation were observed inside the building.

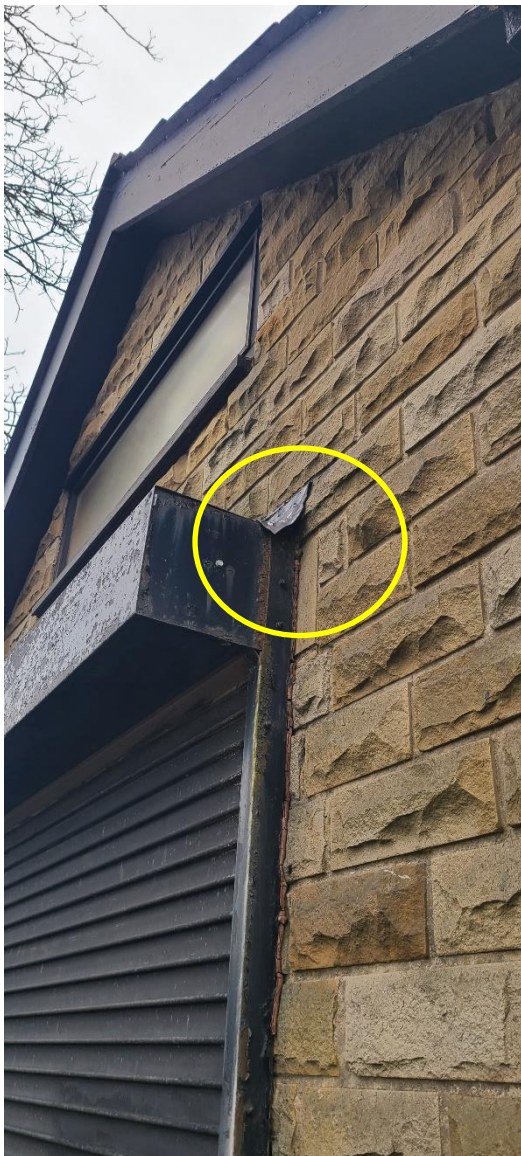
Plate 11

- 3.2.1 A small section of lifted flashing was observed on the western gable end wall above the roller shutter window cover providing low potential for roosting bats (Plate 11, T1 - Figure 1).
- 3.2.2 On the western gable end wall, a hole was observed within the south east facing aspect soffit box end cap, which allowed entry into the south west loft void of the building, providing high potential for roosting bats (Plate 12, T1 - Figure 1).

- 4.2.1 Due to the high potential of the building to support bats, it is recommended that three emergence or re-entry surveys are conducted to identify whether bats are using the building or potentially absent. These surveys are also used to categorise the type of roost (if bats are present) and to inform possible future licence applications.
- 4.2.2 These surveys must be carried out within the bat active season (May to September inclusive), with at least one survey between May and August, at least two weeks apart.

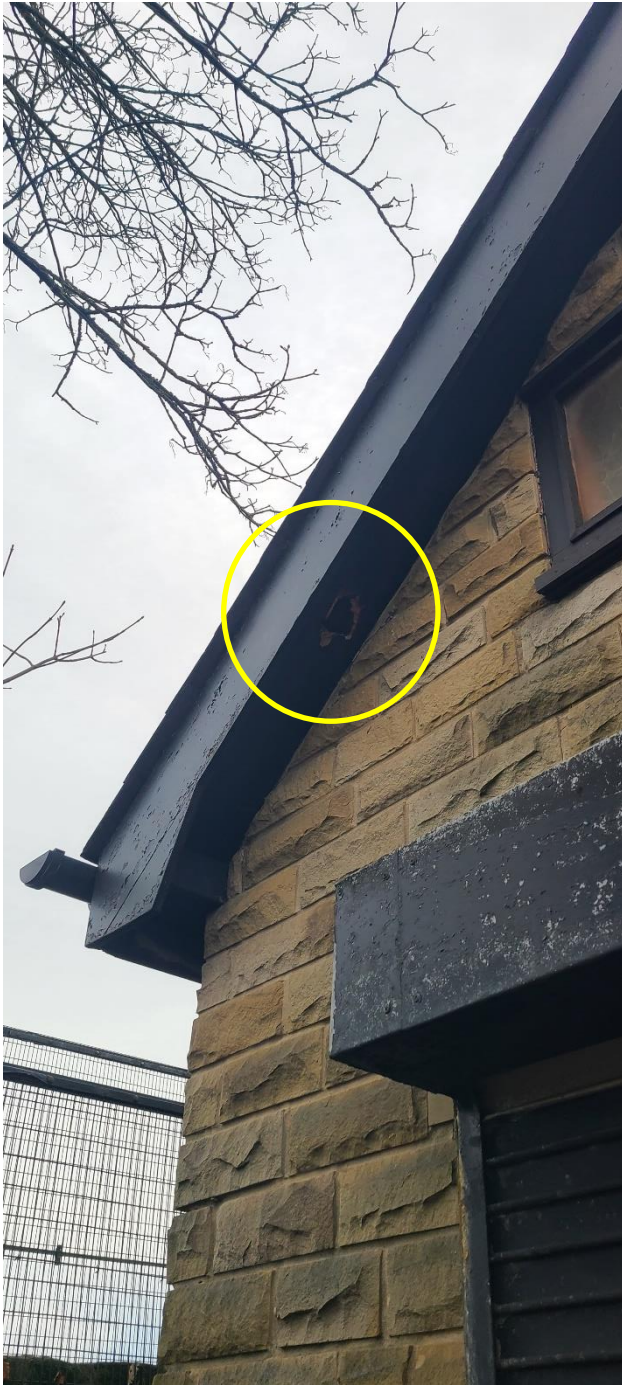
Plate 13

- 3.2.3 On the western end gable soffit box, a large hole was observed, allowing access to the southern loft void, and providing high bat roosting potential (Plate 13, T2 – Figure 1).
- 3.2.4 A similar hole was observed on the north west aspect (rear of the building) soffit box, providing flight access to the north east loft void, providing high potential for roosting bats (Plate 14, T3 – Figure 1).
