**Barnsley Schools  
Extended Phase 1 DRAFT Report**

**August 2006**

## 1.1 Introduction

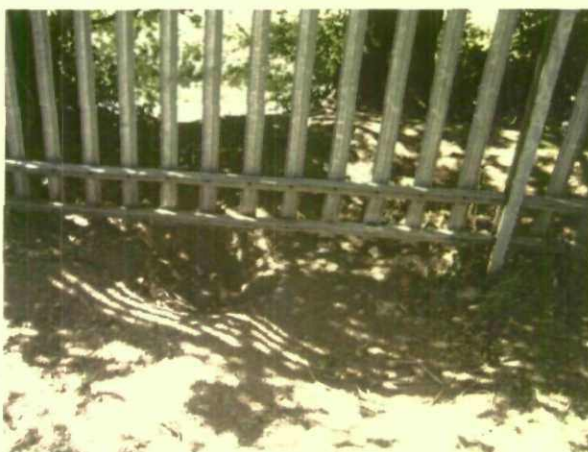
**Figure 1: gap under school fence, with animal run beyond**

An area of dense plantation woodland can be found at the south western corner of this site. This contains a variety of semi-mature and scrub species of birch, Scots pine, sweet chestnut (*Castanea sativa*), sycamore, oak, rowan (*Sorbus aucuparia*), hazel and hawthorn. Potential badger activity was noted within this area, with three access points under the school security fencing (see Figure 1).

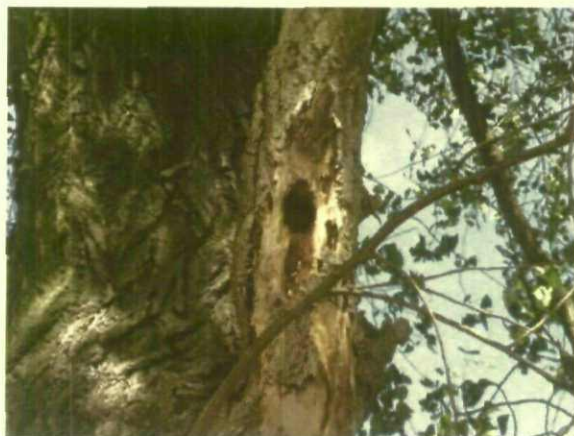
**Figure 2: Potential bat roost in poplar (TN 02)**

There are a number of mature trees scattered across this site. Those of ecological value include the mature poplars and aspen (*Prunus tremula*) to the north west of the site (TN 02), and to the north east of the site, one of which has bat potential (TN 01).

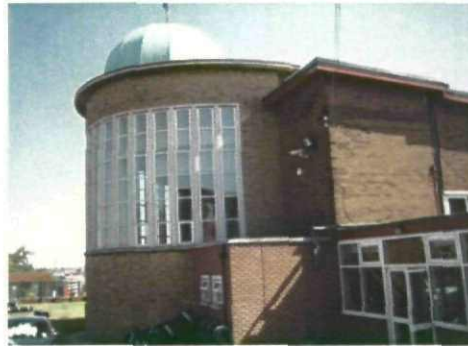
**Figure 1: Main Hall and Chapel**

This building consists of a large brick-built single-storey hall with a rounded stone frontage that forms the chapel. The hall has a flat bitumen roof, with wooden framed windows. The building is generally in a good state of repair, and the few holes noted were covered in cobwebs. The bitumen-clad roof overhangs the walls, with wooden soffits and plastic down-pipes to the main building. The chapel has a rounded dome, sitting on top of a flat concrete roof. Concrete slabs overhang the circular walls, with no apparent gaps seen. The large windows, all uPVC, are intact. There is no evidence of bats using this building.

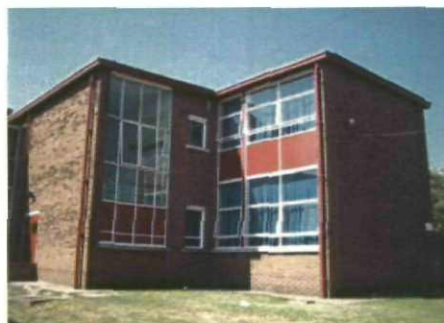
**Figure 2: Main Block**

The main block is constructed of brick and ranges from one to two storeys, and has a flat bitumen roof, wooden window frames, soffits and fascias, and concrete lintels. There were gaps seen between the brickwork of the main block (rooms 1-5), but no signs of bats were seen. The few remaining holes seen were covered in cobwebs, suggesting that bats are not using the buildings.

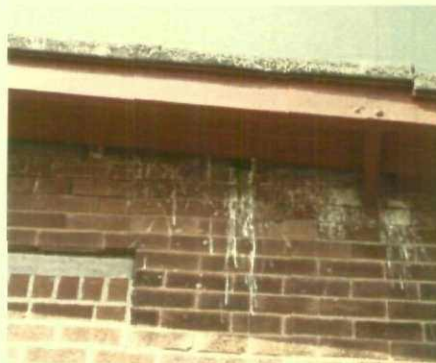
**Figure 3: Boiler House**

The only other building considered to have any potential value for bats is the boiler house, as there are gaps at the top between the brickwork and the wooden soffits. However, bird droppings can clearly be seen around these holes. As bats and birds tend not to co-exist within such structures (Drewitt 2006), it is assumed bats are not roosting within this building.

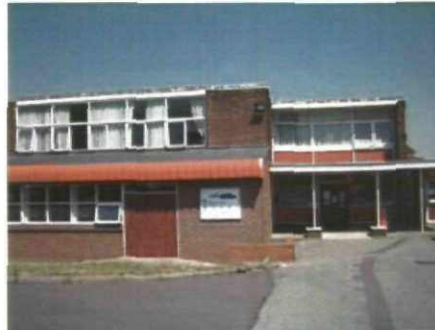
**Figure 1: Main Reception**

The majority of the school buildings date from the 1960's, and are redbrick structures with flat bitumen roofs with synthetic guttering and overhangs. Except for the caretakers house and boiler room, few opportunities were seen within this school for bats. Whilst some of the buildings were in a general state of disrepair, few gaps were seen. There was also a lack of suitable foraging habitat surrounding most of the buildings.

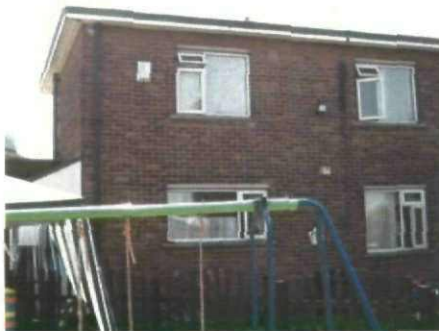
**Figure 2: Caretakers House**

A redbrick two-storey structure, with a flat roof. A hole within the soffits, facing the boiler house, was identified. Anecdotal reports exist of bats emerging from this hole during the preceding weeks.

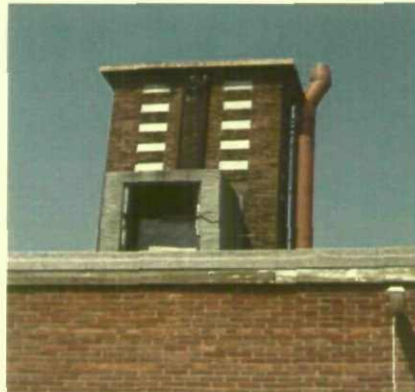
**Figure 4: Boiler House**

The boiler house & water tower have potential for bats, and a false ceiling means access to this area was not possible.

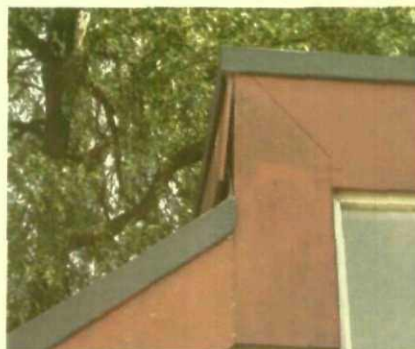
**Figure 5: Loose Bargeboards, Technology**

Gap in bargeboards between the technology rooms (Figure 5), and at the rear of the science block, did not reveal any evidence of bats.

Technology (loose barge-boards).

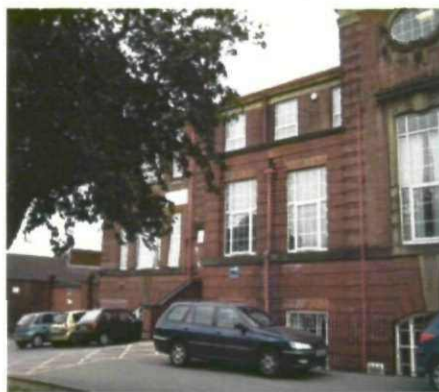
**Figure 1: Frontage of main building and reception**

The frontage of this school is dominated by a redbrick building dating from 1908, consisting of two storeys with a basement, and a pitched slate roof (Figure 1). This building is known as A-block. Running parallel to this building, at the rear, is B-block, a later building of similar style (circa 1920). Due to the age and design of these buildings (e.g. sloping tiled roofs and overhangs, roof spaces), they are considered to have bat potential, and a full internal inspection of any roof voids is recommended. There were a number of loose tiles to the front of the main building, and loose tiles and some loose flashing to the rear and sides of B-block.

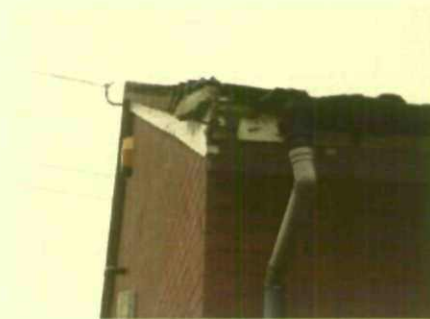
**Figure 3: C - Block (kitchens), gap and missing/loose tiles**

C-block, which is to the left of the main building, is a modern redbrick building with a sloping concrete-tiled roof. To one corner of this building can be found several missing or loose tiles and a hole with potential bat access (Figure 3).

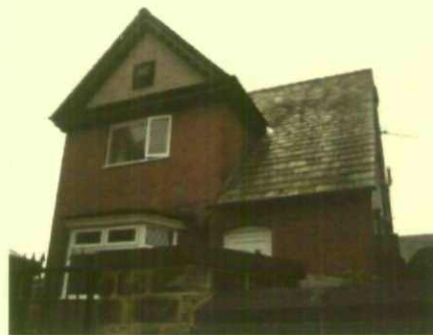
**Figure 4: Caretakers House**

The caretakers house, dating from 1911, is a two-storey redbrick structure with a gable end and a pitched, tiled roof. The chimney flashing is intact, but the presence of some loose tiles means that this house also has bat potential, and an internal inspection is again recommended.

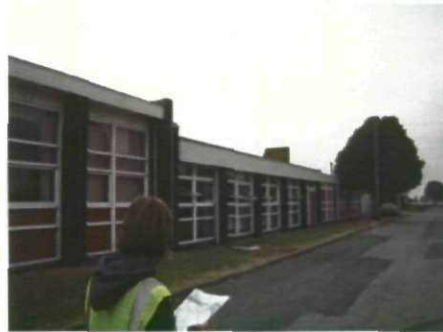
**Figure 1: North building**

This school is divided into two main sections, known as the North and South Buildings. The north building dates from the 1960's, and ranges from one-two storeys. This area also includes the ex-caretakers house. The buildings in this region do not appear to have any bat potential.

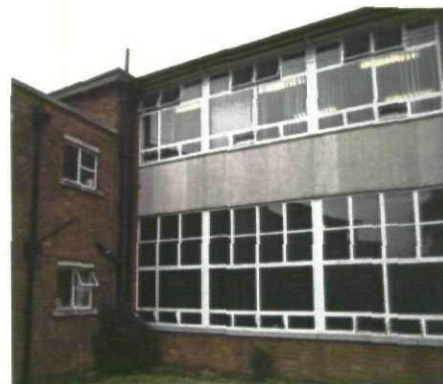
**Figure 2: South building**

The south building (Figure 3) dates from the 1950's, and this area includes the sports hall, performing arts and the water tower. This area also includes the caretakers house and the boiler house. The caretakers house has a gap in the brickwork on the side facing main reception (Figure 3). This building is also covered in ivy and has good surrounding habitat (well-developed gardens with trees and shrubs).

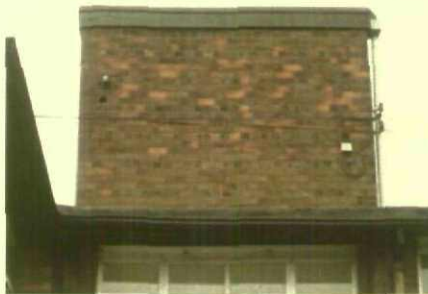
**Figure 4: Gap in brickwork in water tower**

There is a hole in the brickwork in the water tower at the back of the old performing arts building (Figure 4) that has bat potential.

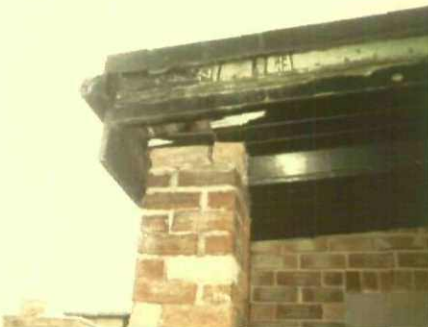
**Figure 5: Loose soffits/bargeboards in the region of the I-T suite**

There are also loose bargeboards in the region of the I-T suite, to the corner of the south building opposite the row of poplar trees (Figure 5).

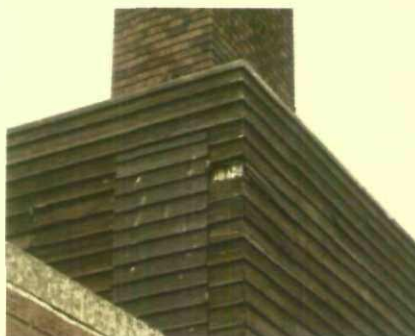
A small school, dating from the 1960's. One potential bat roost was identified in the boiler room, where bat access is possible via loose barge boards. An internal inspection for evidence of bats is recommended for this building.

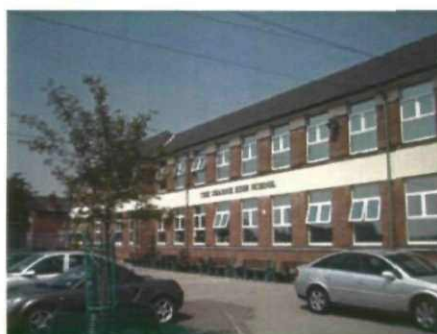
**Figure 1: main building frontage**

The main building dates from the 1930's (Figure 1). The building is redbrick, with a sloping tiled roof, and wooden soffits. An internal roof void inspection is recommended for all areas where possible. The frontage has one hole to the right of the main entrance, and some loose soffits (Figure 2).

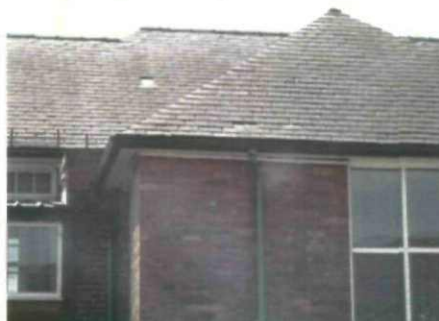
**Figure 3: missing roof tiles in quad**

Within this building are three quads. The quad to the east has some bat potential, as roof tiles are missing, and gaps exist in soffits (Figure 3).

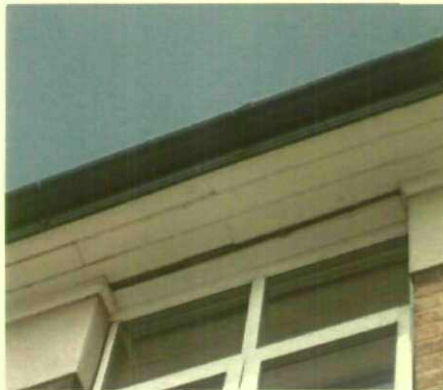
**Figure 4: loose soffits at rear of main building**

The rear of the old building (facing the new block) has one area of loose soffits (Figure 4).

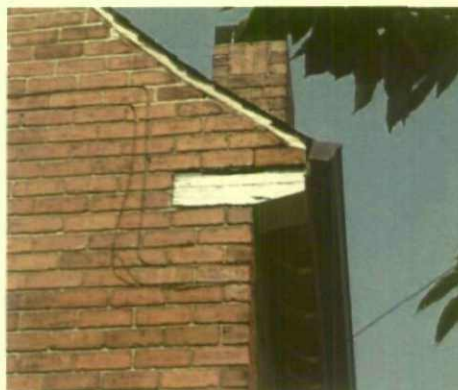
**Figure 5: caretakers house**

The caretakers house, a redbrick two-storey house with a pitched sloping roof has some bat potential, as there is loose brickwork in one corner (Figure 5). As a result, an internal inspection of this building, and of the other buildings with bat potential at this school, are recommended.

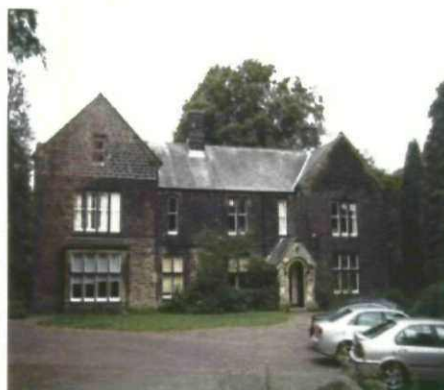
**Figure 1: Weirfield building**

The oldest building within the grounds of the school (1850). Built from traditional Yorkshire stone, with a pitched roof over two-three storeys, the building has two gable ends, two chimney-stacks, and one skylight. All flashings appear intact except at the base of one chimney-stack, and one missing tile was noted. The house has outbuildings, in a general state of disrepair.

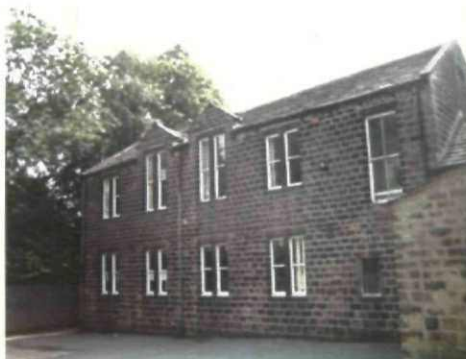
**Figure 2: C-block**

A stone building, with a pitched roof and stone tiles. Two dormer windows have missing stone tiles on either side.

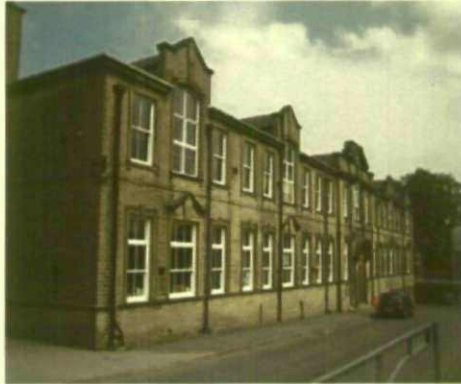
**Figure 3: Fulford building**

A large stone-built building with two-three storeys (circa 1910), with a pitched, slate roof. There are five dormer windows, all apparently intact. Some loose tiles were seen, but the building is generally in a good state of repair.

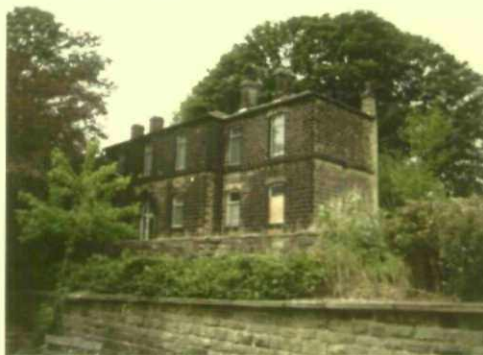
**Figure 4: one of the sixth form buildings**

A collection of houses, buildings and barns dating from around 1850-1900. The buildings are in varying states of disrepair. There is one large building adjacent to the B6462, and a further 7-8 connecting houses in a cross-formation, further east. In addition, there are two small outhouses, or barns, within a masonry wall dividing the Netherfields area from the main body of the school to the north. There are gaps in the brickwork throughout most of these buildings, and many loose and missing roof and ridge tiles. As a result, internal inspections of these buildings for their potential to support roosting bats, is recommended, in addition to all other suitable buildings.

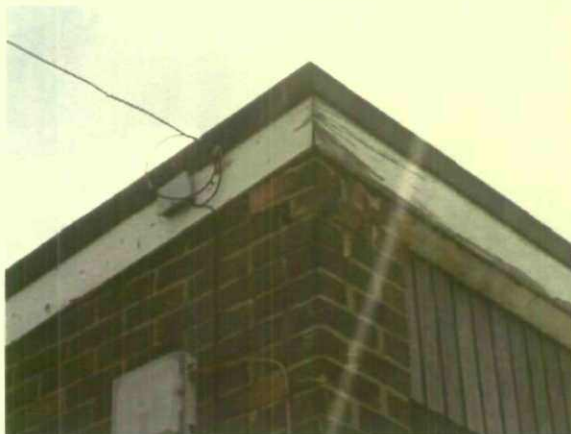
**Figure 1: loose brickwork at corner of dining room**

A modern 1960's school with extensive grounds. Only one potential bat roost was noted within the school buildings, at the corner of the dining room (Figure 1)

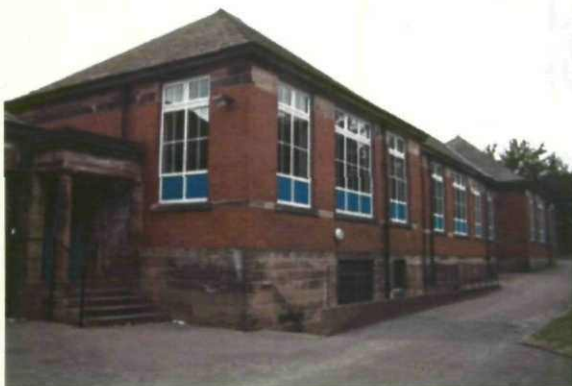
**Figure 1: English & Special Needs (1930's buildings)**

Two large square buildings to the east and north of the site, which form the original school buildings (Figure 1). They are both redbrick structures, with basement cellars, and pitched slate-tiled roofs. There are a number of loose and missing roof tiles on both buildings, in addition to loose flashing around the joins between some buildings.

Both buildings have been subjected to modifications, including the replacement of the traditional window frames with uPVC double-glazing throughout. In places, modern guttering and soffits have replaced the traditional stone and wooden structures. Where the traditional features still exist, gaps have appeared in some of the stonework, especially around stone entrance porches.

It is recommended that internal inspections be carried out on all roof voids within the older buildings to the east, in order to look for evidence of bats.

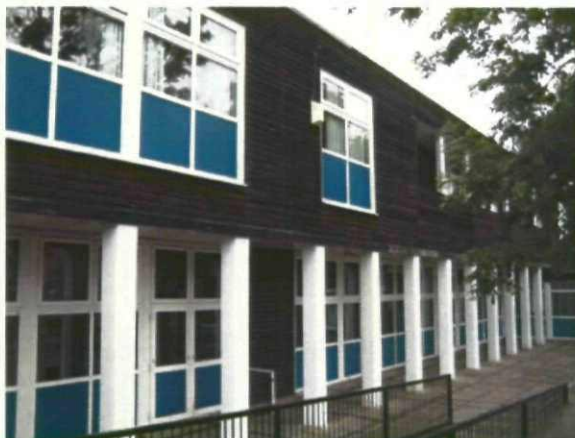
**Figure 4: main hall, eastern face**

Most of the modern buildings have restricted bat potential. These buildings tend to have flat bitumen-covered roofs, and have wooden fascia boards covering all external walls. Most of these are intact. Where gaps exist, such as in Figure 5, the holes do not appear to lead into crevices that would be considered suitable as bat roosts. Missing grills to a vent above an entrance to the science block allowed for potential access for bats into the roof space above (Figure 6), but no actual signs of bats (droppings, stainings) were seen.
