**ARBORICULTURAL METHOD STATEMENT  
to BS 5837:2012  
at  
New Road  
Pilley  
Barnsley  
South Yorkshire  
S75 3BQ**

13039a/SR – amended 03.04.17

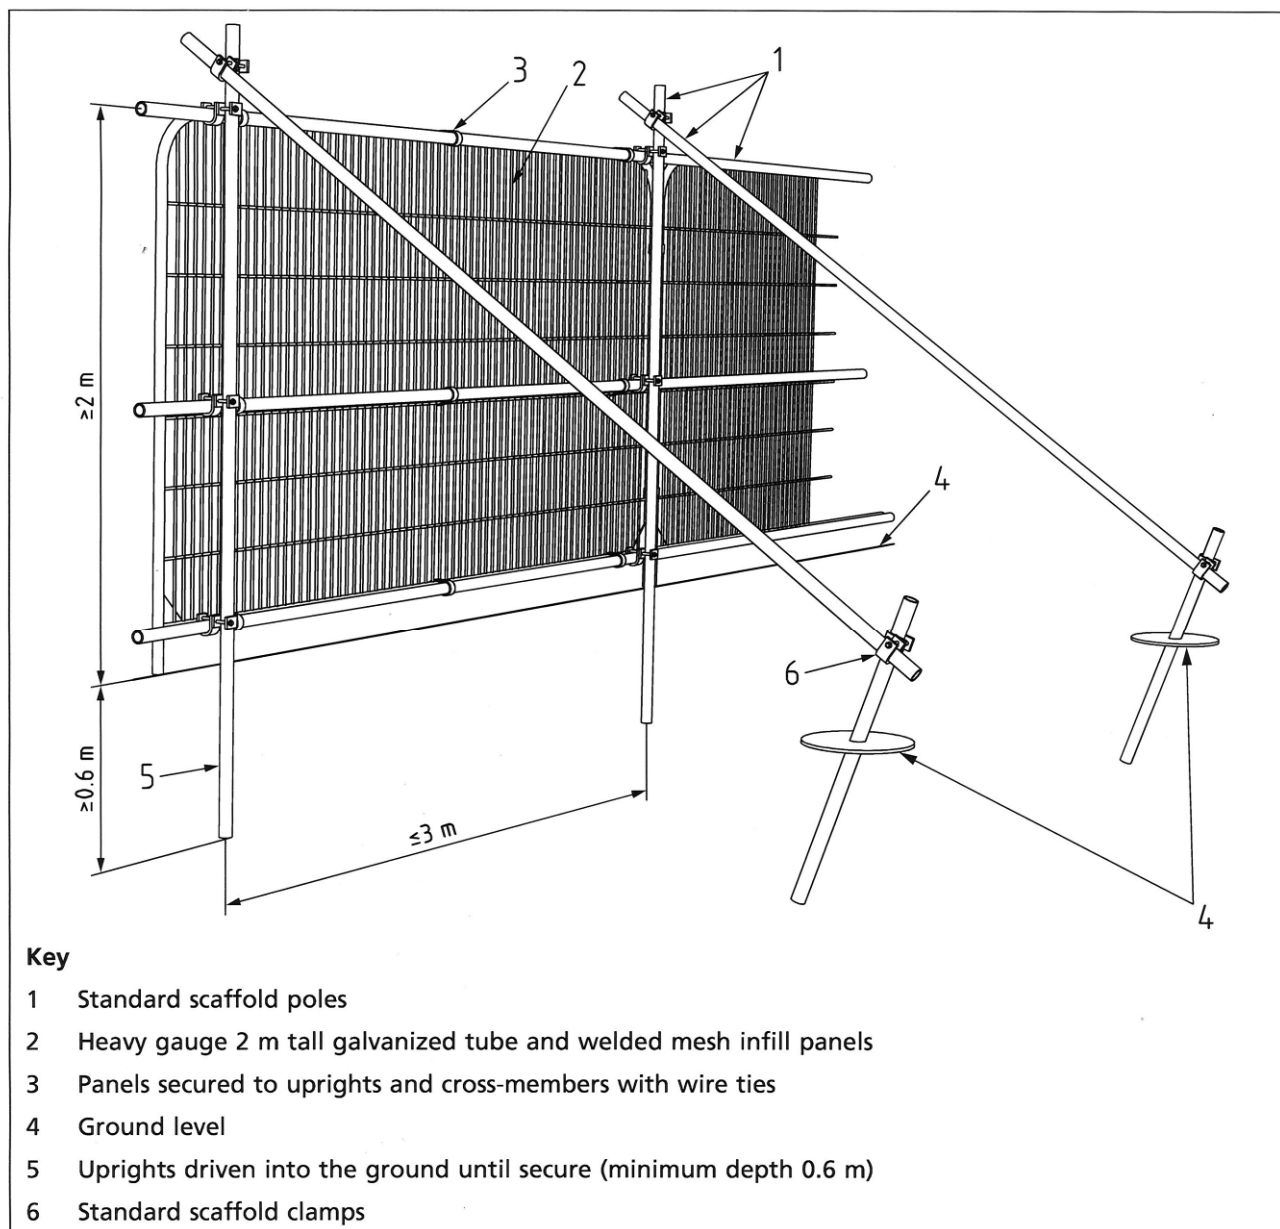
Figure 1: 'Protective Barrier to BS 5837: 2012'. To be used where situated in open ground.

- 3.1.4 The protective fencing will be installed in accordance with BS 5837: 2012 and will comprise of a vertical and horizontal scaffold framework, well braced to resist impacts. The vertical tubes should be spaced at a maximum interval of 3m and driven securely into the ground, taking care to avoid underground services and structural roots. Finally, weld mesh panels are to be securely fixed on the scaffold framework. Please refer to **Appendix 2 (Fig 1)** for protective fencing details.

A2.1 The protective barrier will be installed in accordance with BS5837: 2012. The default specification of BS 5837: 2012 (pictured below for reference) recommends a vertical and horizontal, scaffold framework, well braced to resist impacts, with vertical tubes at no more than 3m intervals. These should be driven into the ground. Weld mesh panels should be affixed to this framework with scaffold clamps - See Figure 1 and Figure 2.

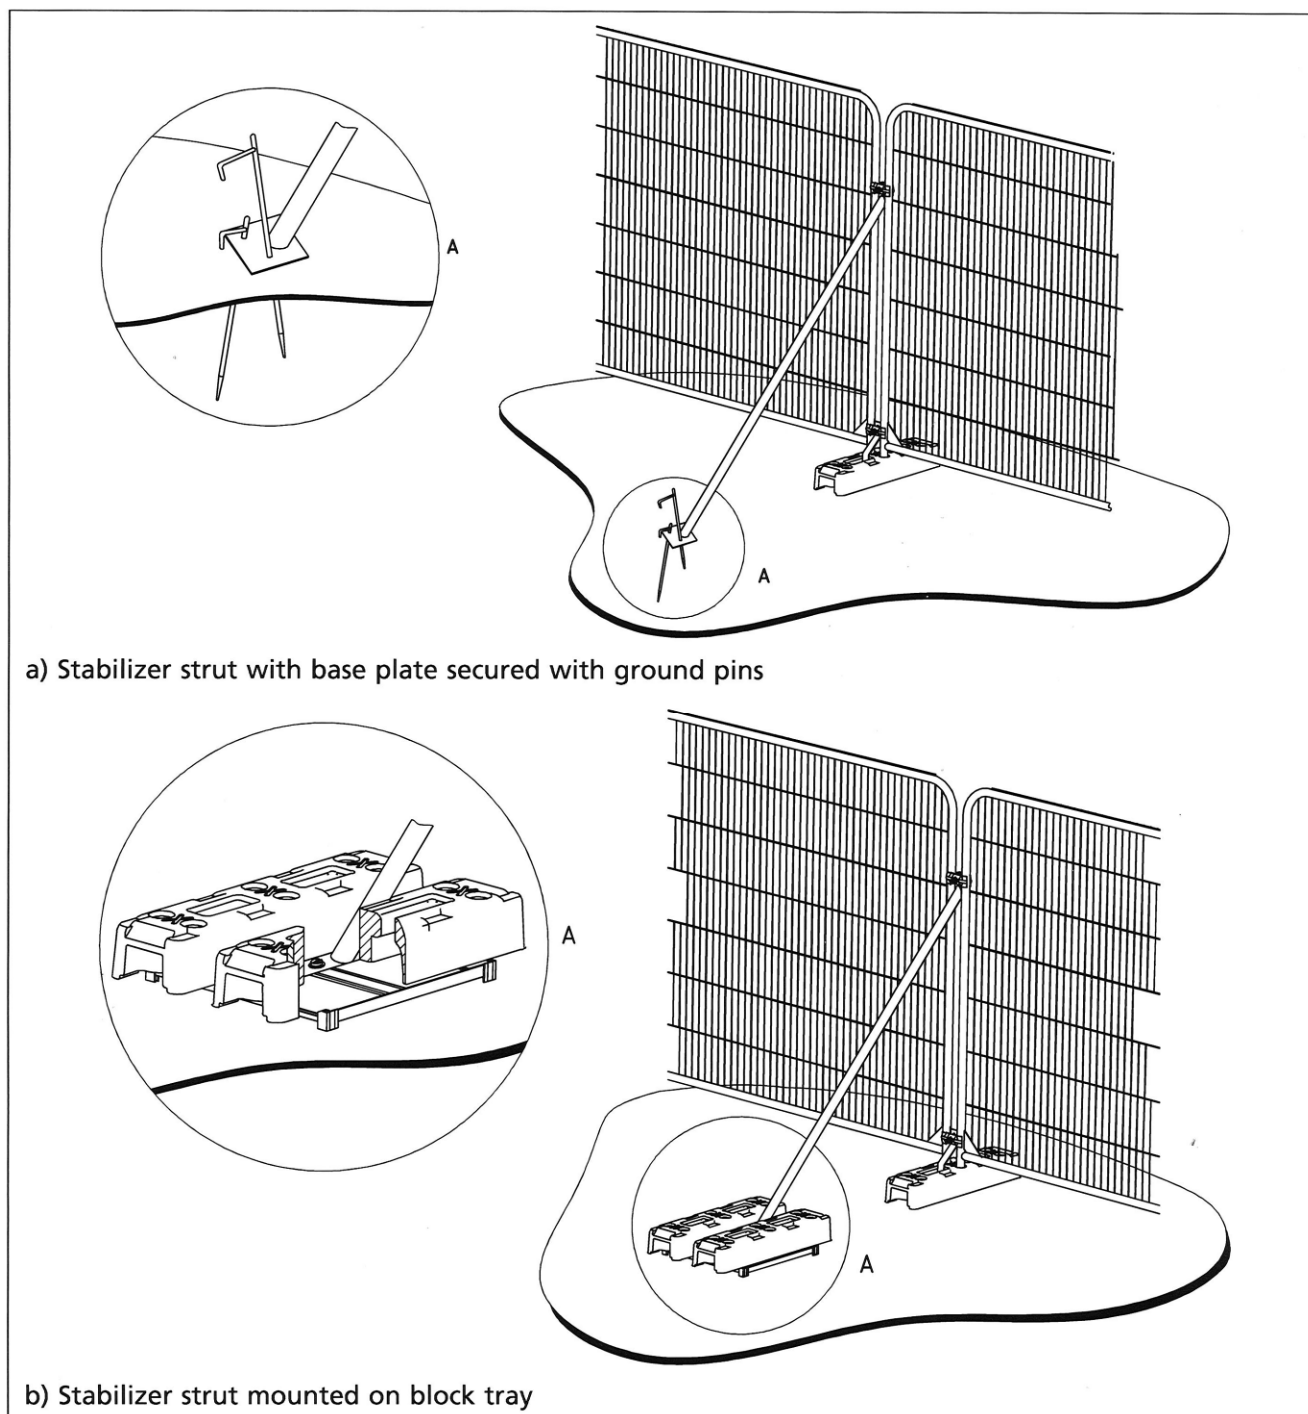
Figure 2: 'Examples of above-ground stabilisation systems'. To be used where there is hard surfacing which is to be retained.

The specific stabilisation method to be used is detailed in **Section 3**.

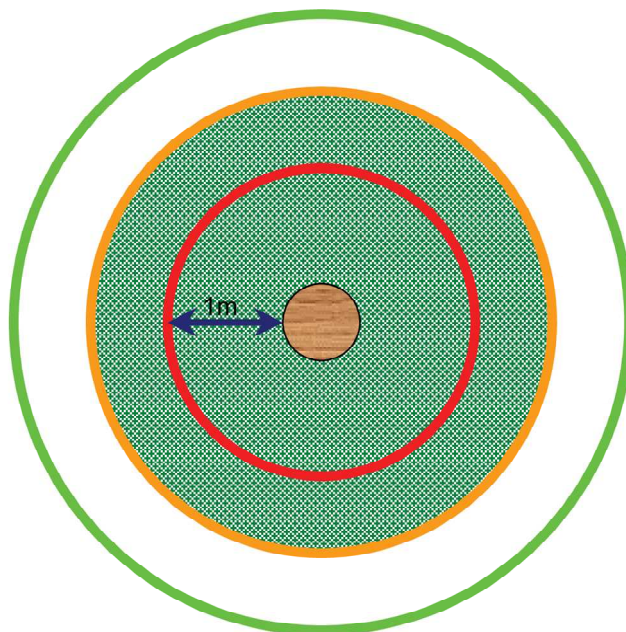
NJUG Guidelines for the Planning, Installation and Maintenance of Utility Apparatus in Proximity to Trees – Issue 2

**PROHIBITED ZONE – 1m from trunk.** Excavations of any kind must not be undertaken within this zone unless full consultation with Local Authority Tree Officer is undertaken. Materials, plant and spoil must not be stored within this zone.

**PRECAUTIONARY ZONE – 4 x tree circumference.** Where excavations must be undertaken within this zone the use of mechanical excavation plant should be prohibited. Precautions should be undertaken to protect any exposed roots. Materials, plant and spoil should not be stored within this zone. Consult with Local Authority Tree Officer if in any doubt.

**PERMITTED ZONE – outside of precautionary zone.** Excavation works may be undertaken within this zone however caution must be applied and the use of mechanical plant limited. Any exposed roots should be protected.

- A3.1 Over-ground services should be routed away from areas where they are likely to interfere with the crowns of trees. Similarly any landscaping should take account of over-ground services and mature tree size.
- A3.2 Underground services must be routed outside the RPA of retained trees, unless otherwise specified within this report. NJUG Volume 4 Issue 2 (on the next page) is a set of accepted guidelines for installing services in the proximity of trees. Please note that this is not a substitute for site-specific advice by an arboriculturalist and consultation should be made wherever incursions of RPAs are envisaged. The contents of this report, specifically **Section 4.5**, supersede the set of guidelines on the next page, which are only included for reference.

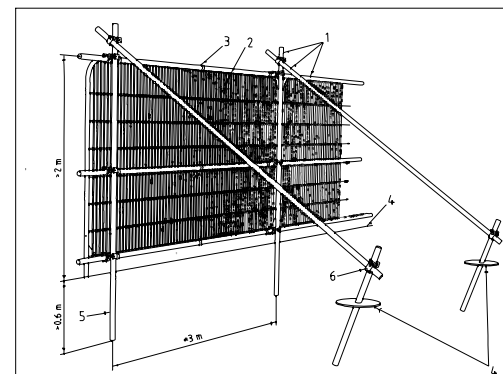
Default specification for a protective barrier

- Key
1. Standard scaffold poles
  2. Heavy gauge 2m tall galvanized tube and welded mesh infill panels
  3. Panels secured to uprights and cross-members with wire ties
  4. Ground level
  5. Uprights driven into the ground until secure (minimum depth 0.6m)
  6. Standard scaffold clamps
