Section 19 application for amendment of listed building consent 2025/0480 to allow repair of lintel found to be affected by beetle and rot during other approved works

Northern College, Wentworth Castle, Stainborough, Barnsley

Section 19 application: Lintel repair at the Northern College

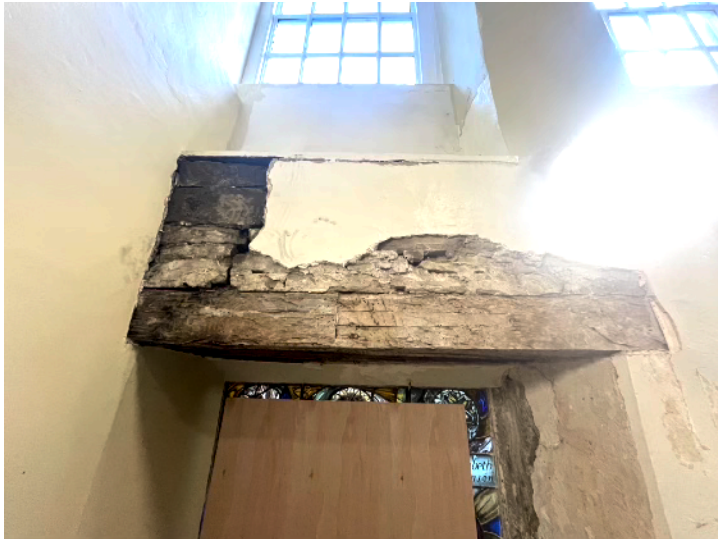
During works to refurbish the reception and repair Cutler House, loose plaster was removed for refining above the stair window. When the plaster was removed the inner lintel (the centre of three) was found to have been affected by wet rot and damp resulting in extensive decay to the eastern bearing end.

Plaster removed showing past water ingress and lintels.

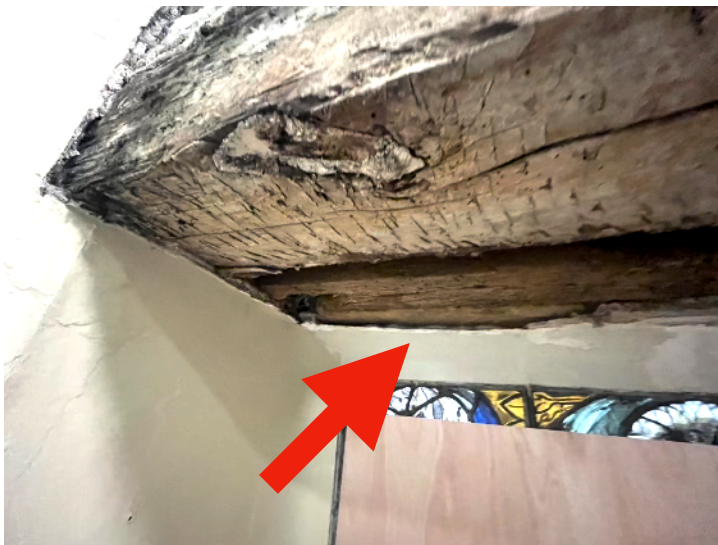
Decayed end of inner lintel.

Retaining the lintel in-situ, but cutting out the decayed end would allow maximum retention of historic fabric. The lintel should be cut back to sound material and treated with fungicidal paste. The void can then be packed with a similar sized oak (matching species) block. As there is no room to provide a load bearing joint within the confined space, this will require additional support.

To provide the required additional support it is proposed to insert steelwork below the existing timber inner and centre lintels new steel L sections will be inserted to provide additional support. The steel will be bolted to the existing lintel to create a composite inner lintel, with a flange below the inner lintel to provide the required support. This can be inserted from below but will require cut outs above to allow for bolted connections and washer plates to be inserted.

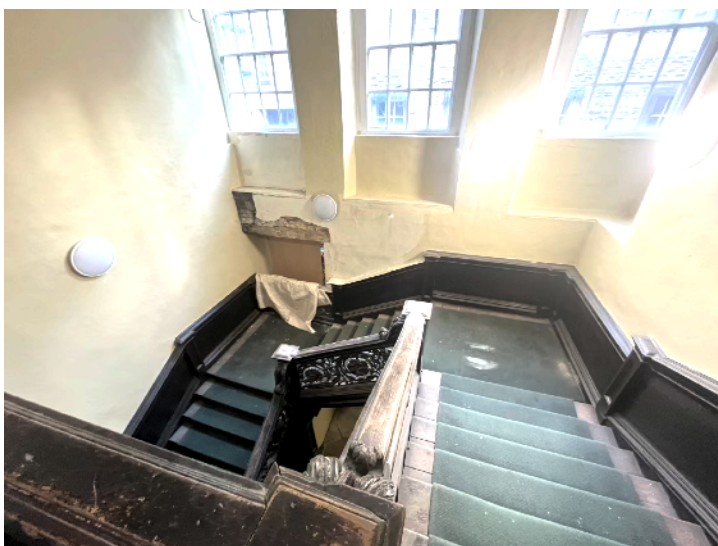
Removal of the centre lintel would require propping and removal of a lintel to either side. The removal of the outer lintel would affect the rear elevation of Cutler House and the stained glass stair window. This would affect historic fabric and risk harm. Removal of the inner lintel would require support through the stair and floor to the solid lower ground floor, damaging ceilings and structure to allow load transfer. This would affect historic fabric and cause harm which can be avoided.

Location on stair makes propping difficult
