Bat Scoping Survey to
Town Farm
Churchfield Lane
Kexborough
S75 5DU

12th August 2020

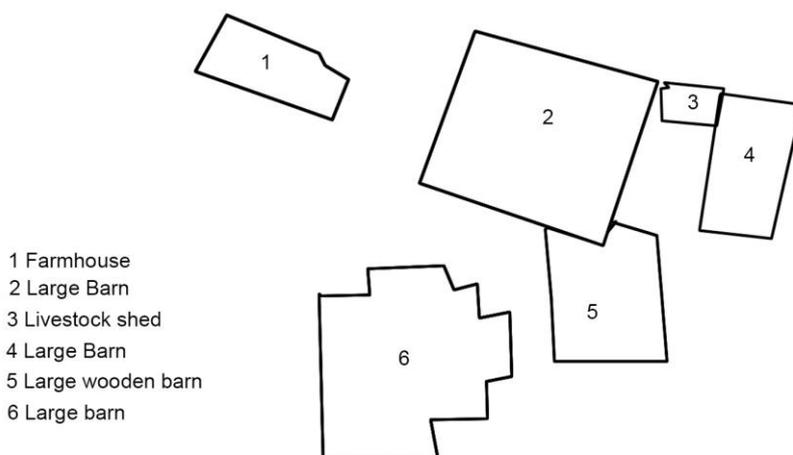
Figure 3. Layout of the buildings

The site consists of several large agricultural units, a livestock shed and a farmhouse. Figure 3 plots the location of each and identifies each of the buildings.

The large units (fig.3 buildings 2, 4 & 6) are all of the same style of construction with the lower section of walls made from breeze block in between a steel framework, while the upper walls and roofing is covered with corrugated sheeting, mostly cement fibre. The walls have no cavities that would allow bats to roost and the single thickness sheeting on the upper walls and roof are also of no potential interest to bats. The ridge sections tend to be wide, open and without a central ridge beam and are highly unlikely to be used by ridge dwelling species.

Building 3 is a small, open-fronted livestock shed that has been partially bricked up to the front. The original building has stone walls to rear and sides and a slate roof. The roof has been replaced in recent years and is in good condition with a full set of ridge tiles that are well bedded and in situ. The gable walls have heavy stone caps and are sound on the verges. There is no

evidence to suggest use by bats and the building appears to have limited potential. It may be worth checking during the summer period when the farmhouse is being surveyed.

Building 5 is a large open-fronted wooden barn with a tin sheeting over the roof. The lower walls are single thickness blockwork while the upper walls are single thickness cedar planks on a timber frame. The lack of wall cavity and open ridges make this an unlikely unit for bats to roost in.

The farmhouse is built from artificial stone and is sound and has no structural cracks. The walls have a traditional cavity that bats often use when they can gain access to them. The dry verges are very well sealed and the roof has a sound, slate covering which has no obvious entry points. The soffits along the north elevation are fairly well sealed to the walls and, where there are any minor gaps, they have a heavy build-up of dust and cobwebs. The soffits running along the south elevation do have some suitable gaps between the woodwork and the stone walls. In places these are large enough for birds to gain entry and may be less suited to bats. However, given the south facing aspect and the partial suitability of the gaps, it would be difficult to establish that bats are not present without at least one activity survey during the summer months.
