TREE SURVEY TO BS5837:2012

Job MONCKTON COKE WORKS

Tree  
TREE SURVEY PAGE 1 OF 4

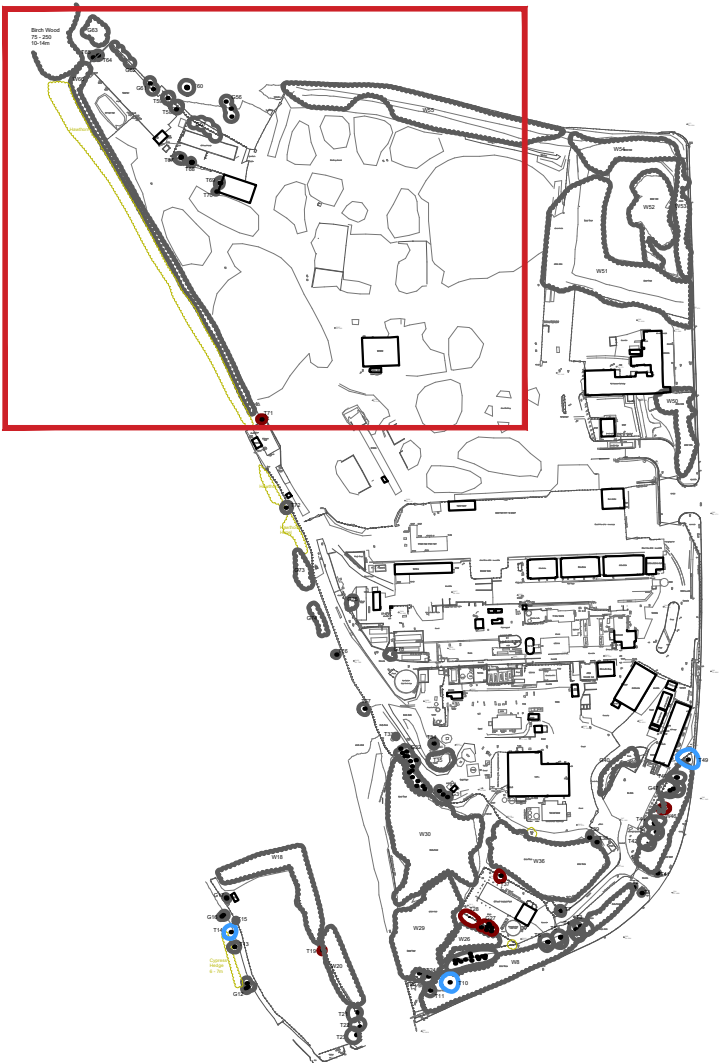
This survey records amenity quality and desirability of tree retention in relation to proposed construction by visual inspection from ground level where accessible.

Tree heights and spread approximate. The diameter of single stem trees is taken at 1.5m above ground level. For the diameter of multistemmed trees, each multistem is measured at 1.5m above ground level and calculated to give a notional diameter as if all multistems were fused into one stem.

Several trees have girdling damage by wire or rope gartotting. This is noted where visible. There may be other girdling damage not visible due to density of shrubberies. Detailed inspection of retained trees should be carried out at time of site clearance.

Trees with girdling wire have safe life expectancy of not more than 20 years. A programme of planned replacement and removal is recommended.
