<b>PROJECT:</b>	LD10361 – Appendix 7.2
<b>SUBJECT:</b>	Barnsley West GCN eDNA Survey
<b>DATE:</b>	12th October 2023 (Updated 16 <sup>th</sup> May 2024)
<b>PREPARED BY:</b>	Olivia Satur (Ecologist)
<b>UPDATED BY:</b>	Lorraine Palmer (Associate Director)
<b>REVIEWED BY:</b>	Tim Palmer (Technical Director)

# Technical Note

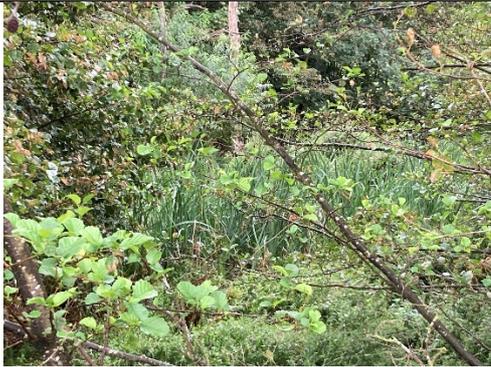
Waterbody Description	Photo	Survey Results 2021	Survey Results 2023/2024	HSI Score
<p><b>Pond 1</b>                      Located within Craven Wood, on the northern half of the Site. At the time of survey, water levels were very low and restricted to the centre of the waterbody. The pond is functionally linked to a stream which runs south-north through the wood, and also links to Ponds 2 and 3 in the north east. The pond contains dense bullrush and willowherb, and is surrounded by dense nettles and bramble scrub.</p>

eDNA: Negative	100% of the waterbody margins were sampled.  HIS: 0.48 (poor)  eDNA: <b>Negative</b>	n/a
<p><b>Pond 4</b>                      Former garden pond with ornamental fish. <b>Pond now removed</b> (c.January 2024)</p>	No photo	eDNA: negative	Infilled	n/a

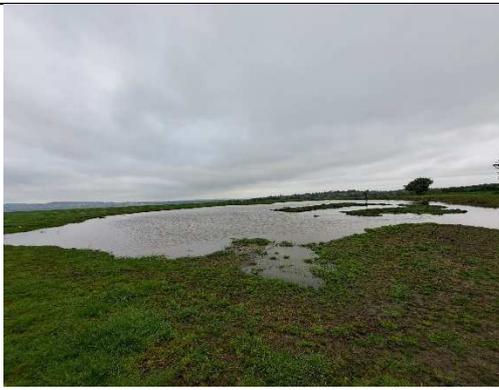
<p><b>Pond 5</b> No. 22 St John's Avenue. Ornamental garden pond, kidney shaped approximately 3m x 1m. Steep sided and concrete lined ornamental water feature with a complete absence of any plants, considered entirely unsuitable as a breeding pond for GCN. Pond is set within paved garden area.</p>	<p>No photo.</p>	<p>No access</p>	<p>Unsuitable</p>	<p>0.10 (Poor)</p>
<p><b>Pond 6</b> 18 St John's Avenue. Ornamental garden pond. <b>Infilled in 2021</b>, prior to extension on dwelling house.</p>	<p>No photo</p>	<p>No access</p>	<p>Infilled</p>	<p>n/a</p>
<p><b>Pond 7</b> Adjacent to the south western boundary of the Site and the M1 motorway. Pond is approximately 30x20m and is a depression in a sheep-grazed field. Waterfowl are present, water turbidity is high and there is no emergent/aquatic vegetation.</p>

<p>Not surveyed in 2021.</p>	<p>100% of the waterbody margins were sampled.  HSI: 0.38 (poor)  eDNA: <b>Negative</b></p>	<p>n/a</p>

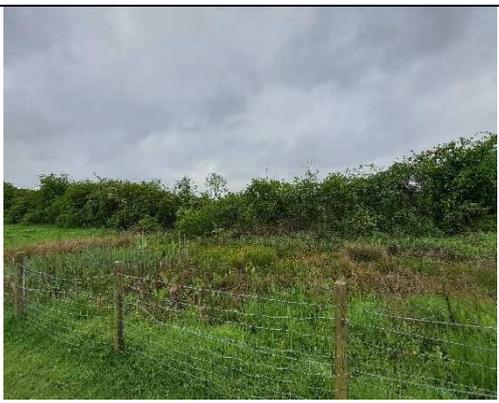
<p><b>Pond 8</b> Located directly to the north of a hawthorn hedgerow with a horse-grazed field. Water levels were very low at the time of survey with moderate turbidity. Dense vegetation includes willowherb, bullrush, meadow foxtail, creeping buttercup, bitter dock, cuckoo flower, and nettle. No waterfowl or fish present.</p>

<p>Not surveyed in 2021.</p>	<p>100 % of the waterbody margins were sampled.  HSI: 0.48 (poor)  eDNA: <b>Negative</b></p>	<p>n/a</p>

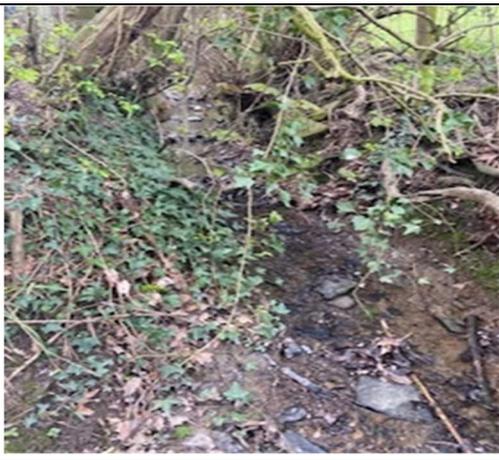
<p><b>Ditch 2 and Ditch 3</b></p> <p>Ditch 2 and 3 are a stream that runs through Craven Wood. The water has a slow to moderate flow (south to North). The watercourses are devoid of any vegetation and shallow. In combination they are not considered to be suitable for breeding/foraging GCN.</p>

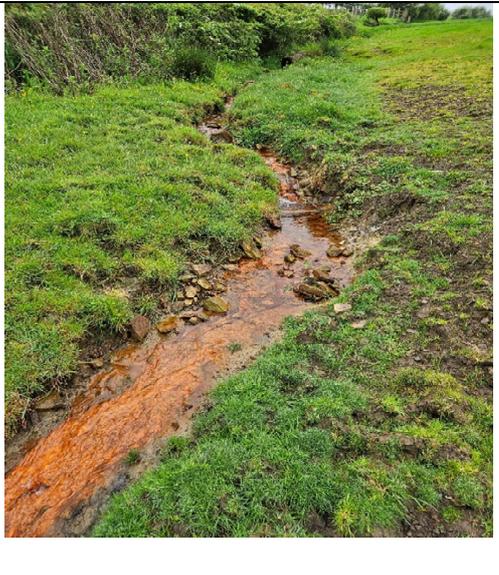
<p>Unsuitable</p>	<p>Unsuitable</p>	<p>0.33 (Poor)</p>
<p><b>Ditch 4</b></p> <p>Ditch 4 is a partially culverted ditch which flows beneath Hermit Lane and adjoins D2. The channel is narrow &lt;0.5m wide in places with a red discolouration. Where the culvert is broken there is some limited emergent vegetation floating sweet-grass <i>Glyceria fluitans</i> and brooklime <i>Veronica beccabunga</i>, however, the watercourse is flowing and shallow and offers negligible opportunities for breeding and foraging GCN.</p>

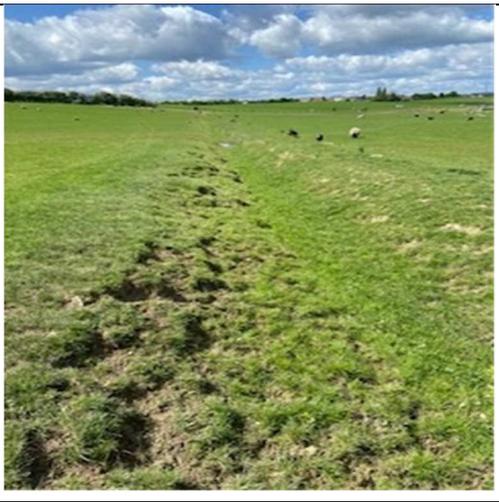
<p>Unsuitable</p>	<p>Unsuitable</p>	<p>0.19 (Poor)</p>
<p><b>Ditch 8</b></p> <p>Possibly man-made ditch in the centre of a modified grassland field. The ditch at the time of the PEA survey held very shallow water (approximately 0.05m). However, on a return visit, after a particularly wet winter the drain was dry. NO aquatic vegetation is present.</p>

<p>Unsuitable</p>	<p>Unsuitable</p>	<p>0.23 (Poor)</p>
