# Geoenvironmental Appraisal

Land at New Road, Pilley

For Barratt & David Wilson Homes  
Yorkshire West

Report no: 2222/2

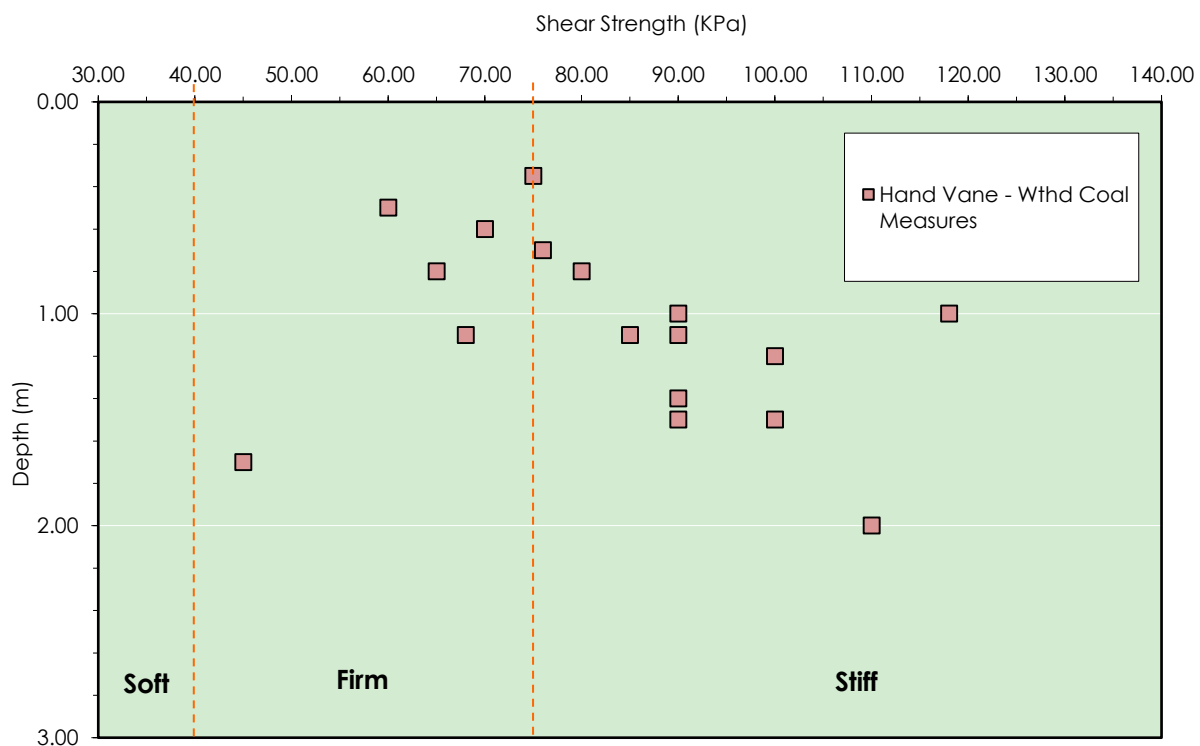
12.3.8 The results are summarised within the plot below and illustrate a linear increase in undrained shear strength ( $S_u$ ) with depth within the Weathered Coal Measures stratum. Below approximately 0.9m depth  $S_u$  is typically greater than 65kPa.

12.3.9 The plot below provides a summary of undrained shear strengths.

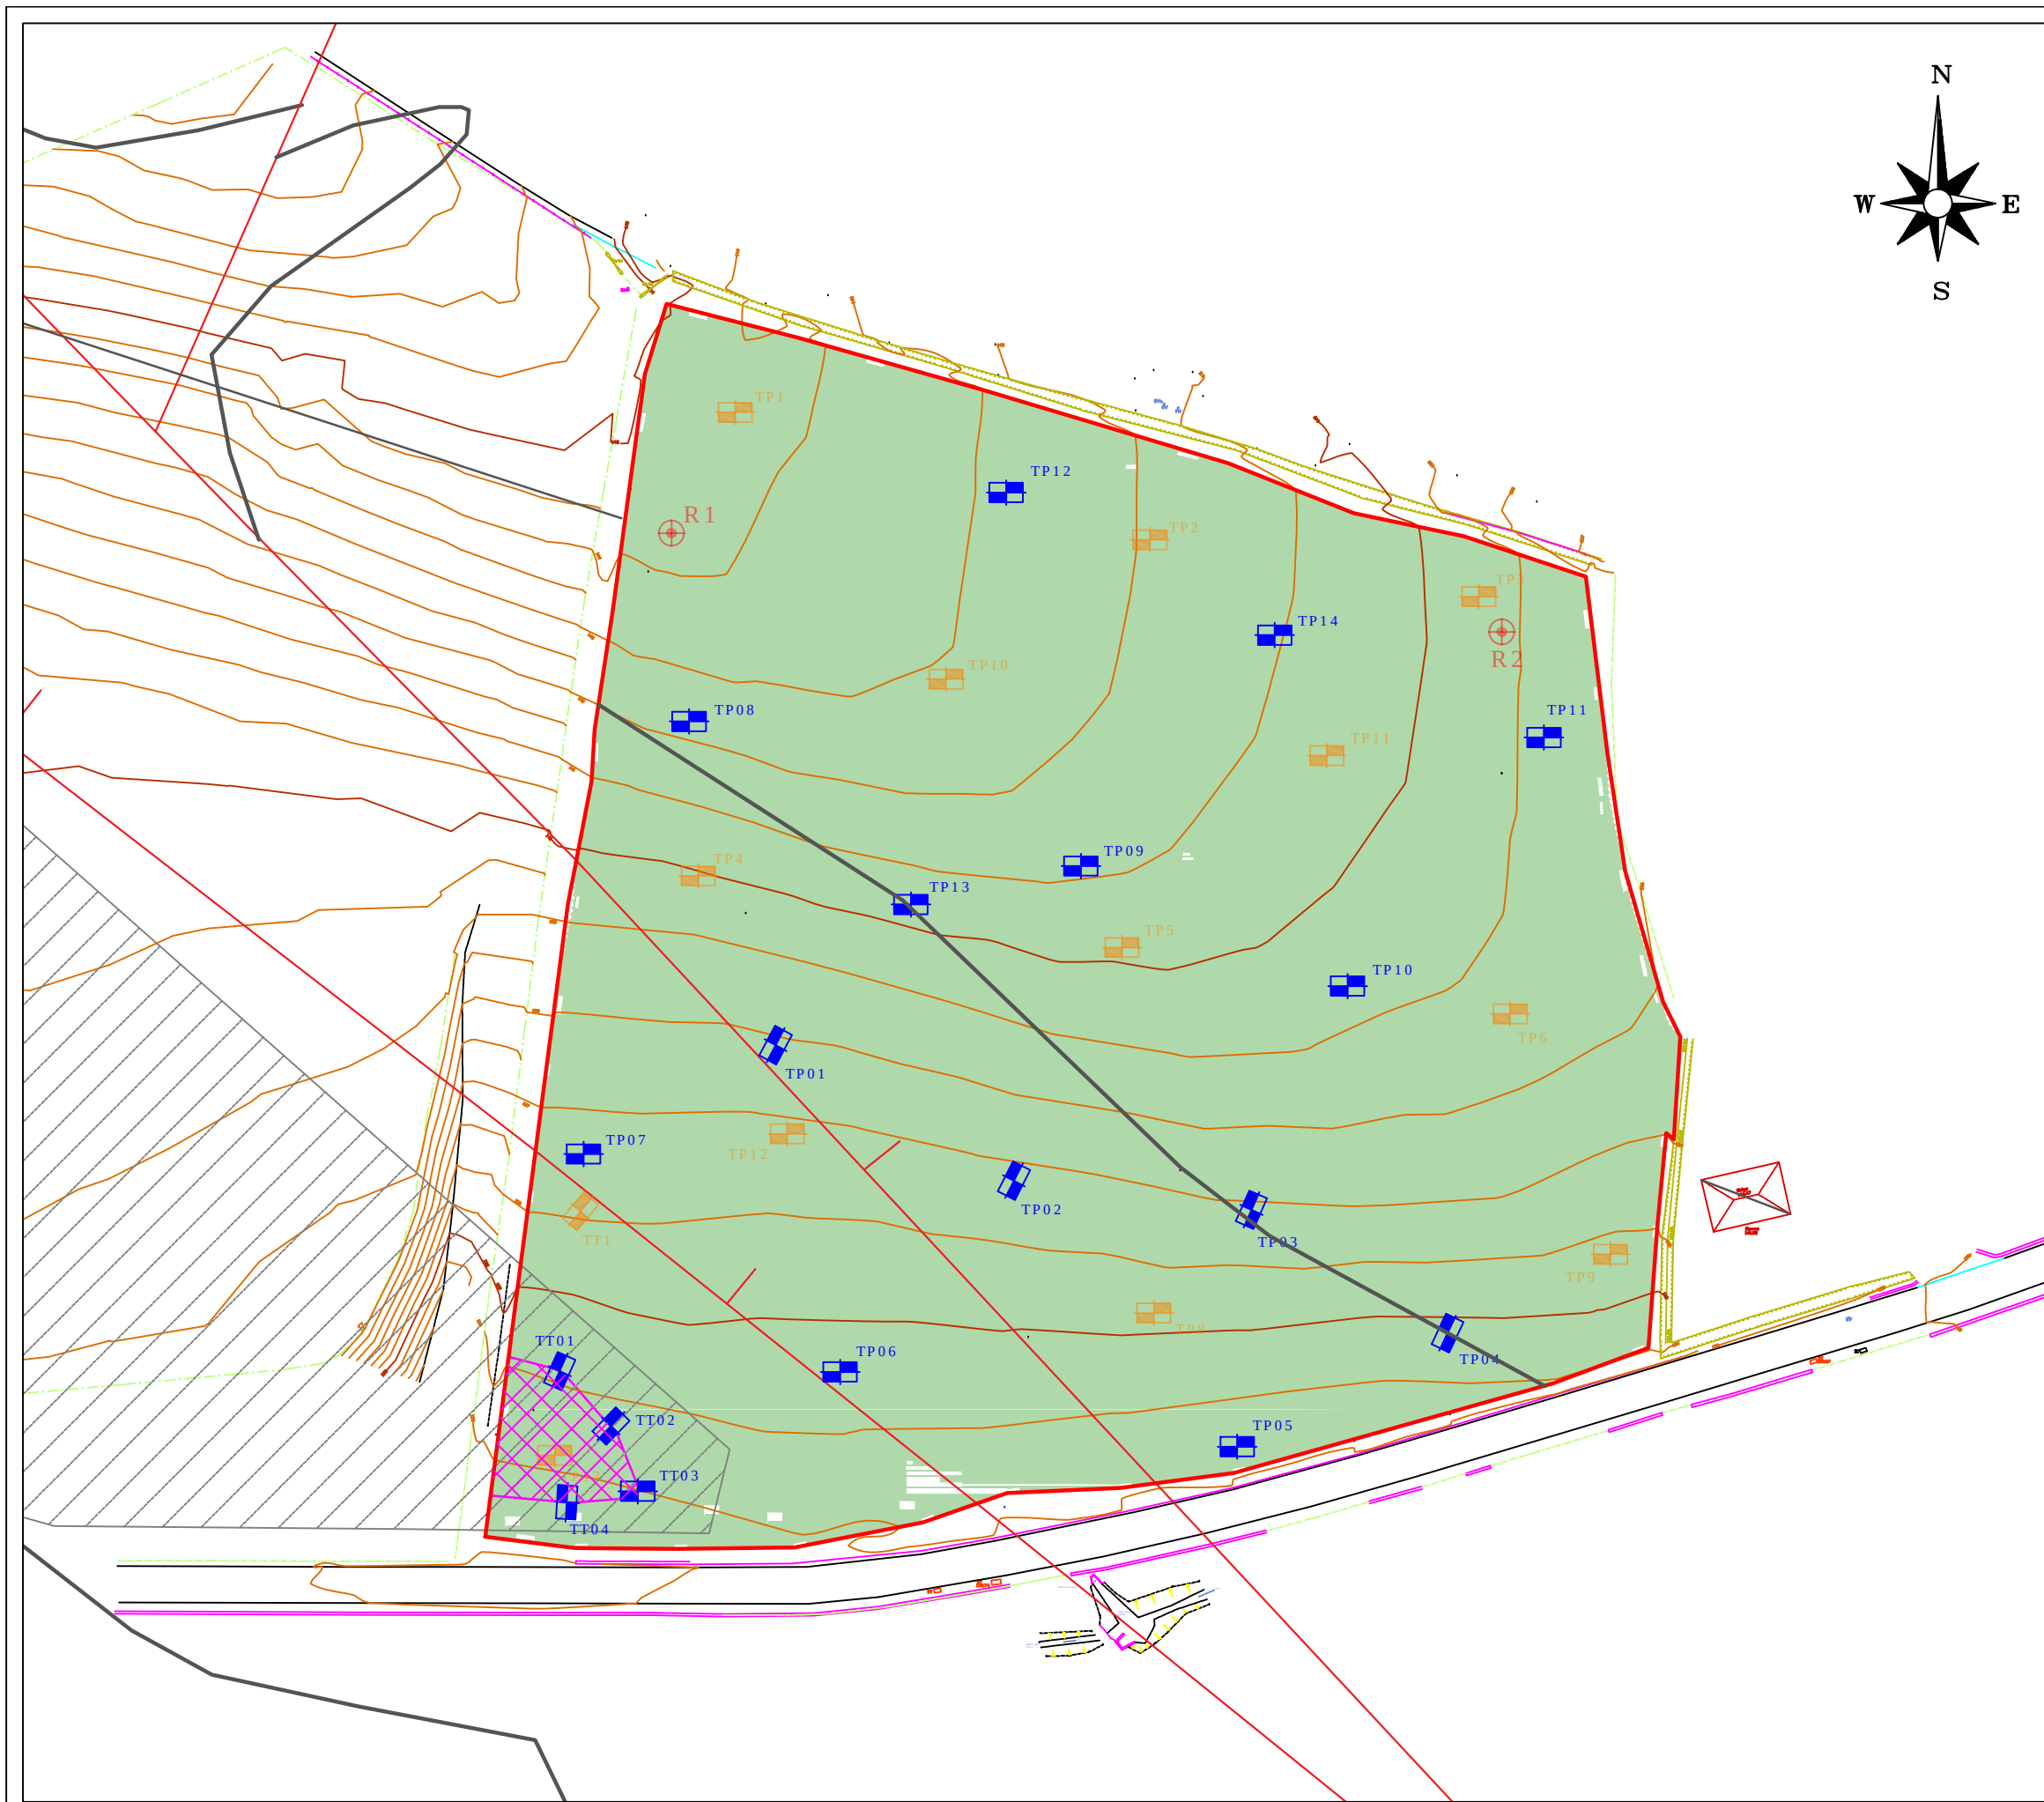
| 1:1,000 | A3 | 2222/E/6 | |

- LITHOS TRIAL PIT (2016)
- CODA PROBEHOLE
- CODA TRIAL PIT LOCATION
- FORMER OPENCAST (CA PLAN)
- FORMER OPENCAST (AS ENCOUNTERED)
- LIDGET SEAM OUTCROP (AS ENCOUNTERED)
- APPROXIMATE SITE BOUNDARY

- 5.2.2 CoDa's exploratory holes are shown on Drawing 2222/E/6 in Appendix B
- 5.2.3 Ground conditions encountered by CoDa have been incorporated in Lithos' summary table on pages 14 & 15, but generally comprised topsoil overlying firm clay (cohesive residual soil) to an average depth of 1.5m, with mudstone/sandstone bedrock from depths of between 0.2m (TP6) and 2.4m (TP9).

- Piles for plots located **within** the opencast backfill
- 13.4.5 Any plot layout for this site should take account of the known high walls (as shown on Drawing 2222/E/6. Most notably, the foundations of plots just *beyond* the area of opencast backfill would ideally be placed below a line drawn up at 45° from the base of the high wall. Assuming a quarry depth of 12m and sub-vertical high walls this would effectively result in a sterile zone about 12m wide. However, a slimmer sterile zone of 3m should suffice, subject to NHBC approval, provided plots between 3m and 7m from the high wall are founded entirely in rock. This is likely to be the case for Plot 33.

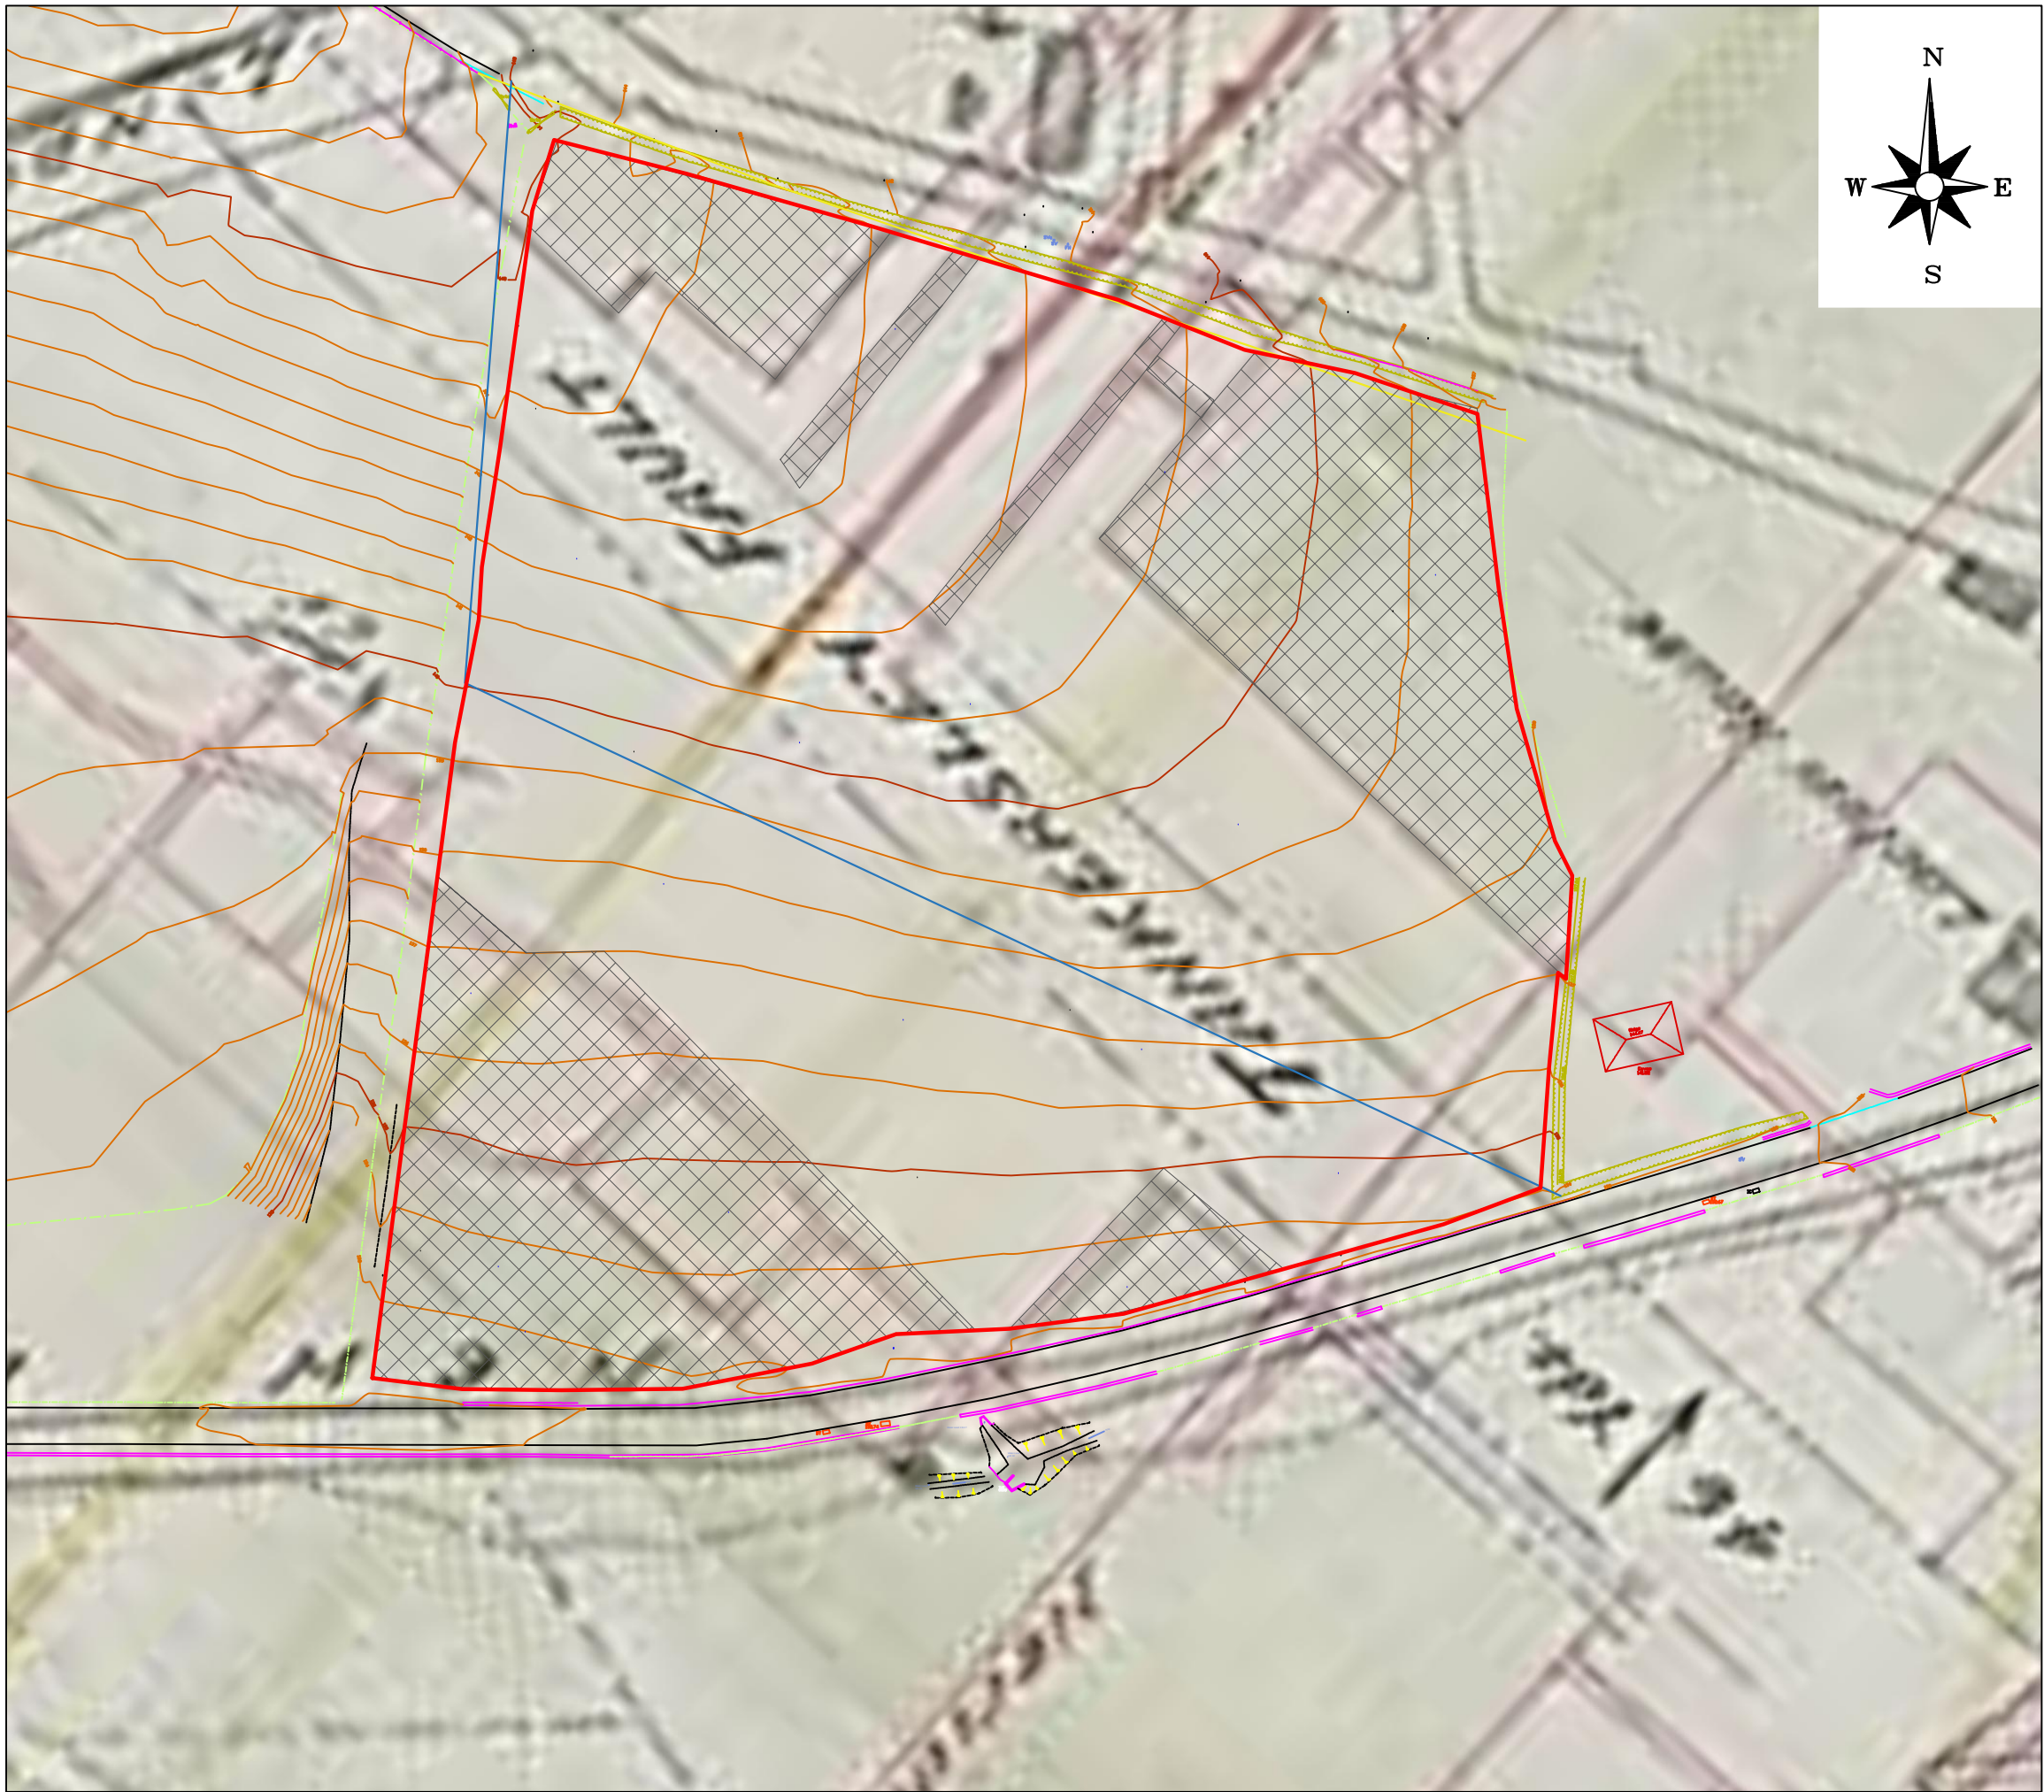
| <b>SCALE</b><br>1:1,000 | <b>SHEET</b><br>A3 | <b>DRAWING NO.</b><br>2222/E/9 | <b>REVISION</b> |

APPROXIMATE SITE BOUNDARY

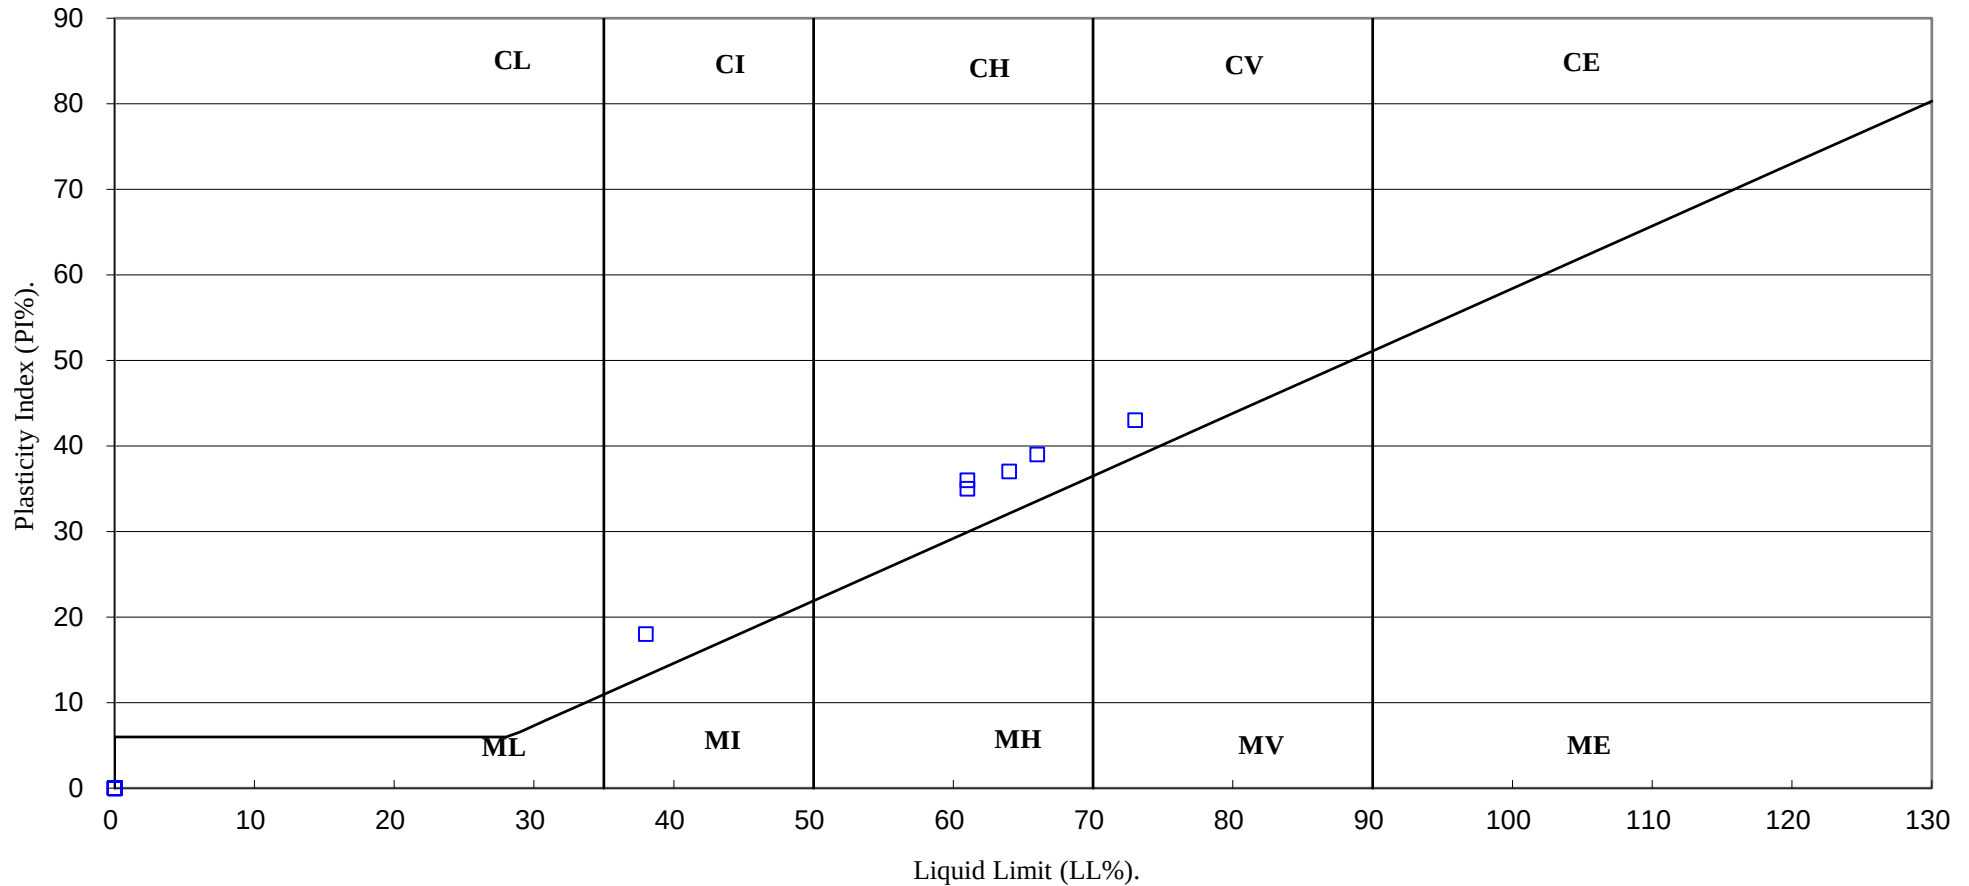
# PLASTICITY CHART FOR CASAGRANDE CLASSIFICATION.

(BS5930 :2015)
