BELLWAY HOMES LTD.

Land Off Dodworth Road, Barnsley

Phase I and II Environmental Assessment

September 2011

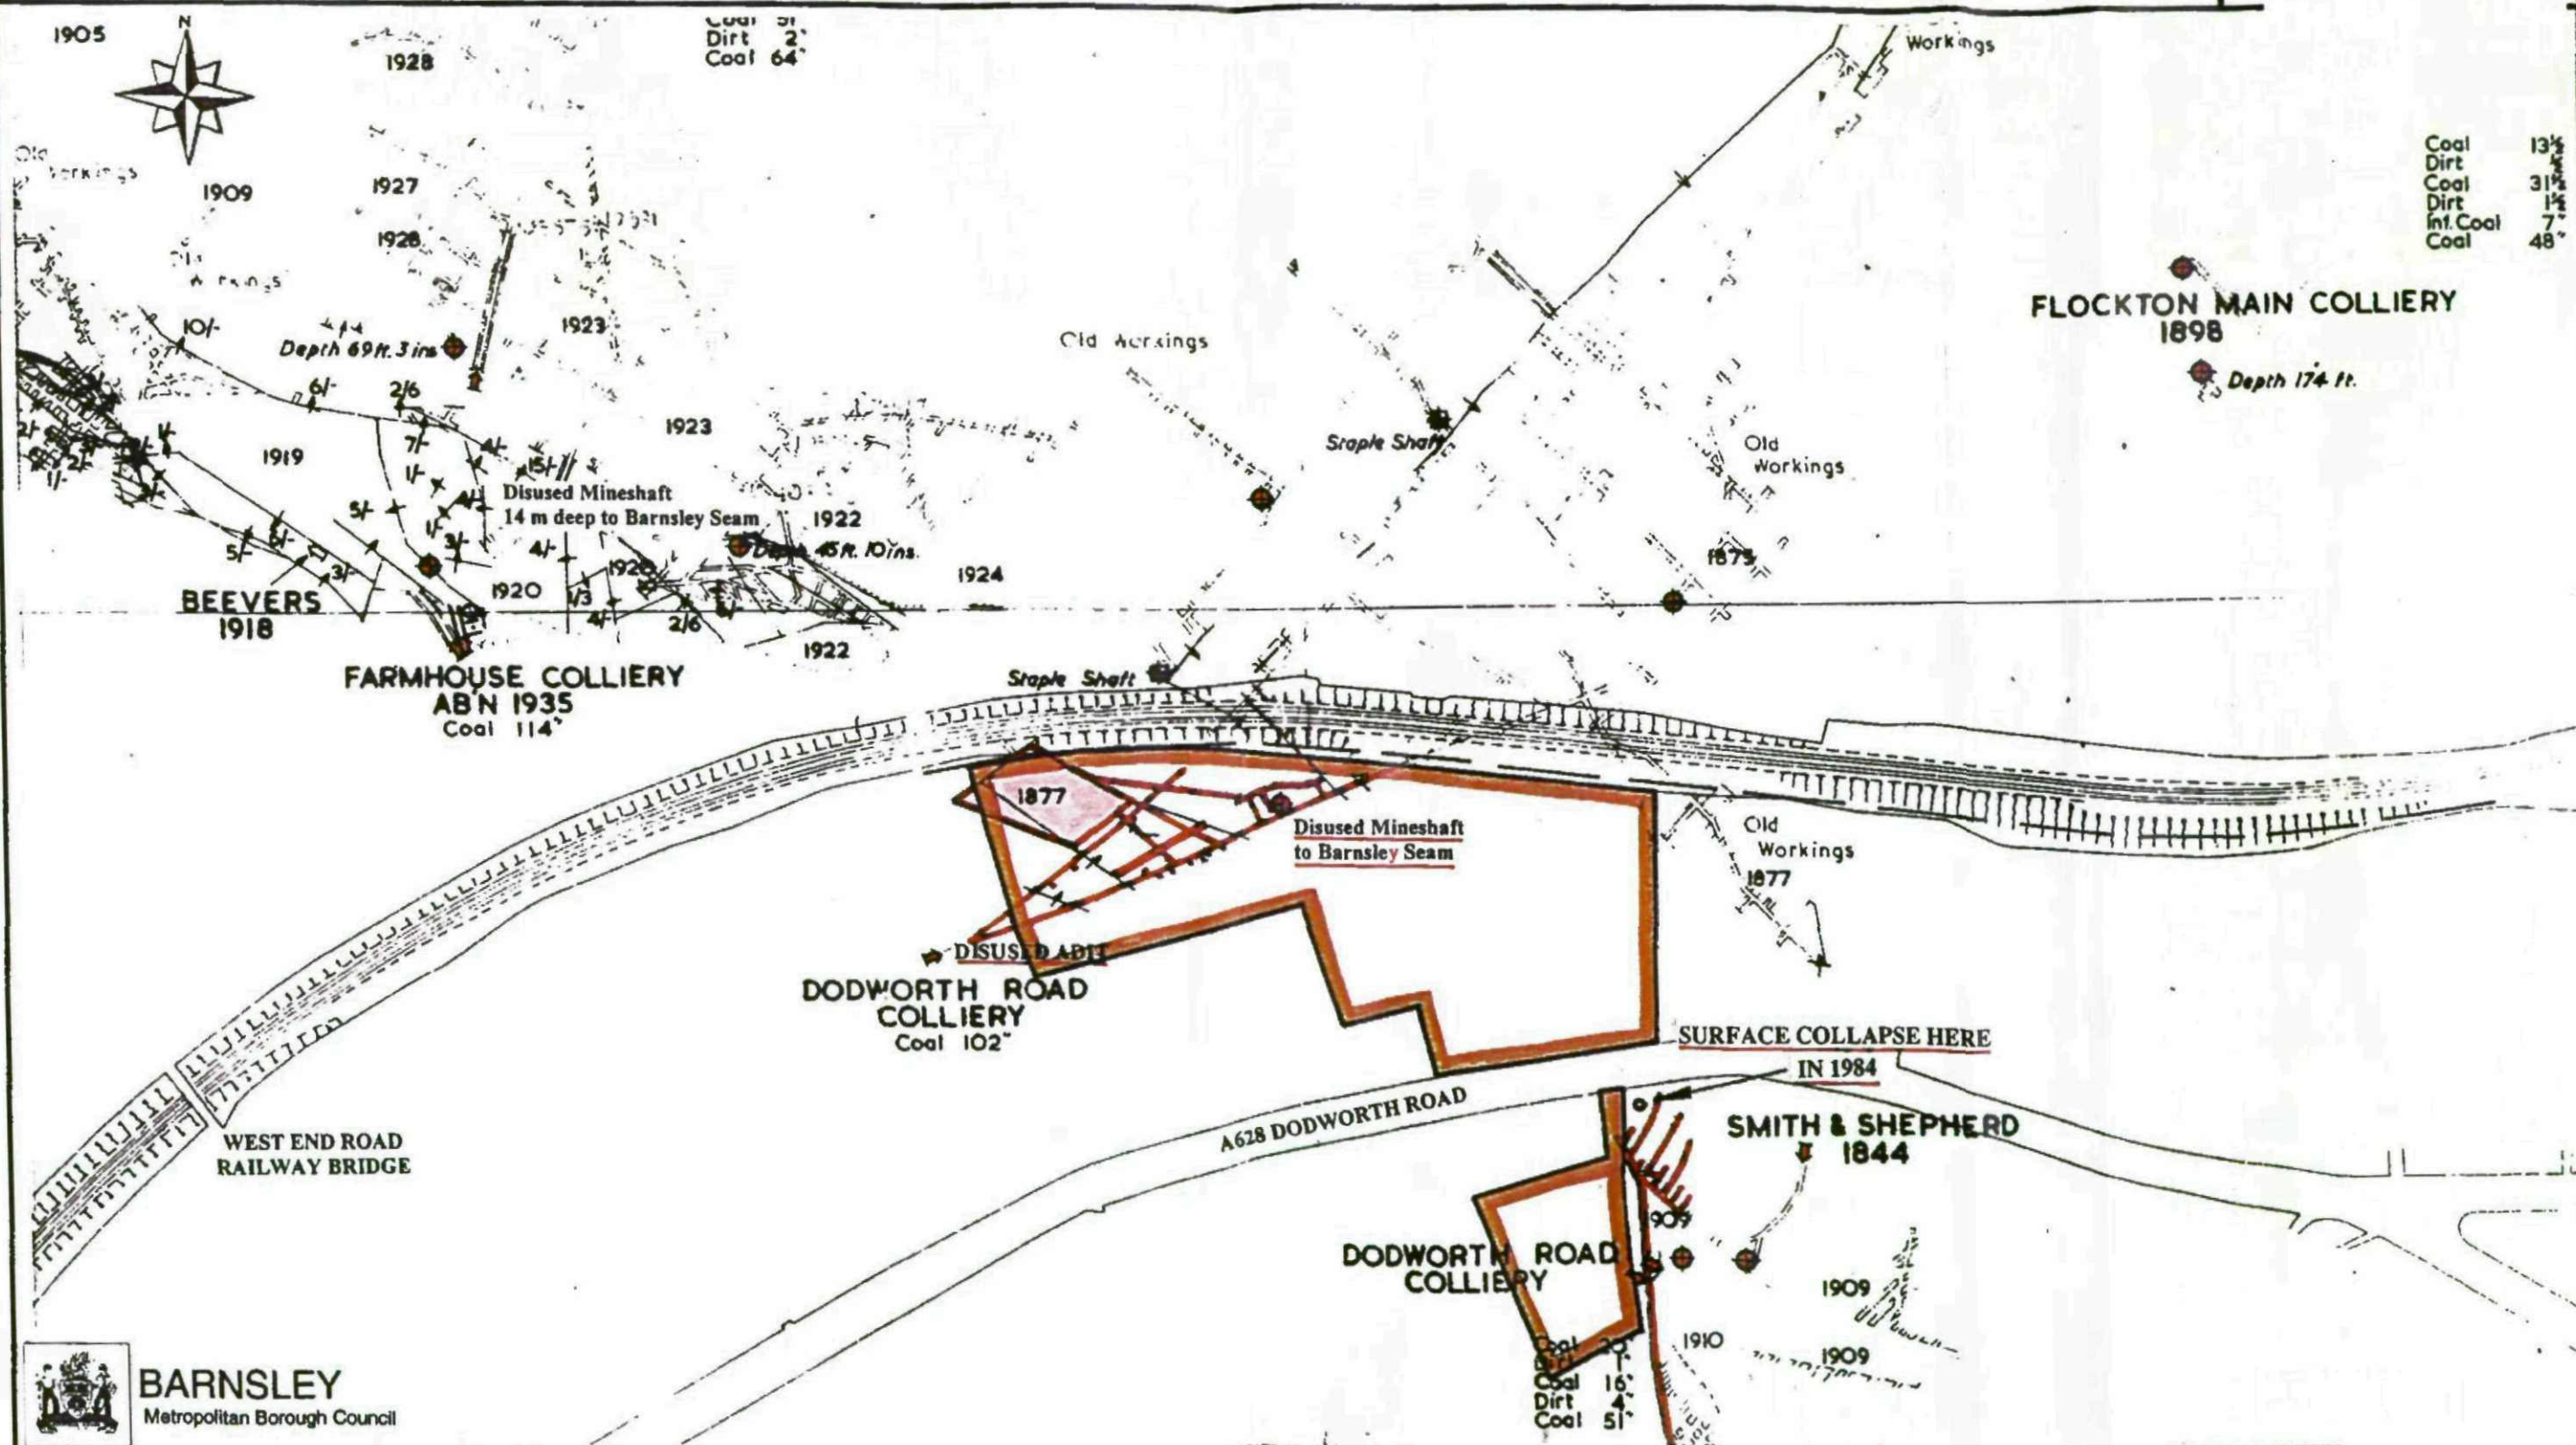
DRAWING NO.

**LAND OFF DODWORTH ROAD, BARNSELY**  
**COMPILATION OF MINE ABANDONMENT PLANS**  
**BARNSELY SEAM**

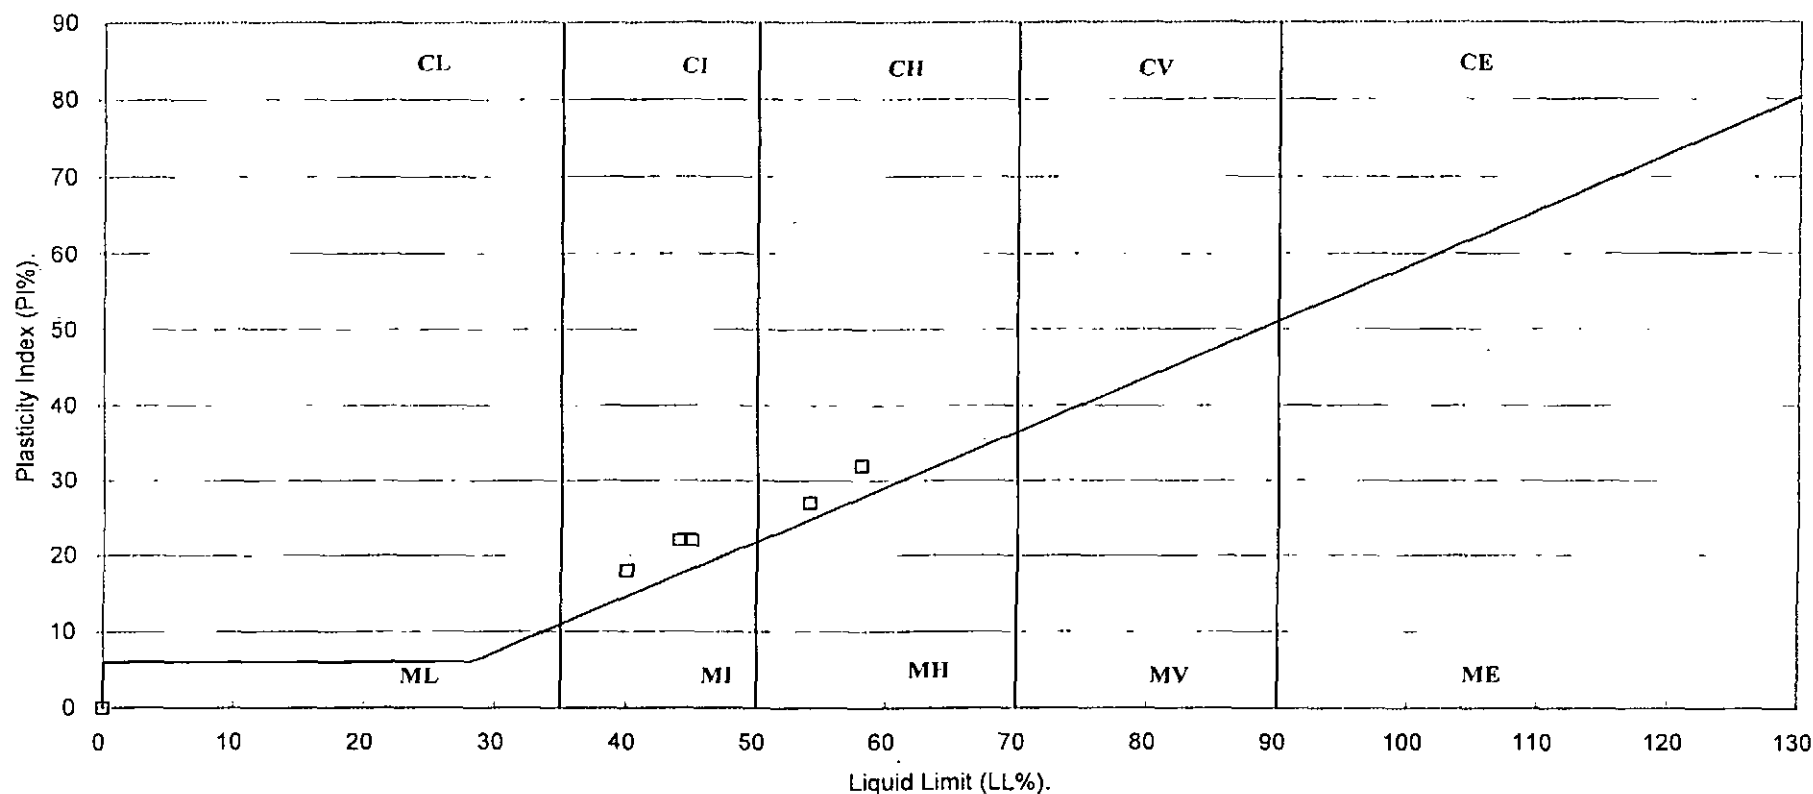
# PLASTICITY CHART FOR CASAGRANDE CLASSIFICATION.

(B.S.5930 : 1999)

12.4.4 One sample was scheduled for Atterberg limits. However, the sample (BH2, 7.6m) was found to be non plastic.
