# The Crescent Cudworth, Barnsley

Preliminary Roost Assessment

Report Ref. ER-8569-01

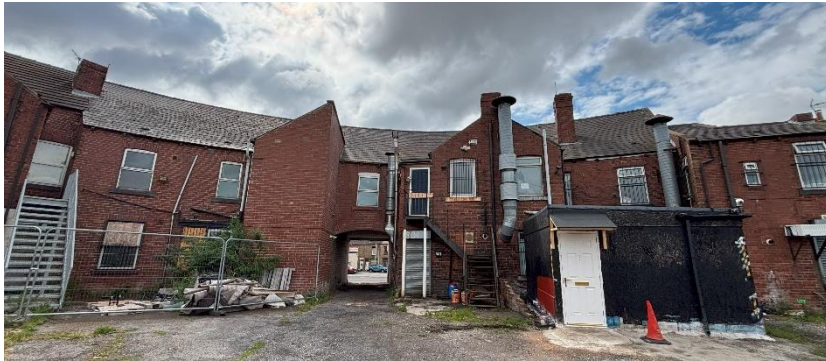
**Figure 3** View of the back of the building from the northwest.

13. The Site is a two storey building, constructed from brick and mortar. The windows are uPVC, some of the doors are wooden, some are boarded up and some have metal shutters. The western end of the building has concrete render. The roof comprises a mix of stone, slate and concrete tile.

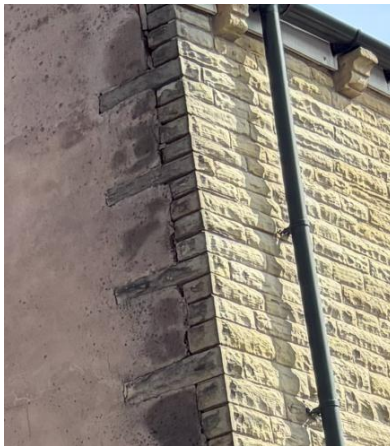
**Figure 4** Showing gaps in wall.

14. A small number of gaps were noted down the south western corner of the building, shown in figure 4. There is also a gap in the wall just under the chimney on the northwest of the building, shown in figure 5. Both features are likely to lead to a small cavity and have been assessed as having low bat roost suitability.

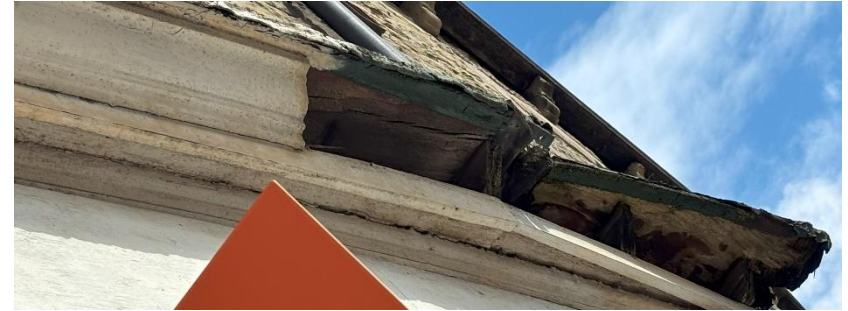
**Figure 6** Showing large gap above of tunnel.

15. There is a large gap above the entrance of the tunnel on the southeast side of the building. This feature would be subject to drafts and rain so has been assessed as having negligible bat roost suitability.

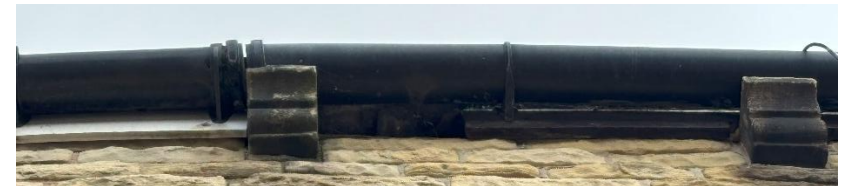
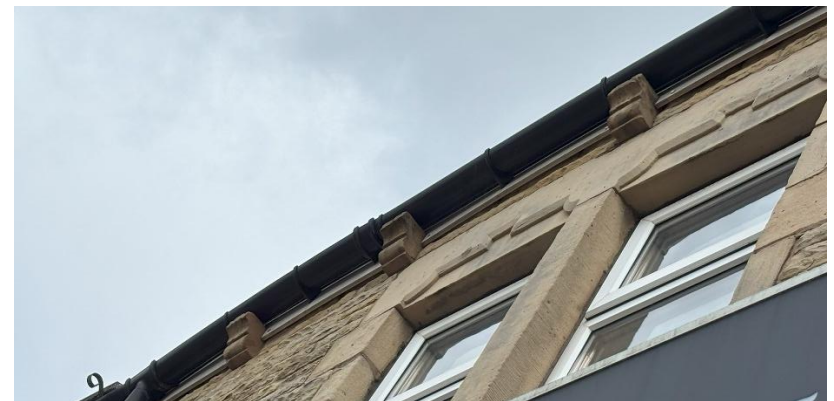
**Figure 7** Showing gap between wall top and soffit box.

16. There is a continuous gap between the wall top and plastic soffit box along the whole of the front side of the building on the southeast. This feature provides a crevice suitable for use by roosting bats and has been assessed as offering low bat roost suitability.

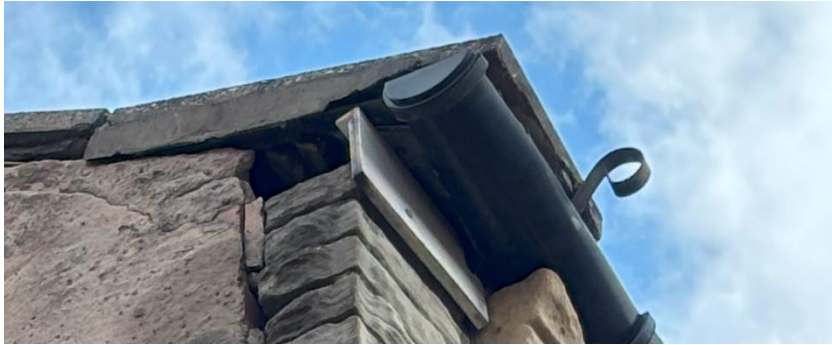
**Figure 8** Showing large gap in southwestern corner.

17. A large gap is present on the southwestern corner of the building, leading to a void behind the barge board and potentially providing access to the roof space.

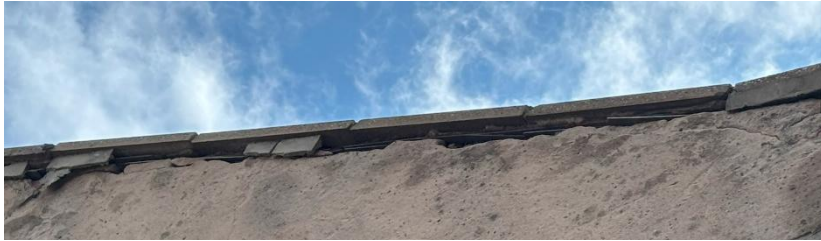
**Figure 9** Showing gaps under the coping stone on western gable end.

18. There are large gaps under the coping stone on the western side of the building shown in figure 9 and the eastern side of the building shown in figure 10.

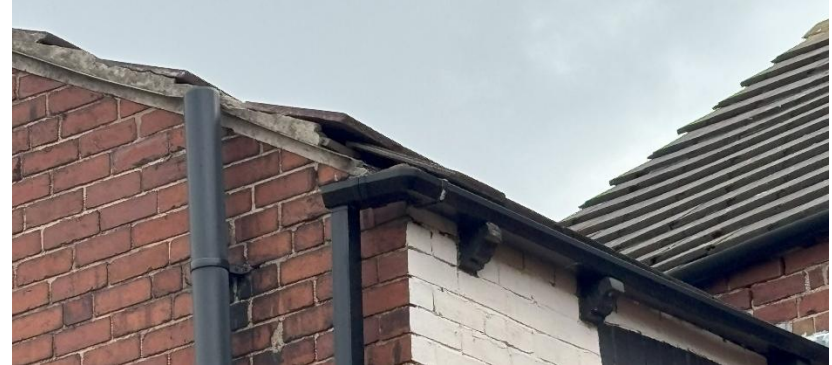
**Figure 11** Showing large gap in southwestern corner.

19. The majority of the roof covering is found in good condition however, there are a few sections with gaps between the tiles. The first one was in the northeast on

the roof, shown in figure 11. There were also gaps in the metal flashing and lifted tiles on the middle of the northern roof, shown in figure 12. All these features provide minor cavities between tiles and have been assessed as having low bat roost suitability.

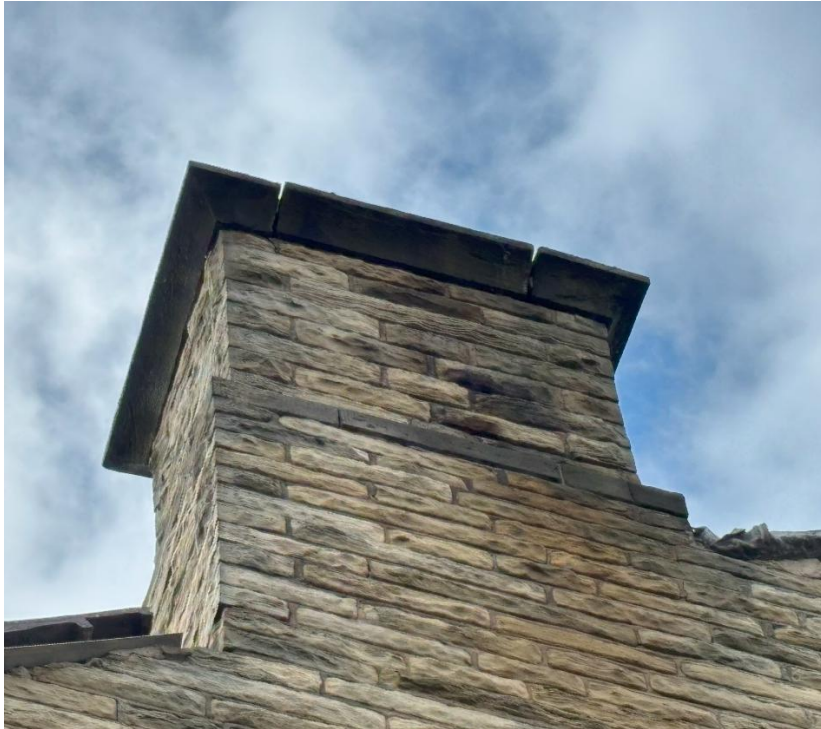
**Figure 13** Showing gap between brick and stones on chimney.

20. There is a gap between the brick and top stone of the chimney in the northeast of the building.

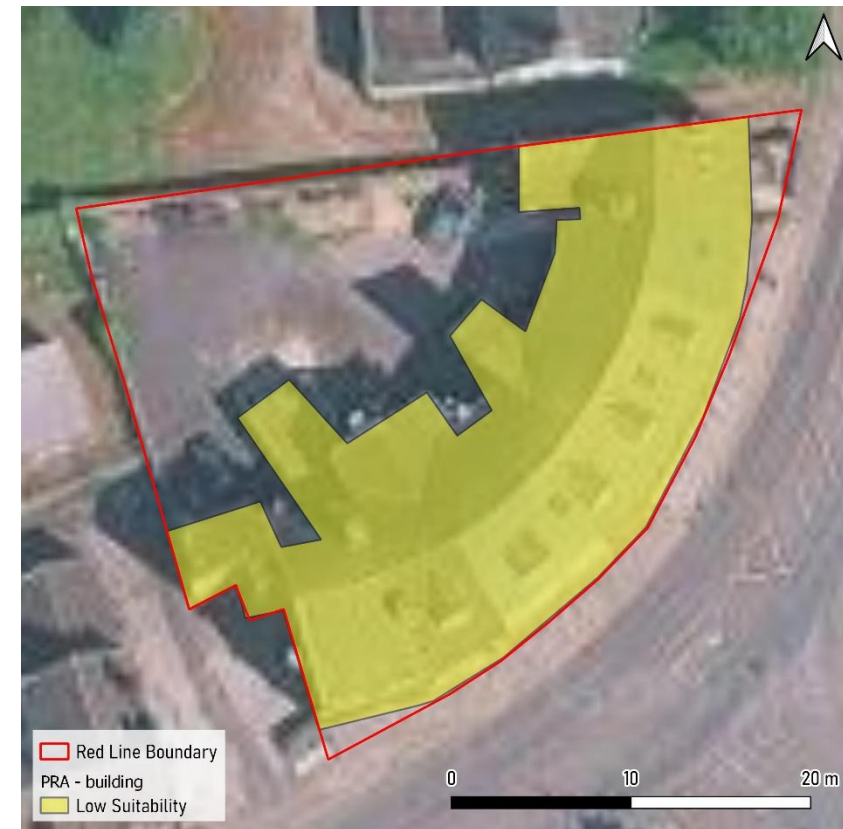
**Figure 14** Showing bat roost suitability of on-Site building and feature points.

25. In line with best practice guidelines (Bat Conservation Trust, 2023), further survey should be carried out to establish if potential roost features are being used by bats. This should take the form of a single dusk bat emergence survey. The survey should be undertaken during the active bat survey season, which runs from May to August inclusive, with September providing sub-optimal conditions.
26. Should evidence of bats be found, and proposals will result in impacts to bats or their roosts, a mitigation licence from Natural England is likely to be required. Further survey would likely be necessary to support a licence application.
