## Phase 2: Site Investigation

Twibell Street, Barnsley

Allenby Commercial and Peel Developments

S191055/SI

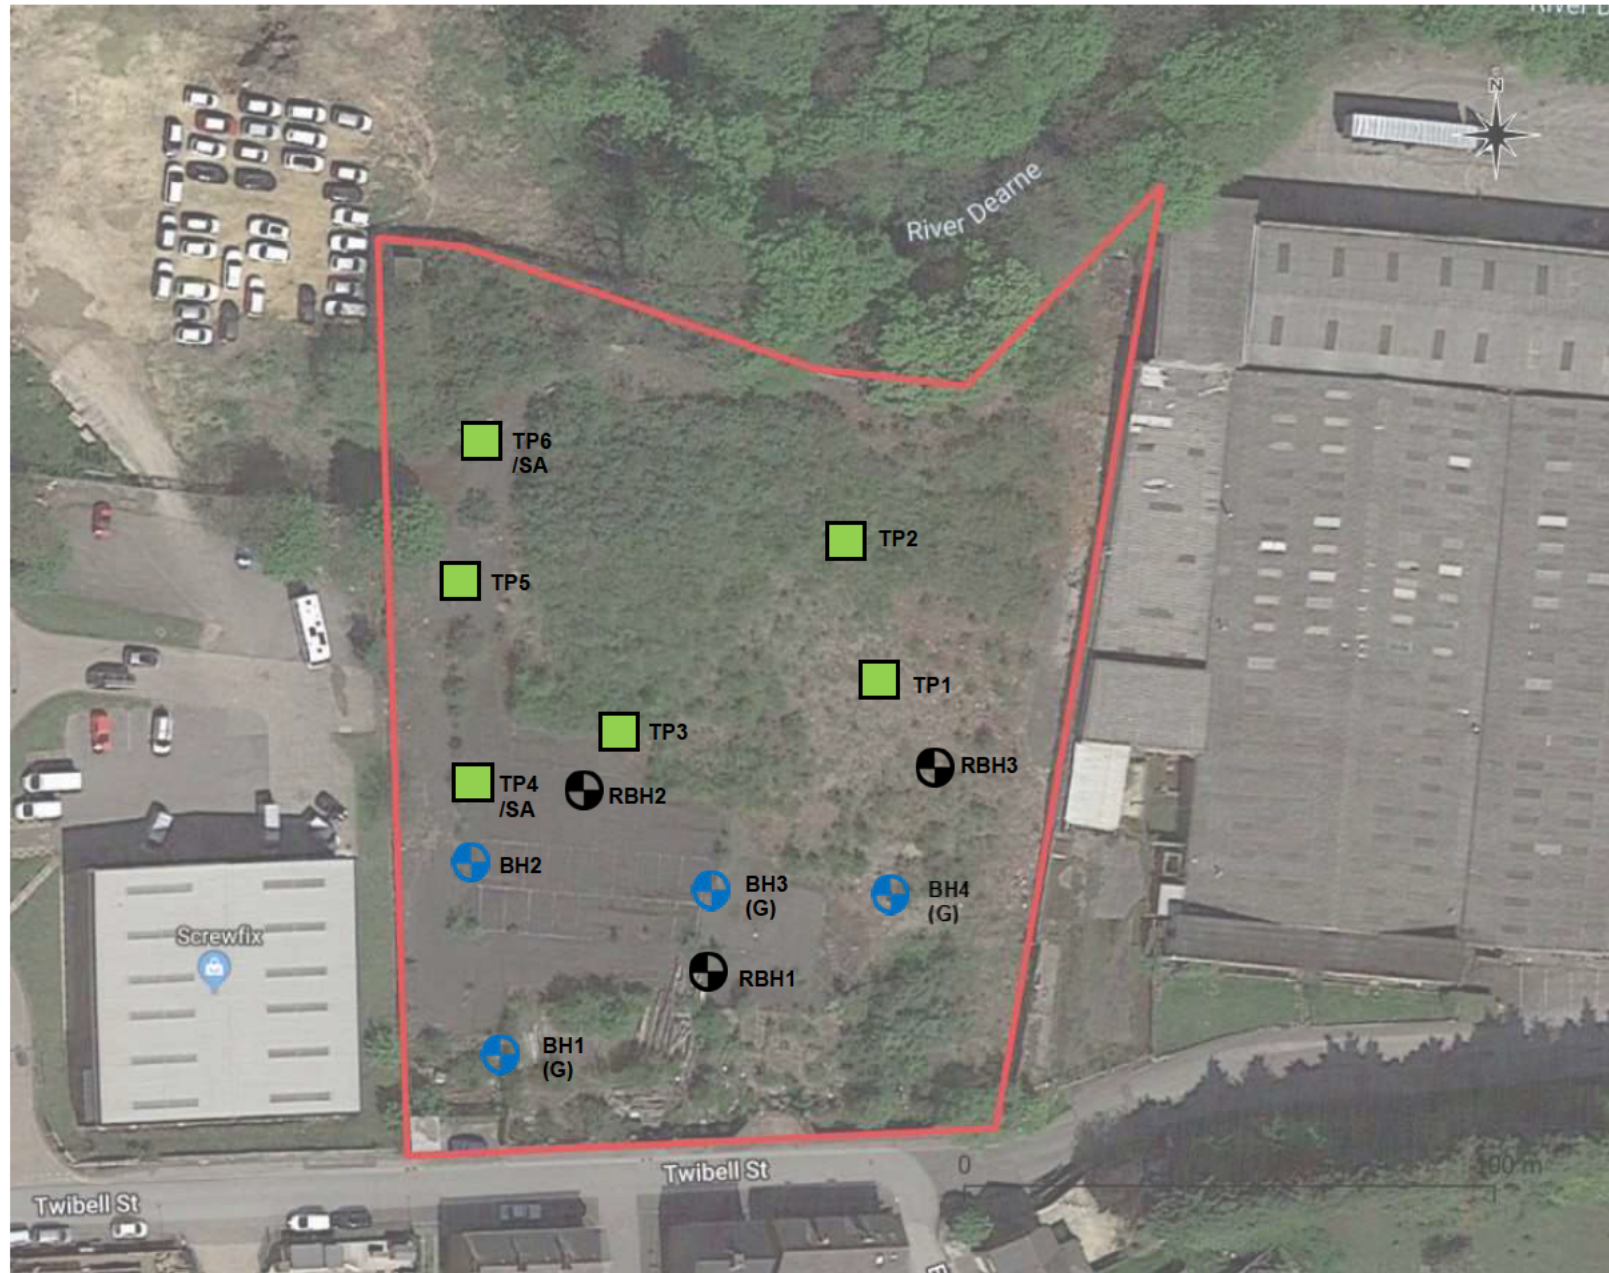
Descriptions of the strata encountered in the boreholes and trial pits together with details of sampling and groundwater are presented in Appendix B of this report. A plan showing the location of the boreholes and trial pits can be found in Appendix A (Figure 2).

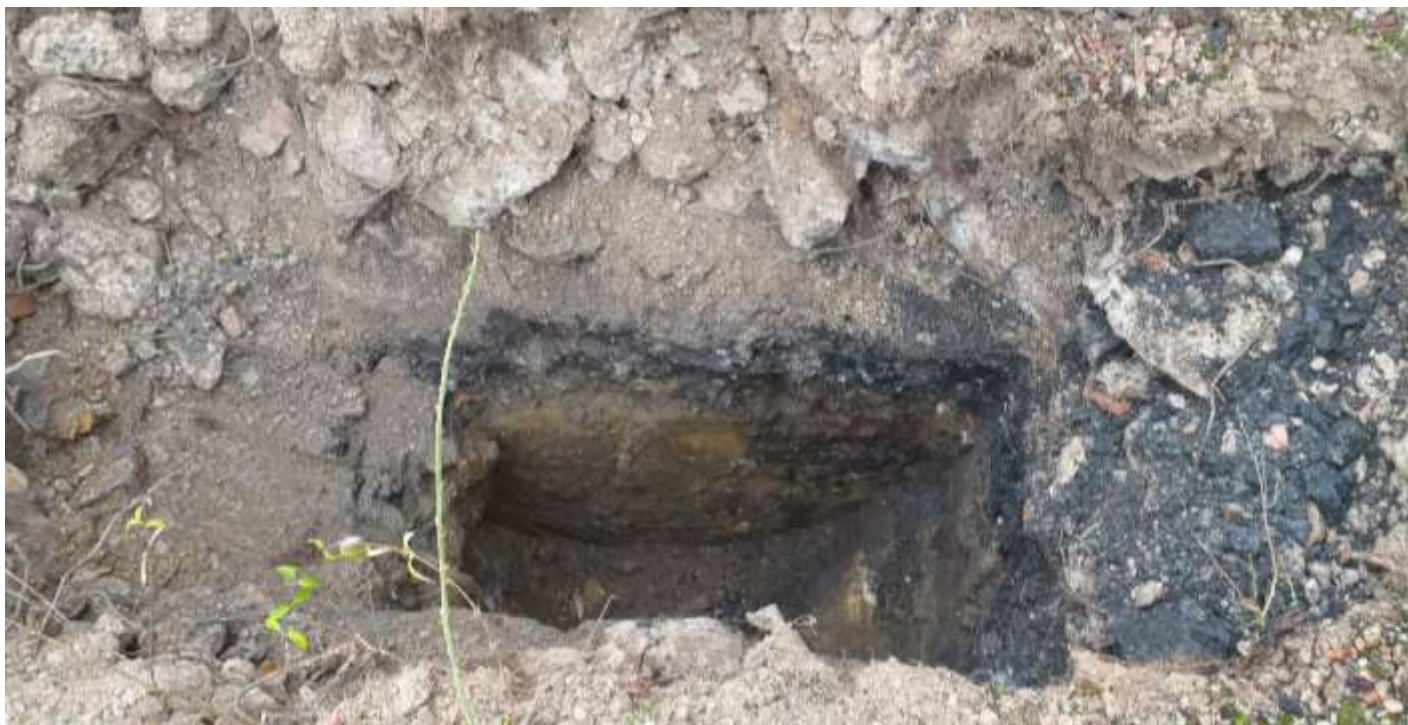
Photo 1: TP1 complete at 2.00mbgl.

| <b>SOLMEK</b><br>Solmek Ltd<br>12-16 Yarm Road<br>Stockton on Tees<br>TS18 3NA<br>Tel: 01642 607083<br>Email: info@solmek.com | | | | <h1>Trial Pit Log</h1> | | | | TrialPit No<br><b>TP1</b><br>Sheet 1 of 1 | |
|---|---|---|---|---|---|---|---|---|--|
| | | | | | | | MADE GROUND: Soft to firm consistency blackish orange very sandy gravelly clay infill. Sand is fine to medium gravel is fine to coarse subangular including brick and tarmac. Drain noted at the base of the pit. | | |

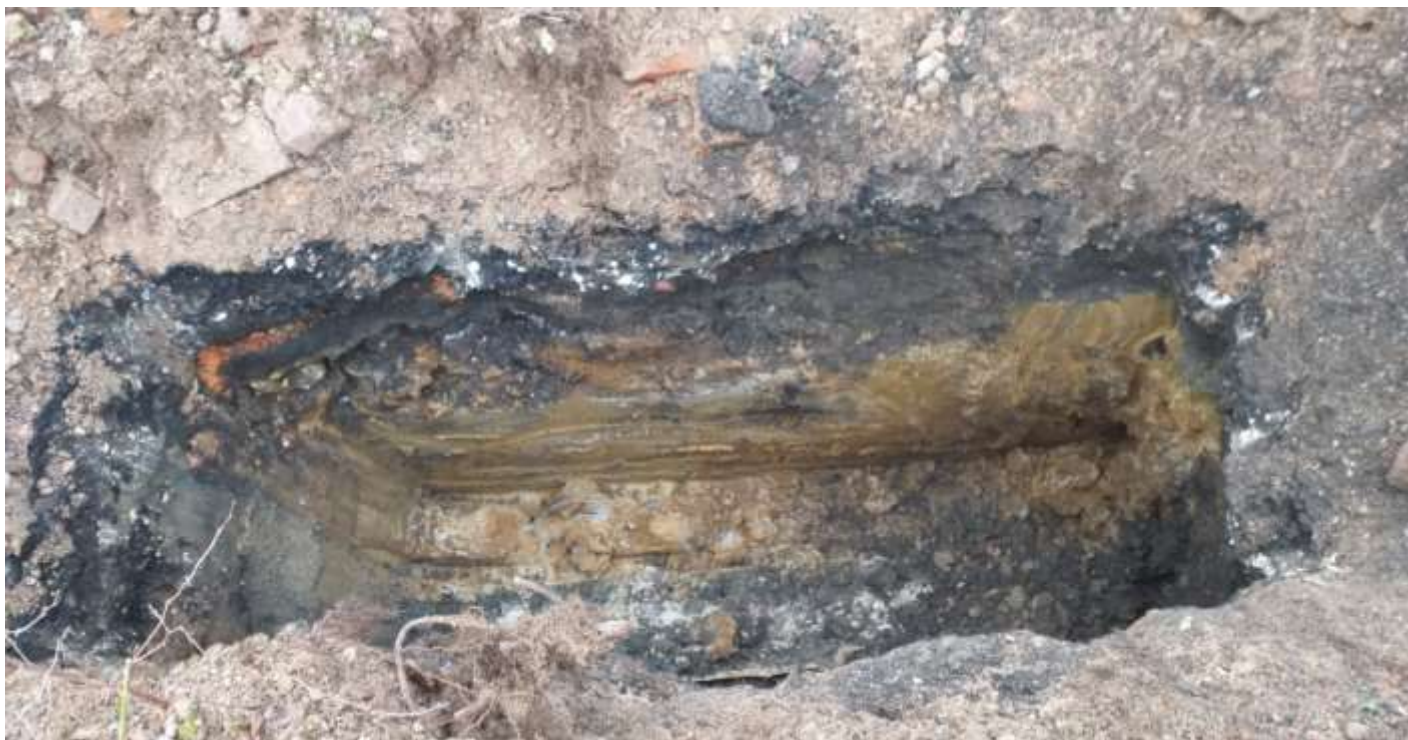
Photo 2: TP2 complete at 2.40mbgl.

| Water Strike | Samples & In Situ Testing | | | Depth (m) | Level (m) | Legend | Stratum Description | |
|---|---|---|---|---|---|---|---|---|
| | | | | 0.80 | | | MADE GROUND: Loose consistency sandy fine to coarse subangular gravel fill. Gravel consists of whole brick, concrete, rebar and ceramics. Tarmac slab noted at 0.80mbgl. | |

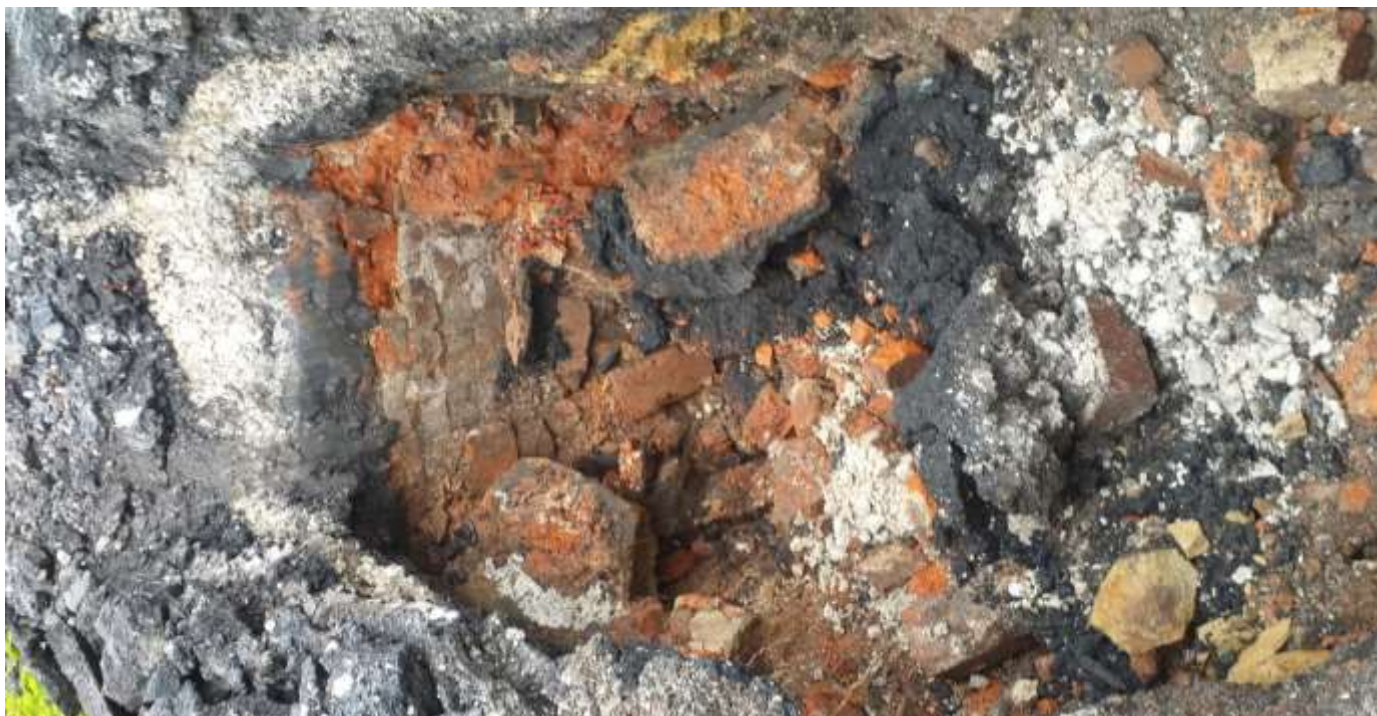
Possible relic foundations or a redundant storm drainage system was encountered within TP3 at 0.50mbgl, brick walls can be seen on all sides of the trial pit (Figure 3) and a tunnel which runs towards the north. The obstruction may be related to the historic buildings on-site such as the depot or saw mills.

Photo 3: TP3 brick wall obstruction encountered.

Based on the nature of the ground conditions encountered, excavations should be within the capacity of normal earthworks plant although breaking out of relict foundations/storm drain (TP3) and other obstructions should be anticipated. Stability of excavations will be poor in the made ground but should improve in the natural clay. Excavation sides should be designed, constructed and supported in accordance with the recommendations given in CIRIA Report No. 97: "Trenching Practice".

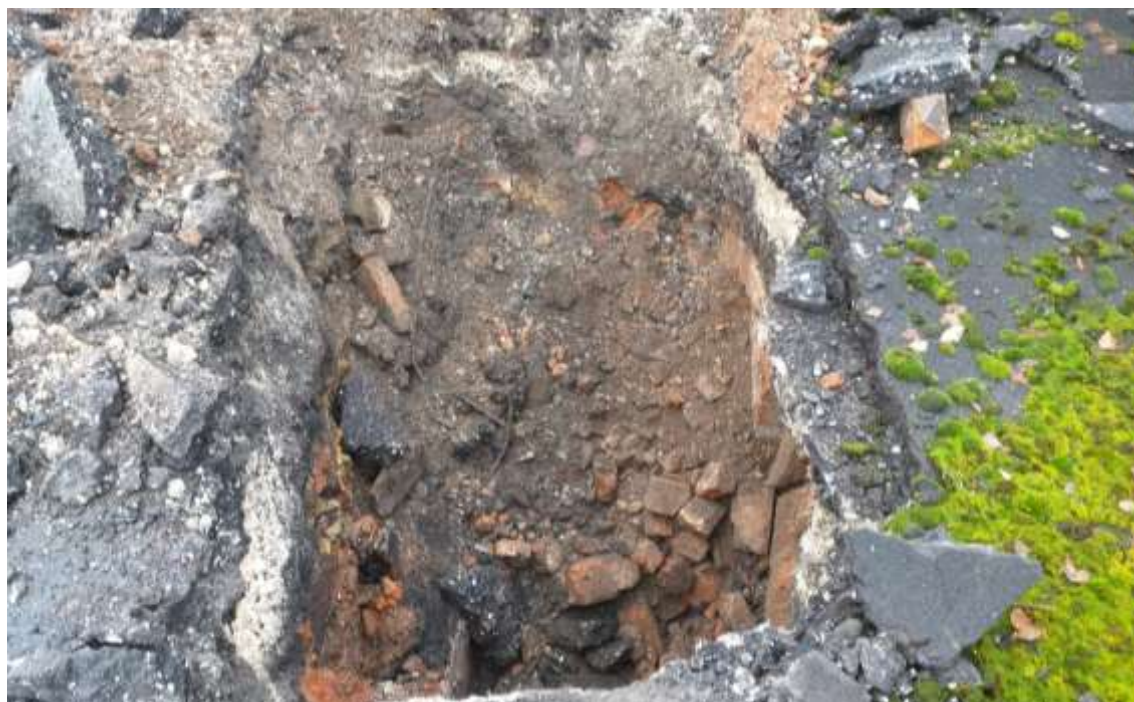
Photo 4: TP3 complete at 1.50mbgl.

| <b>SOLMEK</b><br>Solmek Ltd<br>12-16 Yarm Road<br>Stockton on Tees<br>TS18 3NA<br>Tel: 01642 607083<br>Email: info@solmek.com | | | | <h1>Trial Pit Log</h1> | | | | TrialPit No<br><b>TP3</b><br>Sheet 1 of 1 | |
|---|---|---|---|---|---|---|---|---|--|
| | | | | | | | MADE GROUND: loose sandy clayey gravel infill. sand is fine to medium gravel is fine to coarse including bricks, rebar, concrete and waste fill. (Brick wall was noted on all sides of he trial pit to 1.50mbgl). | | |

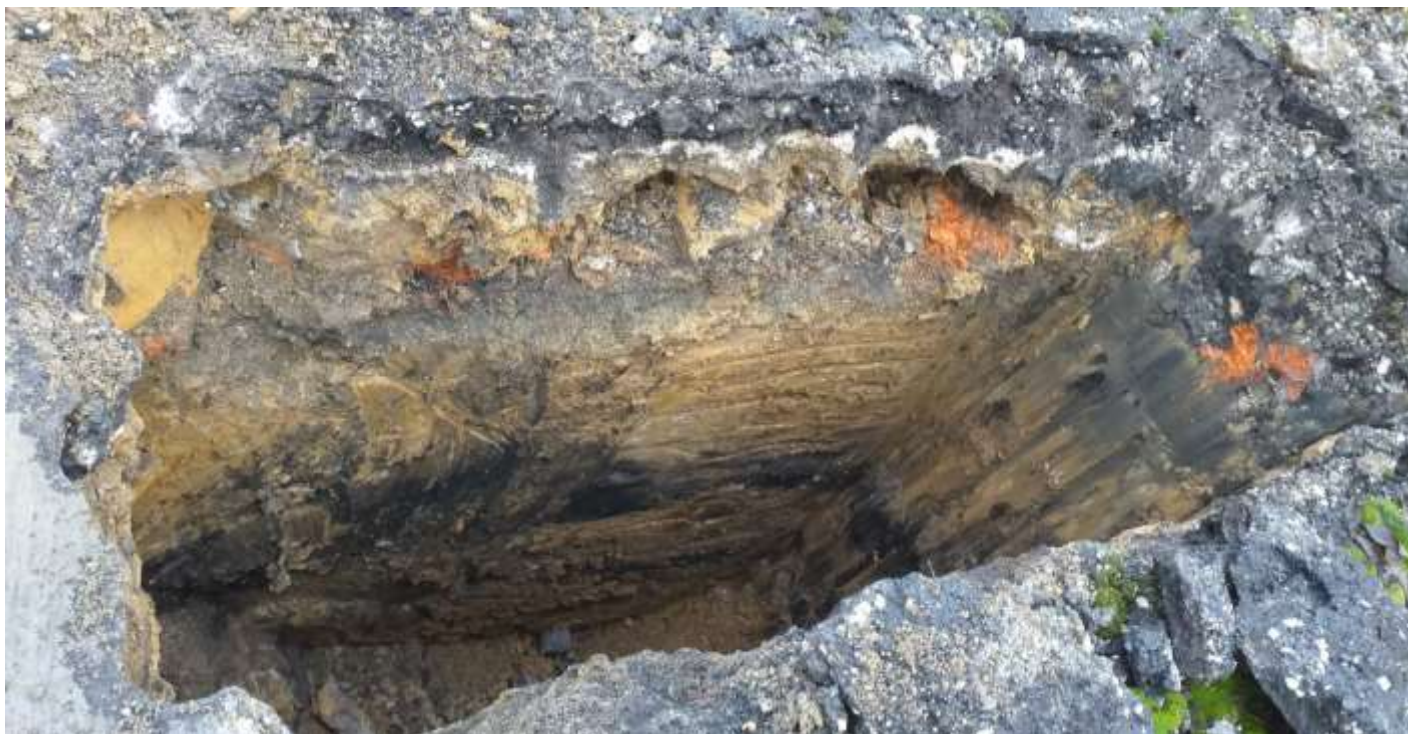
Photo 5: TP4 complete at 2.50mbgl.

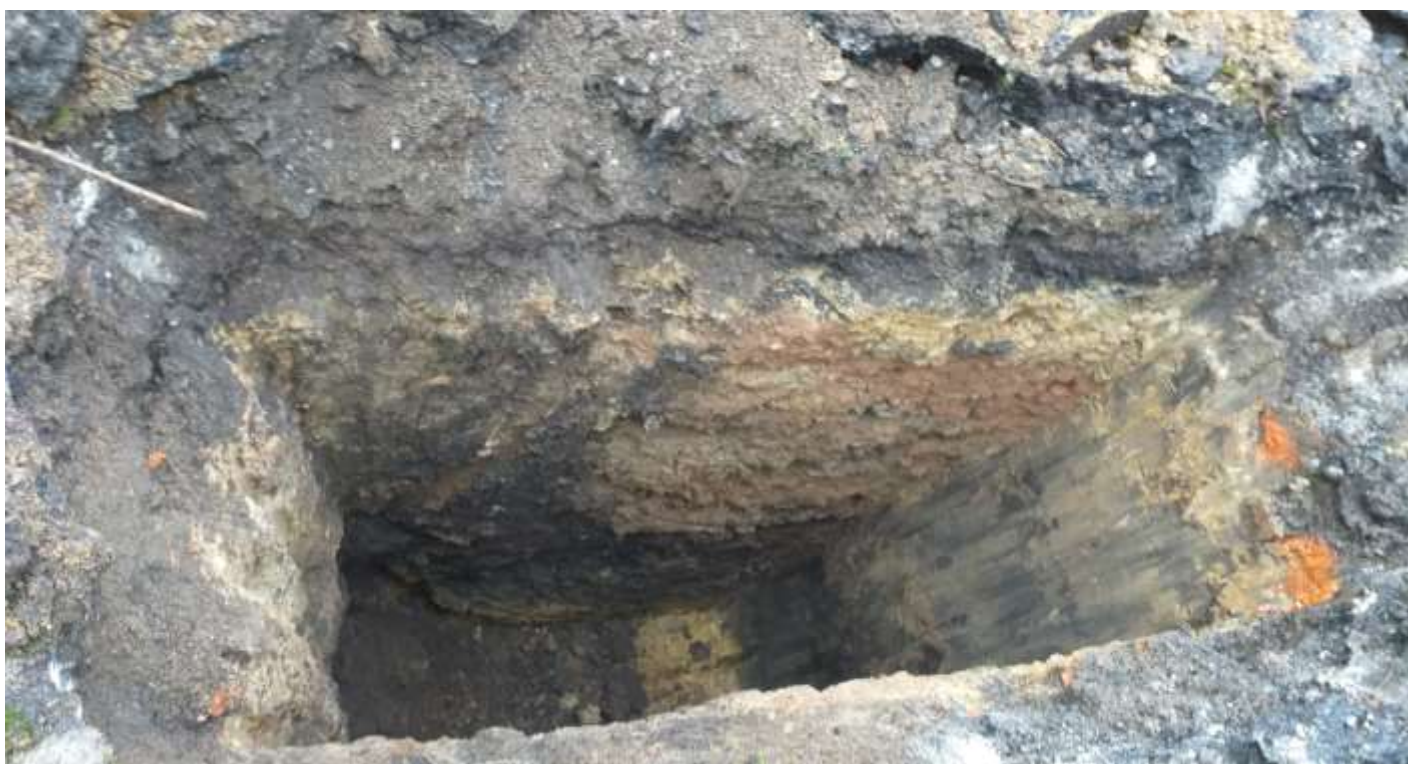
Photo 6: TP5 complete at 3.00mbgl.

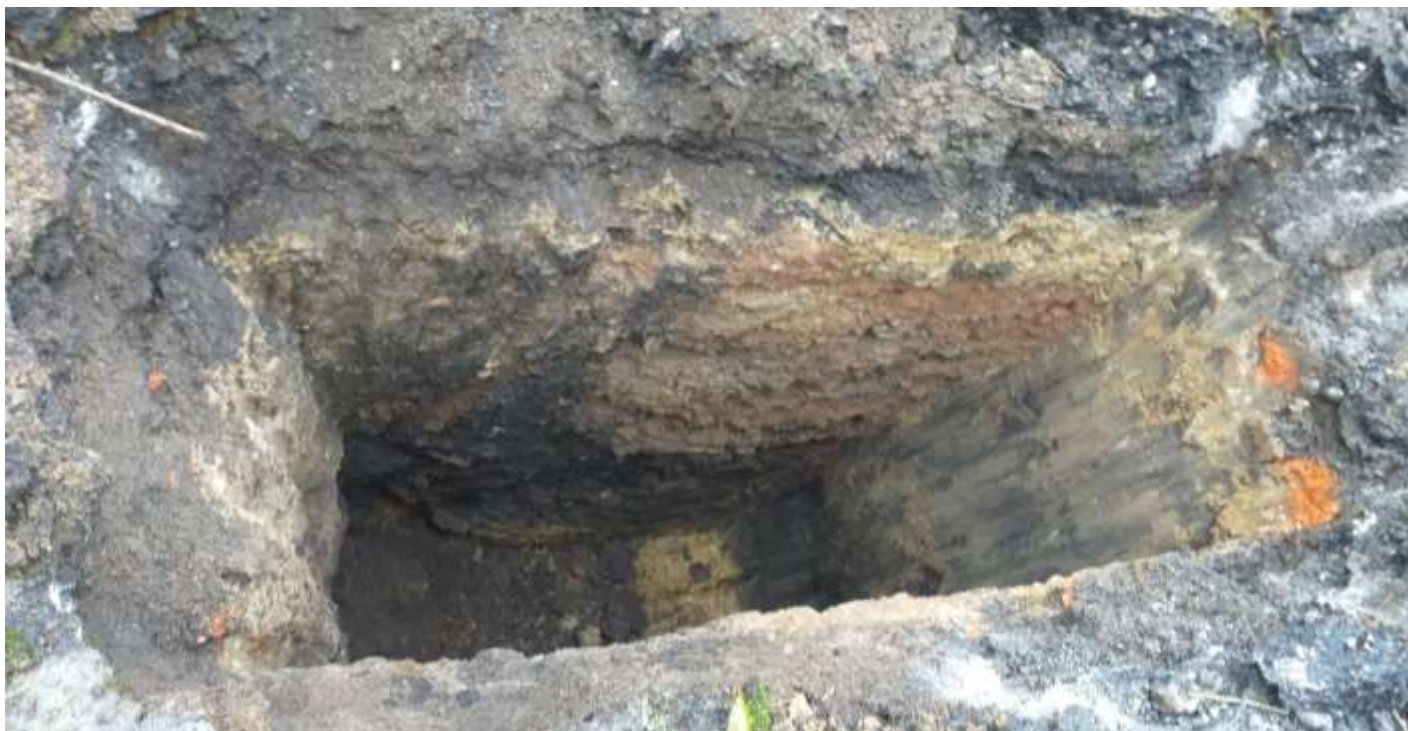
Photo 7: TP6 complete at 3.00mbgl.
