**Baden Street  
Barnsley**

## **Ground Investigation Report**

On behalf of Barnsley Metropolitan Borough  
Council

Report 23-24-18-1-6004/GIR1  
September 2017

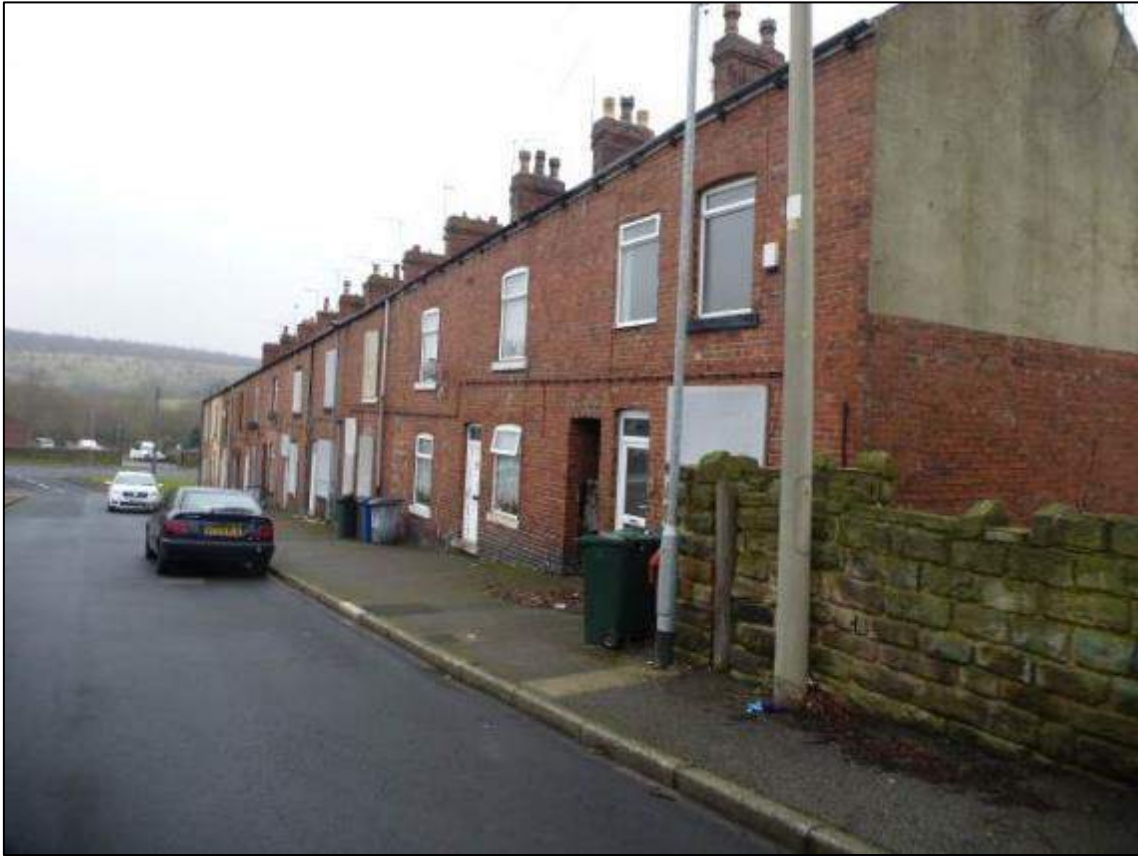
Photograph 1 Baden Street showing existing properties which are to be demolished, looking south.

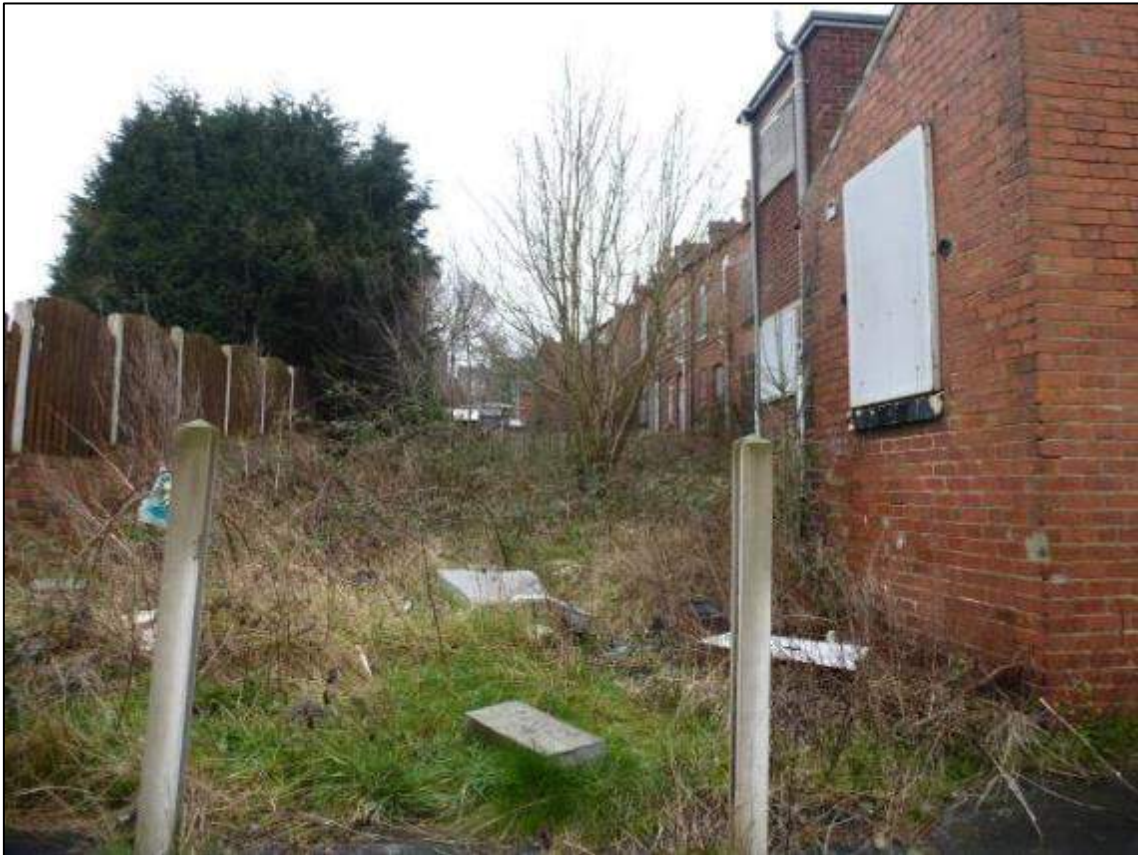
Photograph 2 Gardens to the rear of the properties are overgrown, looking north.

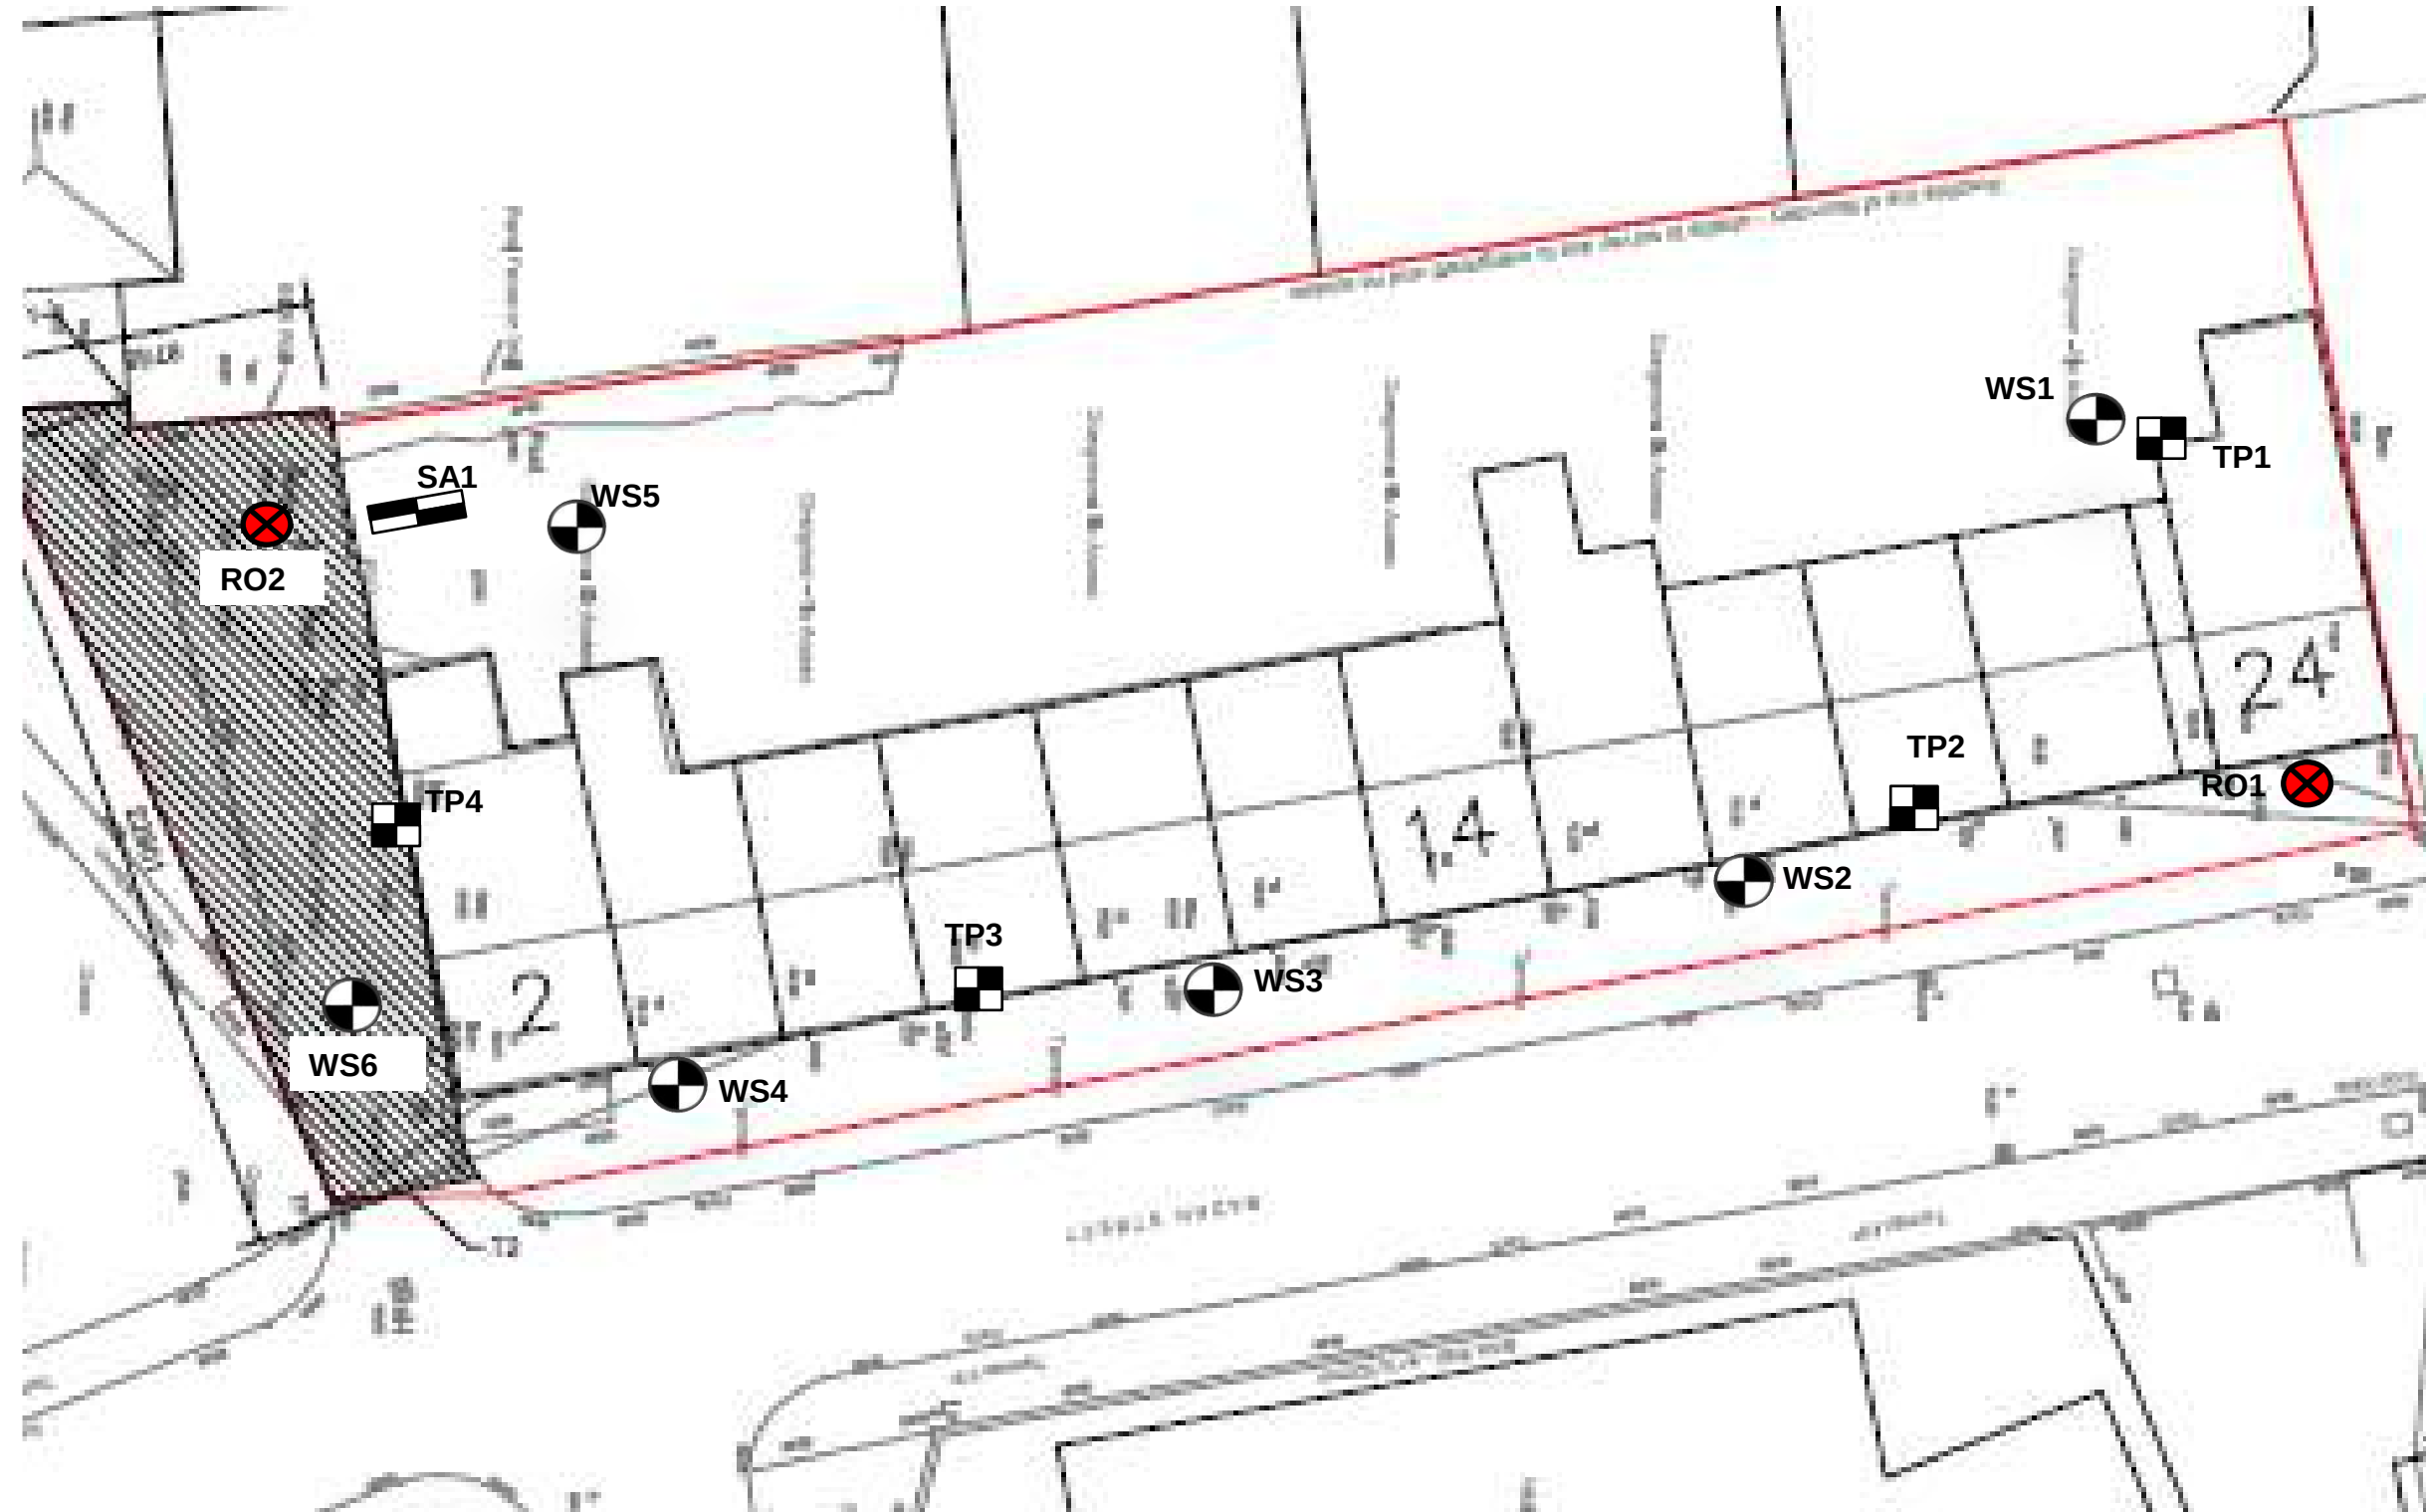
## Exploratory Hole Plan

- Six windowless sampler boreholes.
- Dynamic probe holes undertaken adjacent to each borehole.
- Two Rotary Open Hole Boreholes.
- Ground & gas monitoring wells installed in three boreholes.
- Four hand dug foundation exposure pits.
- One BRE soakaway tests.

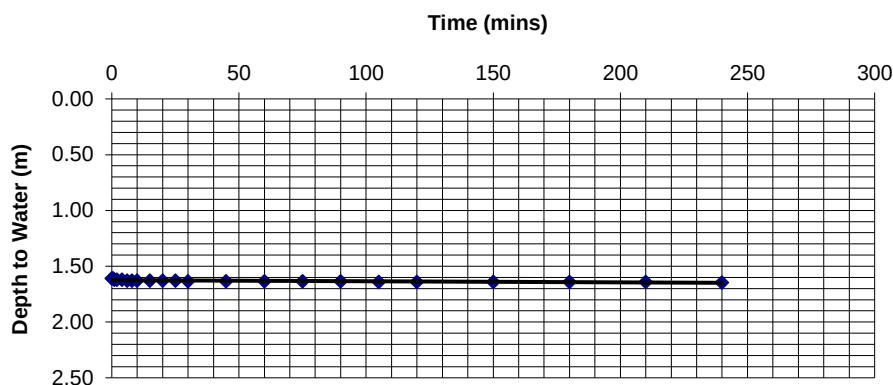
The pit did not drain sufficiently to allow the calculation of an infiltration rate.

However, the very low dissipation of water would suggest infiltrations rates are likely to be less than  $1 \times 10^{-6} \text{m/s}$  and therefore efficient soakaway drainage is unlikely to be feasible.

Length of pit: L = 1.90 m

Width of pit: W = 0.60 m

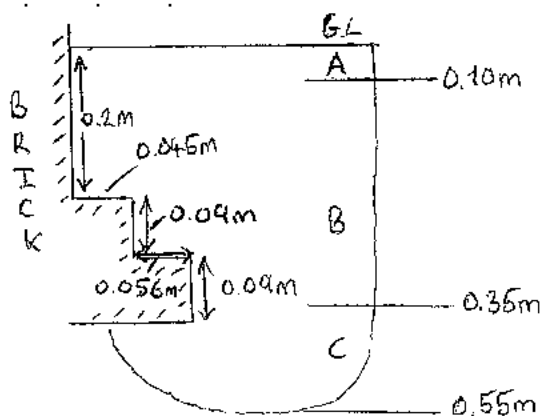
NE3625.HD4

HD4 was excavated to the side of No 2. The base of the foundation was recorded at 0.346m below existing ground level, and extended to 0.101m from the elevation. No evidence of a basement was recorded at this location.

Pit sides remained stable and vertical.  
No groundwater encountered.  
HV = Hand Shear Vane test  
On completion backfilled with arisings.

If a basement is still present beneath No.2 the void will need to be backfilled, with the fill material compacted to an engineered specification. This would result in a uniform material in terms of constituents and strength, allowing easier construction of shallow foundations in the underlying natural strata where thickness allows, or the use of raft foundations for suitable structures where the thickness of fill is too great.
