**PHASE 2
GEOTECHNICAL AND GEO-ENVIRONMENTAL
SITE INVESTIGATION**

LOWER EASTFIELD FARM, THURGOLAND

MR AND MS MILLER

44856-002

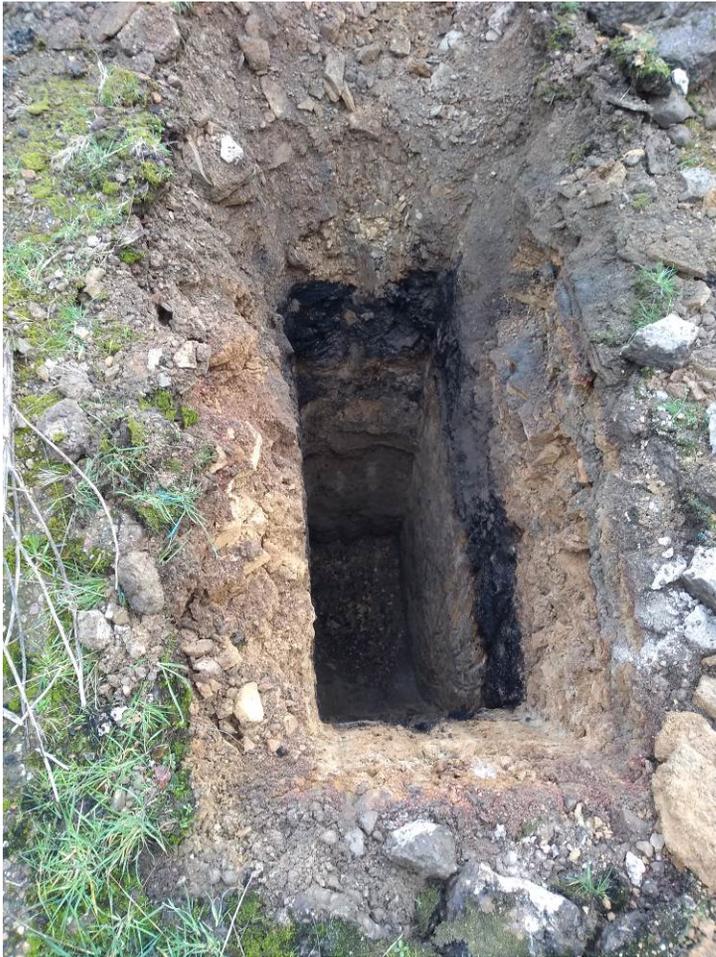
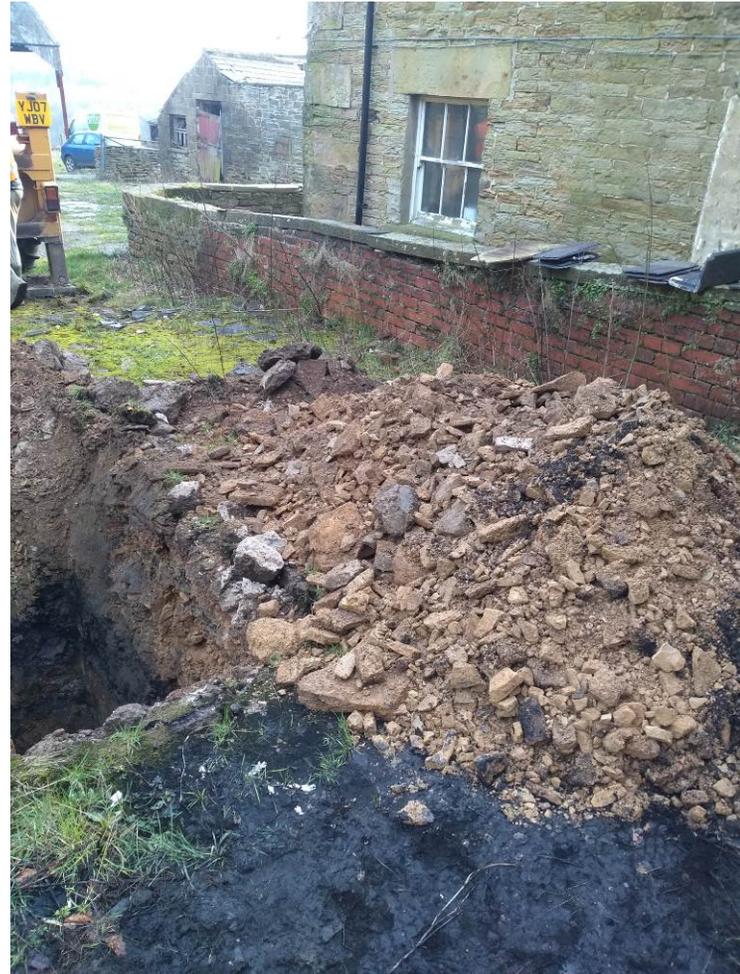
Groundwater was not typically encountered. The exception to this was within TP1, TP2 and TP6 where slight seepages were encountered between 1.2 and 2 m bgl. The seepages within TP1 and TP2 are attributed to the fractures within the coal seam providing a preferential pathway to groundwater that may be limited in its downward migration by the underlying mudstone. TP6 didn't record any coal. However, the nearby borehole (R06) encountered coal from 2.1 m bgl, just below the termination depth of the trial pit where groundwater was recorded.

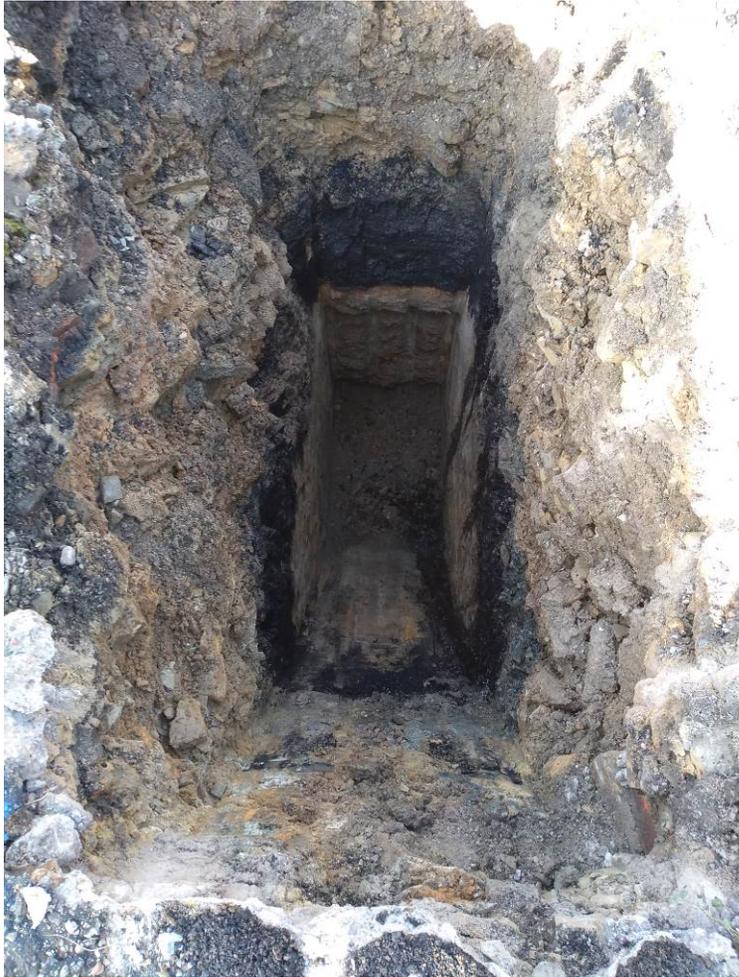
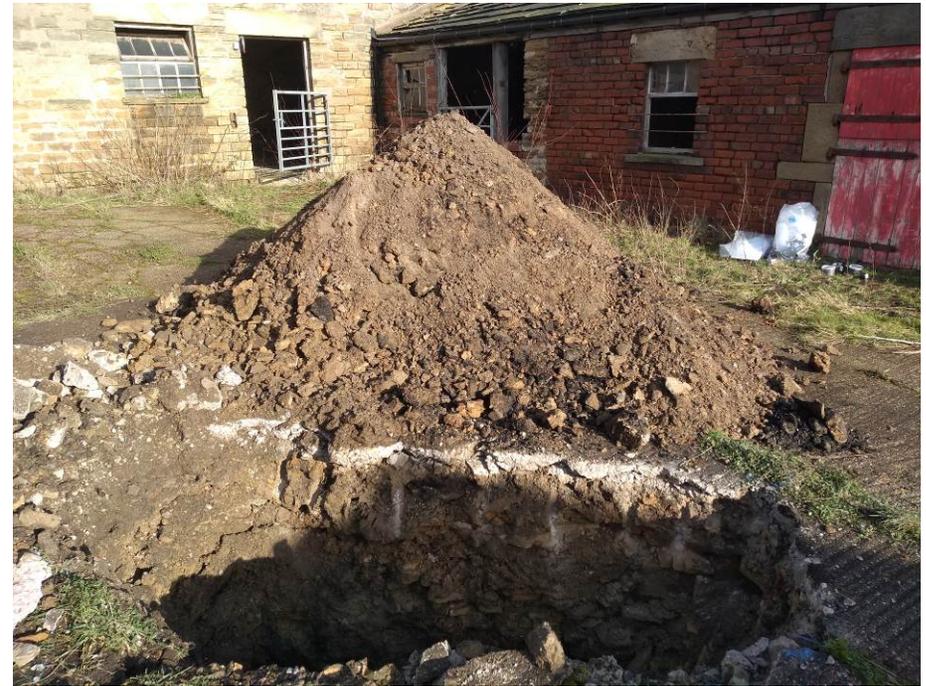
TP2

Visual evidence of possible contamination was identified within the natural strata encountered in TP2. Here, at 1.1 m, a slight black staining was noted to the soils. No odour was recorded and it is suspected the staining may relate to the coal encountered below at 1.3 m coupled with shallow perched groundwater fluctuating within the coal and lower parts of the residual sandstone.

At 1.10 m <i>slight black staining. No odour.</i> Extremely weak black COAL recovered as fine to medium angular gravel.
2.60 - 3.00	ES		1.80

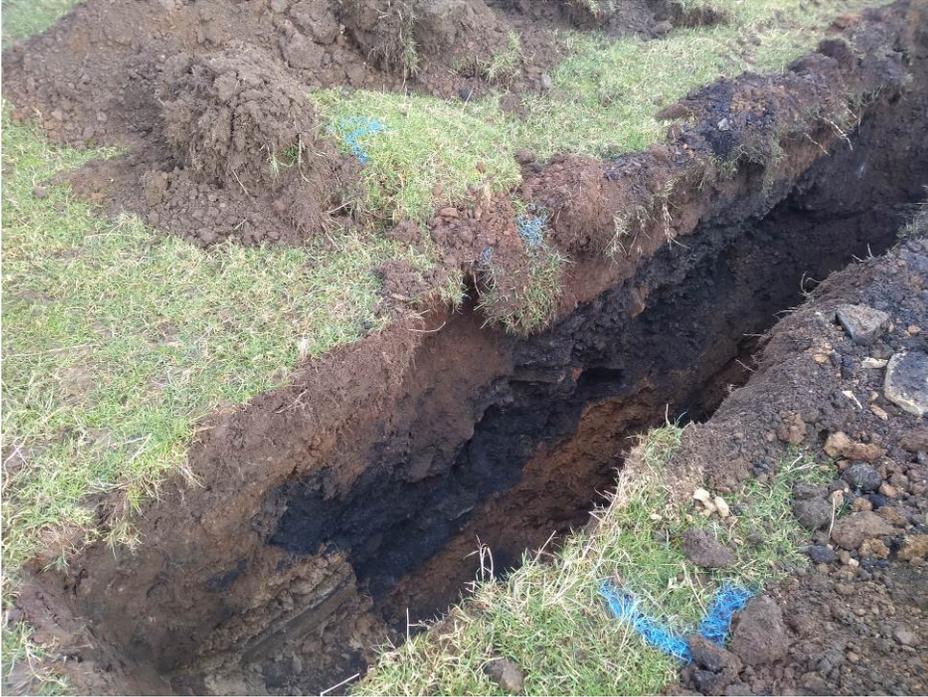
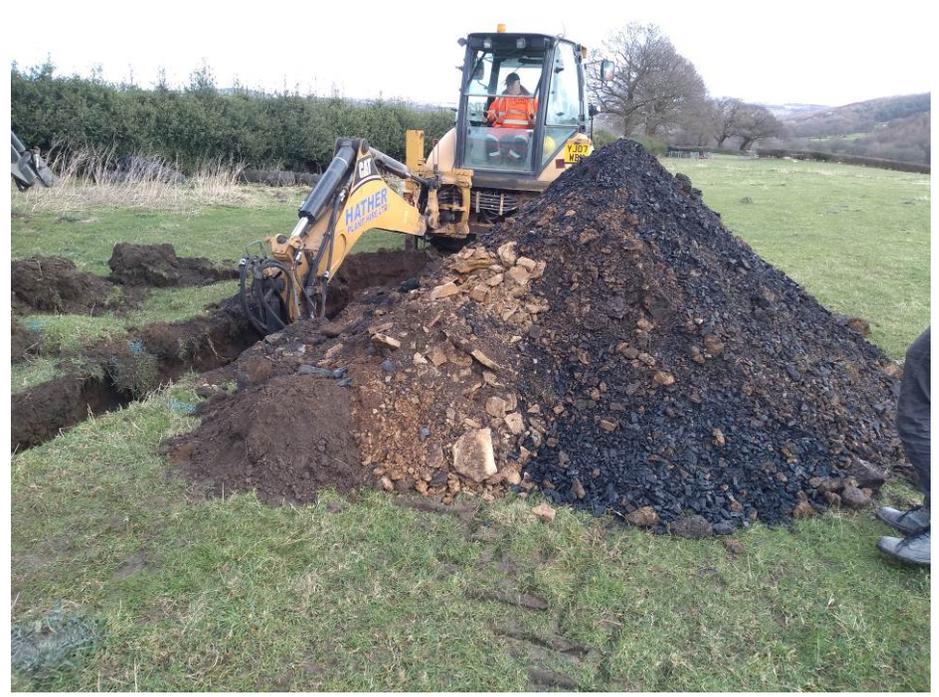
Prepared	JH	Checked	GCB	Date	18.02.2020	Photograph No	5 and 6
----------	----	---------	-----	------	------------	---------------	---------

TP3

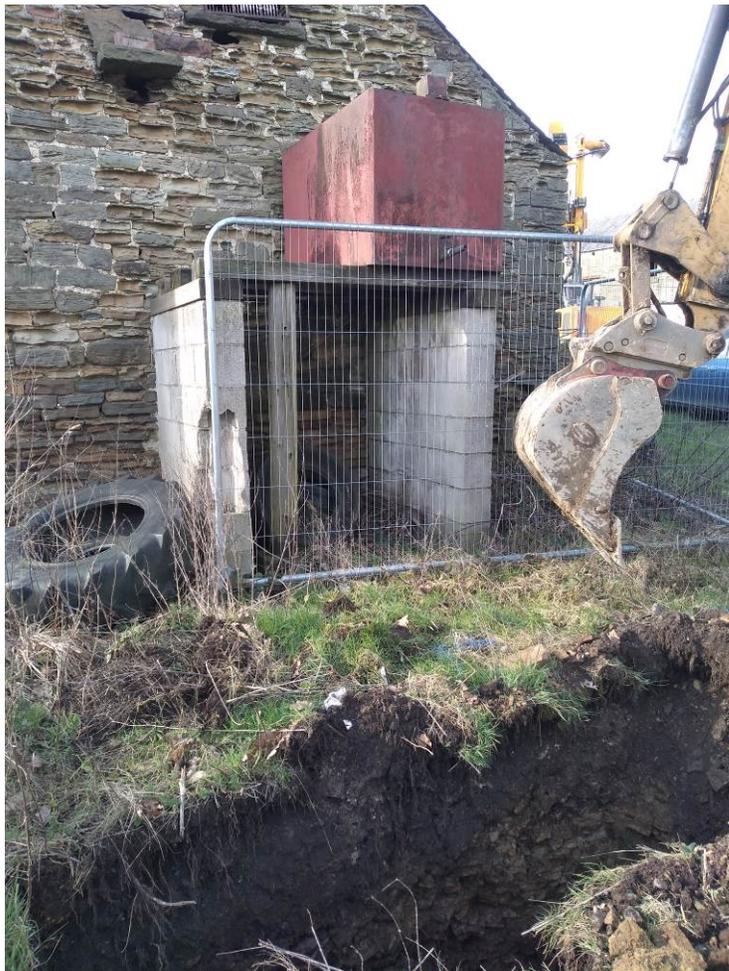
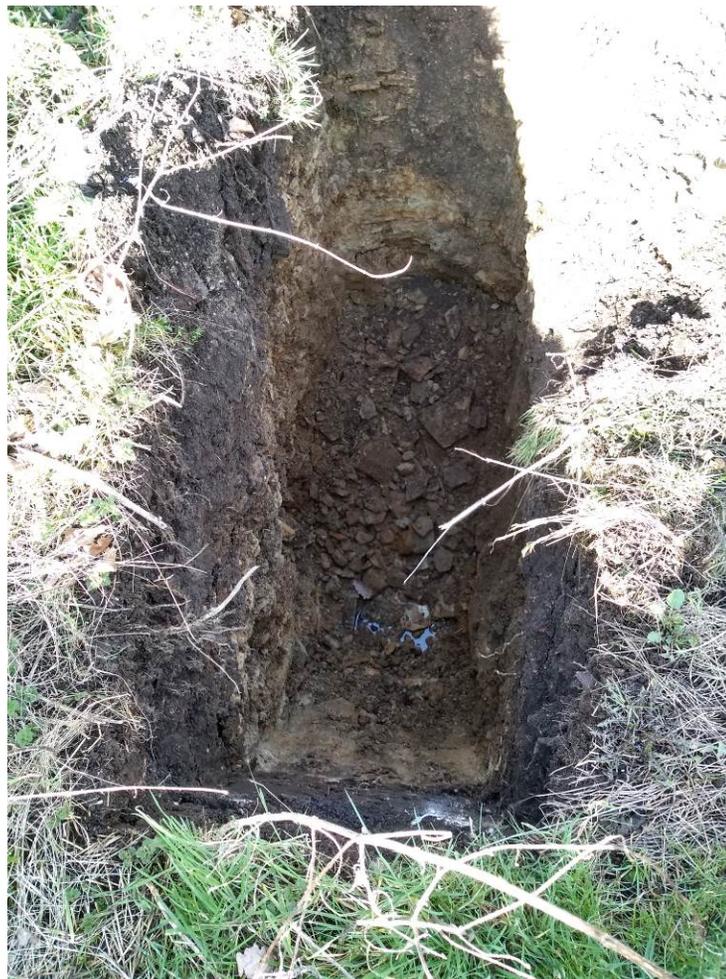
Although no evidence of contamination was noted within TP6, due to its location next to an old above ground tank, a shallow sample was sent for TPH analysis.

Elevated PAH compounds were recorded within two of the three samples of made ground tested. The PAHs recoded within TP6 at 0.2 m bgl are noted to be significantly elevated, with some determinands exceeding the assessment criteria by around 40 times. These concentrations are considered likely to relate to historical spillage / leakage of the nearby above ground fuel tank. Detectable concentrations of TPHs were recorded within the same sample however, these did not

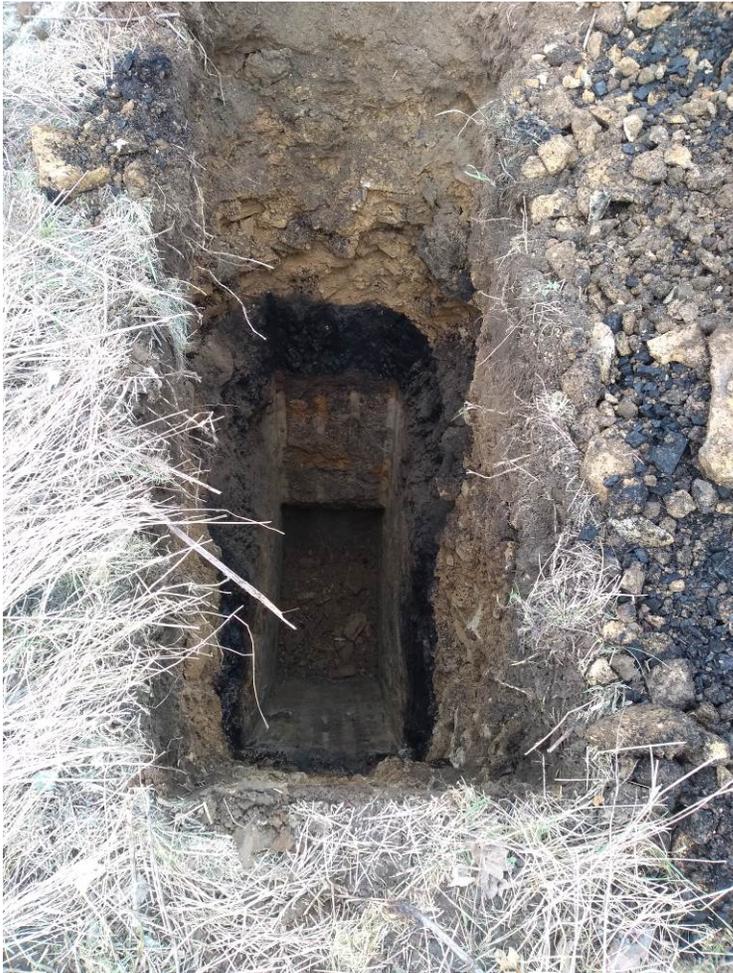
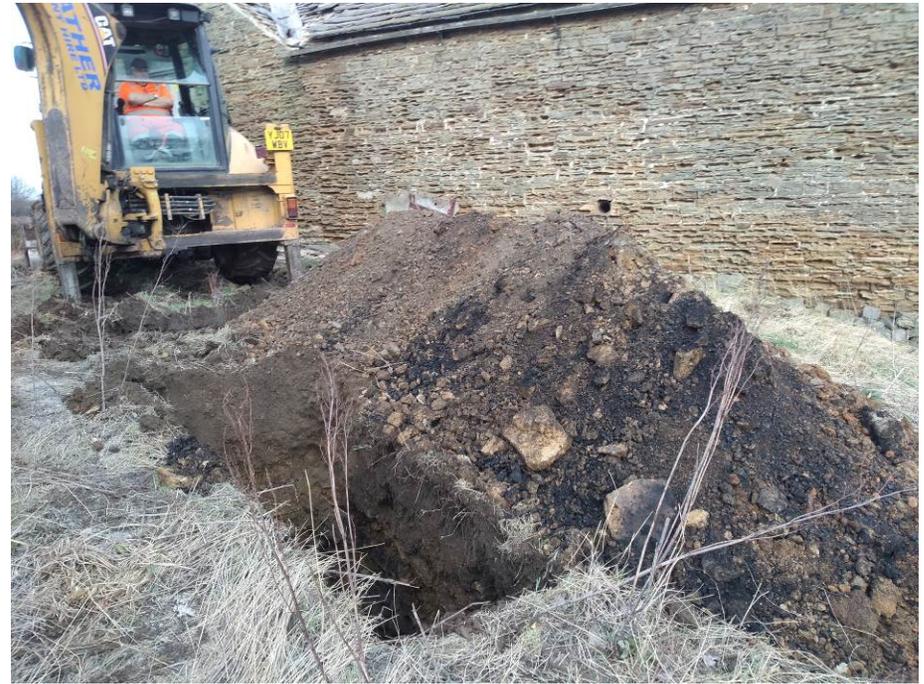
Prepared	JH	Checked	GCB	Date	18.02.2020	Photograph No	9 and 10
----------	----	---------	-----	------	------------	---------------	----------

TP7

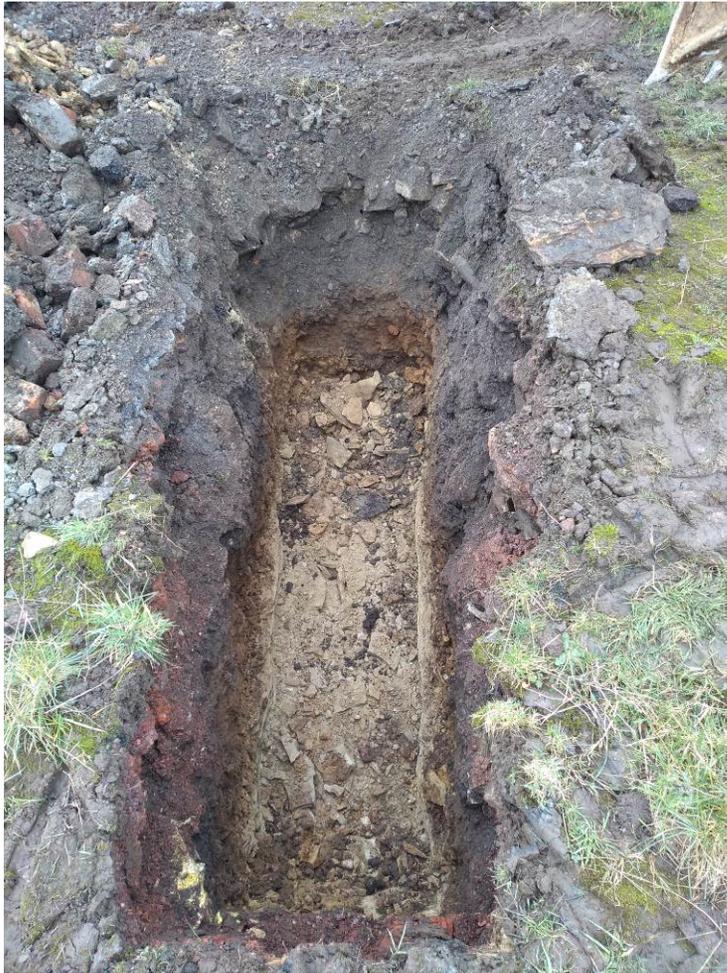
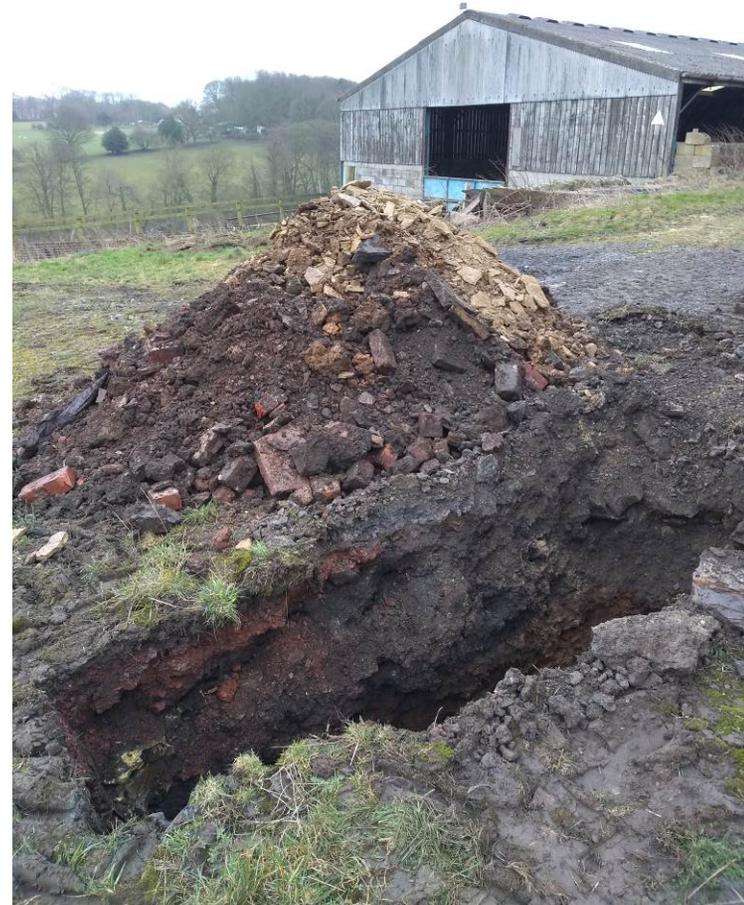
A fragment of suspected asbestos containing material was identified in TP8 and sent for asbestos identification. Similar materials, expected to comprise cement bound asbestos were found at various locations across the site at surface. This included corrugated roofing products near TP5 and cement based rainwater goods to the rear (south) of the southern barn.

The fragments of suspected asbestos containing material recovered from TP8 at 0.3 m was confirmed to contain cement bound fibres of chrysotile. No loose fibres or any other asbestos containing materials were recorded within any of the soil samples tested.

A fragment of asbestos containing material was encountered at 0.3 m bgl within TP8. Given the presence of asbestos products at surface in varying states or repair the presence of further asbestos containing materials or fibres within the made ground cannot be discounted.

Given the above, this material is considered to pose a risk to human health for the proposed development. The made ground is not considered chemically or texturally suitable to be left in-situ beneath gardens or areas of soft landscaping. A 600 mm thick capping system, including 100 mm of clean, inert topsoil is recommended in all gardens where made ground remains.

All ground workers employed on the site should be made aware that elevated concentrations of heavy metals, PAHs and asbestos containing materials are present, and normal site procedures such as the wearing of gloves when handling soils, and the washing of hands prior to eating should be implemented. Damping down of asbestos containing soils may be required in dry weather.

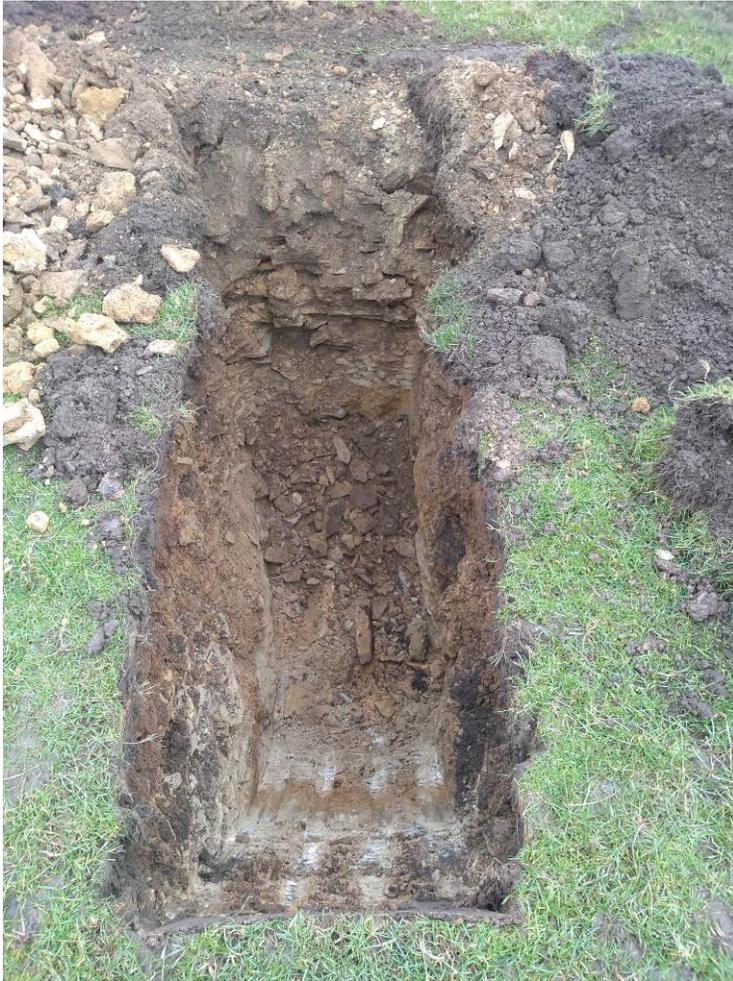
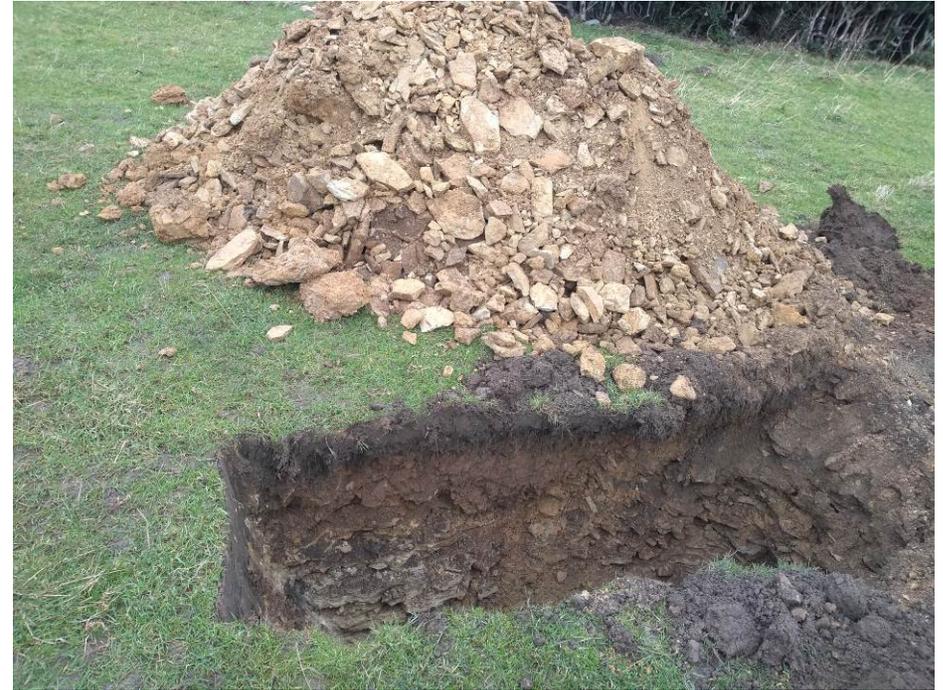
Prepared	JH	Checked	GCB	Date	18.02.2020	Photograph No	13 and 14
----------	----	---------	-----	------	------------	---------------	-----------

TP9
