**Ecological Assessment  
Willowgarth High School  
Grimethorpe**

Report reference: BE-R-0938-01  
April 2011

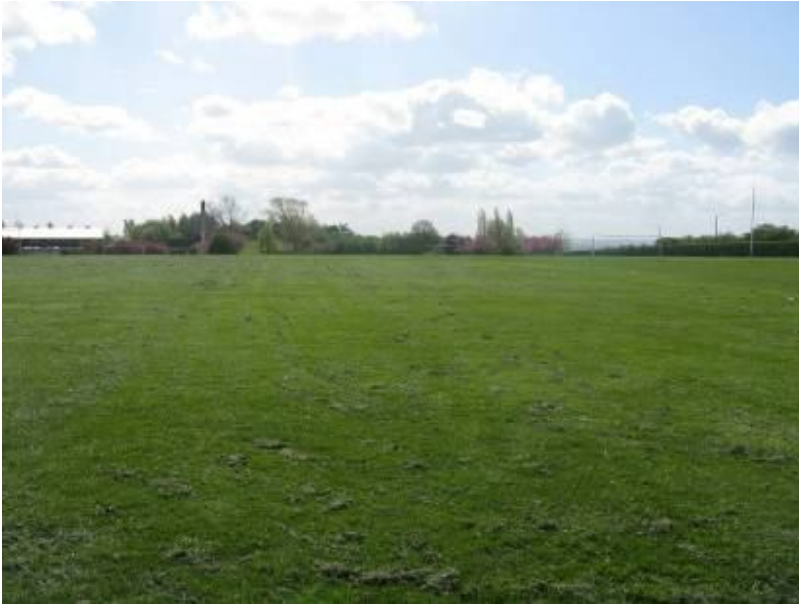
**Figure 1**

The northern section of the site is made up of extensive areas of playing fields, regularly mown and dominated by a limited range of common grasses. Abundant species include perennial rye-grass (*Lolium perenne*), meadow grasses (*Poa* spp.), white clover (*Trifolium repens*), dandelion (*Taraxacum* agg.), ribwort plantain (*Plantago lanceolata*) and the common moss *Rhytidiadelphus squarrosus*.

View of sports field looking south

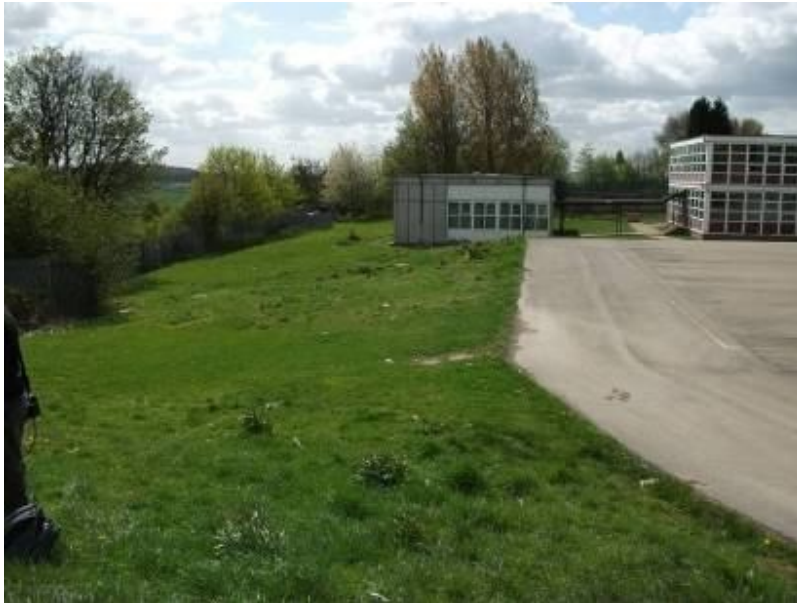
**Figure 2**

Beyond the sports fields and surrounding the buildings and playgrounds, the ground has been less trampled or mowed less frequently which has resulted in a wider range of forb species including common field speedwell (*Veronica persica*), cow parsley (*Anthriscus sylvestris*), groundsel (*Senecio vulgaris*), mugwort (*Artemisia vulgaris*) red dead nettle (*Lamium album*) and sun spurge (*Euphorbia helioscopia*). Closer to the school boundary, stands of cocksfoot are established along with nettle (*Urtica dioica*), hedge garlic (*Alliaria petiolata*) and small amounts of bramble (*Rubus fruticosus* agg.)

Area of grassland at eastern boundary

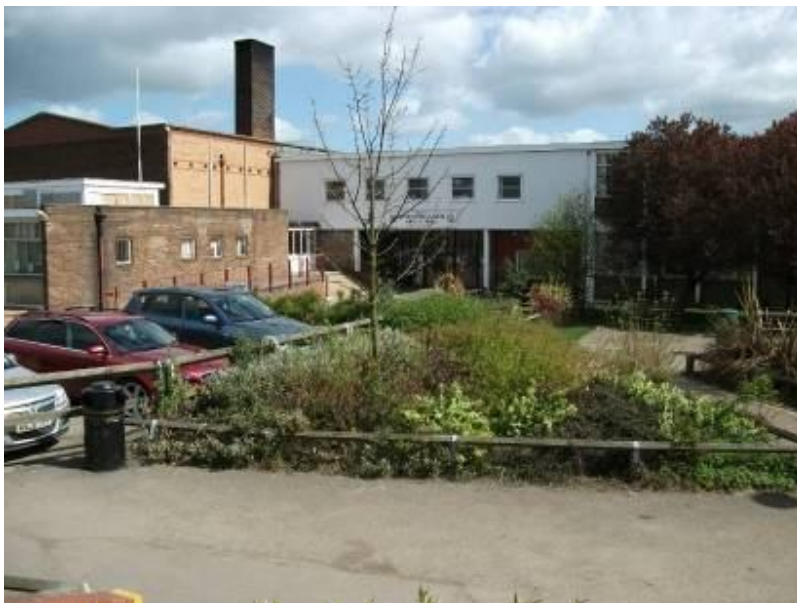
**Figure 3**

As part of the landscaping of the site, a range of shrubs have been planted around the buildings though most are located close to the school entrance at the western end and around a small paved courtyard surrounding by classrooms.

Landscape planting situated by the entrance of the school

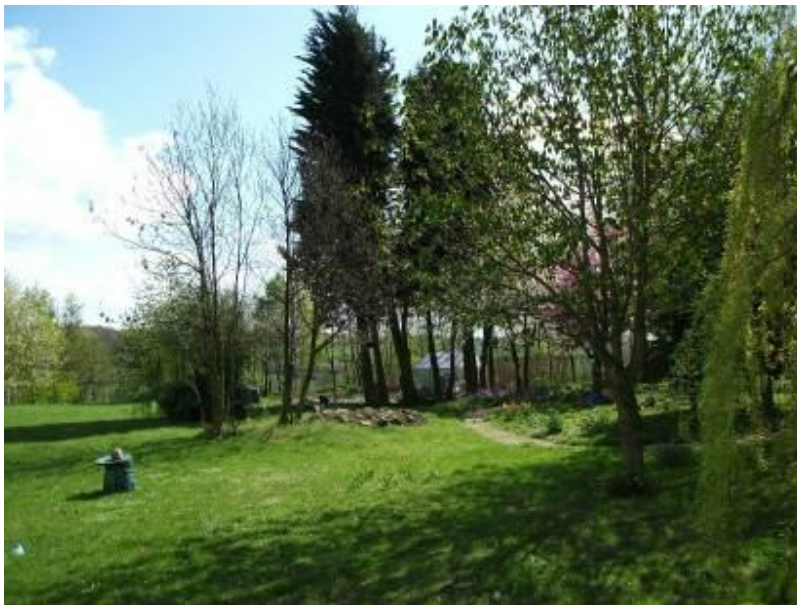
**Figure 4**

Within a separately fenced area currently used as a children's centre additional landscaping includes small vegetable patches and areas of spring bulb planting within the amenity grassland.

Gardens forming part of the children's centre

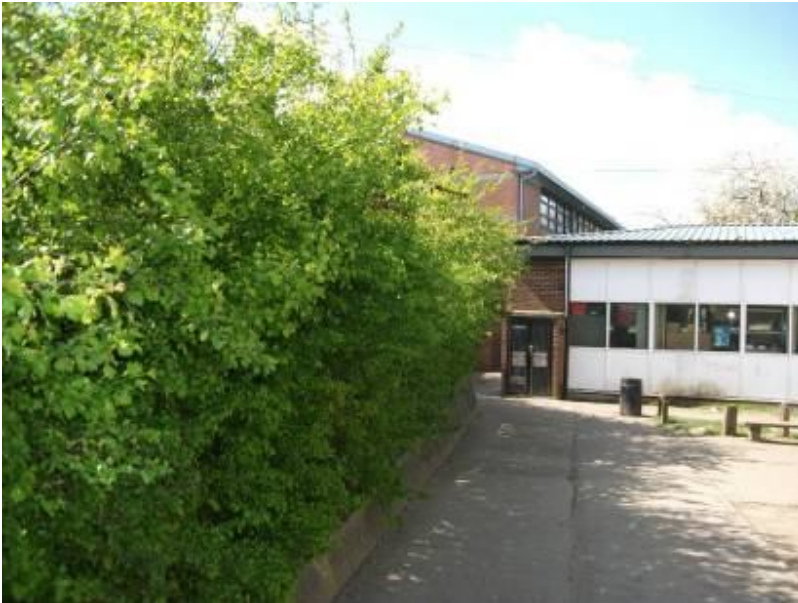
**Figure 5**

A small ornamental hedge containing primarily beech (*Fagus sylvatica*) with occasional hawthorn (*Crataegus monogyna*) and forsythia (*Forsythia sp.*) is located close to school buildings and forms part of the landscaping of the site.

Ornamental hedge within the school boundary

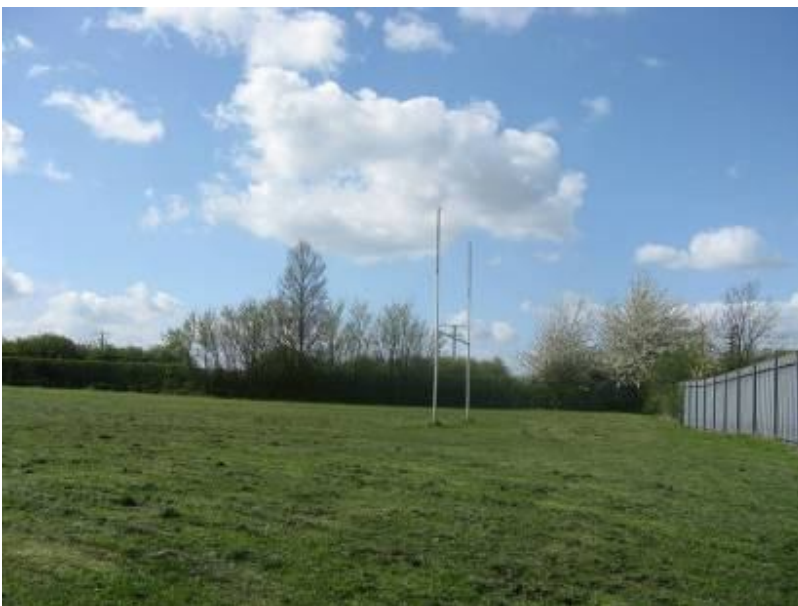
**Figure 6**

Along the western boundary, adjoining the sports fields is a dense heavily managed hedge made up primarily of hawthorn with occasional wych elm (*Ulmus glabra*).

View of hedgerow that borders sports fields at the western boundary of the school.

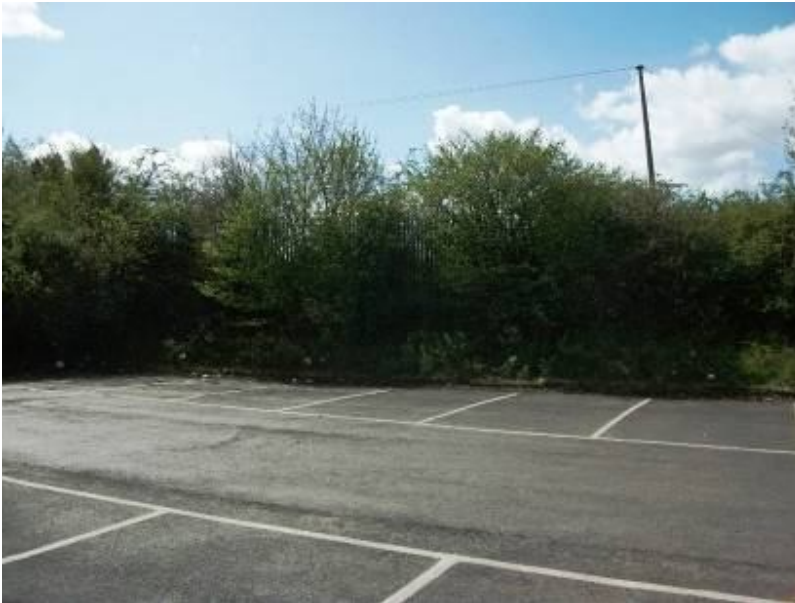
**Figure 7**

At the south western corner of the school grounds, bordering areas of grassland and car parking, a less managed stretch of hawthorn hedge includes a slightly more diverse mix of species including blackthorn (*Prunus spinosa*), elder (*Sambucus nigra*), dog rose (*Rosa canina*), Japanese rose (*Rosa rugosa*) and field maple.

View of hedgerow adjoining car park at south western corner of the site

Two species listed on Schedule 9 (Part 2) of the Wildlife and Countryside Act (1981) were found on site; Japanese Rose (*Rosa rugosa*) is found within the hedgerow at the southern boundary of the site while fishbone cotoneaster (*Cotoneaster horizontalis*) is included within landscaping in front of the school reception. Care should be taken during any works on site to ensure that these species are not caused to spread beyond the site boundary or in relation to its disposal off-site – both would constitute a potential offence under this recently updated legislation.

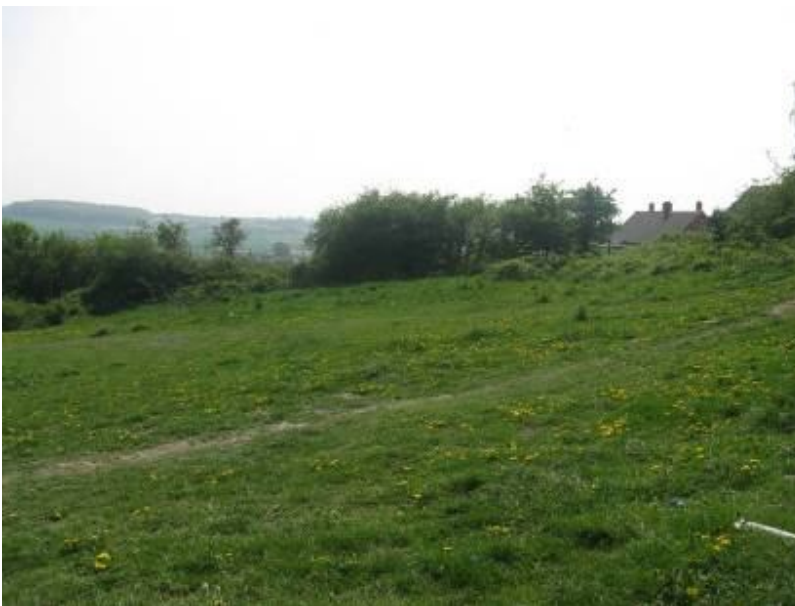
**Figure 8**

A stretch of hawthorn hedge is also found within the pasture to the south of the school although most of this borders the site, separating it from the adjoining housing estate and does not appear to fall within the application boundary. Some scattered fragments of hawthorn with occasional bramble and elder are located at the southern boundary of the pasture where it meets another area of rough grassland.

View of hedgerow at southern edge of site within area not included within development proposals

None of these hedges appeared to be particularly old or contain a diverse field layer.

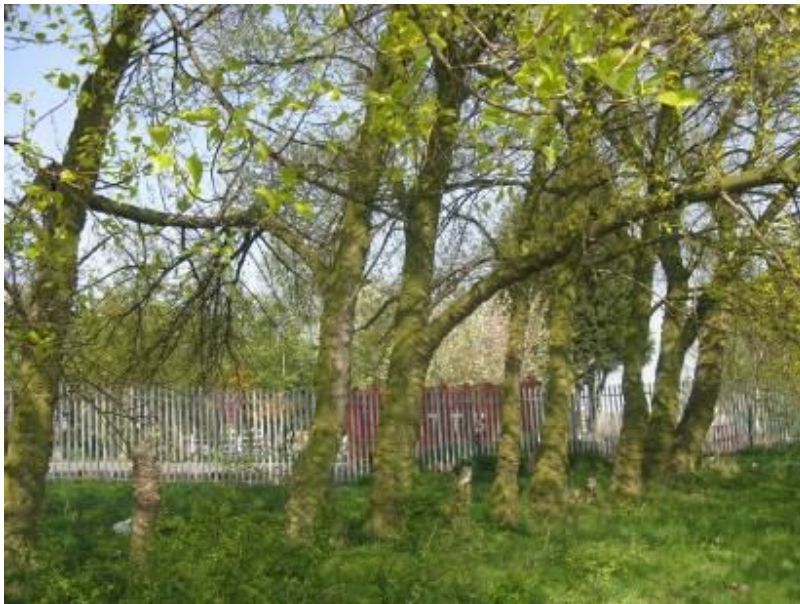
**Figure 9**

Landscaping of the site has included the planting of a number of trees arranged mainly around the southern boundary of the school. Species include ash (*Fraxinus excelsior*), beech, horse chestnut (*Aesculus hippocastanum*), birch (*Betula sp.*), alder, cherry, sycamore (*Acer pseudoplatanus*), weeping willow (*Salix chrysocoma*) and lime (*Tilia sp.*).

Short line of planted limes in grassland to the south of the school

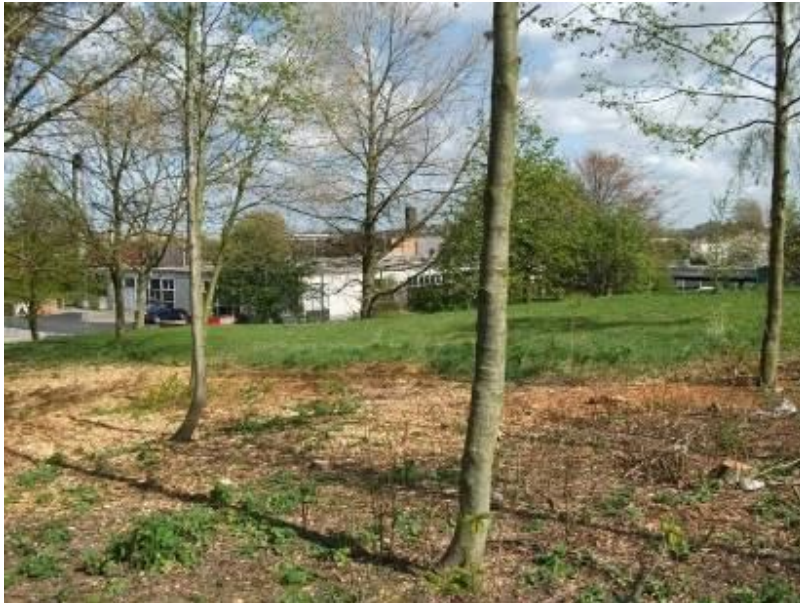
**Figure 10**

Although well established, none of the trees have reached full maturity and many specimens appeared to have been recently planted.

Example of tree planting found within the school grounds at the south western end of the site.

None of the trees on site are mature enough to offer any features such as rot holes, inclusions etc. suited to bat roosting. The site is likely to provide good foraging for local bat populations given the small wooded areas and lines of hedgerows. The potential for buildings to support bats is discussed in the bat roost potential section of the report.

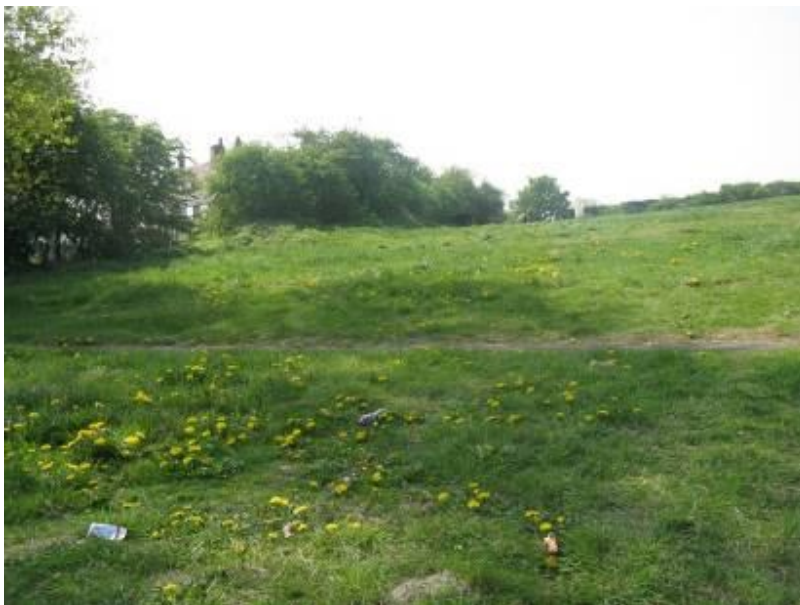
**Figure 11**

Located directly to the south of the school grounds is an area of grassland currently used by dog walkers and as grazing for horses. The area is relatively uniform although only the western section of grassland is currently included as part of the development. The habitat is dominated by perennial rye grass with other grasses including Yorkshire fog (*Holcus lanatus*), cocksfoot (*Dactylis glomerata*) and red fescue (*Festuca rubra*).

View of pasture facing west

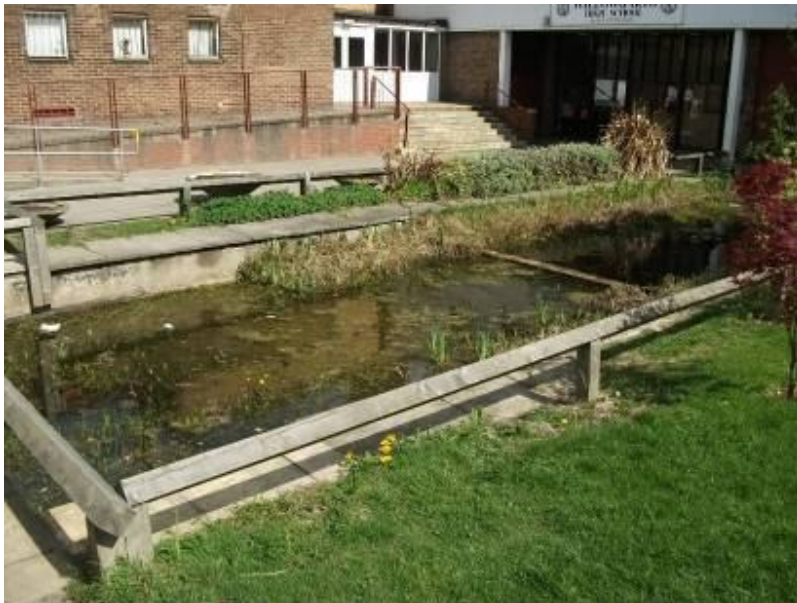
**Figure 12**

An ornamental pond is located close to the reception area of the school, surrounded by areas of hard standing and buildings. Although most of the sides are vertical concrete, a small area of banked earth is found along one side which would provide easy access to the pond for amphibians.

Ornamental pond at school reception

- Amphibian survey to be carried out on the pond on the site to establish the absence of great crested newt prior to development. Four visits between end March and early June (must include 2 visits in the period mid April to mid June). An additional two visits to determine population size will be required if great crested newts are found.

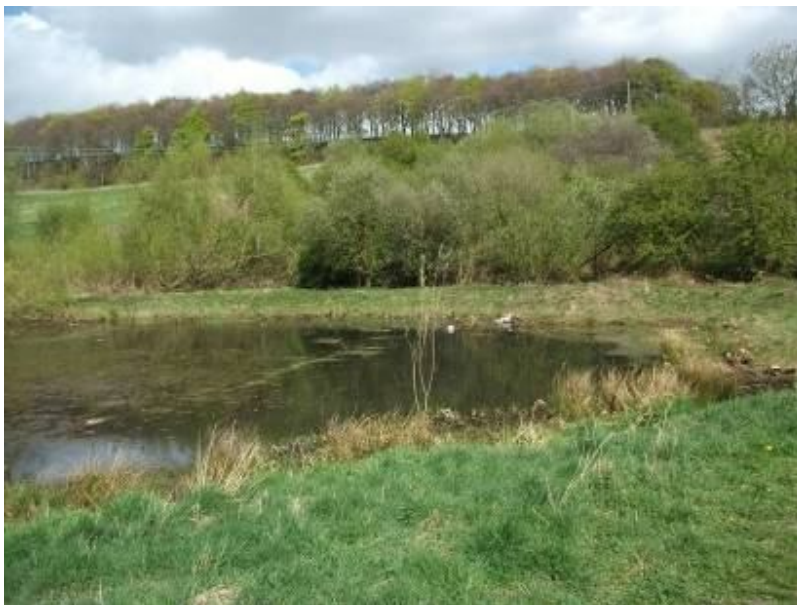
**Figure 13**

An additional collection of ponds is located outside the site approximately 220 m from the site boundary, though 250 m from the land included as part of the development. These ponds could provide suitable habitat for great crested newt and are located adjacent to areas of undeveloped land that would provide good terrestrial habitat for any newts using the ponds.

Pond located outside the development boundary viewed from the south west

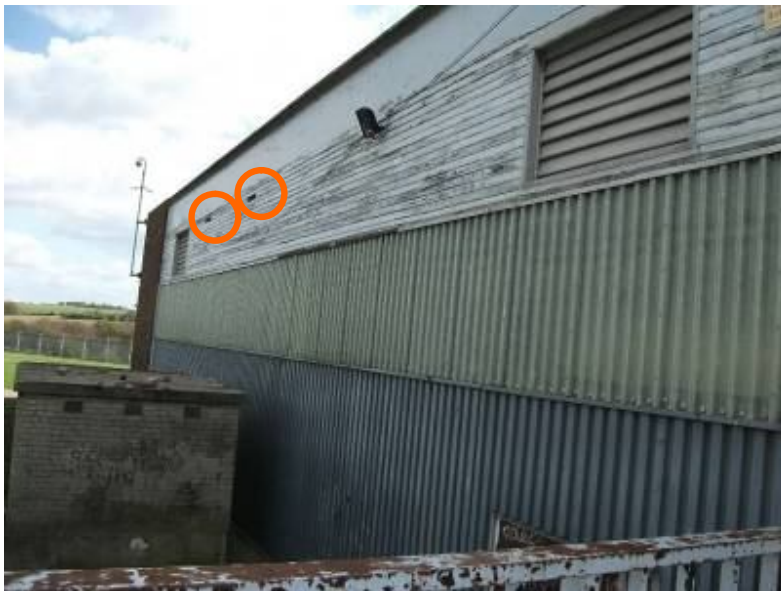
**Figure 14**

This building is a large sports hall with a single pitched roof. The walls on the east and west elevations are of modern brick construction. These are both in good condition, well sealed throughout and offer no potential access for bats. The northern and southern elevations have three different panels on the walls. At ground level the walls are corrugated metal panels, above these are corrugated plastic panels and finally on the top section of the wall are wooden panels (Figure 14). Some of the wooden panels on the northern elevation are either missing or starting to break away. This has created a number of potential ingress points leading behind the wooden panels. From ground level these gaps do not appear to lead into large voids as timber frame behind the panels block access into any potential void spaces.

Building 1: Sports Hall

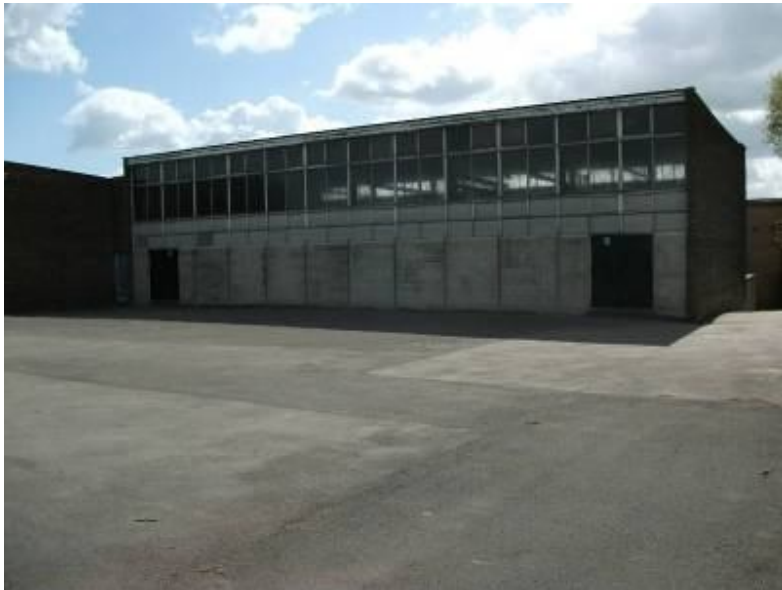
**Figure 15**

block lower wall and glass panel windows above. These are well sealed and offer no access for bats. All of the other walls have a modern brick construction similar to Building 1. On the southern elevation there is a row of windows below the roof and a small boxed eave section. The boxed eave is well sealed apart from a single broken section of plastic panel (Figure 16 below), which could allow access for bats into the boxed eave.

Building 2

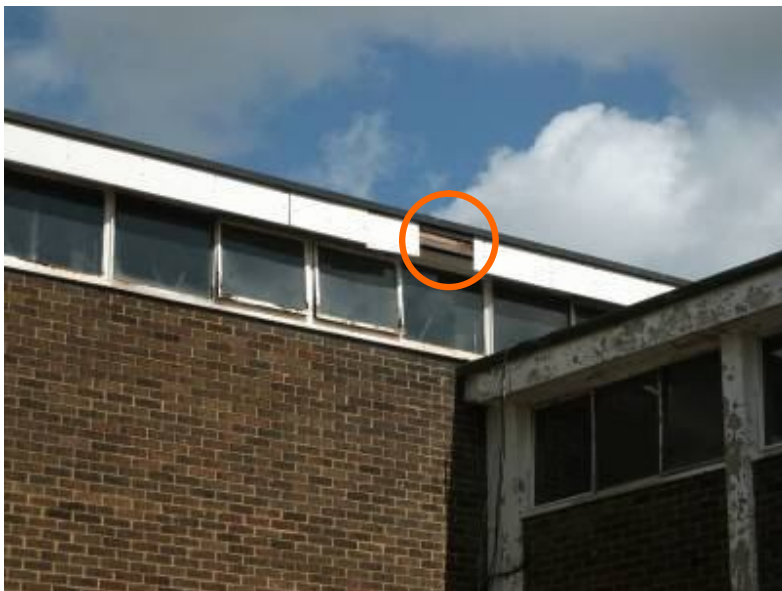
**Figure 16**

Building 2 showing boxed eaves and broken section of plastic panelling

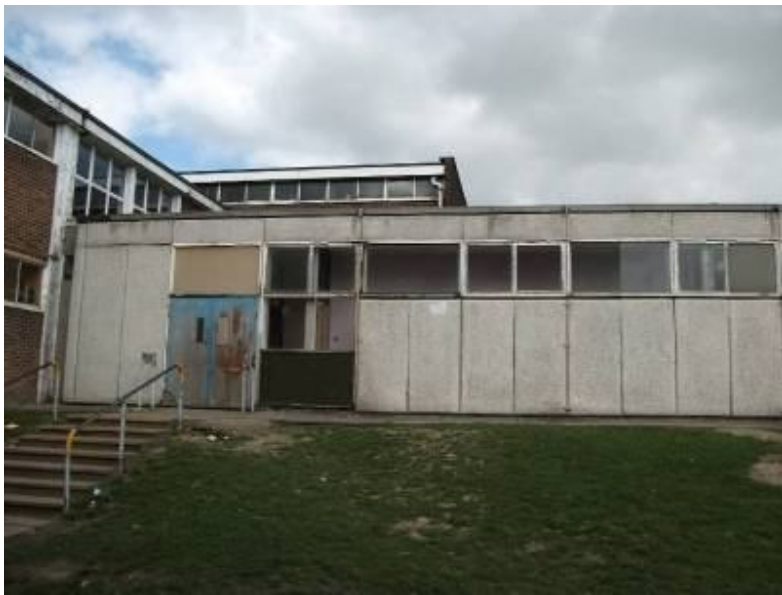
**Figure 17**

This is a tall single storey construction with a flat roof. The walls are constructed from large pebble dashed concrete panel façades. Between these concrete panel façades are small gaps which lead to a plastic sheet behind. Bats could potentially access between the panels which could possibly hold a large roost. Otherwise these gaps are likely to offer potential roost space for solitary bats on an occasional basis.

Building 3

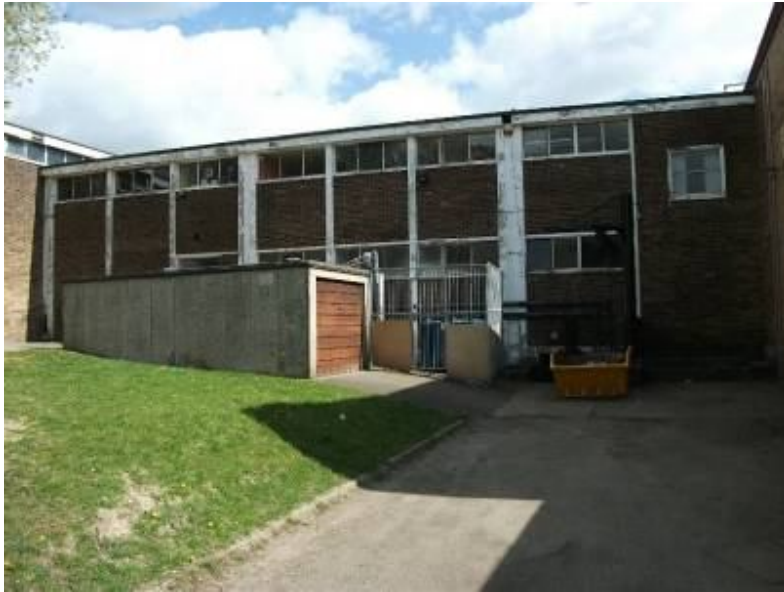
**Figure 18**

This section is connected to Buildings 2 and 6 on the northern and southern elevations respectively. This is a two storey building with a flat roof and modern brick walls with small windows (Figure 18). The entire building is in good condition (apart from peeling paintwork) and is well sealed throughout offering no bat roost potential.

This is a small single garage with a flat metal roof and concrete pebble dashed walls (Figure 18). This presents no roosting opportunities for bats.

Buildings 4 and 5

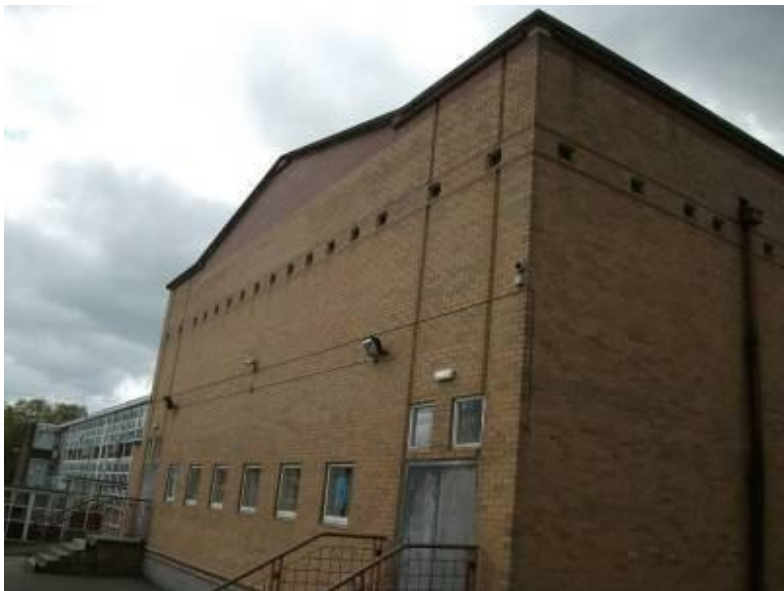
**Figure 19**

A large modern brick construction with a double pitched metal roof surrounded by a large parapet wall. The entire building is well sealed throughout and presents no roosting opportunities for bats.

Building 6

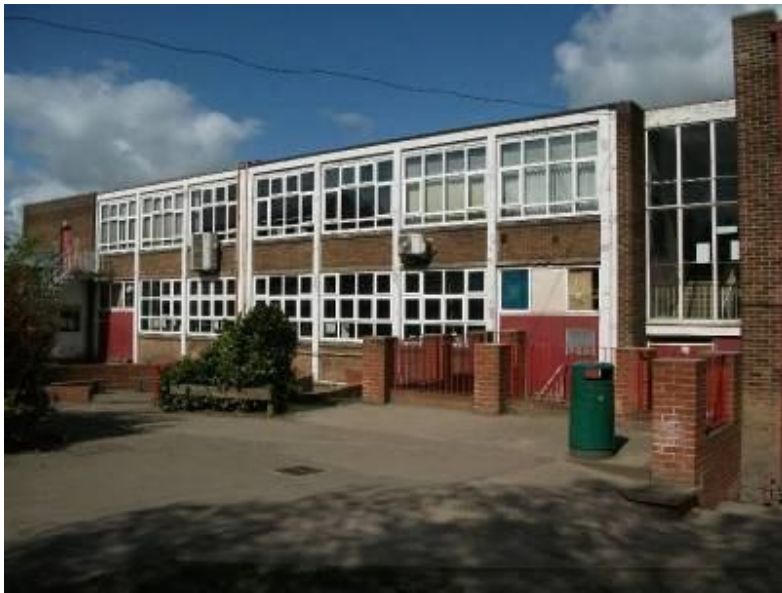
**Figure 20**

This consists of the main entrance building and a large class room section which runs in an L shape in a western direction. This is a large double storey section with a flat roof, modern brick walls and large windows (figure 20). A boxed eave runs around most of this building. But this appears to be well sealed throughout and offers no potential access for bats. The entire building is well sealed throughout and presents no roosting opportunities for bats.

Building 9

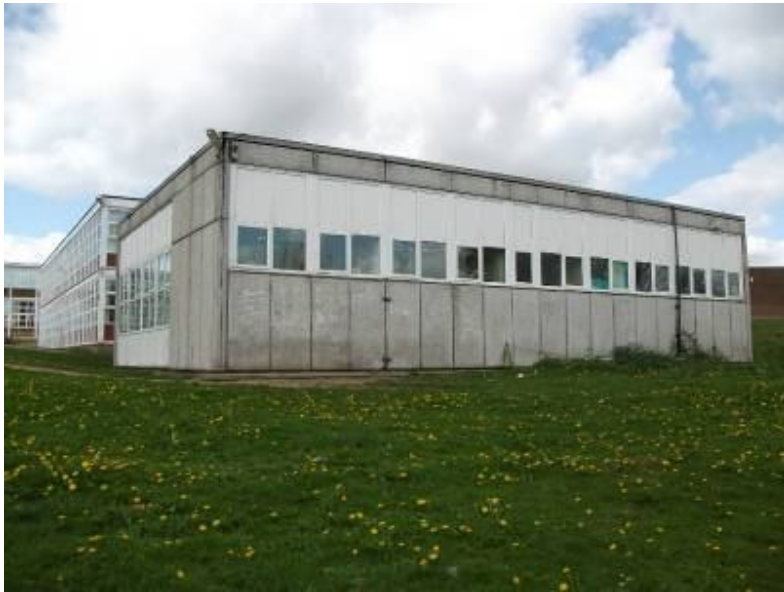
**Figure 21**

This is a tall one storey classroom connected to the main school building by a small walkway. It has a flat roof and large pebble dashed concrete panel façade walls the same as building 3 (figure 21). Again bats could possibly access behind these concrete panels (figure 22). Whilst these voids do not appear to be large enough to support large roosts they provide potential roost sites for crevice

dwelling bat such as pipistrelles. The height of the building make more detailed inspection impossible and it is possible that some voids may be much larger. This building is located close to the tree line that borders the school ground, which is good foraging habitat for the local bat populations. Overall building 10 offers limited bat roost potential.

Building 10

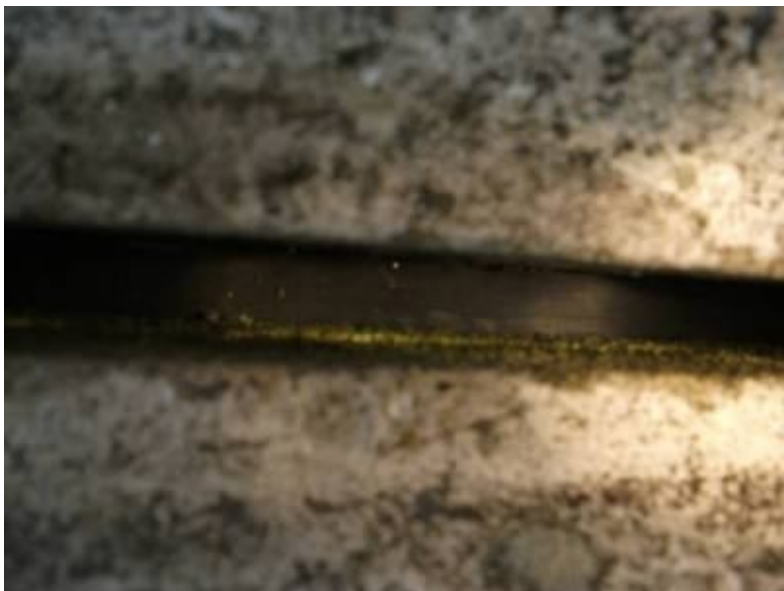
**Figure 22**

Gaps between concrete panel facade on building 10.

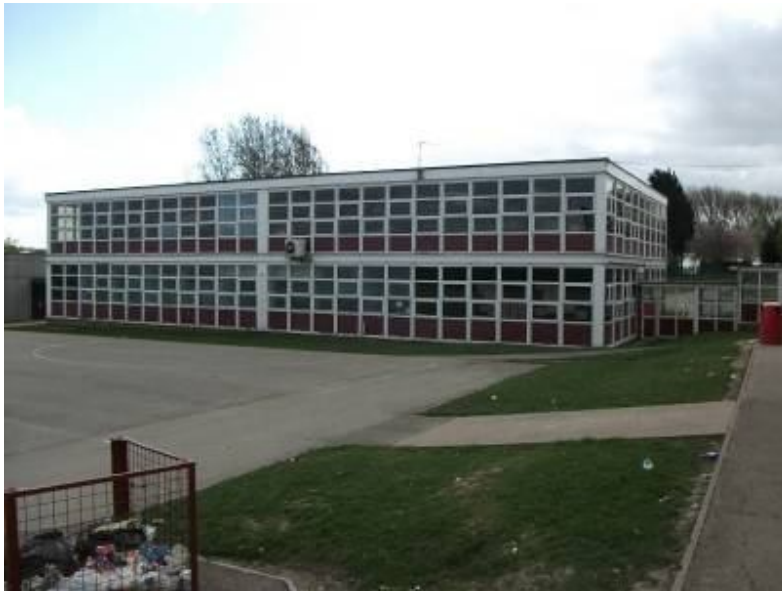
**Figure 23**

This is a large two storey building with a flat roof and PVCu glass and plastic panel walls. All the walls are well sealed and offer no roosting opportunities for bats.

Building 11

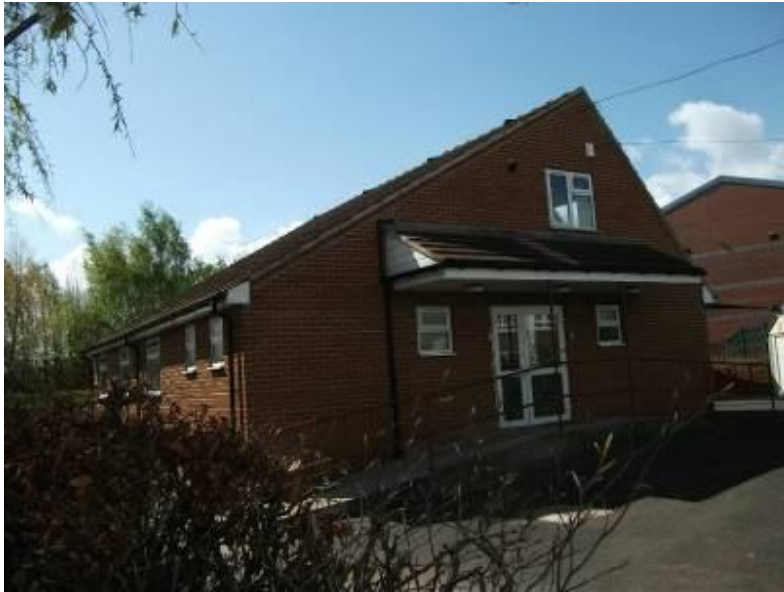
**Figure 24**

This is a modern nursery building with a tiled double pitched roof and modern brick walls (figure 24). Below some sections of the roof is a plastic boxed eave but as the building has only recently been built this is in a good condition and offer no potential access for bats. There is a large conservatory extension on the southern elevation. The entire building is well sealed throughout and presents no roosting opportunities for bats.

Building 13

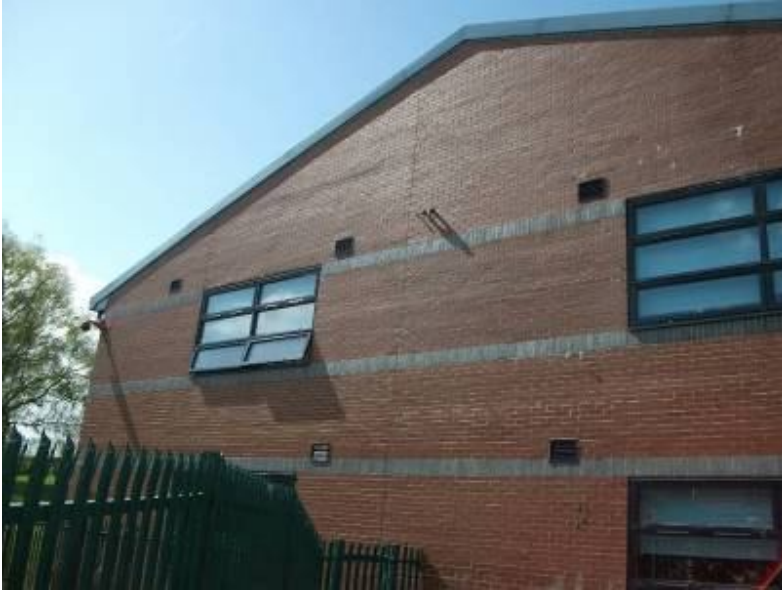
**Figure 25**

This is a two storey brick building, very recently constructed with no crevices with in the brickwork and well sealed eaves beneath a corrugated metal roof. It contains no obvious features which could provide roosting for bats.

Building 15
