# Bat Emergence Survey

The client is preparing a planning application to convert the outbuildings at Little Royd Farm, Halifax Road, Hoylandswaine, Sheffield S36 7EY.

The client has commissioned Arbtech to undertake a bat emergence survey; referring to a method of ecological assessment outlined in the Bat Conservation Trust publication *Bat Surveys—Good Practice Guidelines* authored by L. Hundt, 2012.

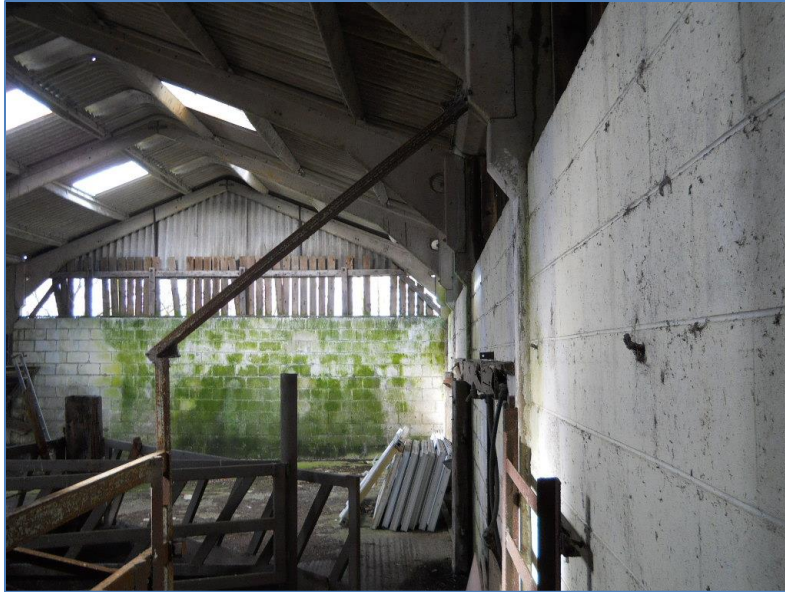
Figure 3: Far northwestern elevation of B3 interior - open access from tree line behind barn to barn interior for foraging bats.

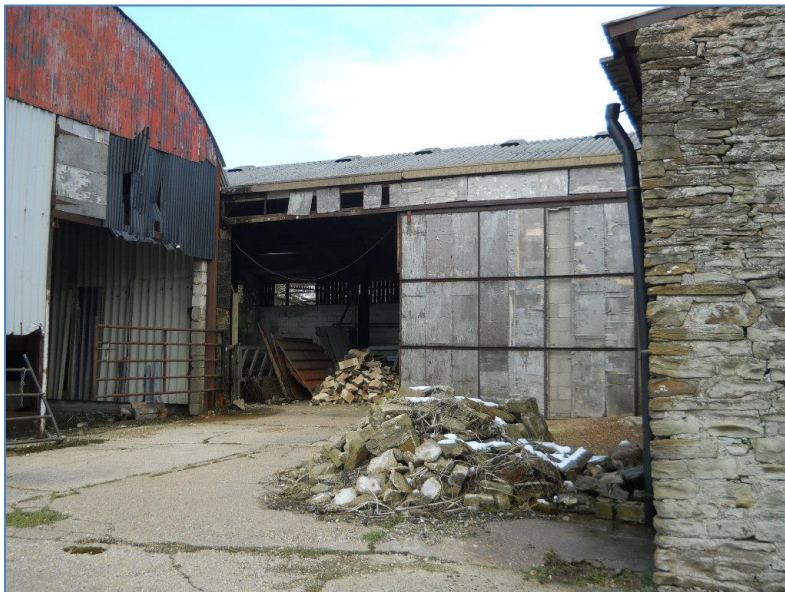
Figure 3: Foraging activity of common pipistrelle bats was observed both inside and outside of the open sided elevation of B3.

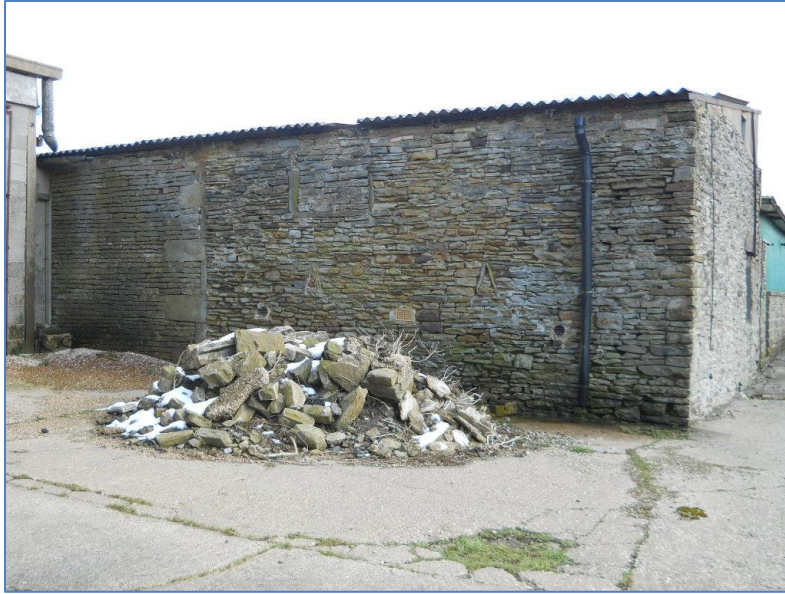
Figure 4: Building B5.

| B5 | Unconfirmed <input checked="" type="checkbox"/><br>Further survey work required <input type="checkbox"/><br>Confirmed <input type="checkbox"/> | No.<br>No roost was confirmed. | Low <input type="checkbox"/><br>Moderate <input type="checkbox"/><br>High <input type="checkbox"/><br>No roost confirmed. | <p>Mitchel-Jones (2004) defines the conservation value of bat habitats and roosts and makes proposals for mitigation that are appropriate to: the species of bat(s); the population using the roost; and the roost's status e.g. maternity, pre-breeding summer roost, <i>hibernacula</i>, etc.</p> <p><b>We recommend:</b></p> <p>Works can be completed without the need for a Licence or mitigations plan.</p> <p>Caution should be observed during works and should a bat be unexpectedly found work should stop and further advice sought.</p> <p>Bat boxes could be added to new development when it is complete to enhance the biodiversity of the site and provide additional roosting opportunities for the common pipistrelles recorded to be foraging at the site.</p> | Yes <input type="checkbox"/><br>No <input checked="" type="checkbox"/> |
