Wortley Village

Bat Survey

March 2011.

Report of Bat Survey

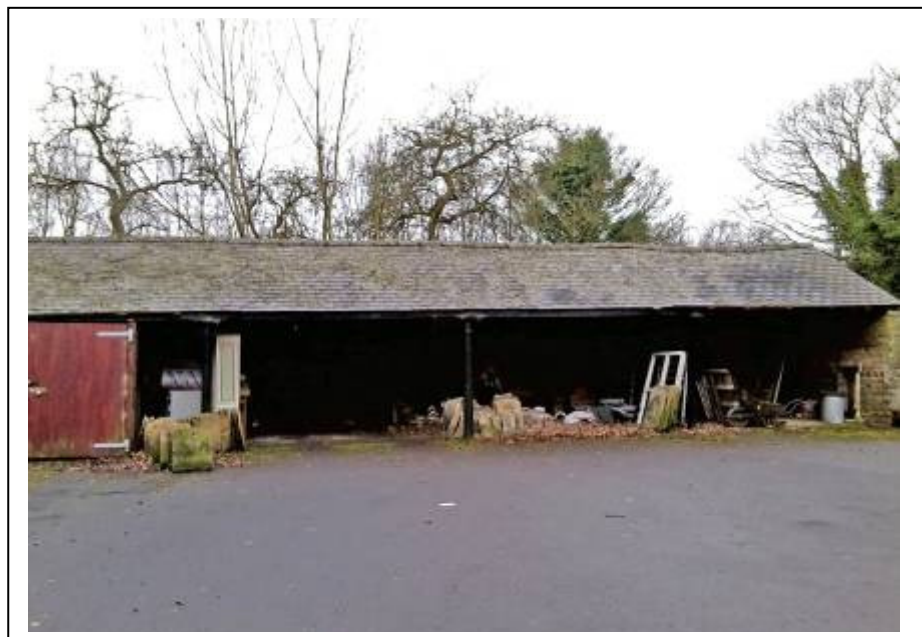
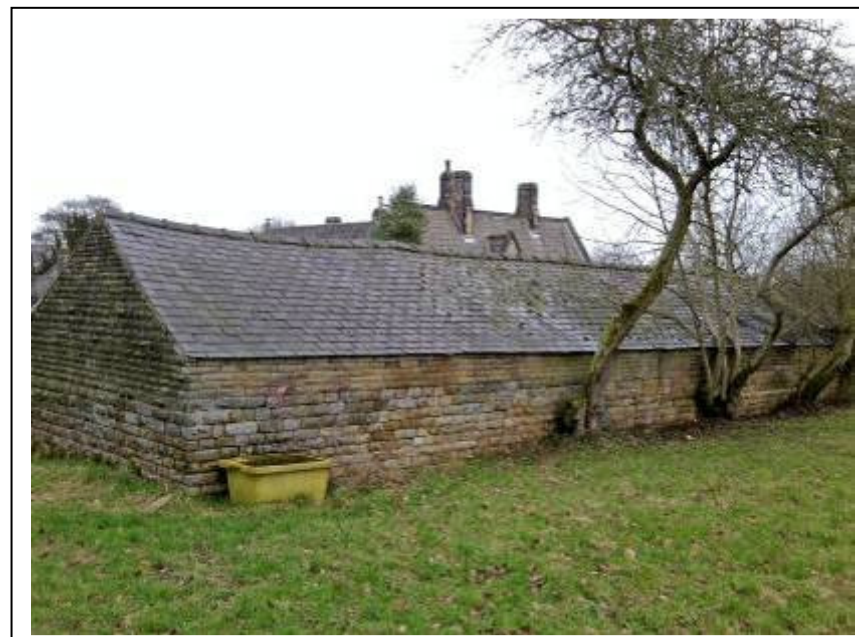
SITE 4

- 10.1 The survey was carried out on 28 February 2011.
- 10.2 The site comprised a single-storey open-fronted shed with stone walls and blue slate roof. The building was cut into the slope of the land with the rear eaves only about 1.6 metres above ground level, much too low to be attractive to bats. The front was largely open with the roof supported on cast iron columns. The east gable was mostly covered by a lean-to structure in an adjacent garden. The west gable was well pointed with no suitable openings for bats.

- 10.3 Internally the building was open to the underside of the roof and used for storage. The roof was supported on sawn timber trusses containing no suitable sockets or joints which could provide suitable roosting crevices. The ridge was well sealed with tile lats butted tightly along both sides of the ridge board except for a short section at the east end but this was quite cobwebby and clearly not used by bats.

- 11.1 Externally the rear walls were too low to be attractive to bats and the gables were covered by a lean-to at one end and well pointed with no openings at the other. Internally the building was potentially more attractive to bats with direct flight access to the ridge area. No signs of droppings, urine spotting or discarded insect remains were found on the floor, inside gable walls or surfaces of stored materials etc. Such signs would normally remain for many years unless disturbed.
- 11.2 The building was used by nesting swallows

- 12.1 No evidence to suggest the presence of a roost. Single bats possible.

| Site 2 | Careful demolition in safe season. Create roost opportunities in replacement building. |

| Site 2 | Purely as a precaution, roof stripping should not be carried out during the breeding season (May-August) unless the absence of bats has been confirmed by a dusk emergence survey. Care should also be taken during roof stripping lifting rather than sliding ridge tiles and checking beneath for signs of bats. If bats or droppings are found further advice should be sought immediately and work halted in that area. |

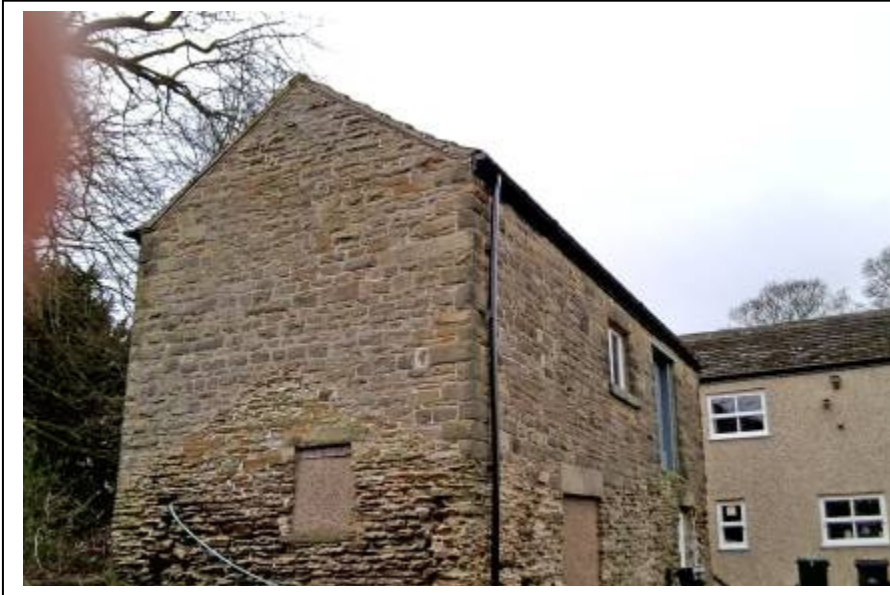
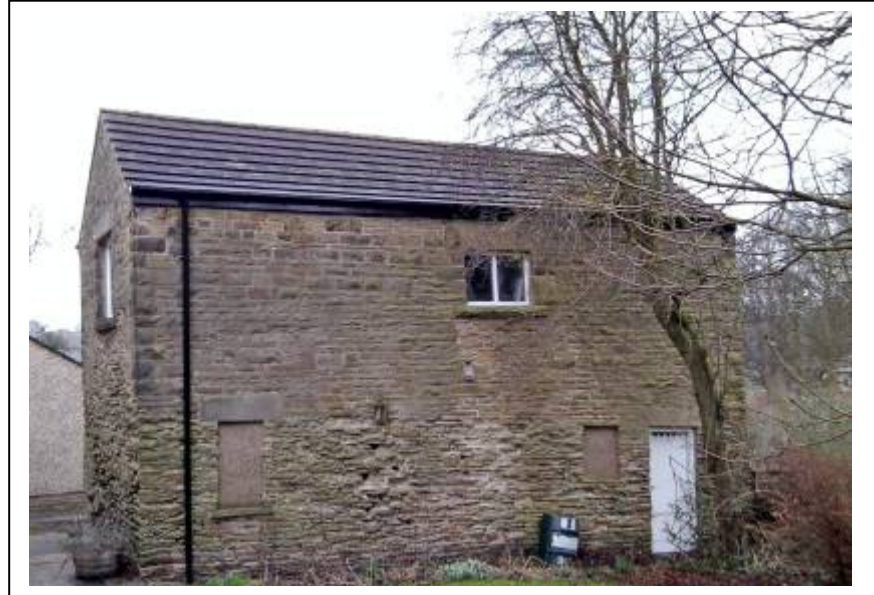
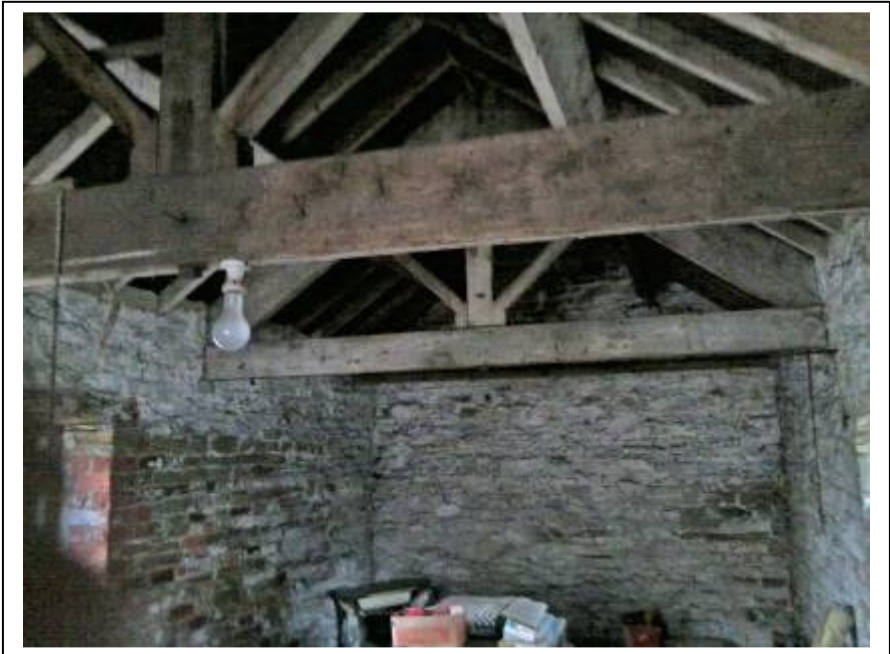
SITE 7

- 10.1 The survey was carried out on 28 February 2011.
- 10.2 The site involved a single two-storey stone barn at the rear of Rose Cottage. The roof was covered with plain concrete tiles. The walls were generally well pointed, particularly in the upper parts with eroded stonework generally low down. The eaves on both sides had timber fascia with quite large gaps particularly on the south side showing evidence of use by small birds. The gable verges were well pointed with one or two potentially suitable openings for bats on the east gable.

- 10.3 Internally the upper floor was open to the underside of the roof which was lined with underfelt. The felt was wrapped tightly over the ridge board with no access gaps for bats except at the gable wall tops. The roof was supported on sawn timber trusses containing no suitable sockets or joints which could provide suitable roosting crevices. The ridge and apexes of internal gable walls were cobwebby suggesting bats were unlikely.

- 11.1 Externally there were potentially attractive roost sites available to bats under the fascias on both sides and small gaps were noted in the verge pointing to the east gable. Evidence of nesting birds was noted under fascias but no bat droppings were found.
- 11.2 Internally the building appeared suitable for Brown Long-eared bats but no signs of droppings, urine spotting or discarded insect remains were found on the loft floor or internal gable walls. Such signs would normally remain for many years unless disturbed.
- 11.3 Tree T1 appeared to have a long split in a large limb overhanging the garden of Rose Cottage. This could not be fully evaluated from the ground but should be checked further if removal is considered.
- 11.4 There is a record of a Brown Long-eared bat found grounded at Rose Cottage in June 1993 but there is no detail of the circumstances.

- 12.1 No evidence to suggest the presence of an internal loft species such as Brown Long-eared bat but there is potential for a summer roost of Pipistrelle behind fascias, particularly on the south side that would need to be checked during the active season if the eaves are likely to be disturbed in the scheme.
- 12.2 The limb cavity in T1 is likely to be attractive to bats.

- 16.1 As things stand no activity has been identified and a bat roost has not been confirmed in any of the buildings. Because of the circumstances however and the character of buildings 4 and 12, a dusk visit during the summer will be necessary to positively confirm or discount a roost. If, however, a roost is subsequently discovered a Natural England license application would almost certainly be required. This process generally takes about 6-8 weeks from submission.
- 16.2 In the remainder of the buildings a roost is considered unlikely and simple precautionary measures are recommended.

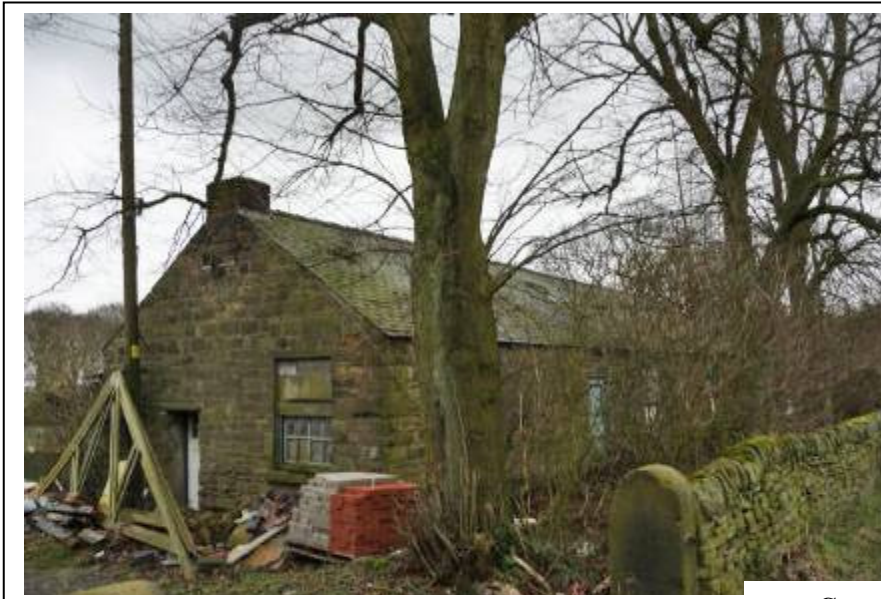
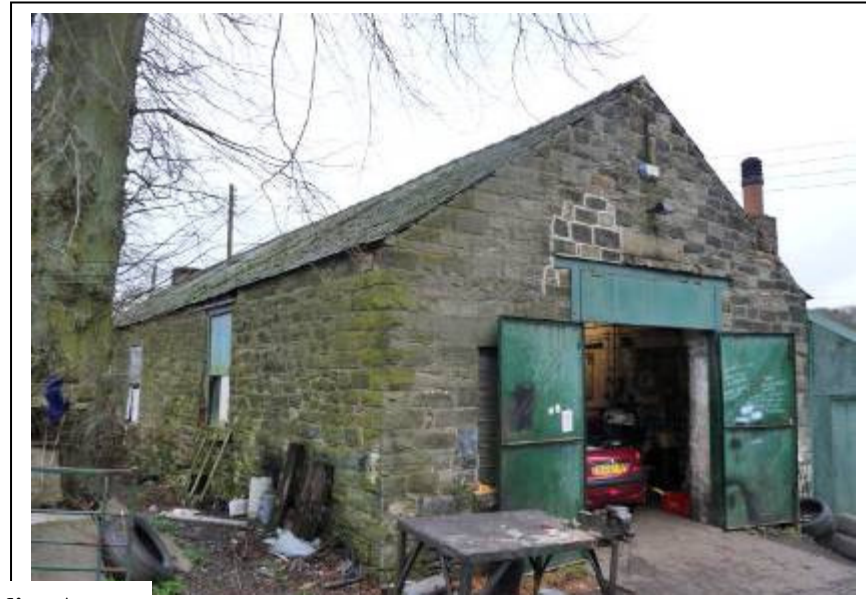
Garage building A

| A | <p>Stone garage with blue slate roof currently used as a car repair workshop. The walls were generally well pointed with no suitable openings for bats noted. Small gaps were noted in the verge pointing to both gables, potentially suitable for bats. Gaps were also noted under the edge of slates at wall top level on the front (west) eaves. The eaves on the east side were covered by a lean-to.</p> <p>Internally the bulk of the building was taken up by the car repair workshop. This area was open to the underside of the roof. No signs were found and the disturbance and fumes etc from the workshop would make the area unsuitable for bats. A small room at the north end, with a separate door in the north gable, was used for storage. This too was open to the roof but the roof and upper walls were heavily covered by cobwebs indicating that bats were unlikely to be present. No signs were found.</p> |

| A Garage | <p>Some small gaps in the gable verge pointing and along the eaves although these were somewhat obstructed by tree branches and likely to be affected by road disturbance.</p> <p>Internally most was actively used for vehicle repair and too disturbed. Store room at the northern end quiet but too small for bats.</p> |

| A Garage | Bat roost unlikely. |

| Site 7 | Careful demolition in safe season. Create roost opportunities in replacement building. |

| Site 7 | <p>Purely as a precaution, roof stripping should not be carried out during the breeding season (May-August) unless the absence of bats has been confirmed by a dusk emergence survey. Care should also be taken during roof stripping lifting rather than sliding ridge tiles and checking beneath for signs of bats. If bats or droppings are found further advice should be sought immediately and work halted in that area.</p> <p>Care should be taken with the demolition of stone walls. Bats will hibernate in the rubble filled core of walls, gaining access through open joints etc. The roost site can be a considerable distance from the access point. Although the risk of significant numbers of bats being present is not high this work should not to be done during winter months when the bats are inactive and unable to escape. Single male bats will also use wall crevices during the active season. During the active season bats are likely to be disturbed by the erection of scaffolding, general building work disturbance etc and move to other sites. Work to demolish stone walls should therefore be started after a sustained period of disturbance around that part of the building.</p> <p>It would be beneficial in conservation terms to retain some openings for bats in the converted building. These need be no more than small un-pointed openings in gable apex locations approximately 15x50mm in size or unsealed openings behind fascias. Locations over doors and windows should be avoided.</p> <p>In general it is preferable to have completed any work before swallows commence nesting in spring or to cover openings to buildings to prevent nest building. Where the birds have commenced nesting it would be an offence to destroy the nests etc. It is normally suggested that the buildings should be demolished or checked and the openings covered before the end of March to prevent nesting taking place.</p> |

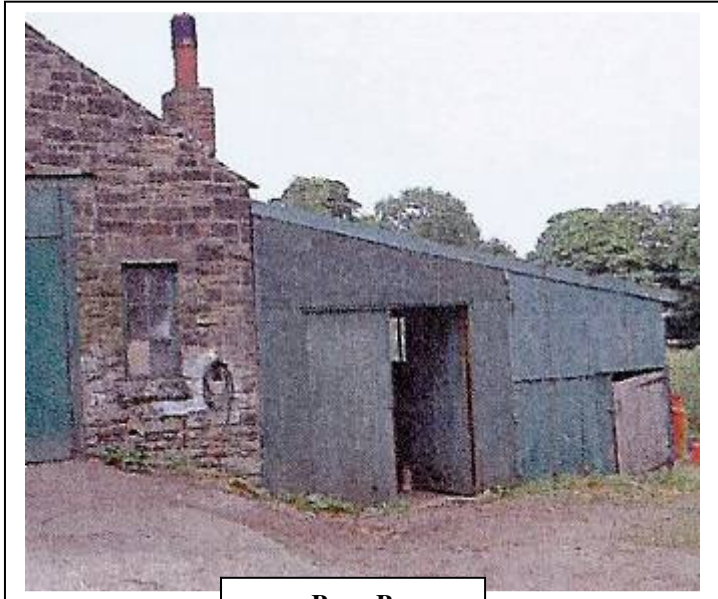
Barn B

| B | <p>Lean-to extension to north side of A. The walls were a mix of corrugated iron and ply boarding with large windows along the east wall. The roof was corrugated sheet. Internally the space was open to the underside of the corrugated roof sheets. There was no potential for bats.</p> |

| B Lean-to | No interest for bats. |

| B Lean-to | Building Unsuitable |

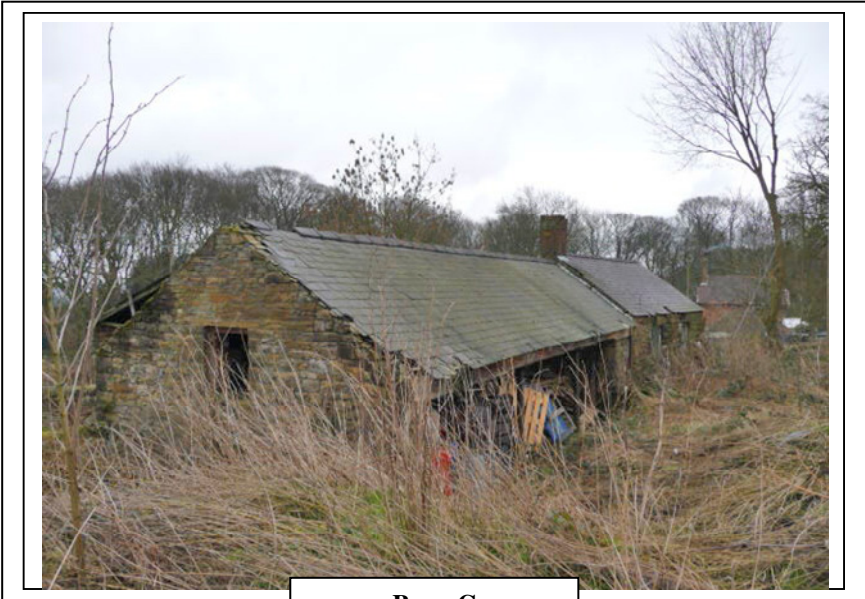
Barn C

| C | <p>Single-storey open fronted stone shed with blue slate roof and cast iron columns supporting the roof along the front. The north gable contained a large uncovered window opening. Slates were missing from the verge to the north gable exposing the wall top.</p> <p>Internally the barn was open to the underside of the roof which was lined with underfelt. The internal space was largely filled with timber pallets and boarding to eaves height. The internal gable wall and the upper surfaces of the pallets etc were carefully examined but no signs of droppings or urine spotting were found to suggest any use by bats although there were a few discarded moth wings on the east gable wall suggesting use as a feeding perch at some time.</p> <p>As a matter of course the building was checked for signs of other protected species. No signs of Barn Owl were found but there were signs of nesting swallows.</p> |

| C Open front | Some openings in the rear walls and north gable but flight access to the ridge area through the open front likely to be more attractive to bats although there were no signs of droppings, urine spotting on the surface of stored timber to suggest any actual use. Several old moth wings at the foot of the south gable wall suggests possible occasional use by Brown Long-eared bat for feeding perch. |

| C Open front | No evidence for a roost but possible occasional feeding perch for Brown Long-eared bats. |

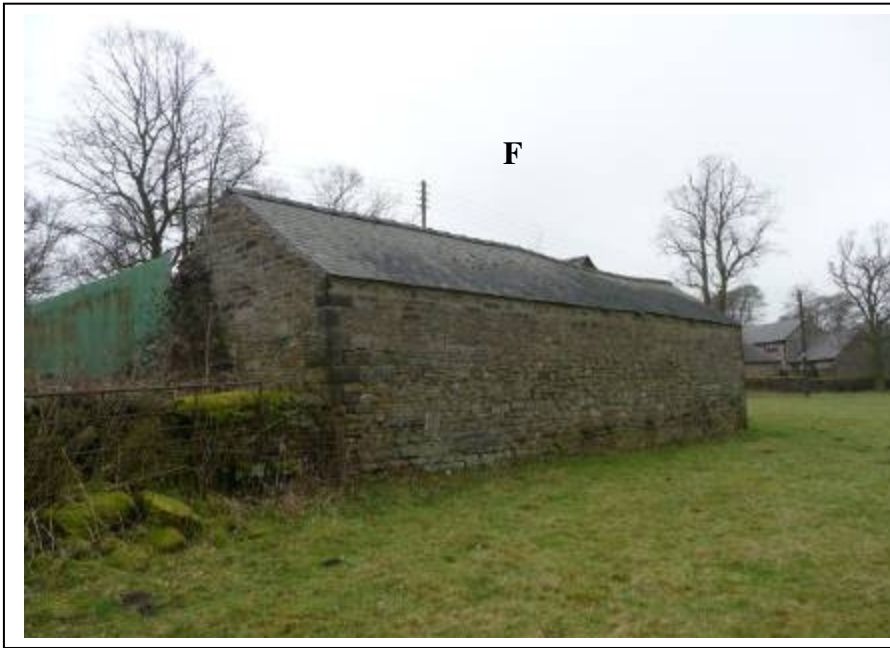
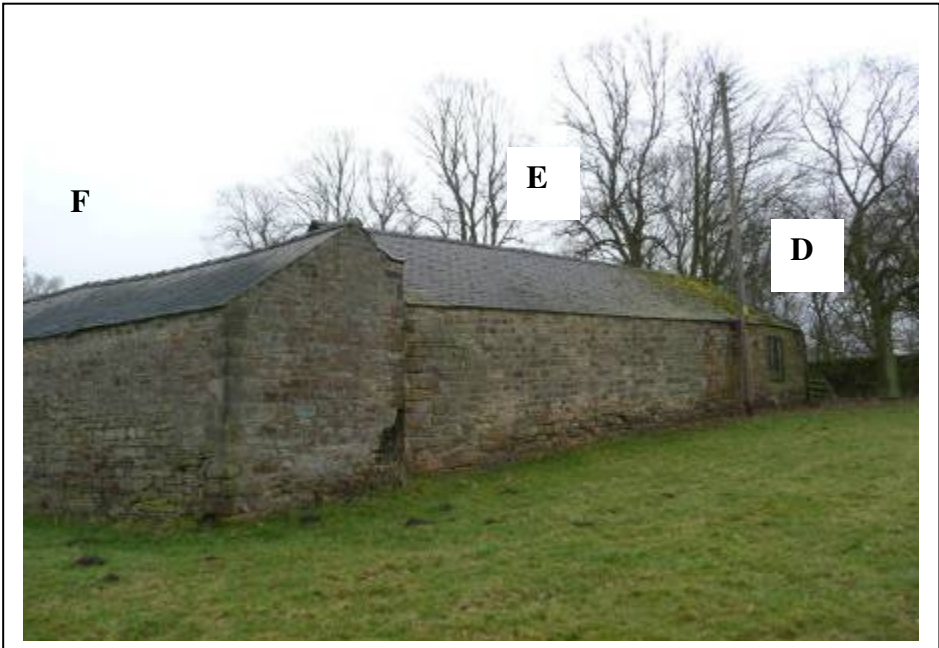
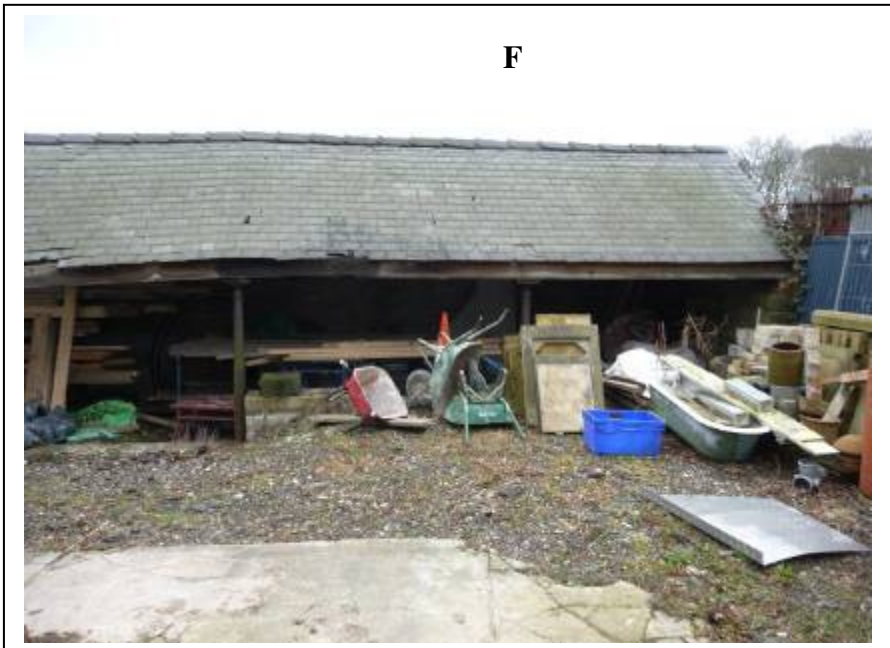
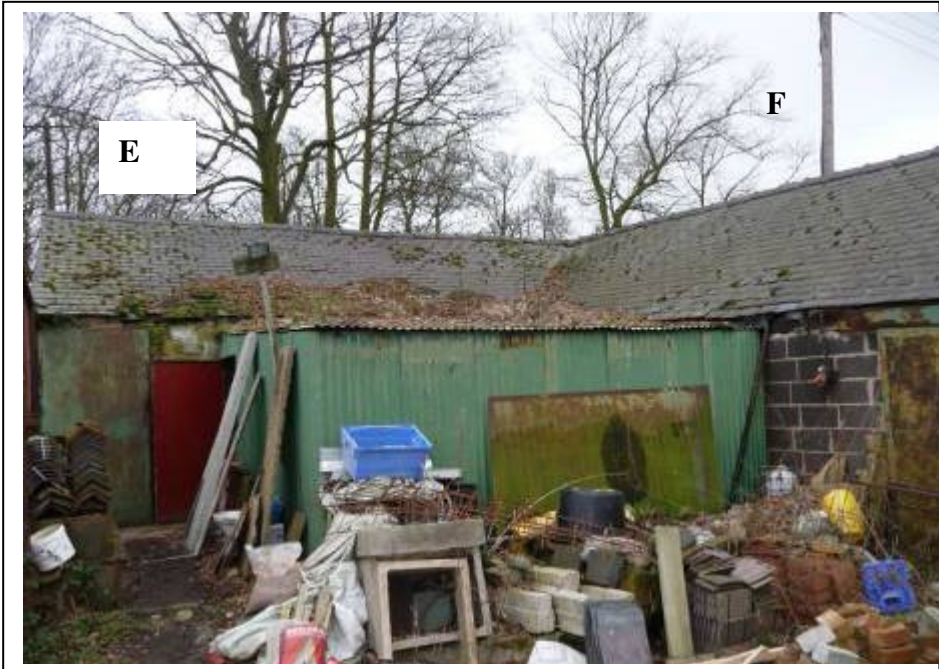
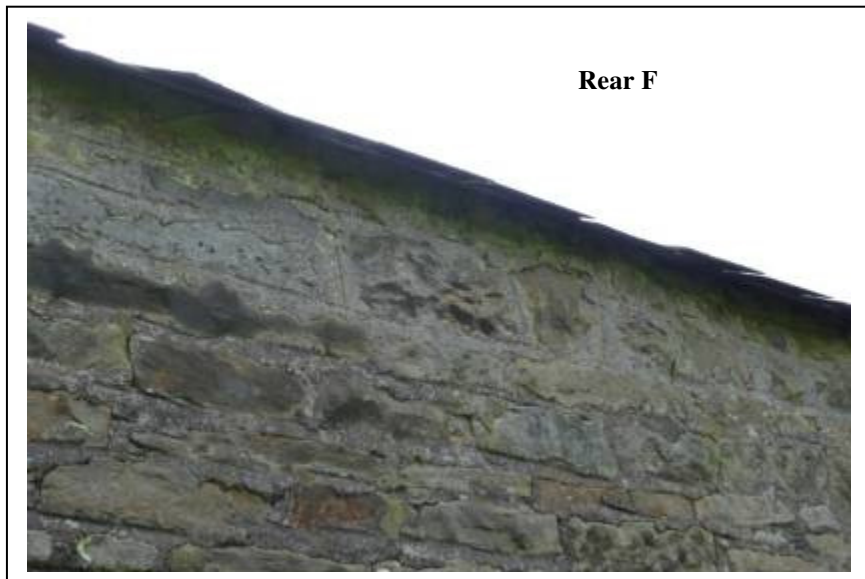
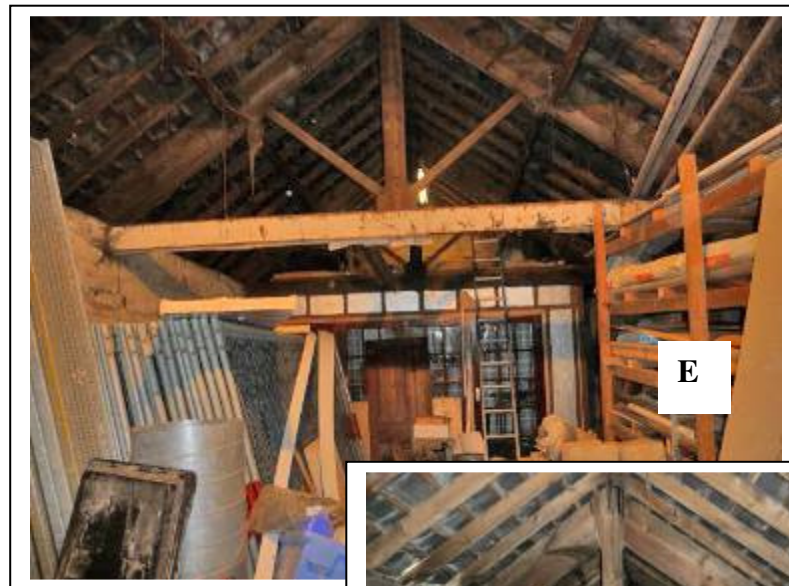
Builders yard

| D | <p>Single-storey stone barn with blue slate roof. South gable showed some gaps in the verge pointing. There were potential openings in the front eaves with open joints along the eaves line but probably too disturbed by the road to be attractive. The rear was hipped with no apex.</p> <p>Internally the roof was lined with insulation board to the underside of rafters with no enclosed loft space.</p> |
| E | <p>Single-storey stone barn with blue slate roof. Only the rear wall was open and accessible to bats. Potential openings at wall top level under the edge of roof slates and in an open building joint in the back wall between barns E and F.</p> <p>Internally open to the roof with trusses containing no suitable mortice or sockets for bats. No signs of droppings, urine spotting or discarded insect remains on any of the stored materials within the building.</p> |

| F | <p>Single-storey open-fronted stone shed with blue slate roof. The rear wall was well pointed with potential crevices only along the eaves line beneath the edge of roof slates. Potential opening also beneath lead flashing on the north gable and gaps in the pointing to the gable apex at the south end.</p> <p>Internally open to the roof with stored timber etc up to eaves level. The roof trusses containing no suitable mortice or sockets for bats. No signs of droppings, urine spotting or discarded insect remains on any of the stored materials within the building.</p> |

| D Workshop | <p>Some small gaps in the gable verge pointing and along the eaves although these were somewhat obstructed by tree branches and likely to be affected by road disturbance.</p> <p>Internally the rafters were fully lined with insulation board with no separate loft space.</p> |

| E Workshop | Some openings in the rear walls at eaves level facing the fields and a vertical open building joint in the back wall between buildings E and F. Summer breeding roost unlikely but could be used by single males or hibernating bats. Internally open but ridge area very cobwebby indicating the absence of bats. No signs of droppings, urine spotting or discarded insect remains. |
| F Open front | Some openings in the rear walls and south gable and under flashing at the north gable but flight access to the ridge area through the open front likely to be more attractive to bats although there were no signs of droppings, urine spotting or discarded insect remains on the surface of stored timber to suggest any actual use. |

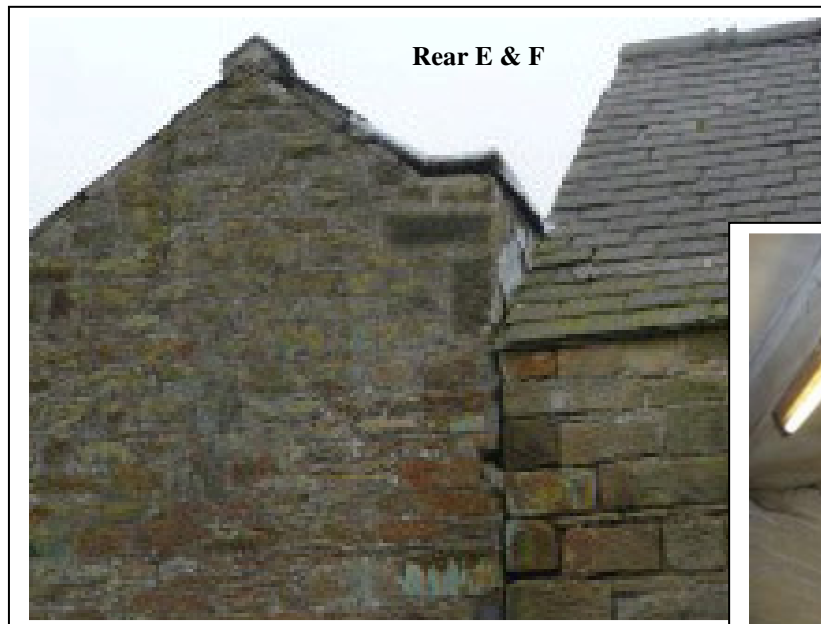
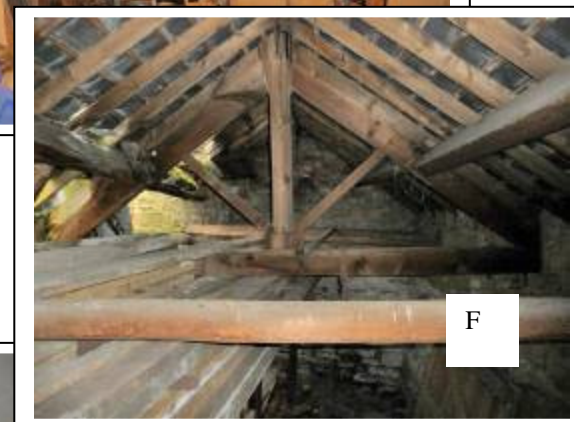
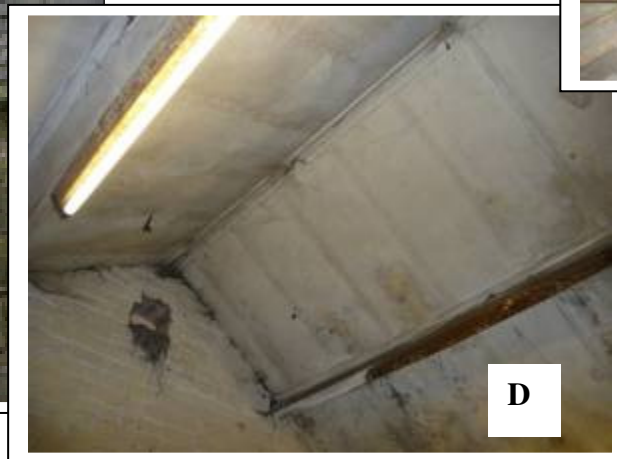
SITE 10

| A | Single-storey stone barn with blue slate roof, part of a range including the adjacent open-fronted barn. Some open joints around quoins at wall corners and under the edge of roof slates along the eaves. Some gaps were also noted in the pointing to the gable verges. Internally the barn was open to the underside of the roof with a half loft along the north side not quite extending under the ridge line. The ridge was generally very cobwebby. No signs of droppings, urine spotting or discarded insect remains were found on any of the many surfaces or on the internal gable walls. |

- 11.1 Building B had no potential for bats at all.
- 11.2 Building A showed potential roost sites under the edge of roof slates at eaves level and in gaps in pointing at the gable verge but overall the building is considered too low to be attractive to bats.
- 11.3 Internally the building was open to the roof but the rafters and ridge board were very cobwebby indicating that bats were not present. There were no signs of droppings, urine spotting or discarded insect remains were found on the loft floor or internal gable walls. Such signs would normally remain for many years unless disturbed.
