# Land off Hoyland, Barnsley, South Yorkshire

## Archaeological Evaluation Report

April 2021

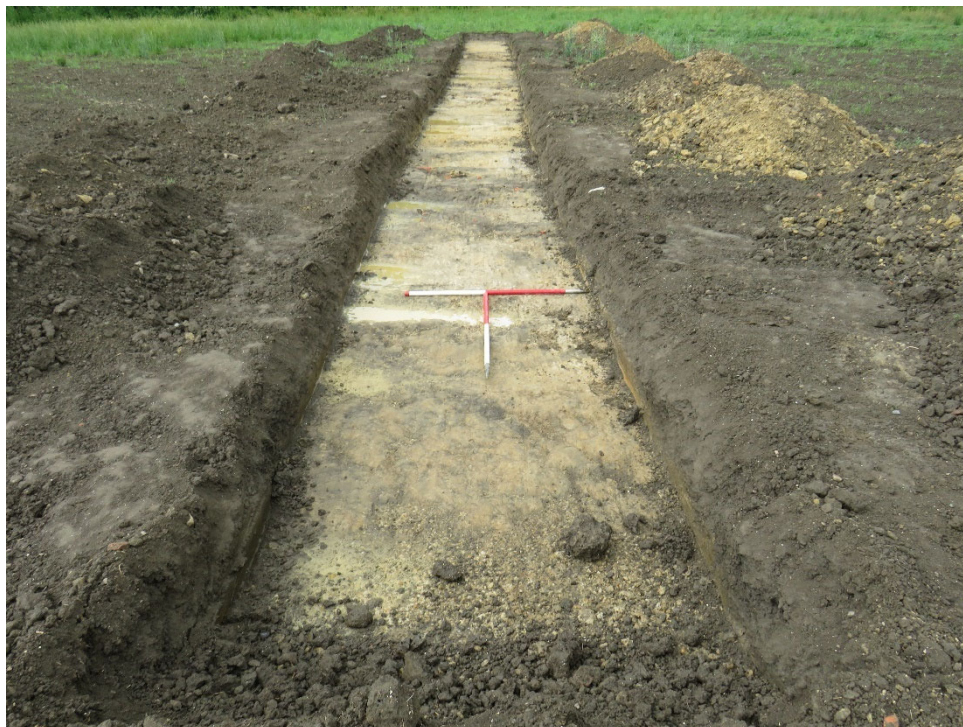
Plate 1: General shot of Trench 5, viewed facing south-east. Scale 2x 1m.

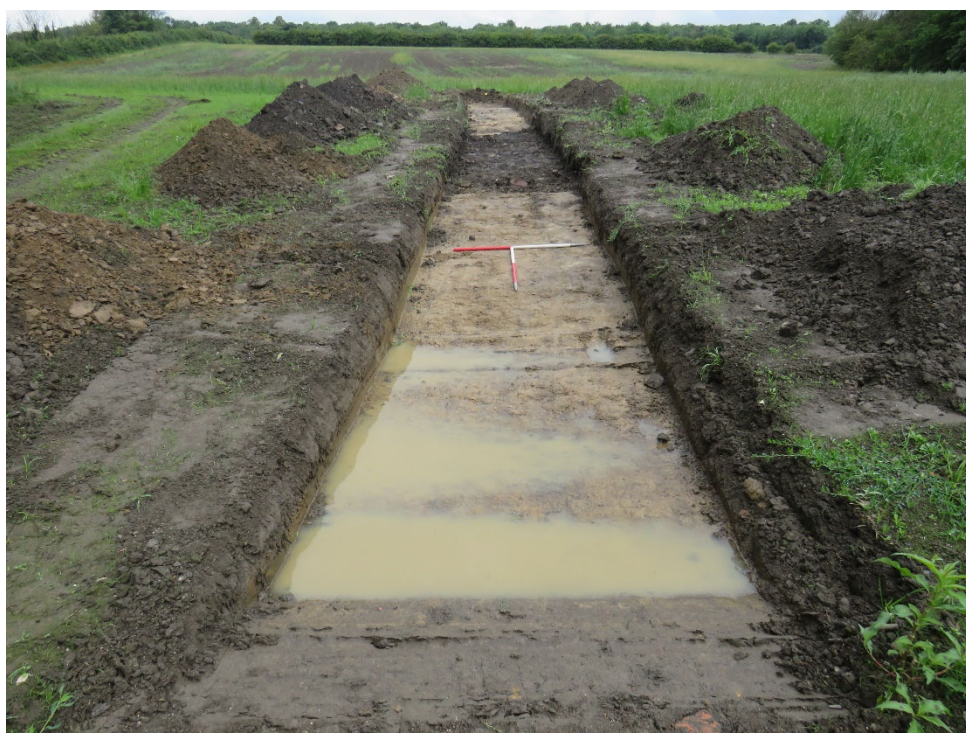
Plate 2: General shot of Trench 6 with modern dump 604 at centre. Viewed facing west. Scale 2 x 1m.

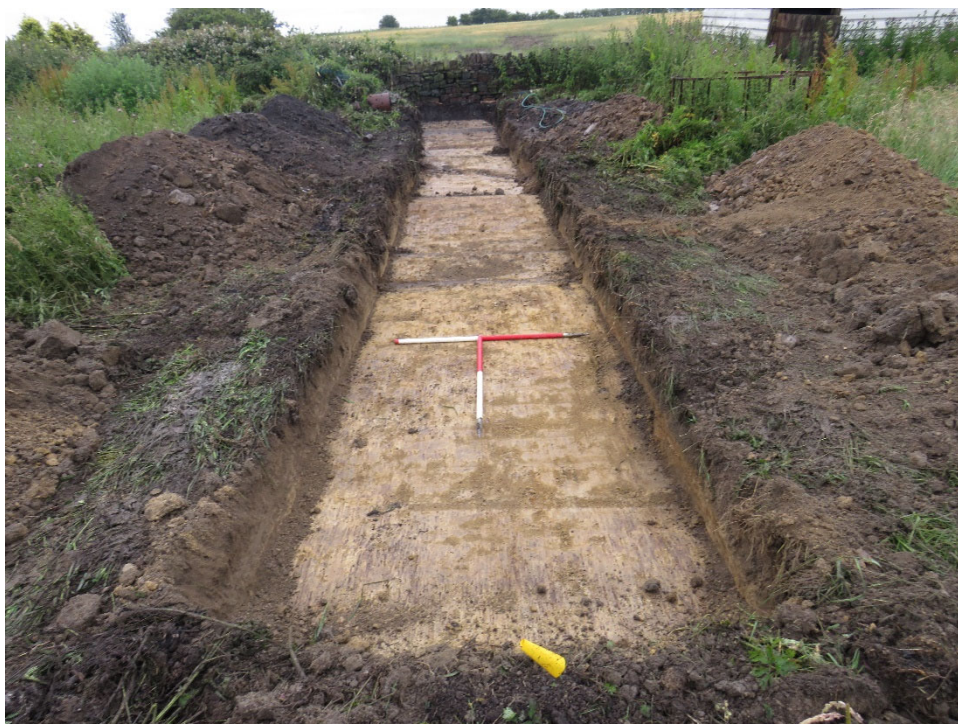
Plate 3: The northern half of Trench 7, viewed facing south toward the boundary wall. Scale 2 x 1m.

3.4.2 The wall dividing the two halves of the trench, was slightly overgrown, but found to be approximately 0.65m wide and up to 1m high, comprising up to seven or eight

irregular courses of sandstone blocks set without mortar. The individual blocks were generally well dressed, but varied in size and shape, with blocks in lower courses set end on end, and larger blocks set side by side, in a crenelated fashion, within the top course. No evidence of dating was recovered associated directly with the fabric of the wall, although it appeared in relatively good condition throughout.

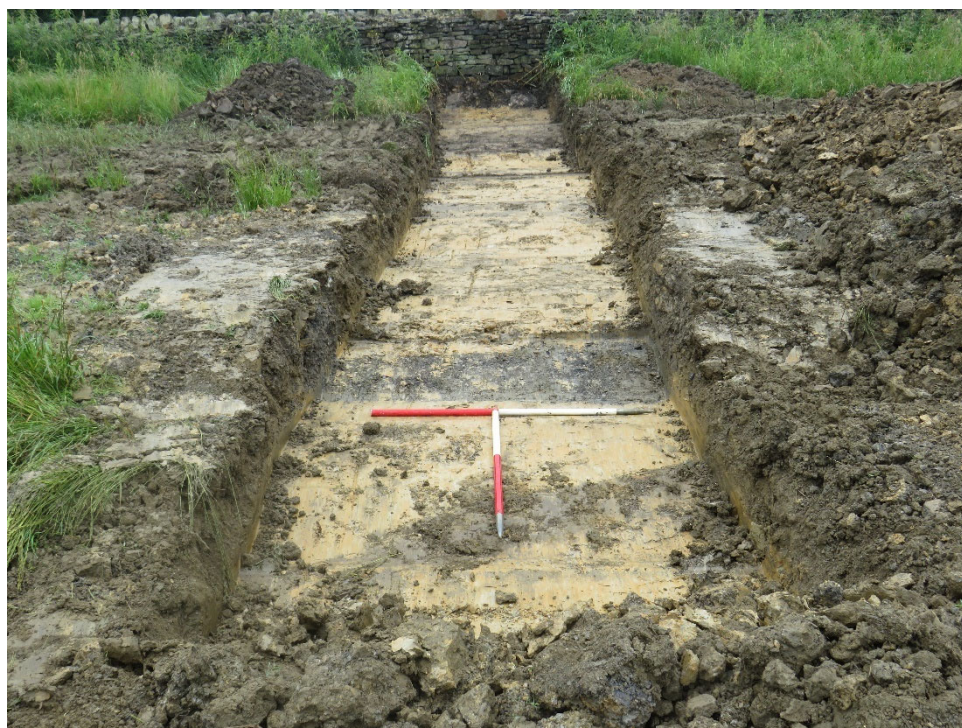
Plate 4: The southern half of Trench 7, viewed facing north toward the boundary wall. Scale 2 x 1m.

- 3.4.3 No other features of archaeological merit were identified in the trench, other than a series of roughly parallel linear features, fairly evenly spaced, and extending roughly east-west across the southern half of the trench only. These features could clearly be related to a series of wheel ruts extending across the surface of the surrounding field and through the overburden deposits (Plate 4). These wheel ruts clearly related to modern agricultural vehicles traversing the area. There was no evidence of a ditched feature, as previously postulated may accompany the deer park boundary wall. Nor was there any evidence of surviving ridge and furrow to the north of the wall, in the field identified as potentially containing such remains.

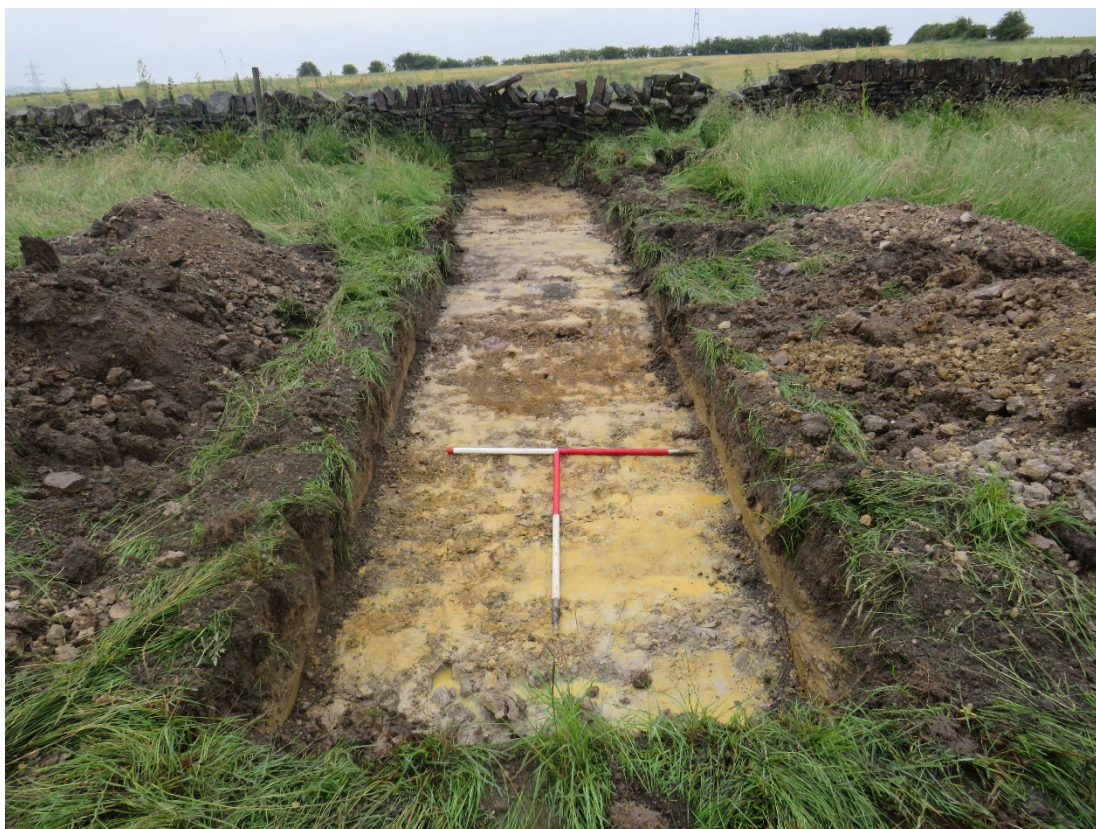
Plate 5: The northern half of Trench 8, viewed facing south-east, Scale 2 x 1m

- 3.5.2 The wall dividing the two halves of the trench, was found to be approximately 0.65m wide and up to 1.20m high, comprising up to ten irregular courses of sandstone blocks set without mortar. The individual blocks were generally well dressed, but varied in size and shape, with blocks in lower courses more often set end on end, while often the largest blocks, were set side by side, in a crenelated fashion, within the top course (Plate 5). No evidence of dating was recovered associated directly with the fabric of the wall, although it appeared in relatively good condition throughout.

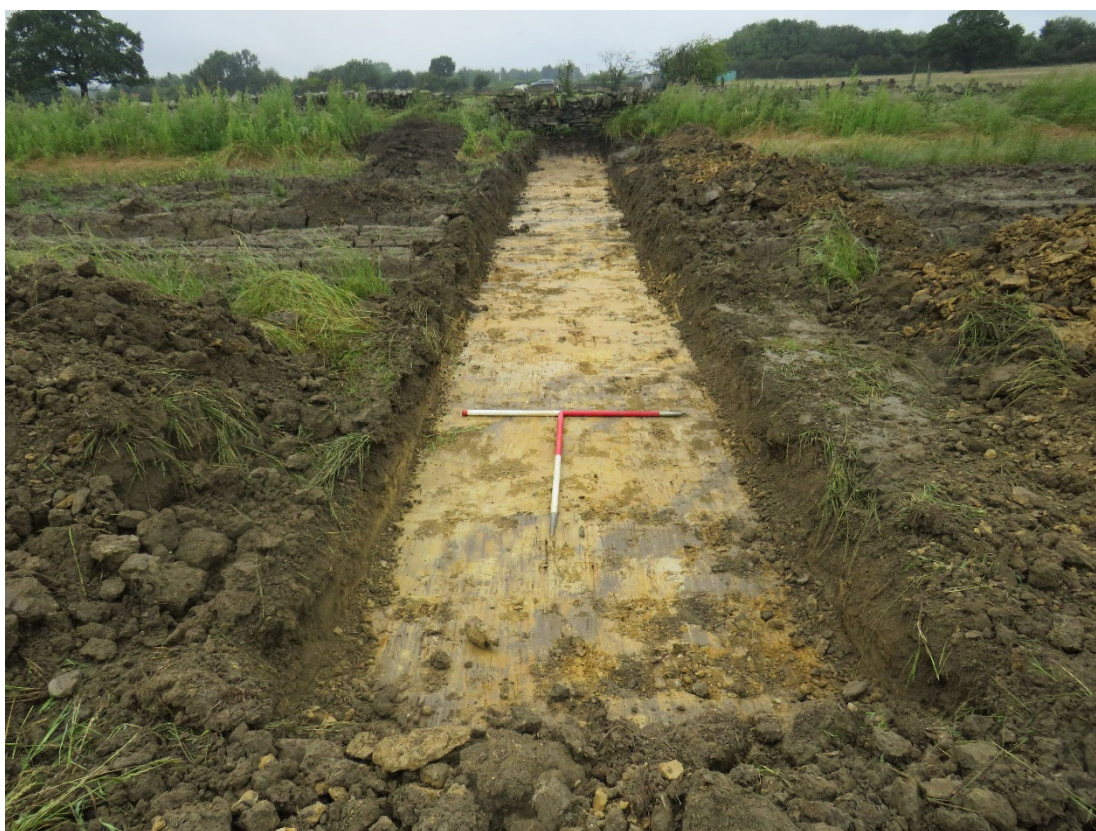
- 3.5.3 A single field drain, constructed with a stone infill, was the only other feature encountered within the trench, and extended east-west across the southern half of the trench, approximately 3m south of the boundary wall. There was no sign of any ditched or other features potentially associated with the former deer park wall.

Plate 6: The southern half of Trench 8, viewed facing north-west towards the boundary wall. Scale 2 x 1m.

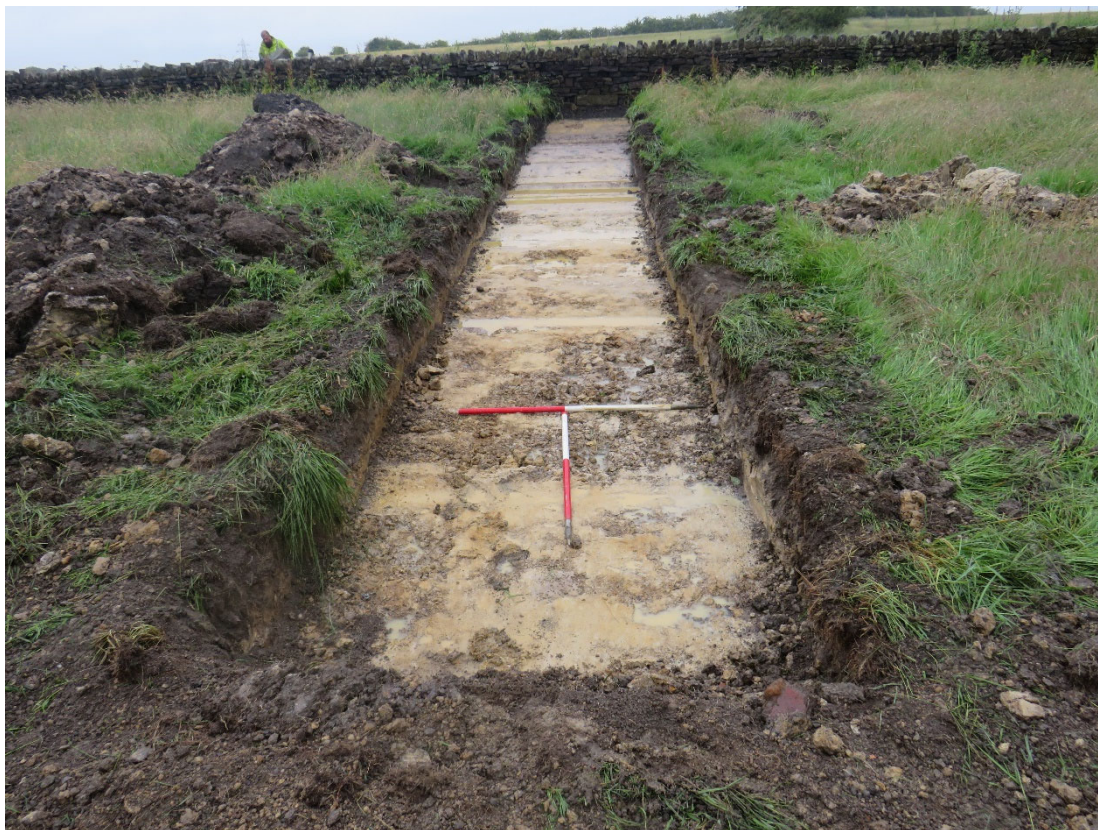
*Plate 7: The northern half of Trench 9, viewed facing south-east towards the boundary wall. Scale 2 x 1m.*

- 3.6.2 The wall dividing the two halves of the trench, was found to be approximately 0.65m wide and up to 1.20m high, comprising up to eleven irregular courses of sandstone blocks set without mortar. The individual blocks were generally well dressed, but varied in size and shape, with blocks in lower courses more often set end on end, some including several large well-dressed blocks, while the upper most course comprised blocks set side by side, in a crenelated fashion (Plate 5). No evidence of dating was recovered associated directly with the fabric of the wall, although it appeared in very good condition throughout.

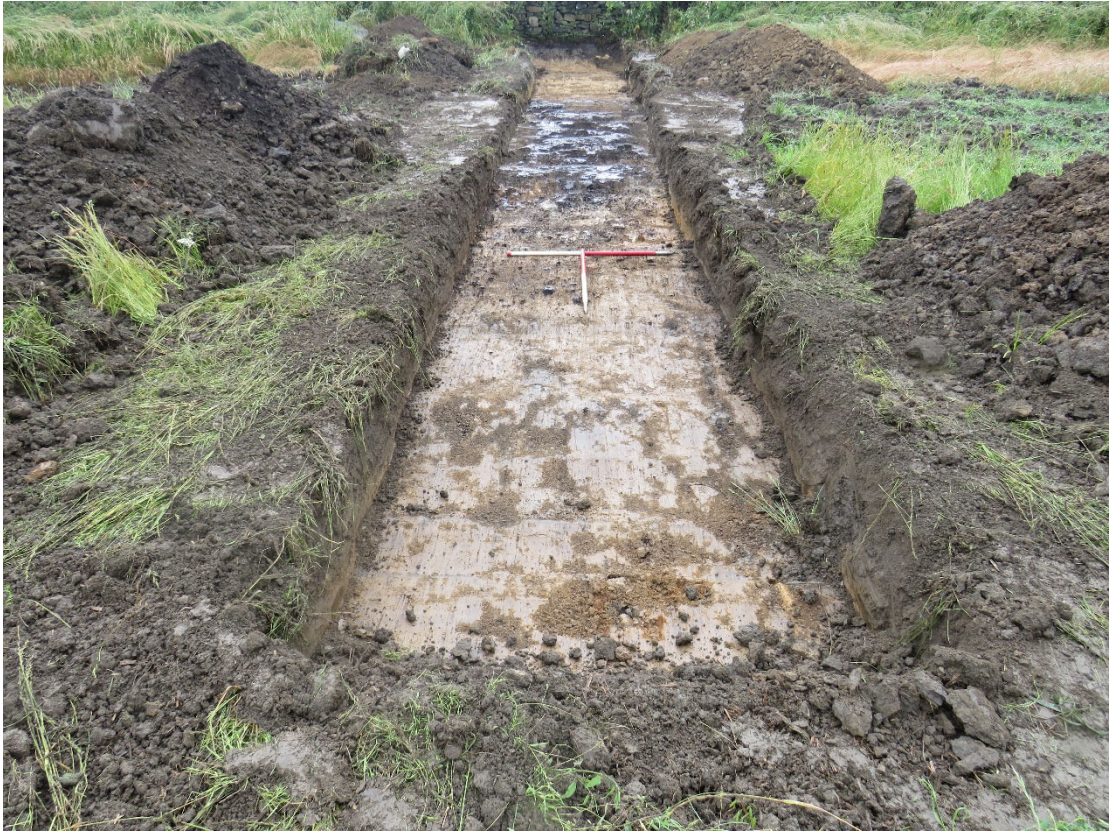
- 3.6.3 A large area of darkened natural (**903**) was identified towards the centre of the southern half of the trench, and was interpreted as an area of probably iron panning (Plate 8). Other than this probable natural feature, a single stone drain, extending north-south, and a single narrow service trench containing a modern plastic hosepipe extending east-west, were identified in the northern half of the trench. There was no sign of any ditched or other features potentially associated with the former deer park wall.

*Plate 8. The southern half of Trench 9, viewed facing north-west towards the boundary wall. Scale 2 x 1m.*
