Phase II Geo-environmental Report

Project: BK UK Barnsley
Wombwell Lane,
Barnsley,
S70 3NS

Reference: M44628-JNP-XX-XX-RP-G-1002 P02

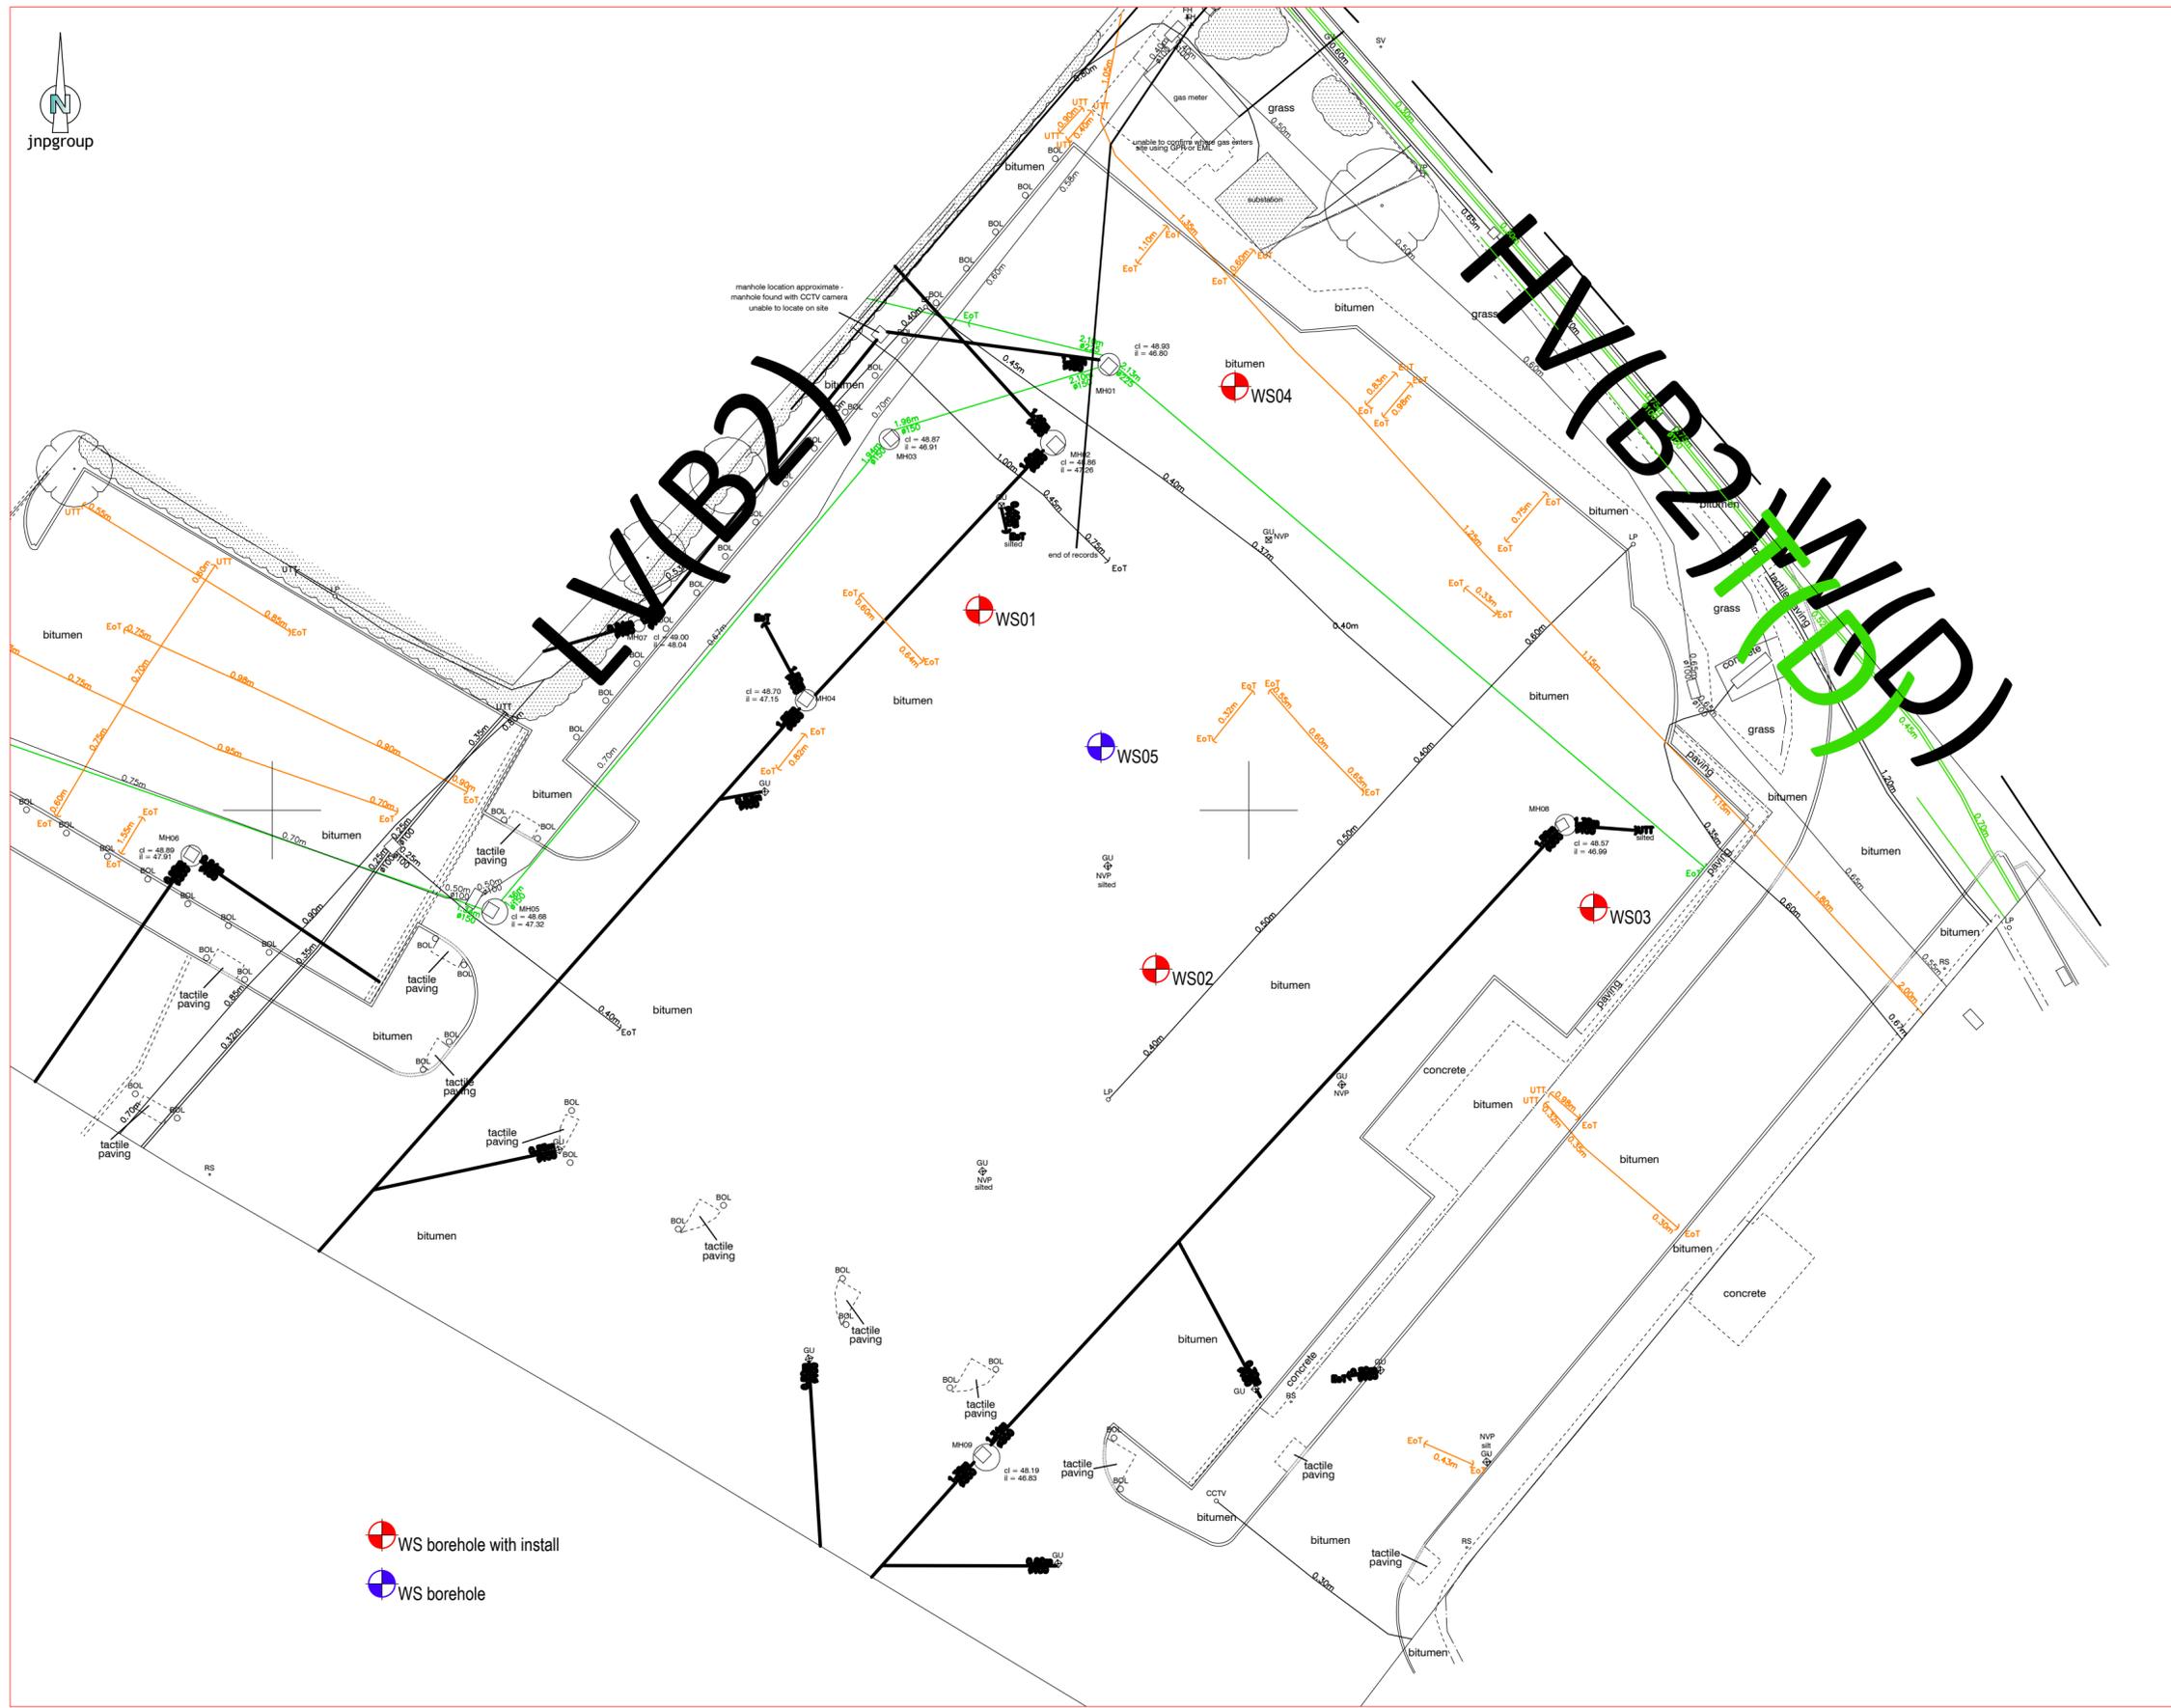
WS borehole with install
 WS borehole

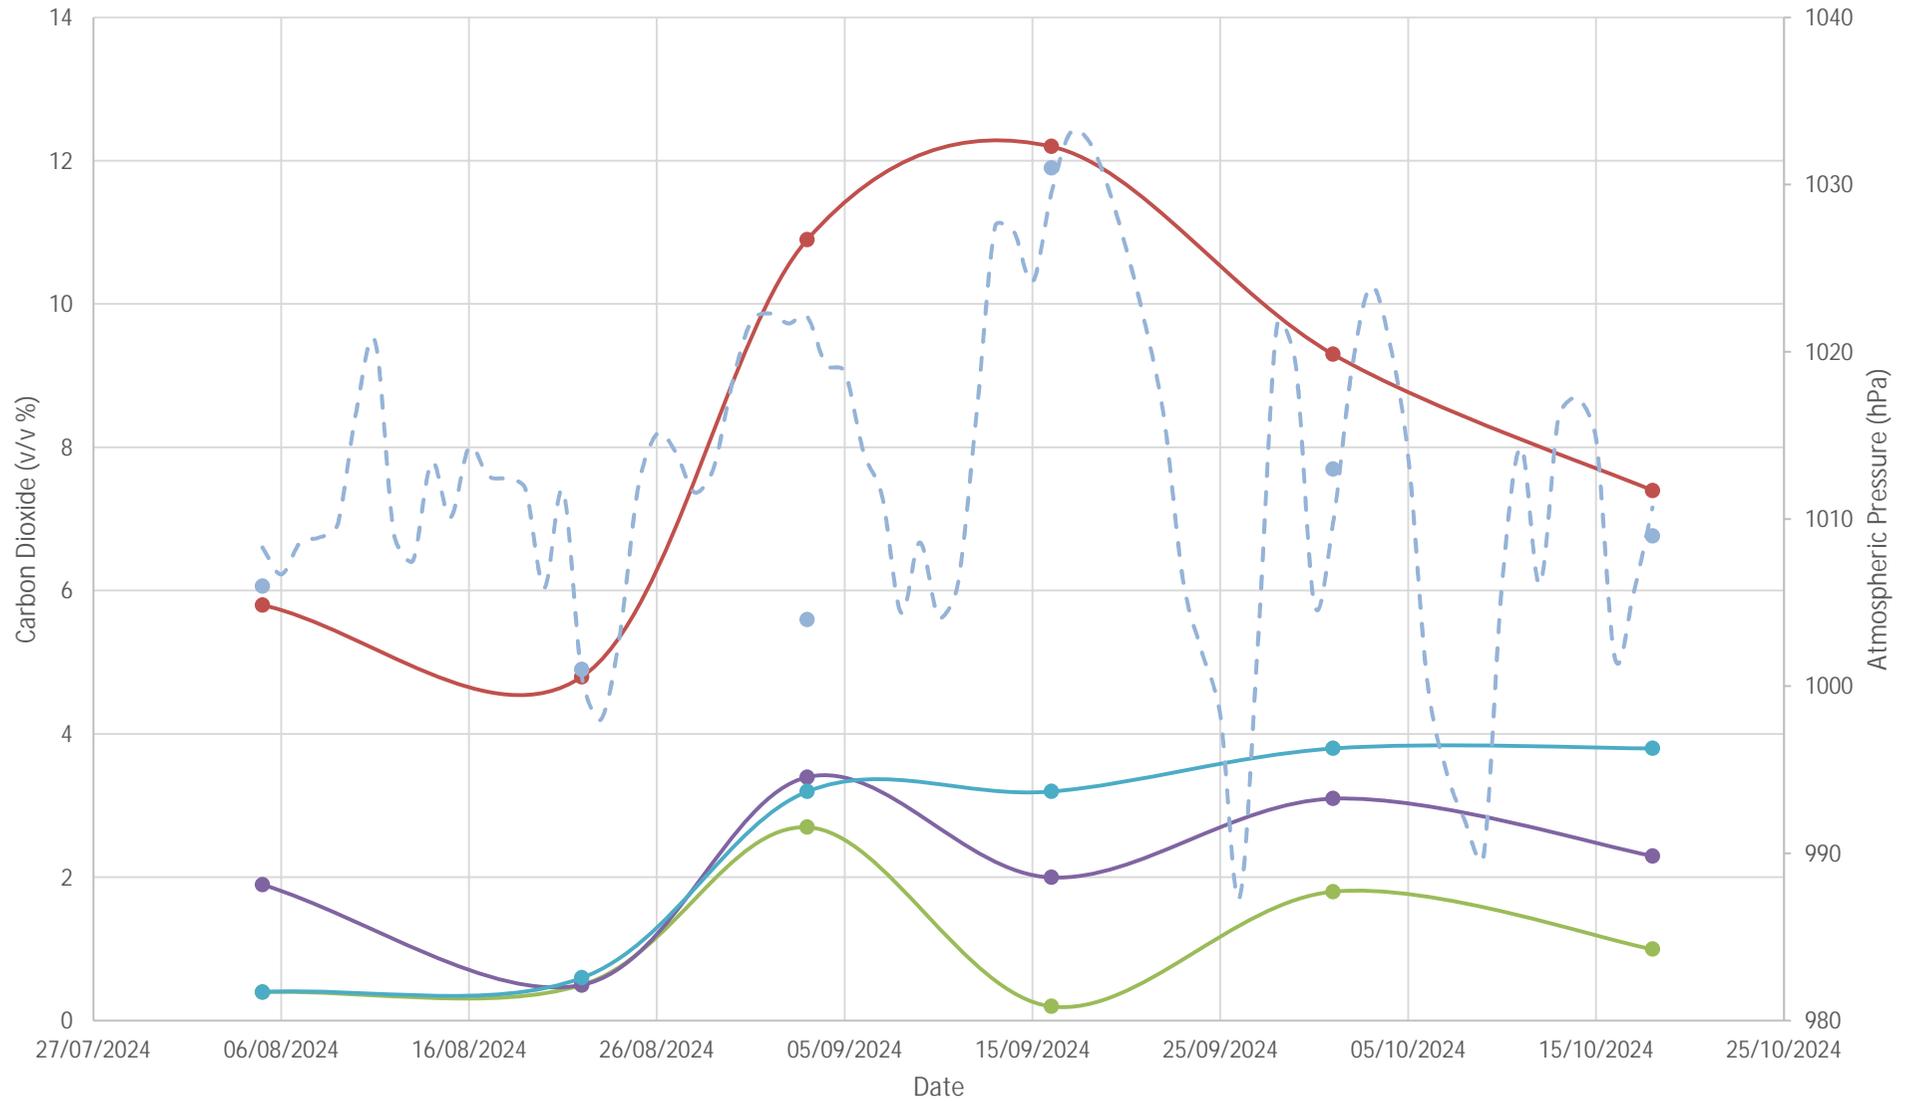
Carbon Dioxide Monitoring Trend

—●— WS01 —●— WS02 —●— WS03 —●— WS04 - - - Air Pressure ● Air Pressure at Visit Date

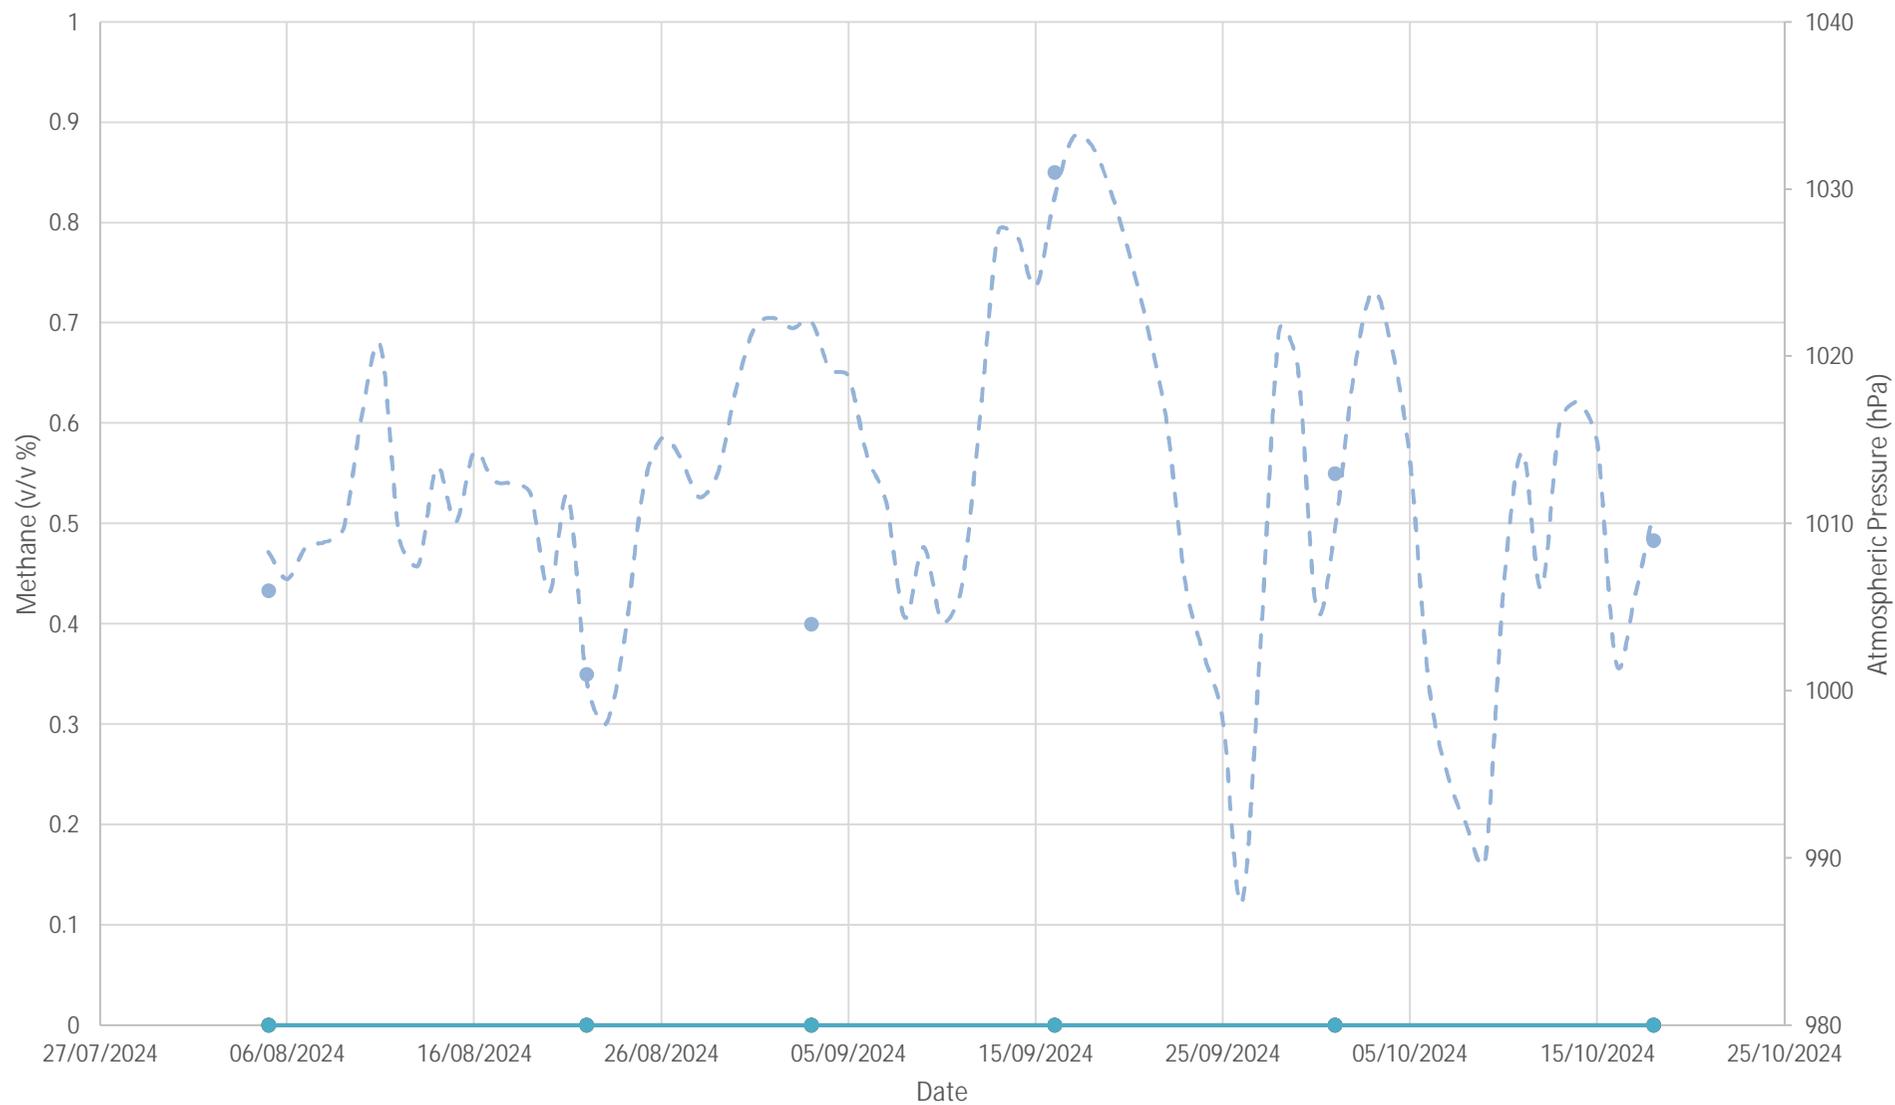
Methane Monitoring Trend

—●— WS01 —●— WS02 —●— WS03 —●— WS04 - - - Air Pressure ● Air Pressure at Visit Date

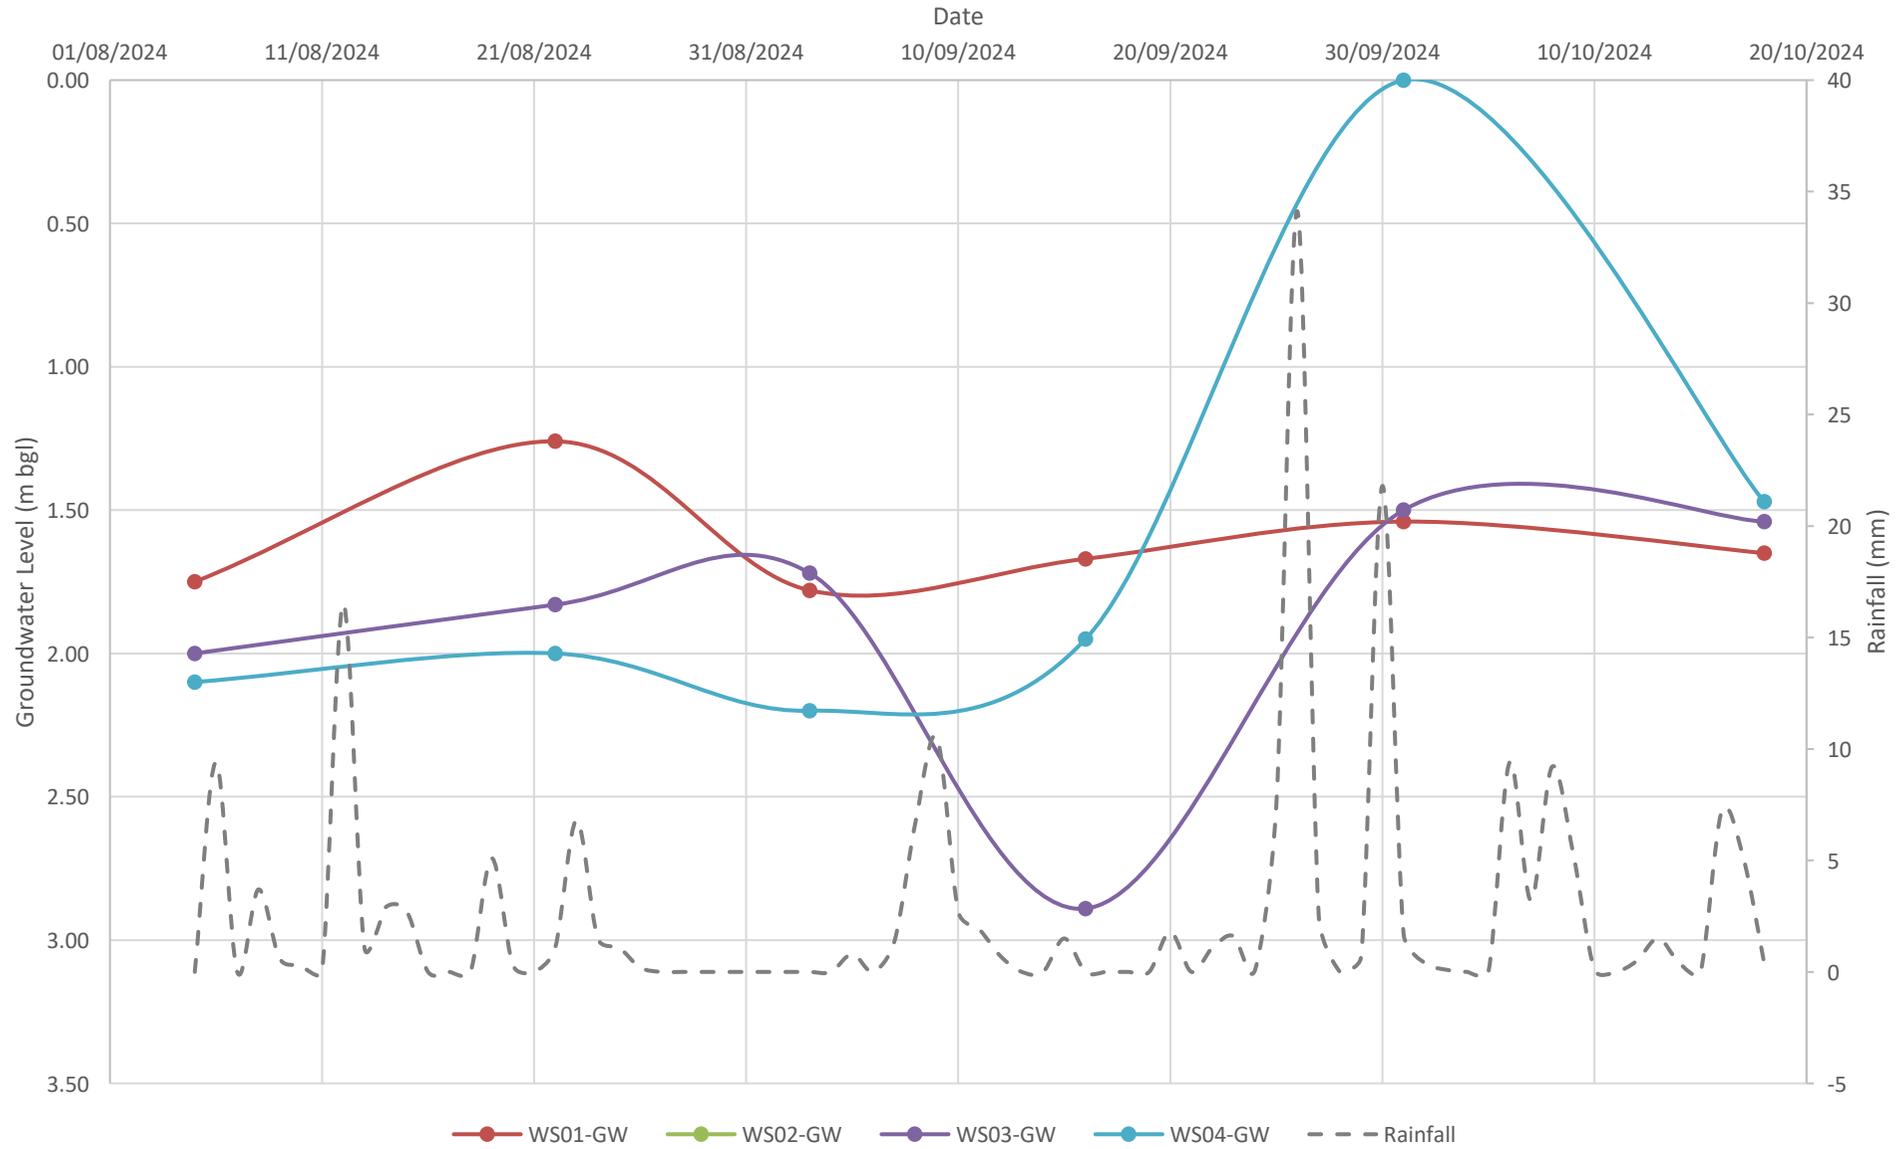
Groundwater Monitoring Trend

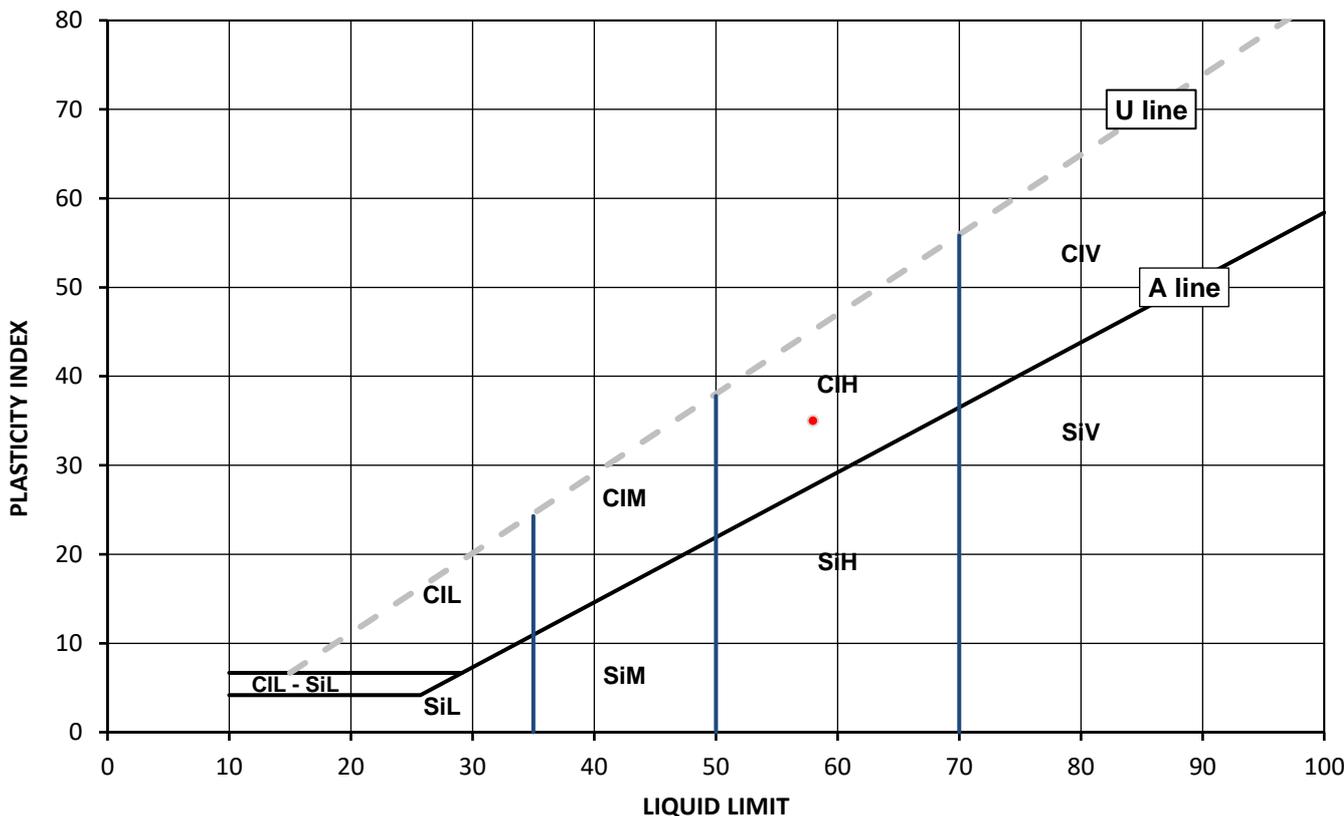
As Received Water Content [W] %	Liquid Limit [WL] %	Plastic Limit [Wp] %	Plasticity Index [Ip] %	Liquidity Index [IL] % #	Consistency Index [IC] % #	% Passing 425µm BS Test Sieve
28.4	58	23	35	0.14	0.86	100

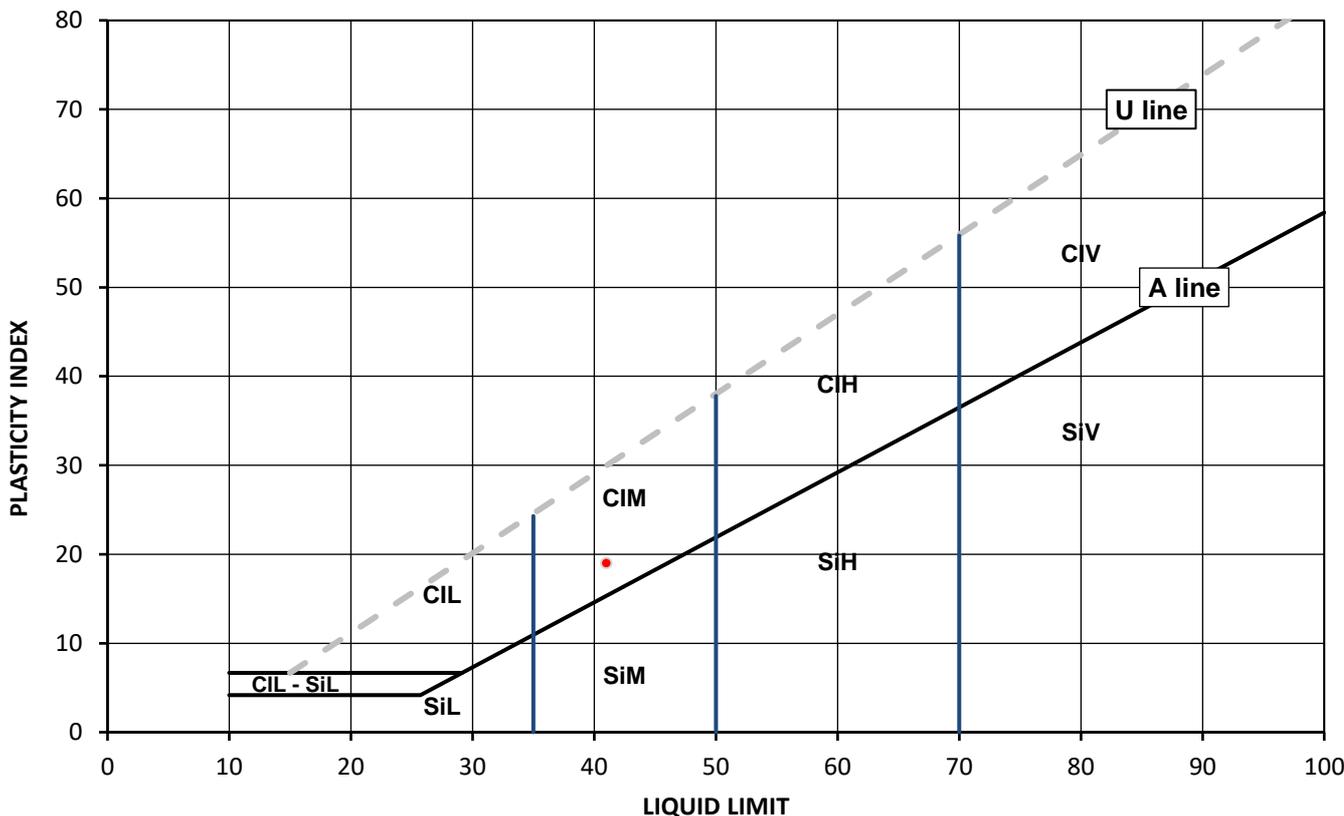
As Received Water Content [W] %	Liquid Limit [WL] %	Plastic Limit [Wp] %	Plasticity Index [Ip] %	Liquidity Index [IL] % #	Consistency Index [IC] % #	% Passing 425µm BS Test Sieve
19.0	41	22	19	-0.16	1.16	100

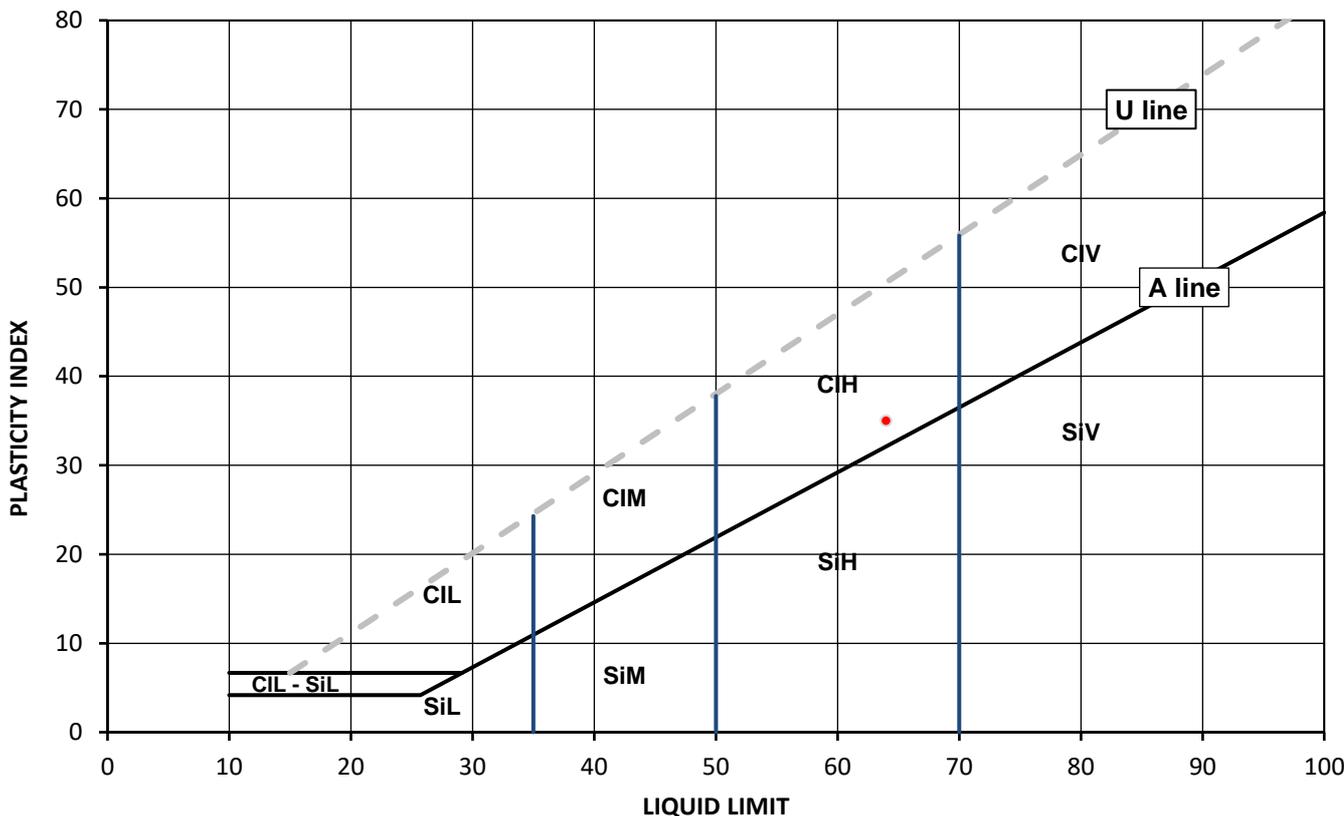
As Received Water Content [W] %	Liquid Limit [WL] %	Plastic Limit [Wp] %	Plasticity Index [Ip] %	Liquidity Index [IL] % #	Consistency Index [IC] % #	% Passing 425µm BS Test Sieve
35.6	64	29	35	0.20	0.80	92

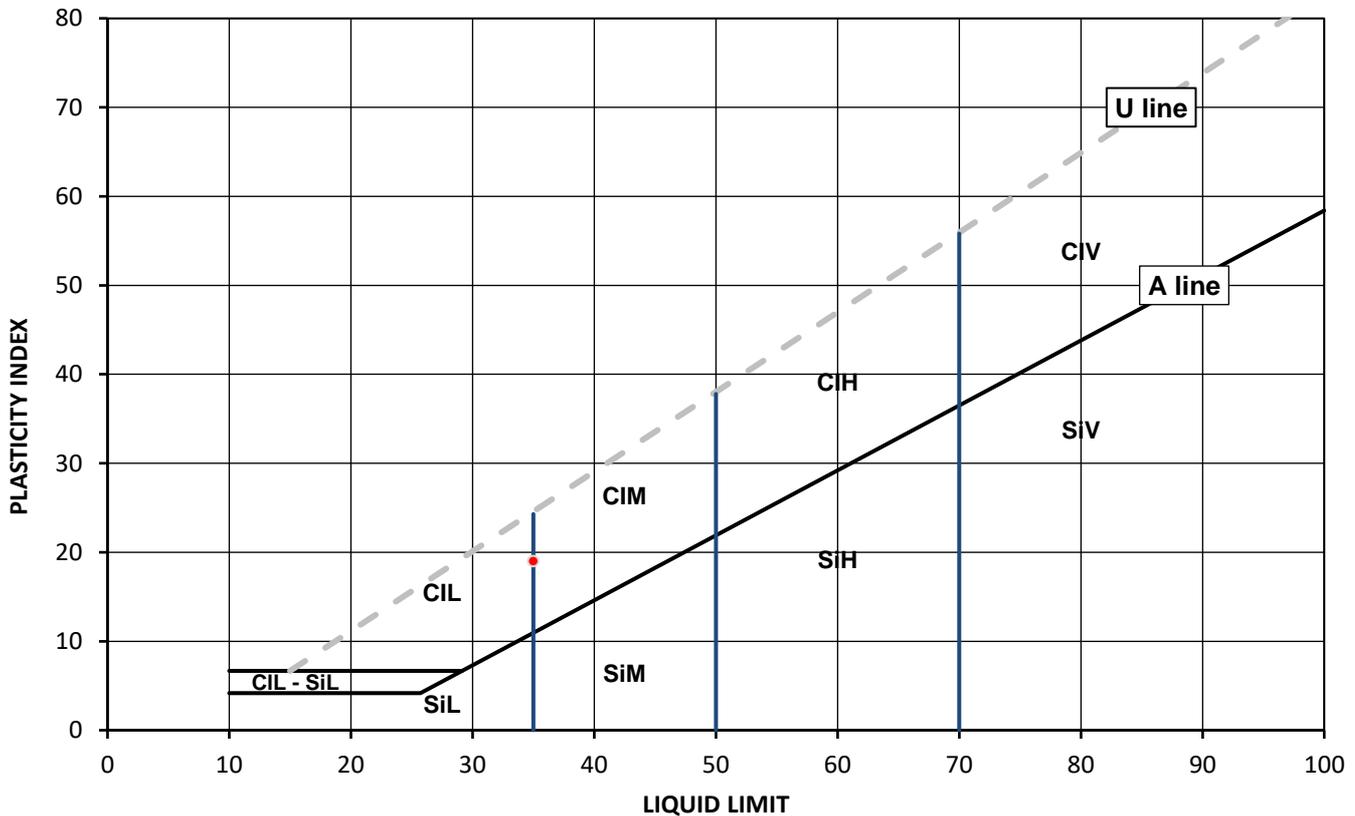
Laboratory Reference: 273090
 Hole No.: WS04
 Sample Reference: Not Given
 Sample Description: Brownish grey sandy CLAY
 Sample Preparation: Tested in natural condition; The water content in the sample was increased
 Cone Type: 80g/30deg

As Received Water Content [W] %	Liquid Limit [WL] %	Plastic Limit [Wp] %	Plasticity Index [Ip] %	Liquidity Index [IL] % #	Consistency Index [IC] % #	% Passing 425µm BS Test Sieve
16.4	35	16	19	0.00	1.00	100
