**BARNSELEY & DISTRICT AMALGAMATED ANGLERS SOCIETY  
PROPOSED ACCESS & PARKING ARRANGEMENTS FOR DISABLED ANGLERS  
AT WORSBROUGH RESERVOIR BARNSELEY**

Planning Ref: 2019/1356  
14 January 2020

**TREE SURVEY**

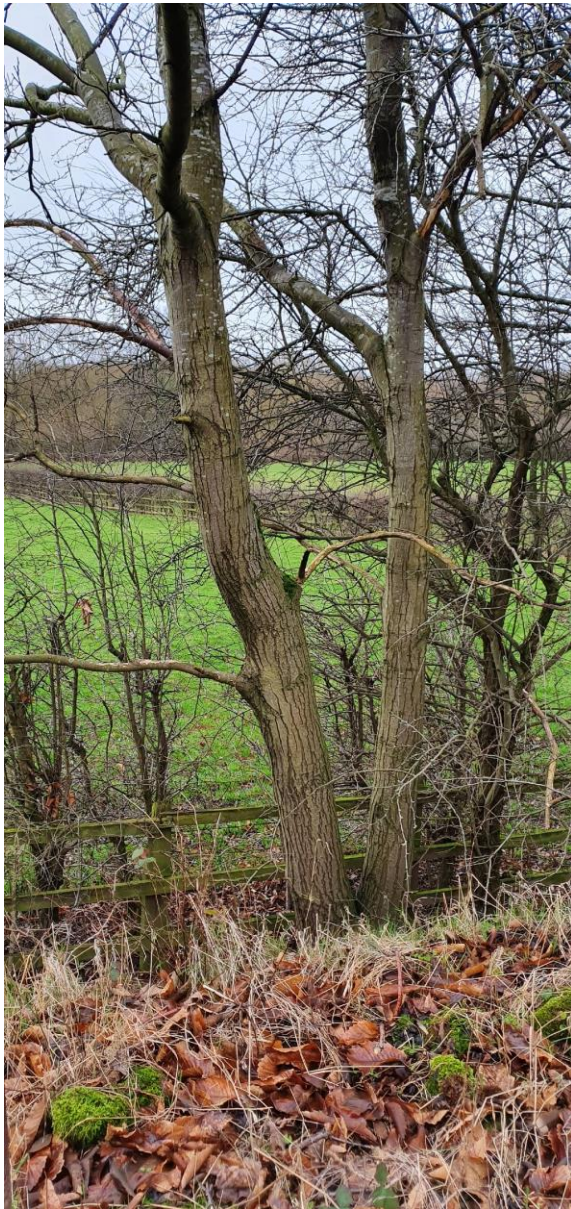
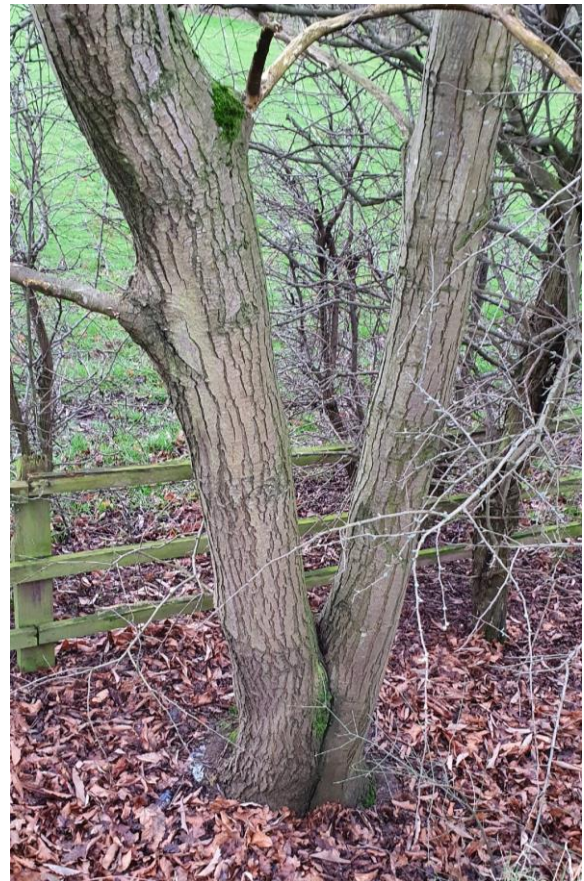
**T1** *Castanea sativa* (Sweet Chestnut) semi-mature specimen to be retained. Low split leader with cavity. Sitting at the base of a small stone retaining wall, this tree is to be protected during the course of the works where the construction of the access ramp will have minimal or no effect on the RPA.

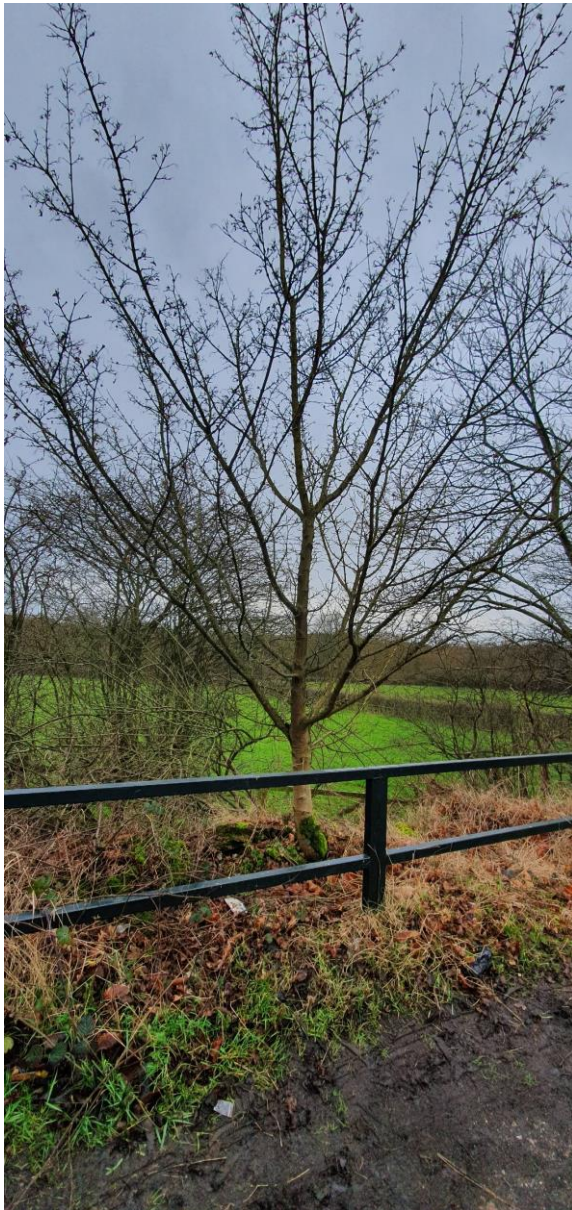
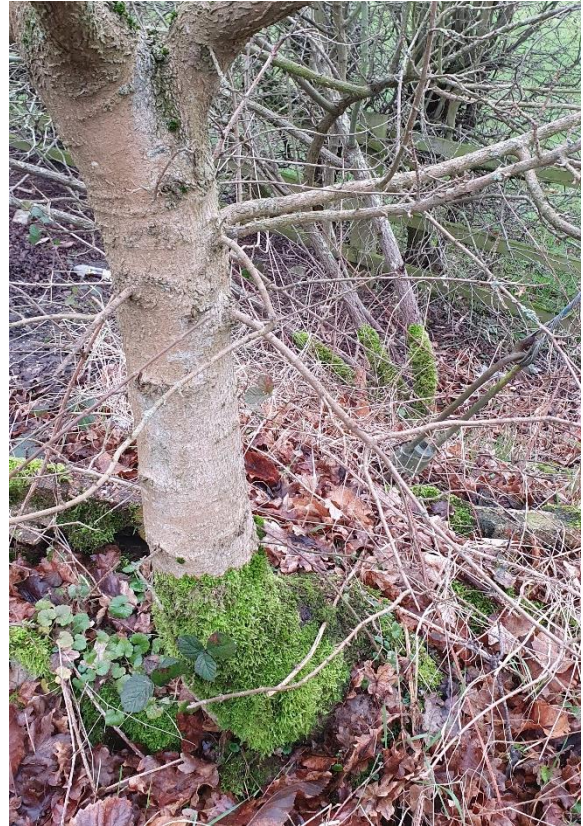
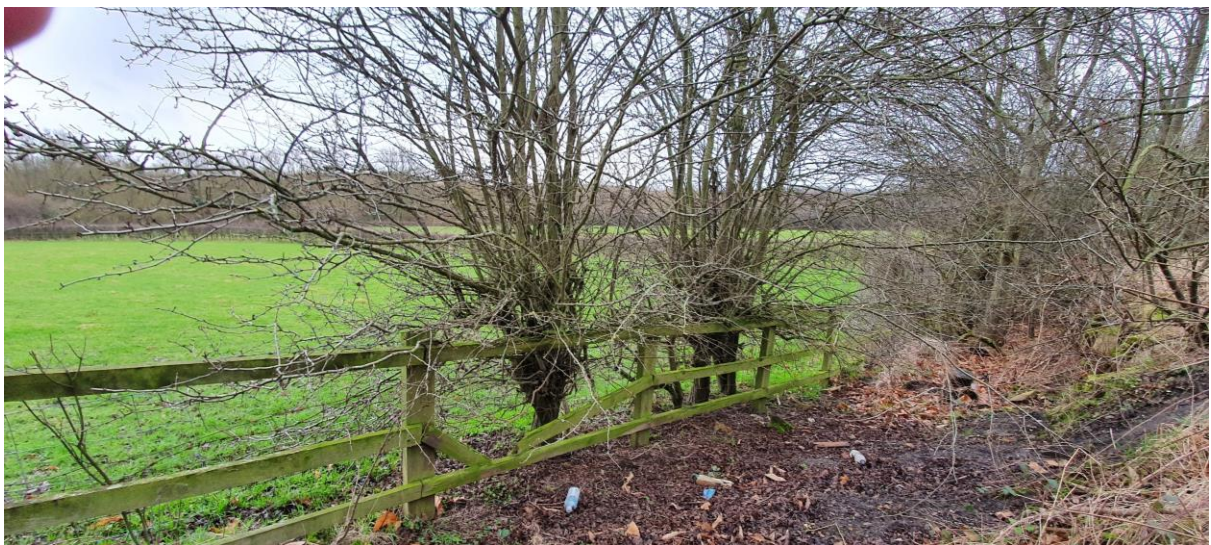
**T2** *Acer campestre* (Field Maple) small but semi-mature specimen to be retained. Base of stem malformed and constrained by stone wall. Occlusion. Sitting at the top of a small stone retaining wall, this tree is to be protected during the course of the works where the construction of the access ramp will have minimal or no effect on the RPA.

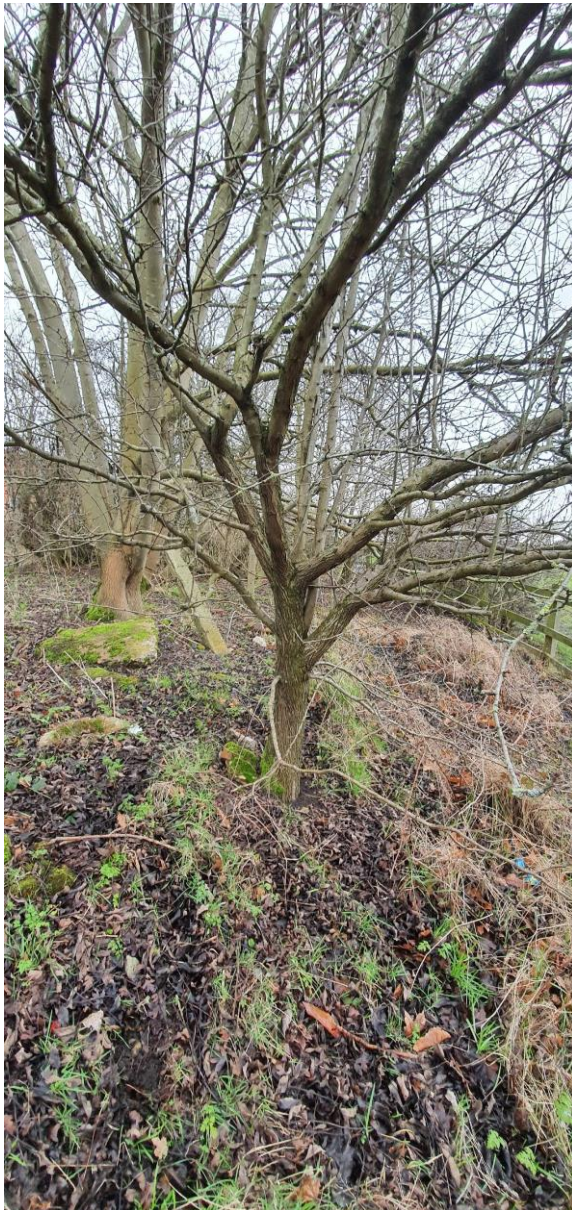
**G1** *Crataegus monogyna* (Common Hawthorn) isolated section of mature hedgerow. Formerly cut at c.1.2m, this hedge is now overgrown. This group will be removed as part of the access ramp construction.

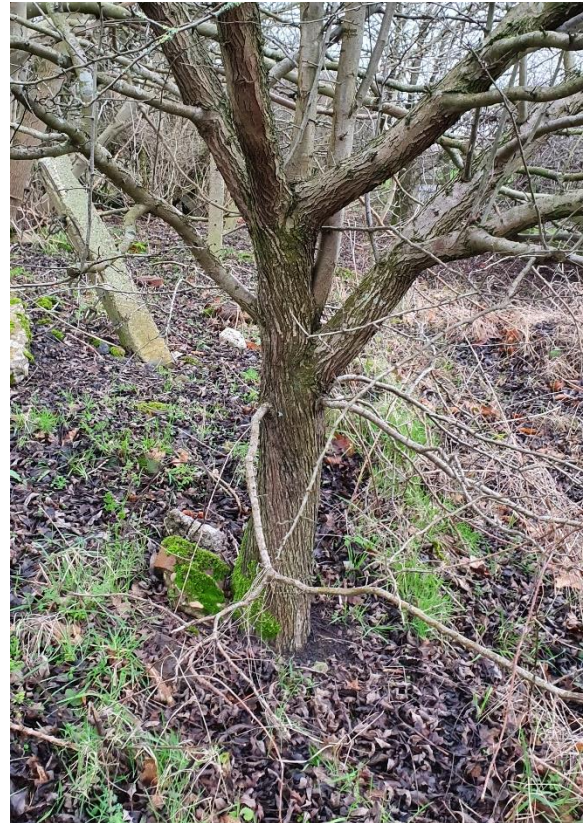
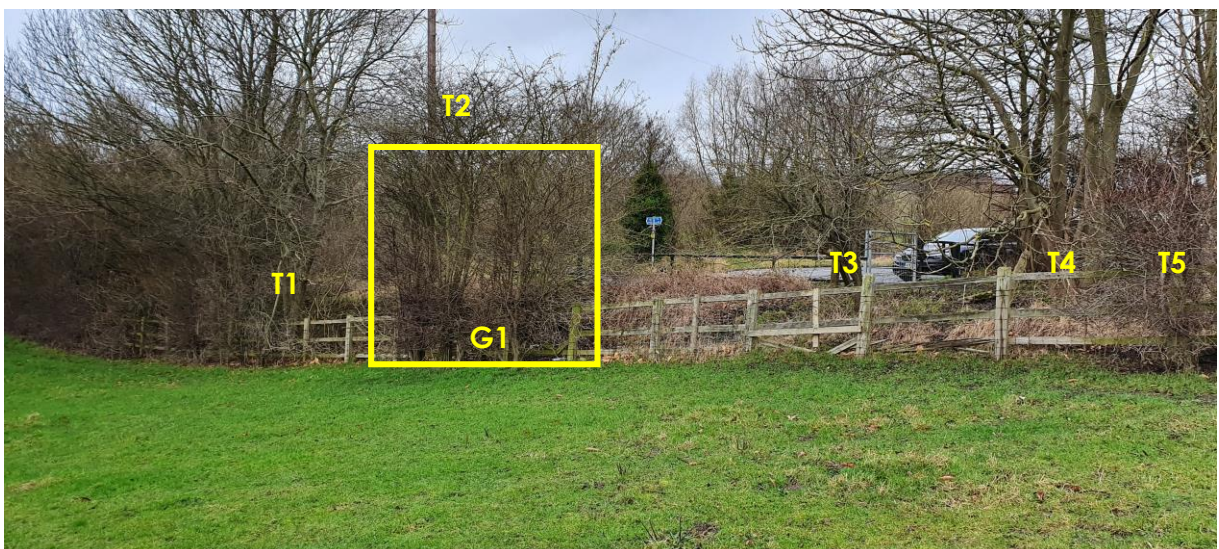
**T3** *Crataegus monogyna* (Common Hawthorn) young to semi-mature specimen to be retained. Short stem. Unmanaged with low branching. Sitting at the top of a short slope, this tree is to be protected during the course of the works where the construction of the access ramp will have minimal or no effect on the RPA.

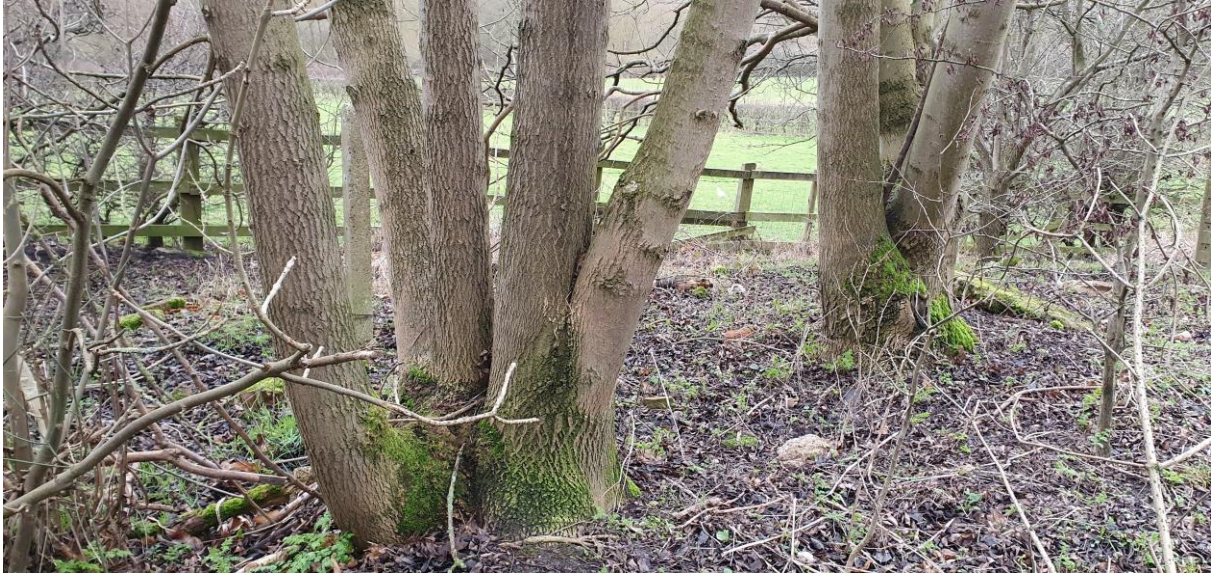
View north towards the site of the proposed gated access ramp with **G1** small section of overgrown hedge to be removed highlighted.

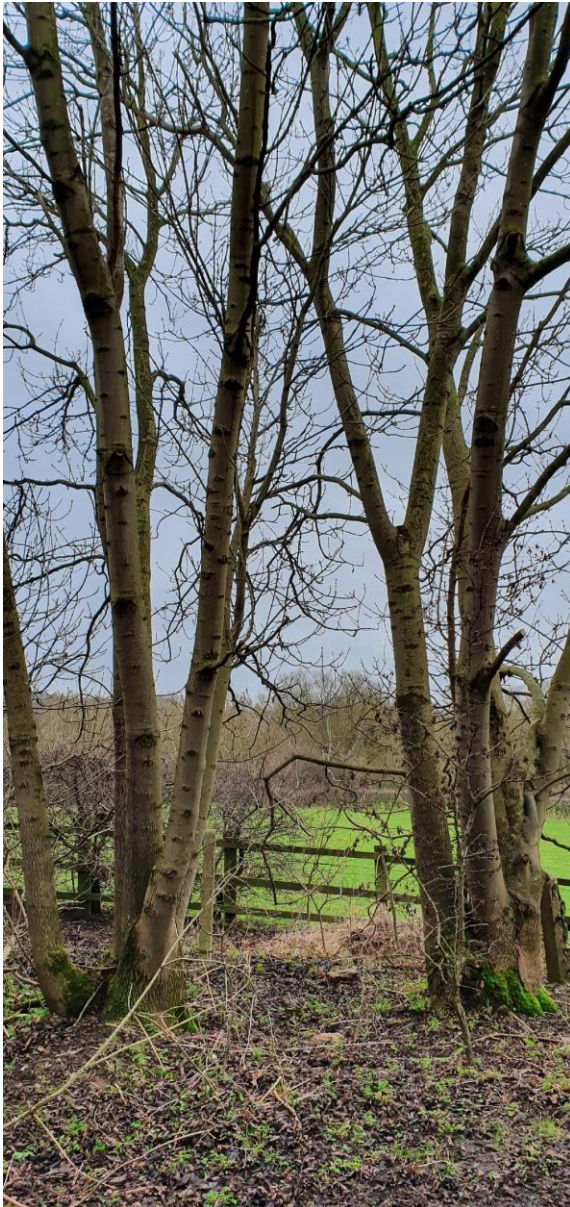
**T4 and T5** *Fraxinus excelsior* (Common Ash) both semi-mature specimens are multi-stemmed from base with cavities that will present future weaknesses. Canopy and RPA clear of the proposed access track. Will not be impacted by the works.

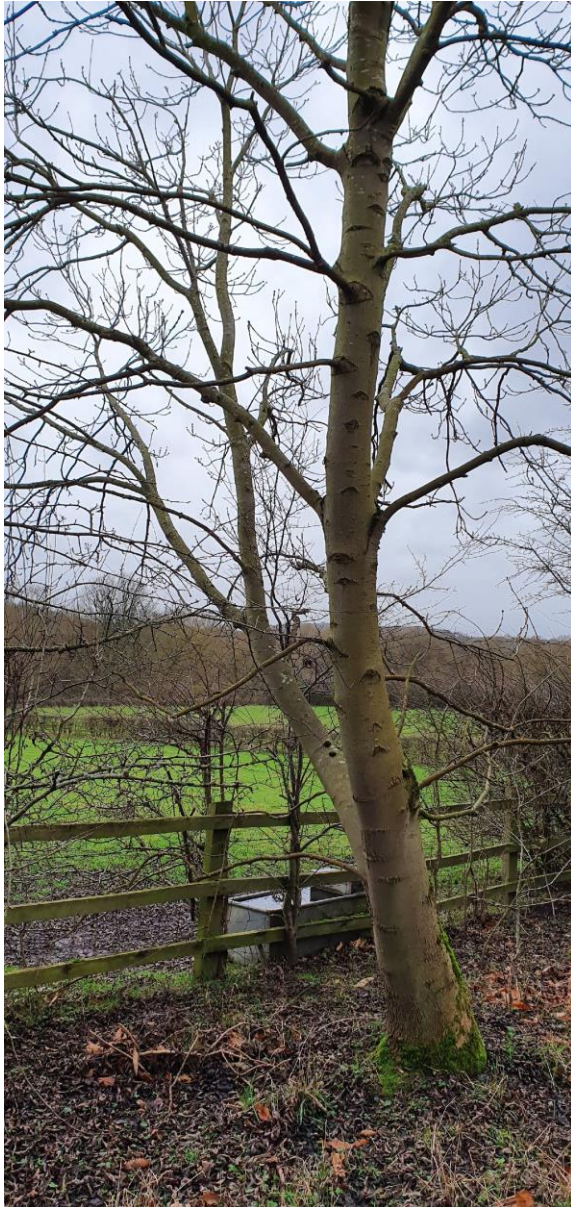
**T7** *Fraxinus excelsior* (Common Ash) young to semi-mature specimen to be retained. Short stem. Unmanaged with low branching. This specimen is unlikely to be affected during the course of the works; however, care will be taken when constructing the access track by hand digging close to the RPA.

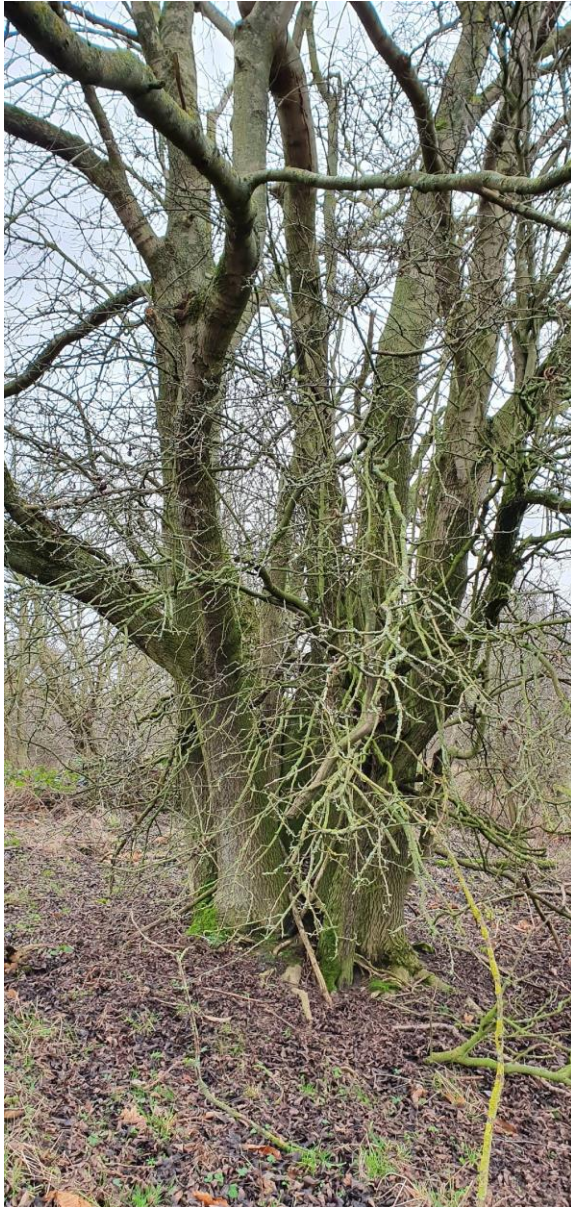
**T8** *Fraxinus excelsior* (Common Ash) mature multi-stemmed specimen in poor condition. Poor self-set hawthorn growing out from multi-stemmed base. Not affected by the construction works.

The area in and around the trees along the southern edge of the TPT is unmaintained with small self-sets, dead wood, and under-storey vegetation.

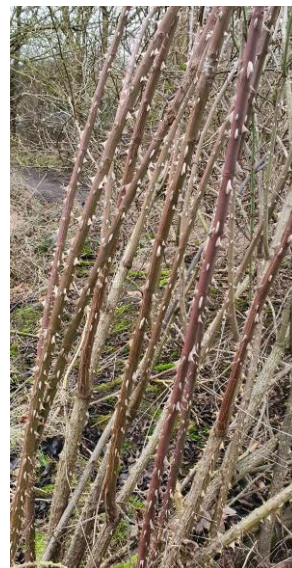
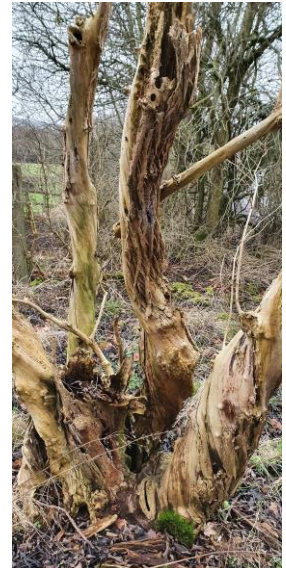
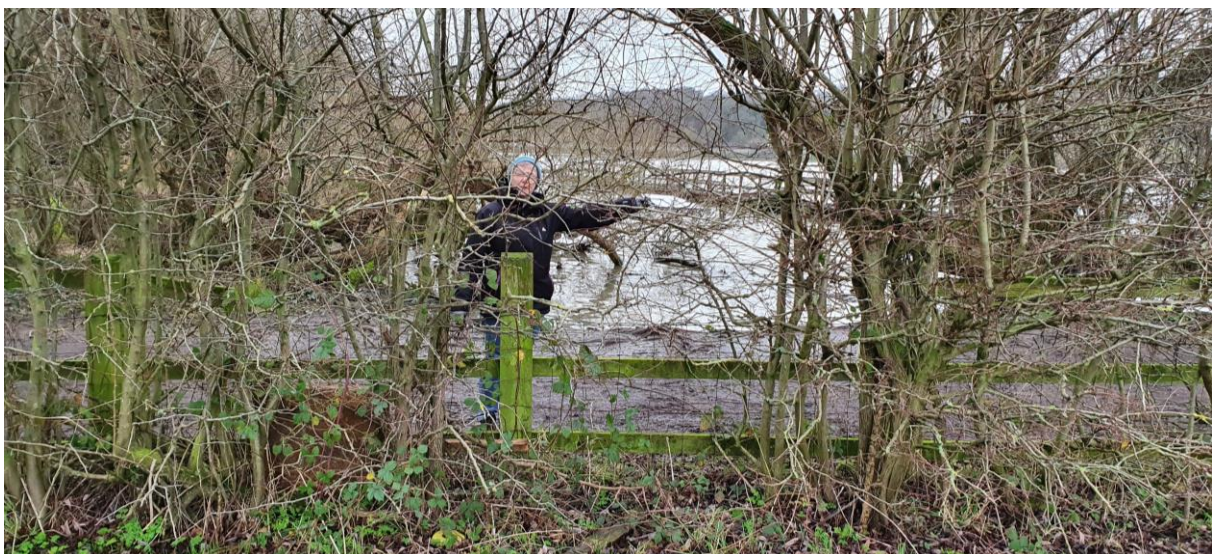
**G2** location of the access from the proposed car park to the fishing platform through a gap in a thinning hedgerow; some hedging to be removed and pruned back.

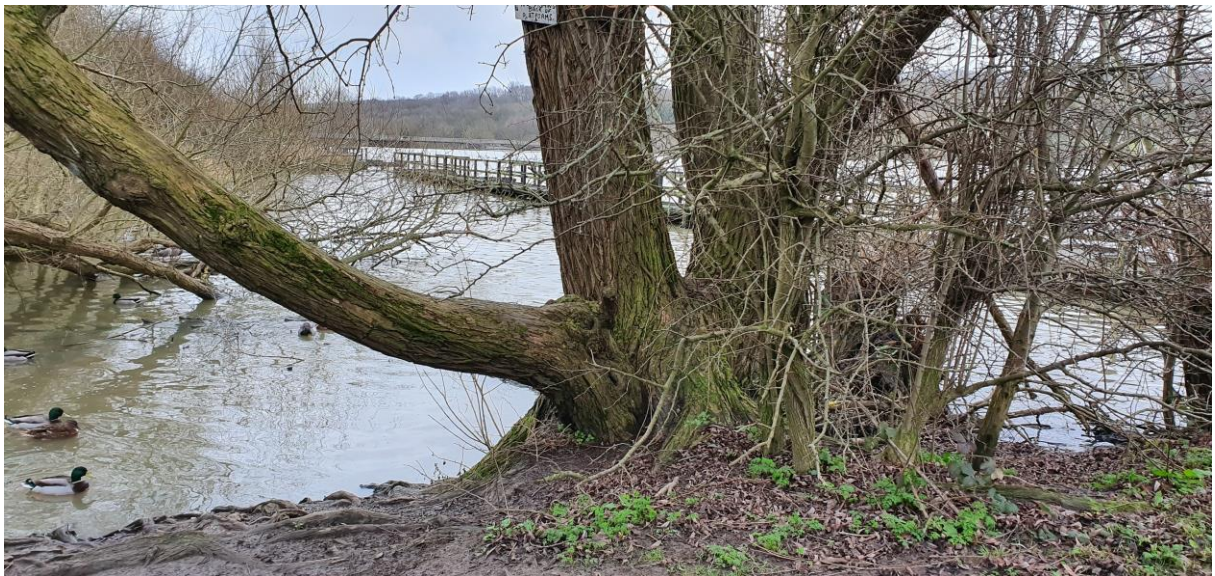
**T9** Salix spp (Willow) large mature specimen multi-stemmed from base. Located on the reservoir bank opposite the planned access from the proposed disabled anglers' car park. Unaffected by the works.
