## **SUPPLEMENTARY GROUND INVESTIGATION REPORT**

**Proposed MVT Building, Barnsley College,  
Honeywell Lane, Barnsley, South Yorkshire**

**Report: 151118GI2**

**Date: June 2022**

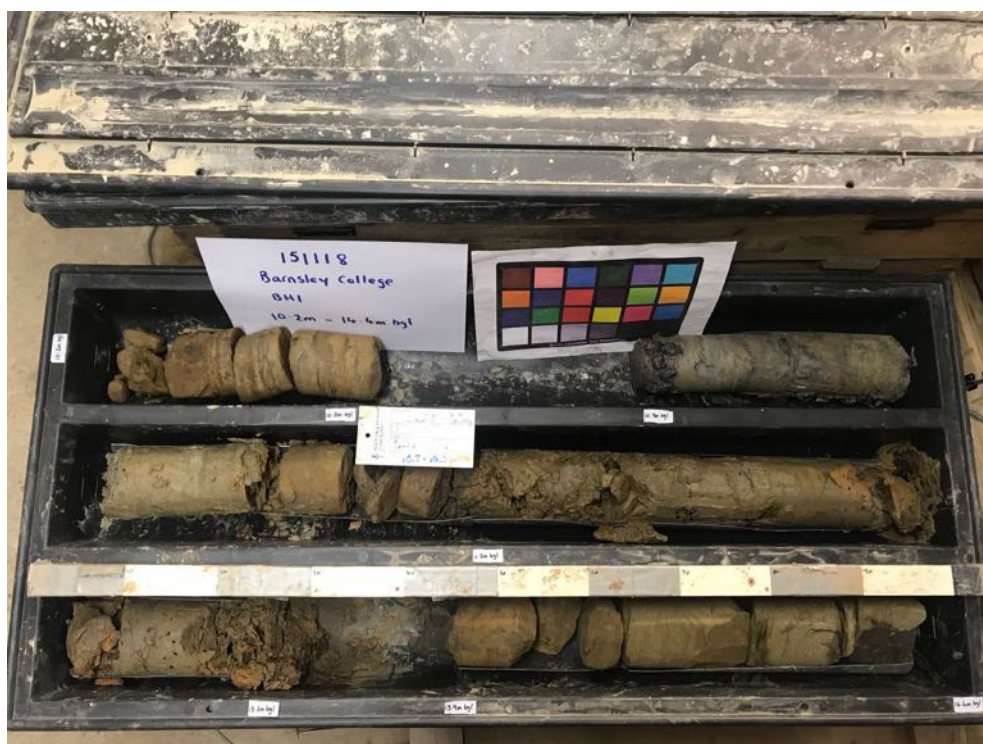
**Plate 1:** BH1 - 10.2m -14.4m bgl

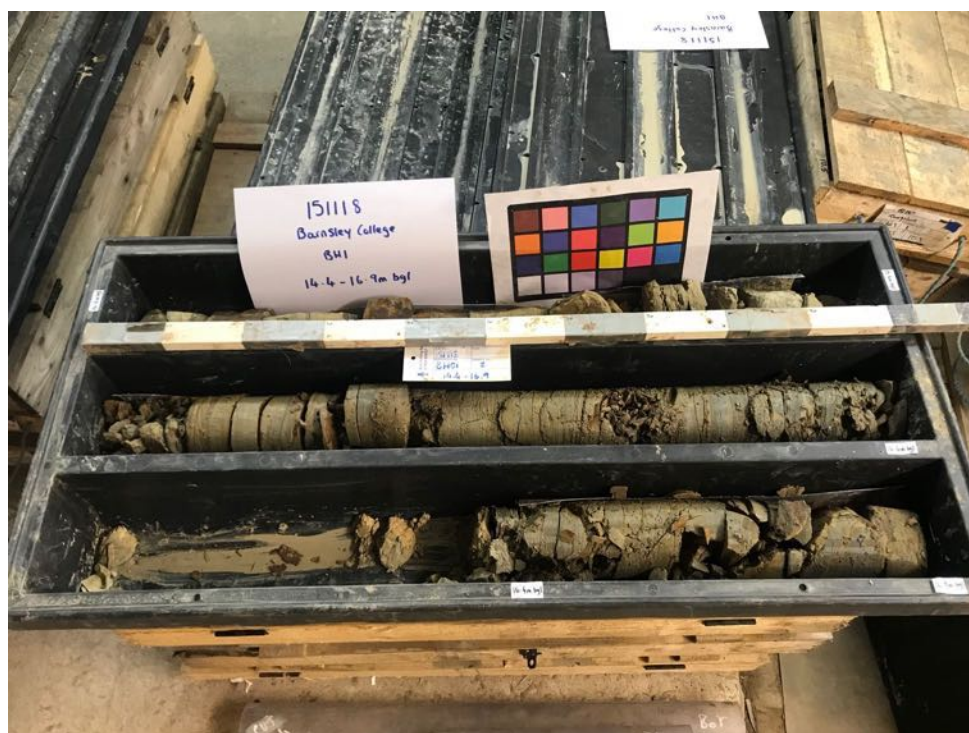
**Plate 2:** BH1 - 14.4m -16.9m bgl

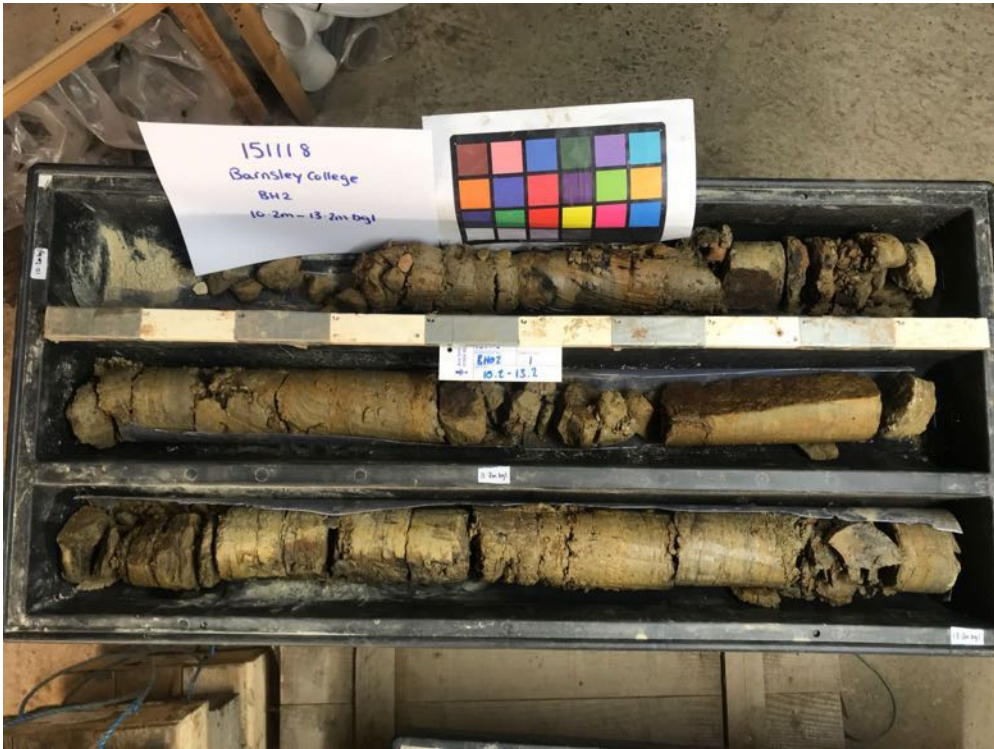
**Plate 3:** BH2 - 10.2m -13.2m bgl

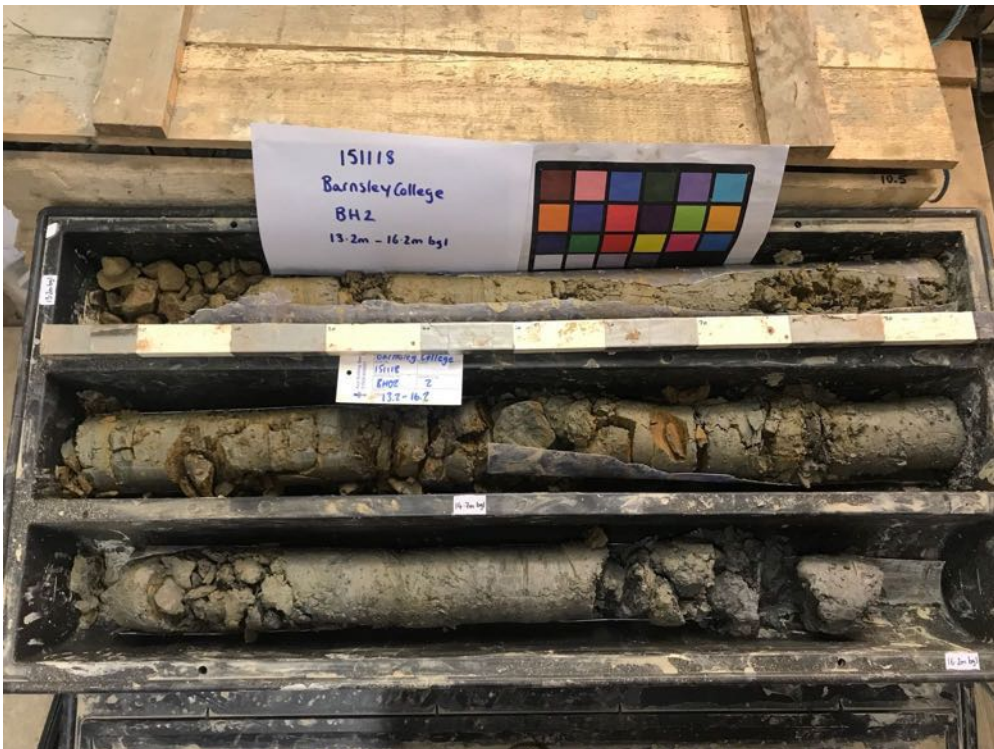
**Plate 4:** BH2 - 13.2m -16.2m bgl
