# Doveside Wetland Design

Final Report

September 2017

The Garganey Trust

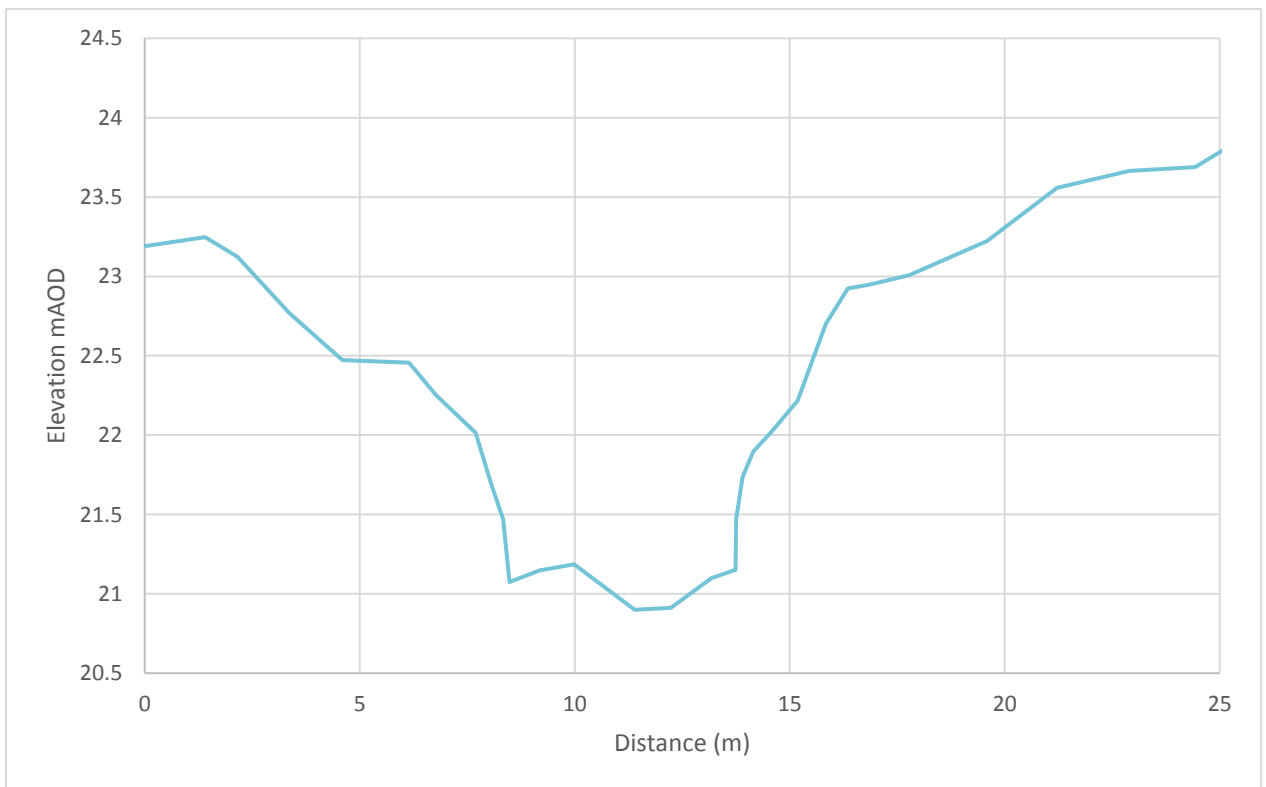
Figure 2-9: Model Cross Section (looking downstream)

Figure 2-9 presents the cross section from the river at a point close to the culvert outfall. It indicates that the base of the river is at 20.9mAOD.

The model is not suitable in understanding the stage at low flows. However, the information within Figure 2-8 and Figure 2-9 indicates that the river is likely to be regularly above the level of the floodplain in moderate flow conditions.
