Our Ref: D6643/2

ADDITIONAL GROUND INVESTIGATION – NANNY MARR ROAD, DARFIELD

Drawing Title:
Exploratory Hole Location Plan – October 2015 Investigation

Drawing No:
D6643/03

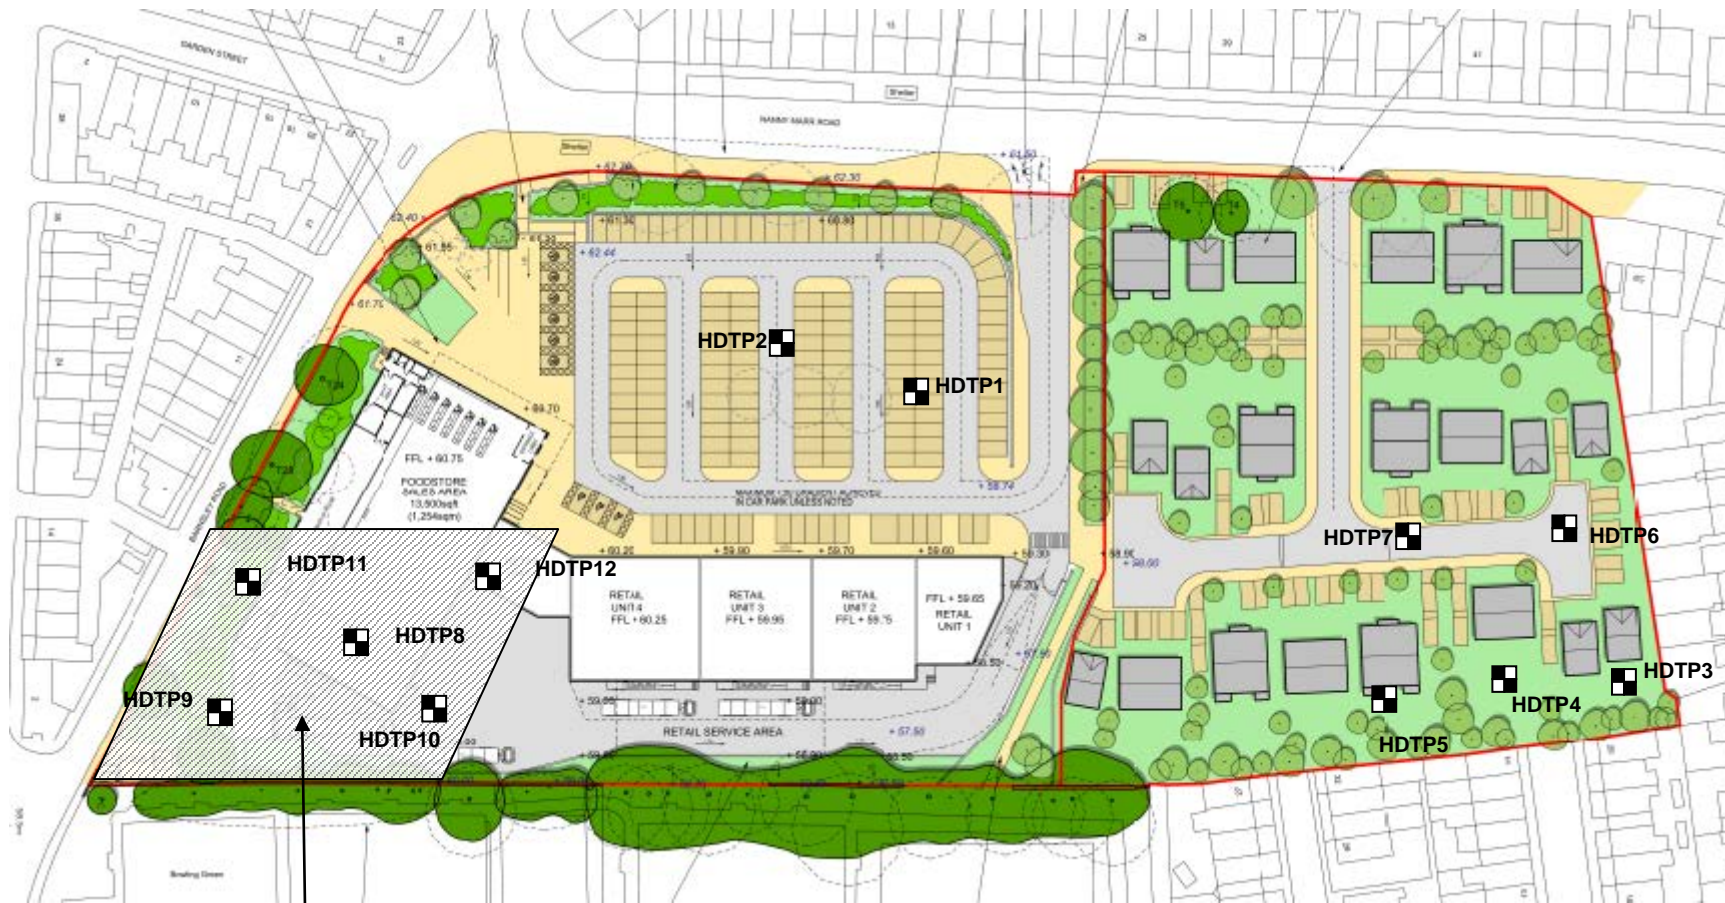
Twelve trial pits (HDTP01 to HDTP12) were hand excavated to depths ranging from 0.30m to 1.20m below ground level and the approximate trial pit locations are shown on Drawing D6643/03 enclosed. Exploratory hole logs relating to each of the trial pits are also enclosed.

Area inaccessible due to underground gas main
