**OAKS FARM, DARTON.**

**BAT SURVEY.**

**Ref No:- 160503.**

**Date:- 27<sup>th</sup> May 2016.**

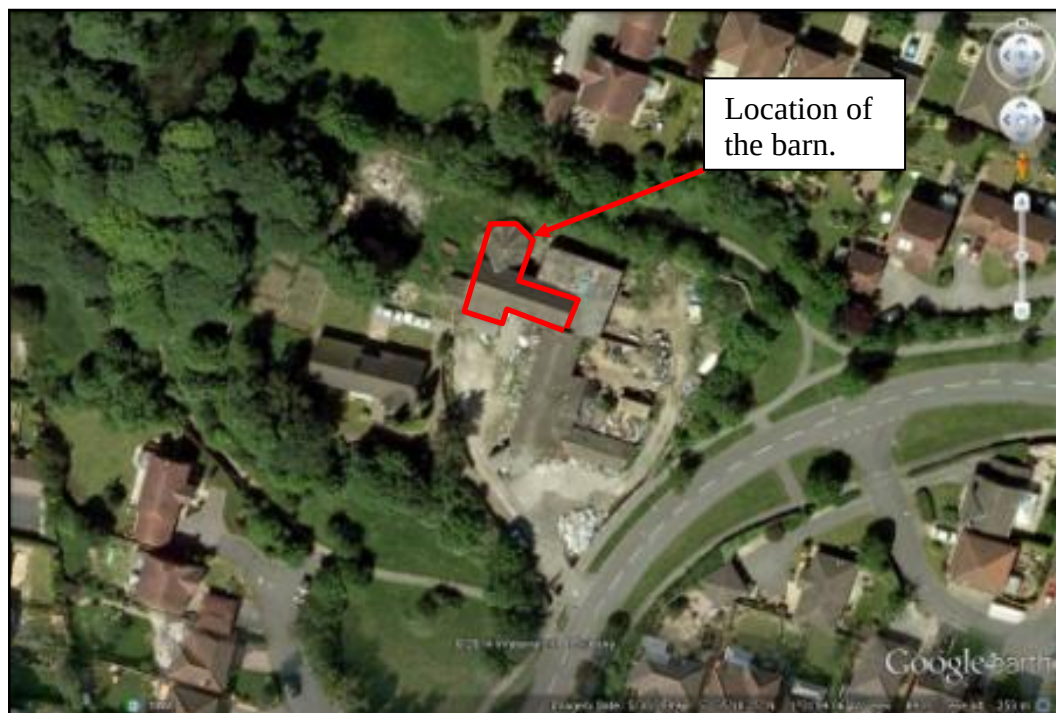
3.2.3. An aerial photograph is provided below which shows the location of the surveyed building and the direct surrounding area.

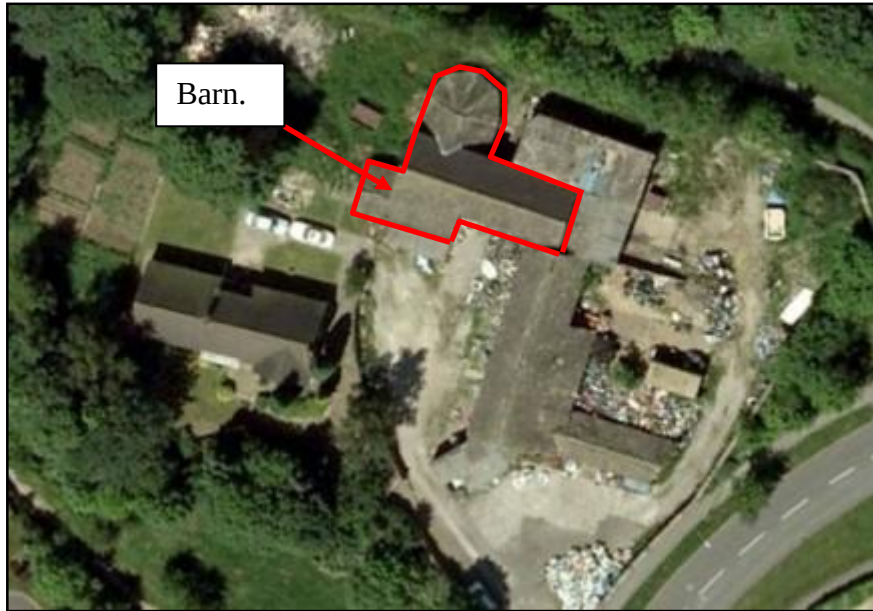
3.3.1. The aerial photograph below shows location of the Barn.

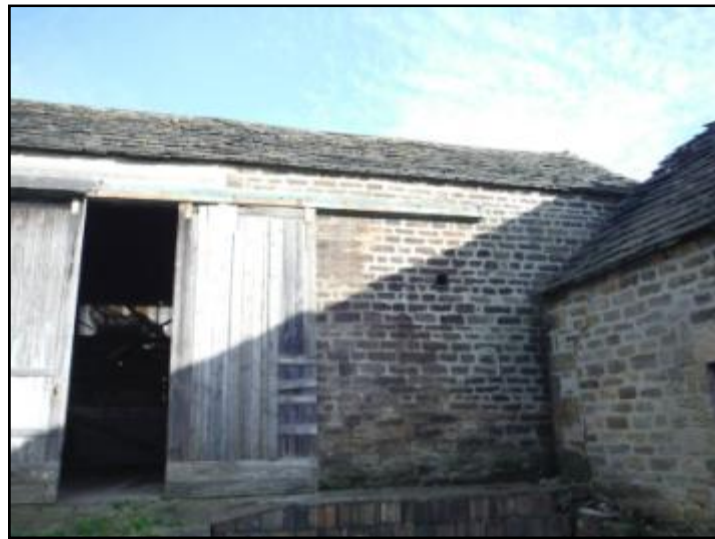
3.3.2. The Barn is a two storey stone structure with a pitched roof. The dressed stone walls are well pointed with some shallow mortar loss.

3.3.3. The roof of the building is pitched and covered with stone roof tiles on the southern elevation and blue slate on the northern elevation. The roof is generally in a good state of repair. However, there are some areas where the stone roof tiles have slipped. Due to the nature of the stone roof tiles there are gaps between the roof tiles which will provide access for bats.

3.3.7. The photograph below shows the southern elevation of the Barn.

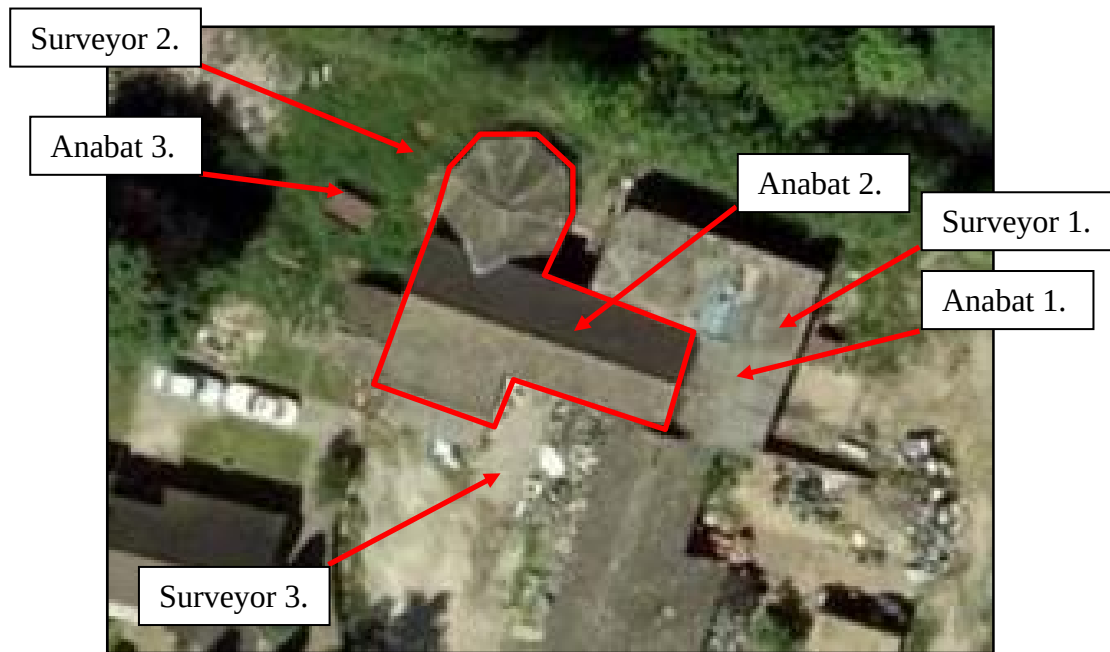
3.4.3. The three surveyors were positioned in suitable places around the site. The aerial photograph above shows the positions where the surveyor and the Anabat recorder are located.

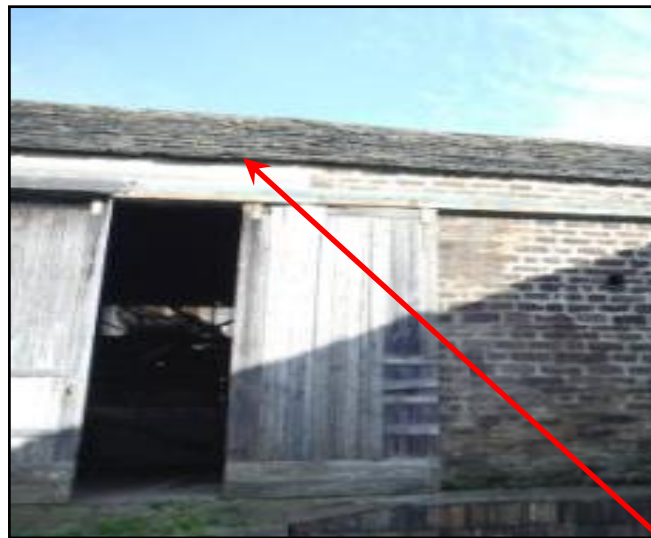
21:09 – A bat was identified emerging from the eaves above the double doors.

3.4.6.4 The photograph below shows the location Surveyor 3 identified a Common Pipistrelle bat emerged from above the double doors at 21:09.

4.2. During the dusk emergence survey three surveyors were positioned in three places around the site and they identified bat activity between 21:09 and 21:42. At 21:09 a Common Pipistrelle bat was identified emerging from the southern elevation of the building above the double doors by Surveyor 3.

5.1. As the bat roost identified during the dusk emergence survey is proven to be an occasionally used Common Pipistrelle day roost used by small small numbers of Common Pipistrelle bats. It is recommended that the proposed works to the roof of building are covered by a Natural England Bat Low Impact Class Licence.

5.2. This licence should be obtained prior to any works commencing on the roof or the walls surrounding this area of the building.

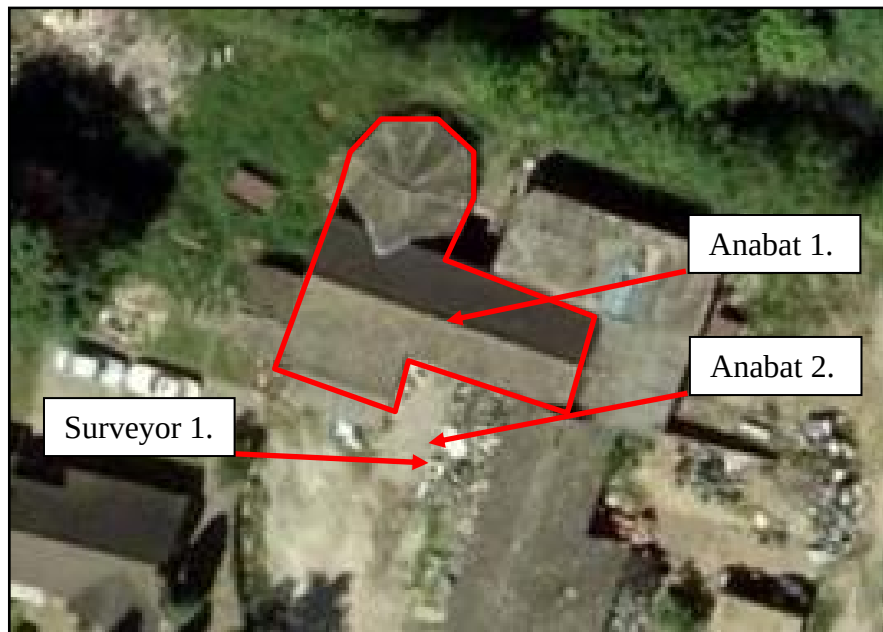
3.5.3. The surveyor was positioned to the south of the building. The aerial photograph above shows the positions where the surveyor and the Anabat recorders were located.
