# Preliminary Ecological Appraisal

BE-584.1

Knabbs Hall Farm

| <b>Report title</b> | Preliminary Ecological Appraisal |

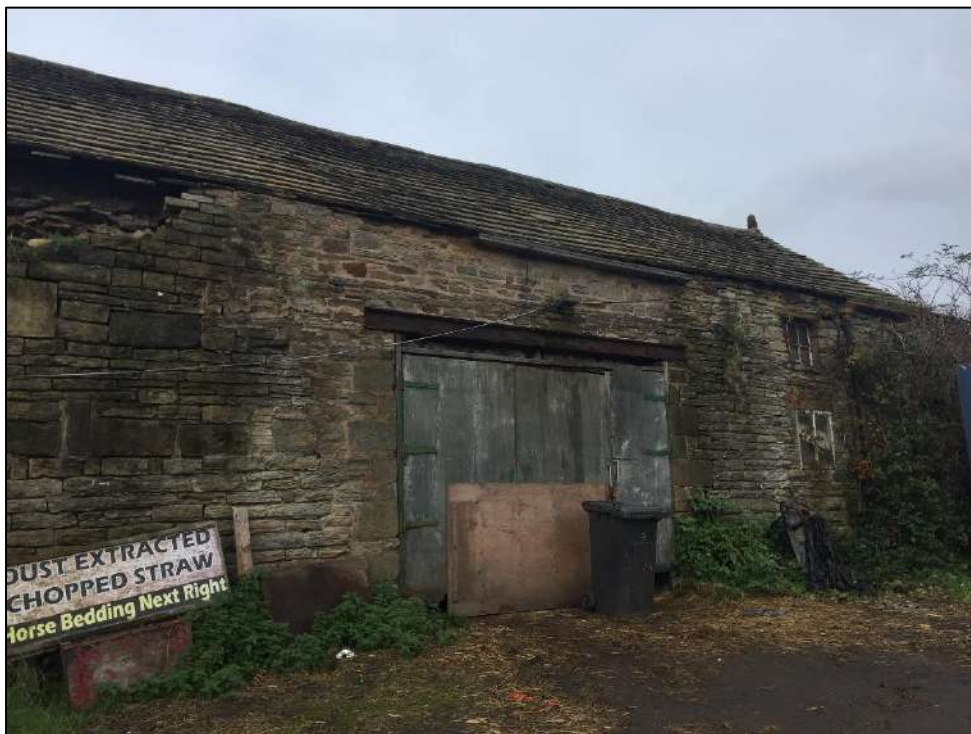
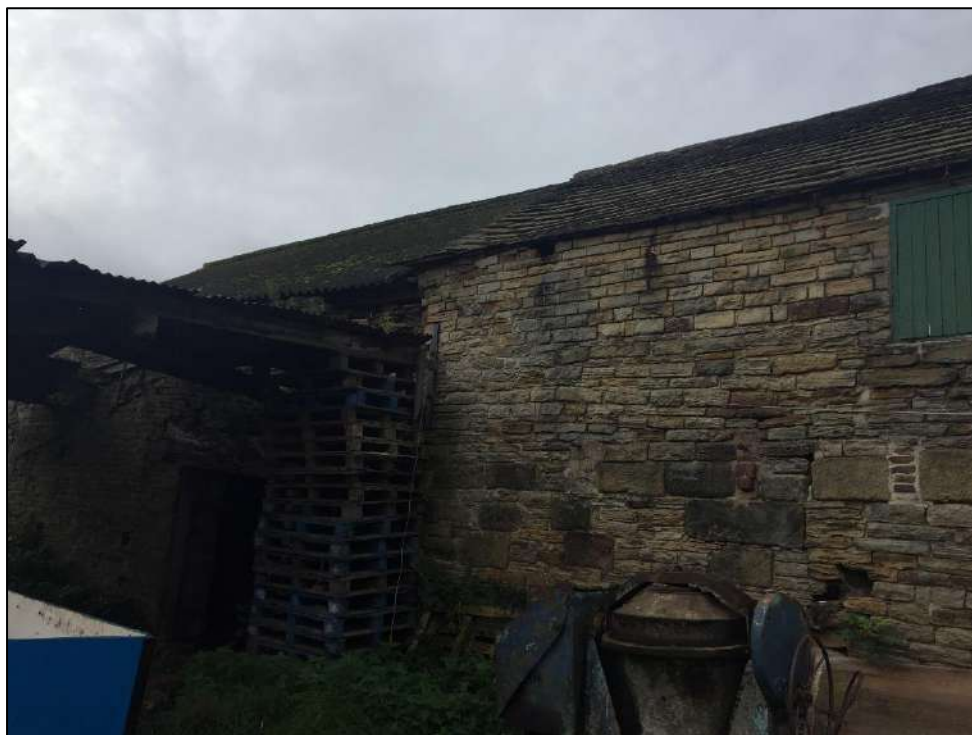
*Plate 1: East aspect of building 1*

*Plate 2: East aspect of building 1*

| Building number | Description | Bat roost trigger index score |
|---|---|---|
| Building 1 | <p>A large single-storey barn located in the centre of the site. The barn was of stone construction and was divided into two sections with the south section being in worse condition. The main section of the barn had a pitched English slate tile roof, several lifted tiles and gaps under the ridge tiles were observed. The south section had a pitched corrugated metal roof. The exterior stonework had numerous cracks and gaps particularly on the south section. There were numerous ventilation slits in the north and south gables. A lean-to with a corrugated roof was adjoined to the east aspect of the south section. This had open sides and no features suitable for roosting bats. The interior of the barn open to the roof.</p> <p>The interior of the building was also divided into two sections. The south section roof was supported by large purlins. Numerous cracks were observed and the ventilation slits on the south gable and two doors on the east and west aspects provided access into the building. It was divided from the main section of the barn by plastic sheeting. The main barn interior had a queen strut roof construction and the roof was unlined. Several gaps under lifted tiles were observed.</p> <p>A swallow nest <i>Hirundo rustica</i> with a large aggregate of old droppings was observed in the south section of the barn.</p> | 0.60 (low) |

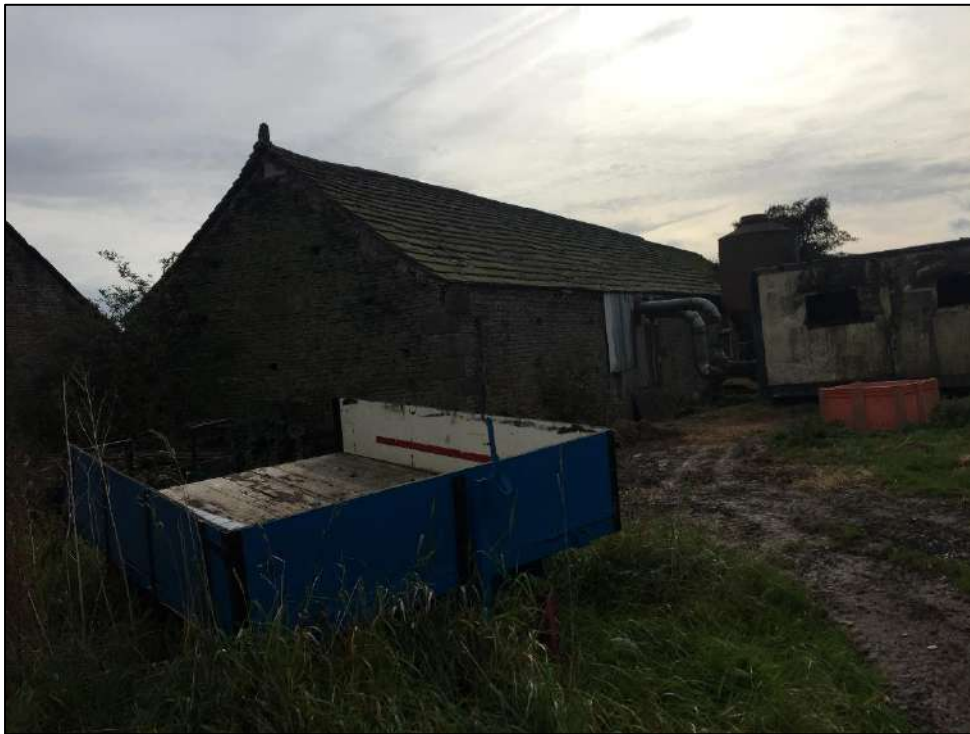
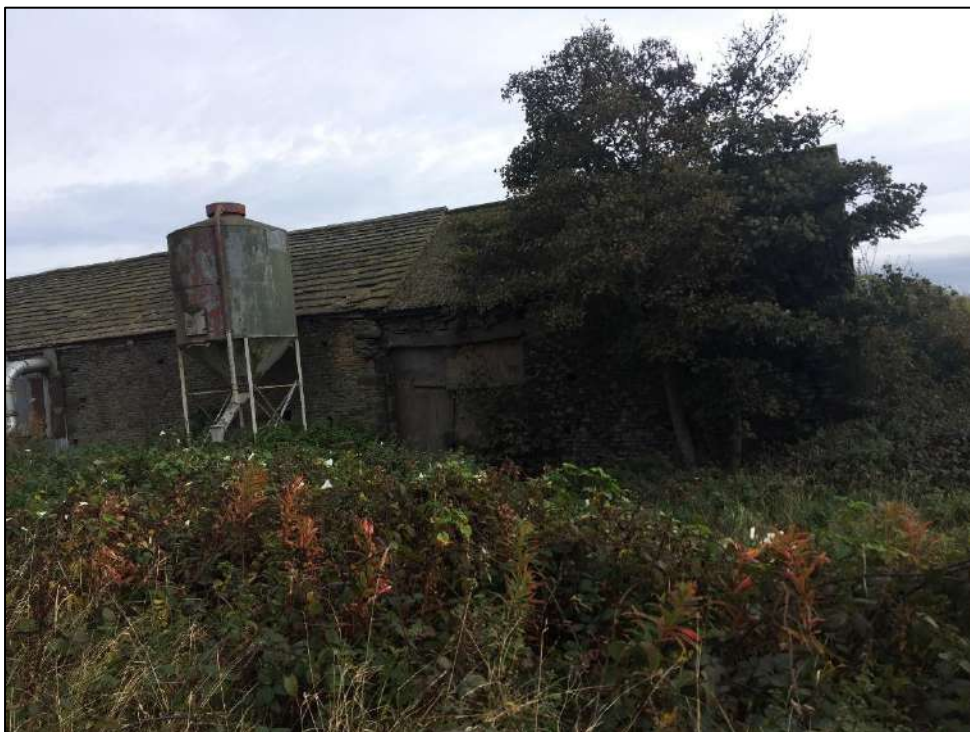
*Plate 3: West aspect of building 1*

*Plate 4: West aspect of building 1*

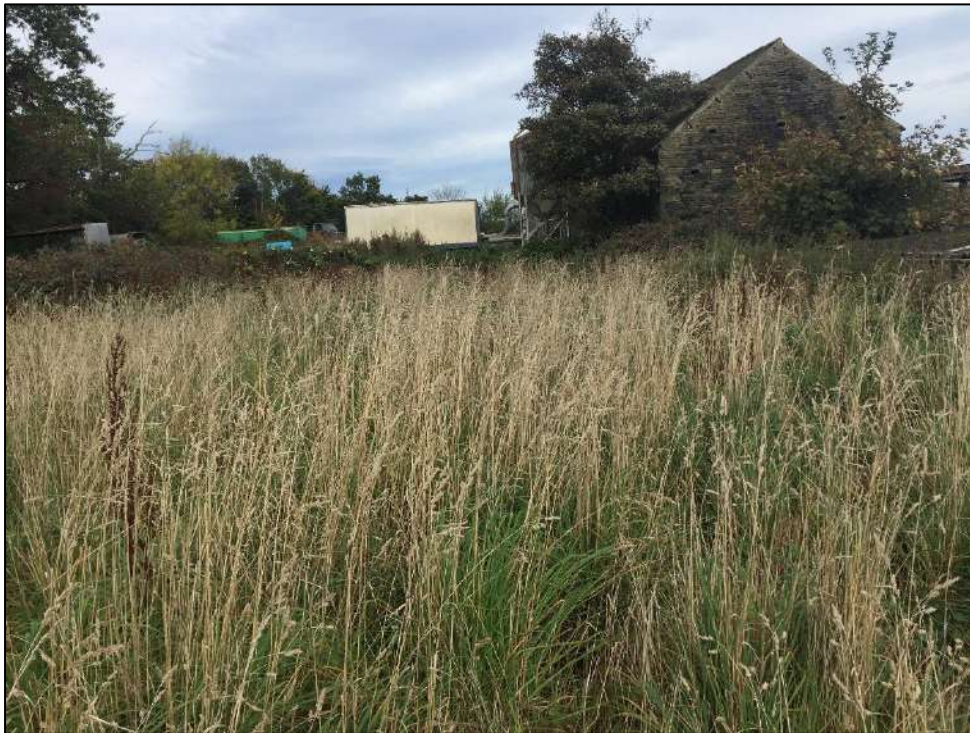
*Plate 5: South gable of building 1 and improved grassland on site*

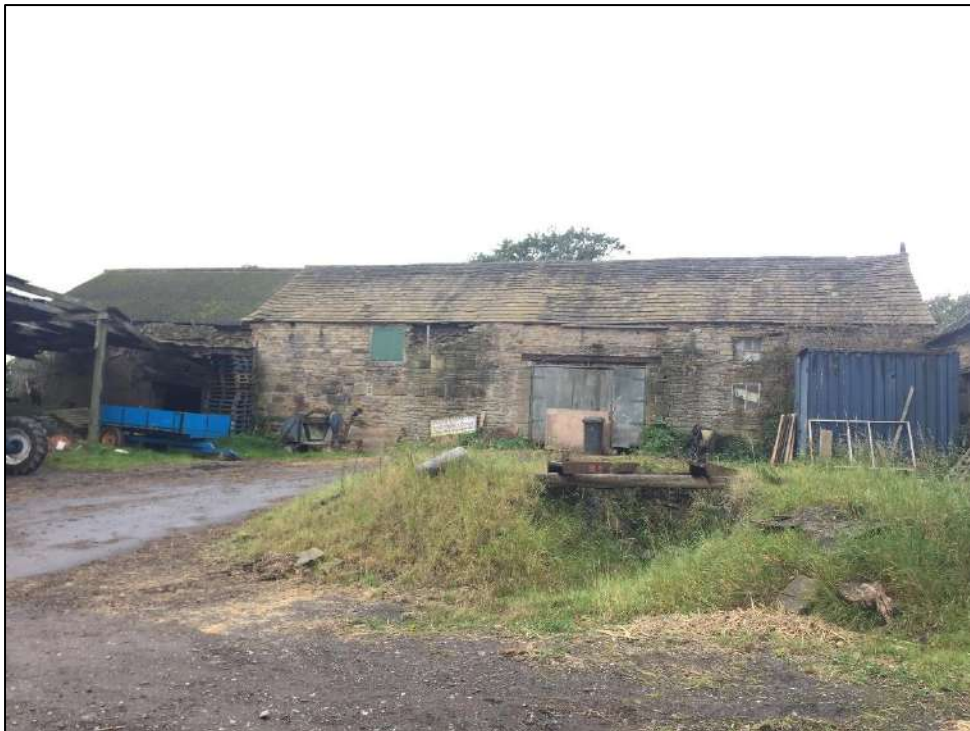
*Plate 6: East aspect of building 1 and adjacent hard standing and ephemeral vegetation*

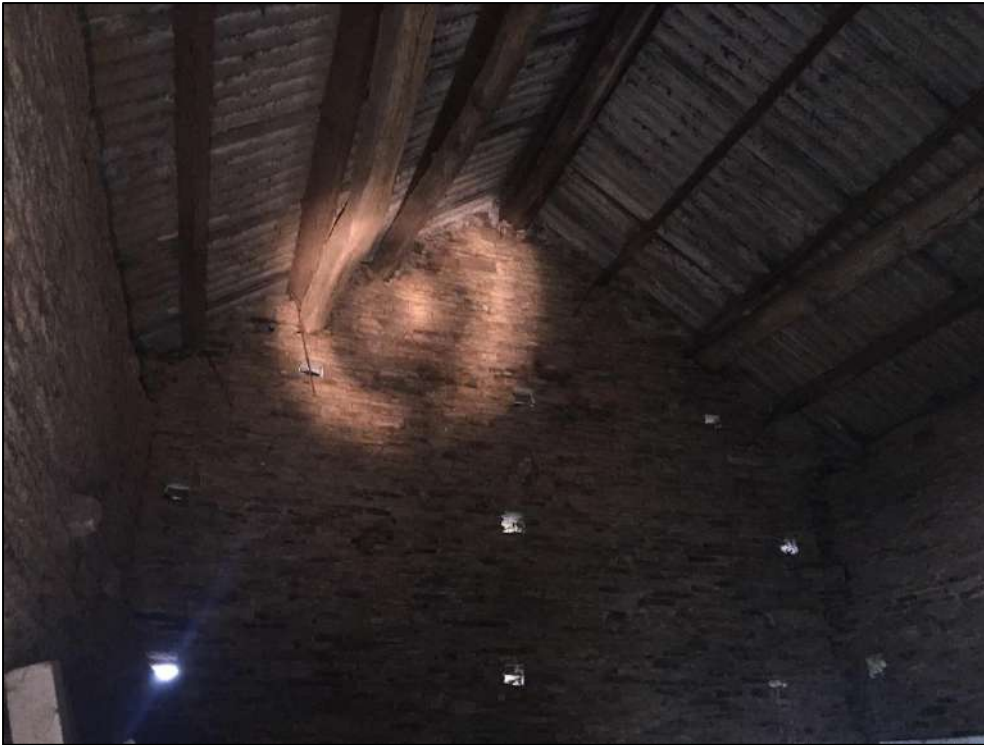
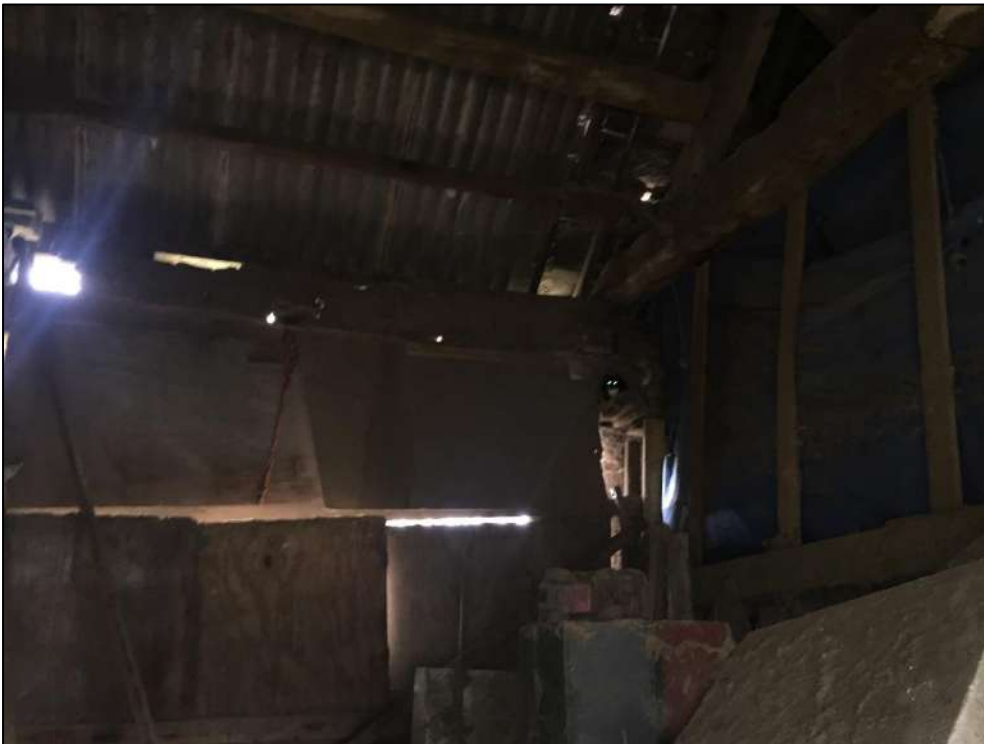
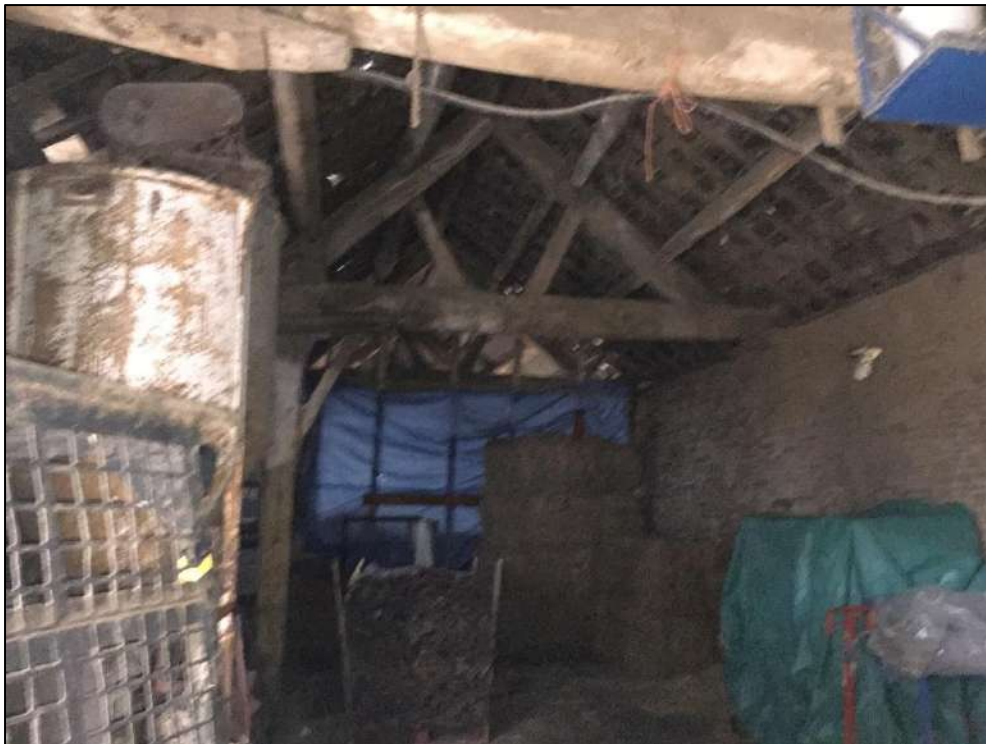
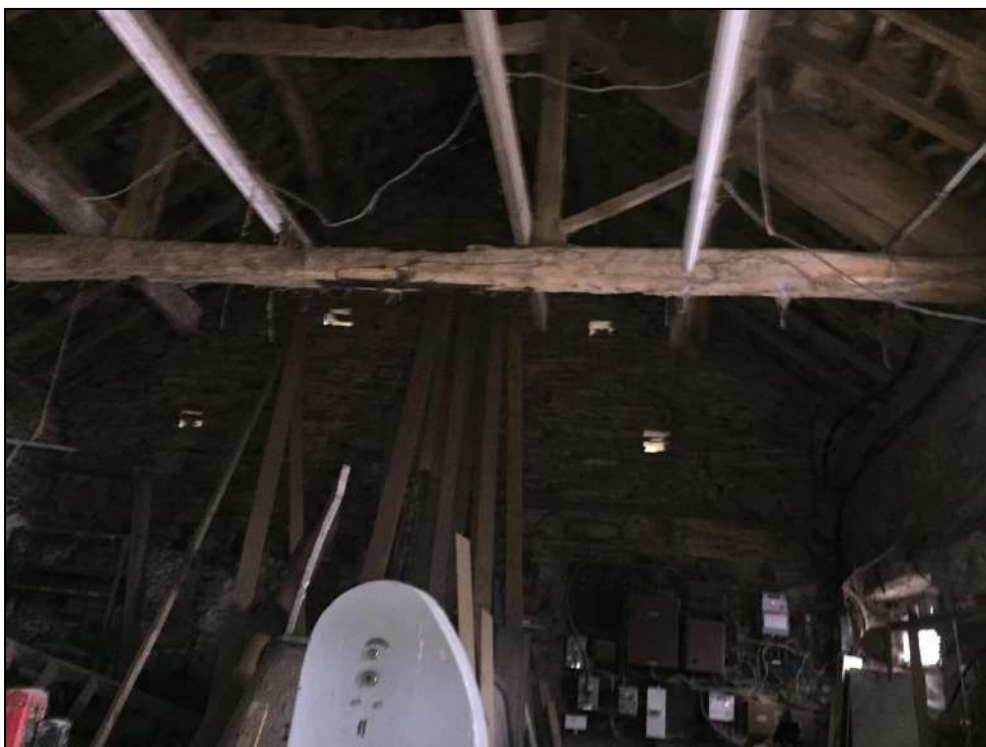
*Plate 7: Interior of building 1*

*Plate 8: Interior of building 1*

*Plate 11: Interior of building 1*

*Plate 12: Interior of building 1*

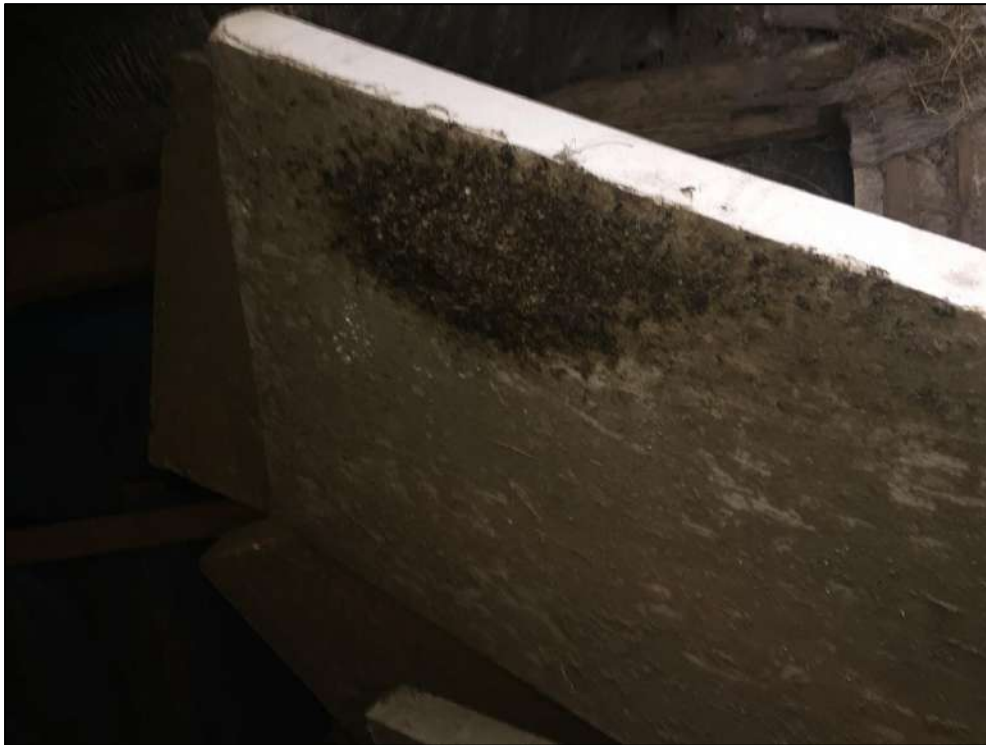
4.7.2. The trees on site provide suitable habitat for nesting birds. Evidence of nesting swallows *Hirundo rustica* was observed within building 1.

*Plate 9: Aggregate of swallow droppings in building 1*

The trees on site provide suitable habitat for nesting birds and evidence of swallows *Hirundo rustica* previously nesting in building 1 was observed. It is recommended that no works are carried out to the trees or building 1 within bird nesting season (1<sup>st</sup> March – 31<sup>st</sup> August), unless a further survey can confirm that the nests are no longer occupied.

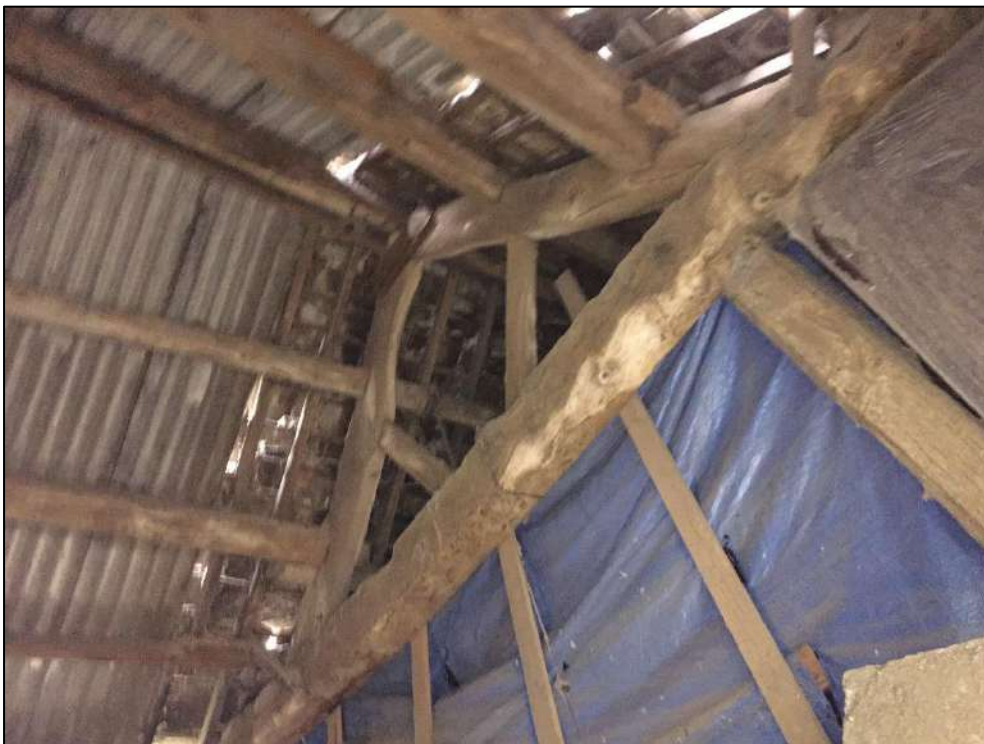
*Plate 10: Detail of interior roof of building 1*

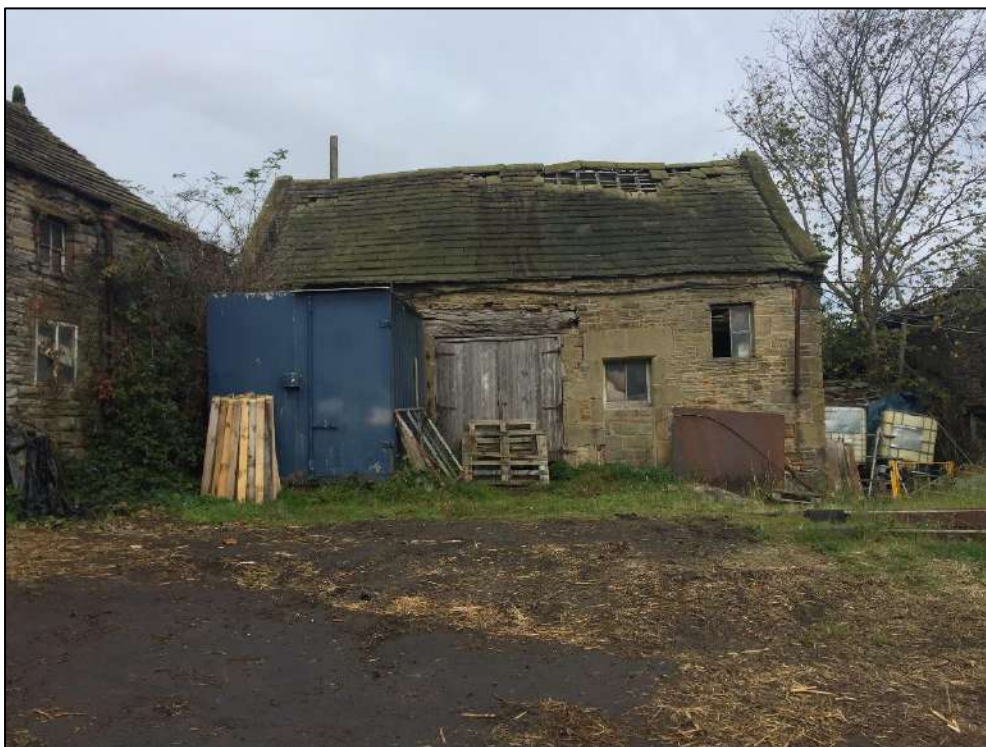
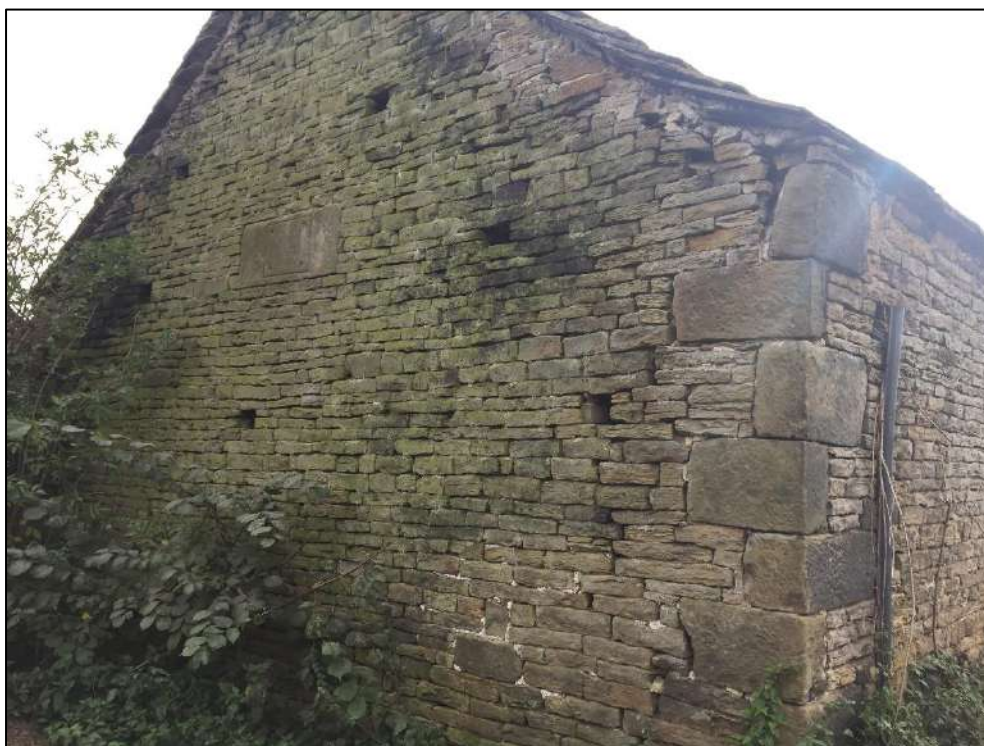
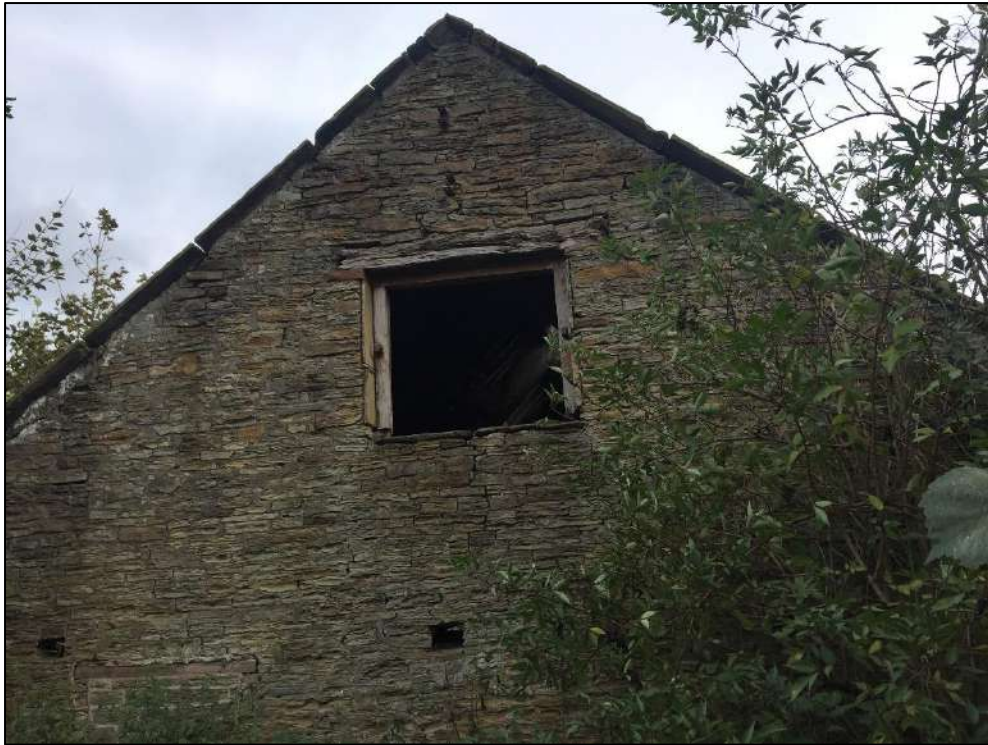
*Plate 13: South aspect of building 2*

*Plate 14: Northwest aspect of building 2*

*Plate 15: West aspect of building 2*

| Building number | Description | Bat roost trigger index score |
|---|---|---|
| Building 2 | <p>A two-storey barn located towards the north of the site. It was of stone construction with a pitched English slate tile roof. There was a large hole at the top of the roof. The stonework was on good condition however some cracks were observed on the west gable along with a large pigeon hole into the second storey. There was a large wooden lintel above the door on the south aspect which also contained numerous cracks.</p> <p>The interior of the building was plastered and no gaps or cracks were observed in the walls. There were numerous holes in the wooden floor of the second-storey. There was no roof void and the roof was unlined. The upper floor gables contained numerous gaps and cracks. No signs of bats were observed within the building.</p> | 0.60 (low) |

- 6.1.1. As buildings 1 and 2 are considered to have low potential for roosting bats, in accordance with Collins (2016) recommendations, one further survey will be required to determine presence or absence of bats. This should consist of a dusk emergence survey, carried out in suitable weather conditions, between May and August 2018.

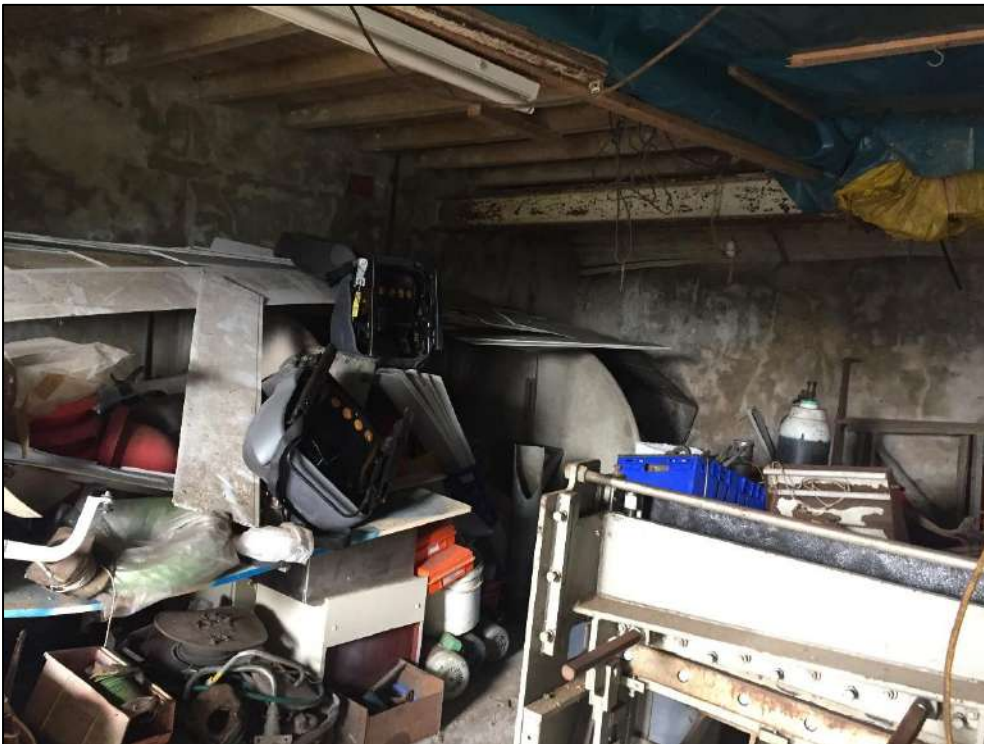
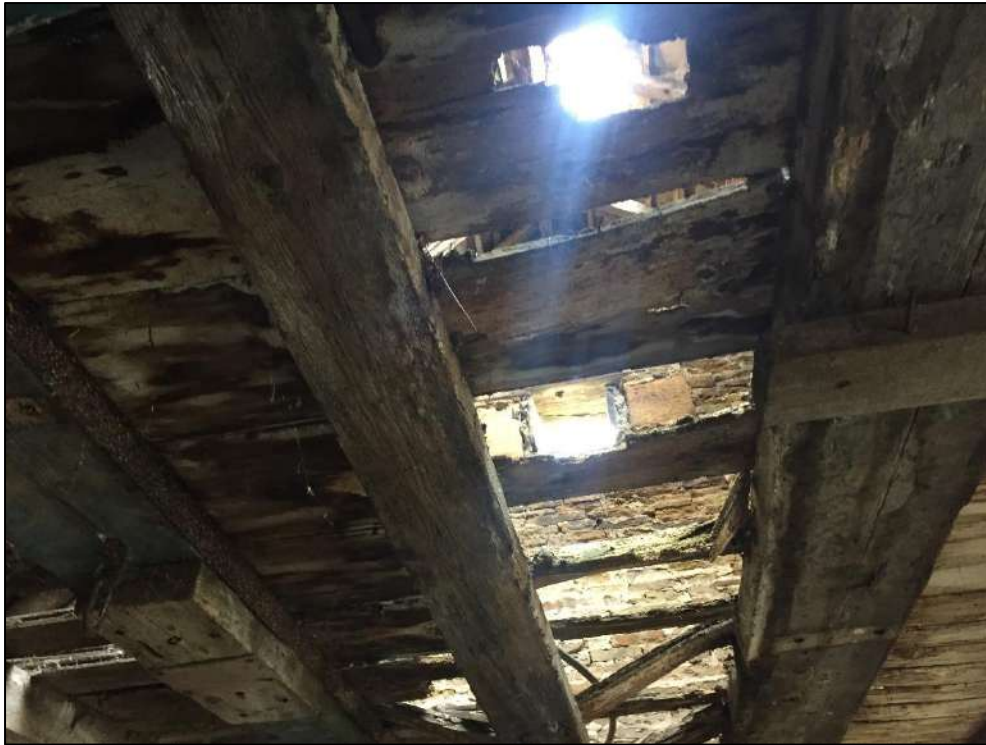
*Plate 16: Interior of building 2*

*Plate 17: Detail of ceiling in building 2*

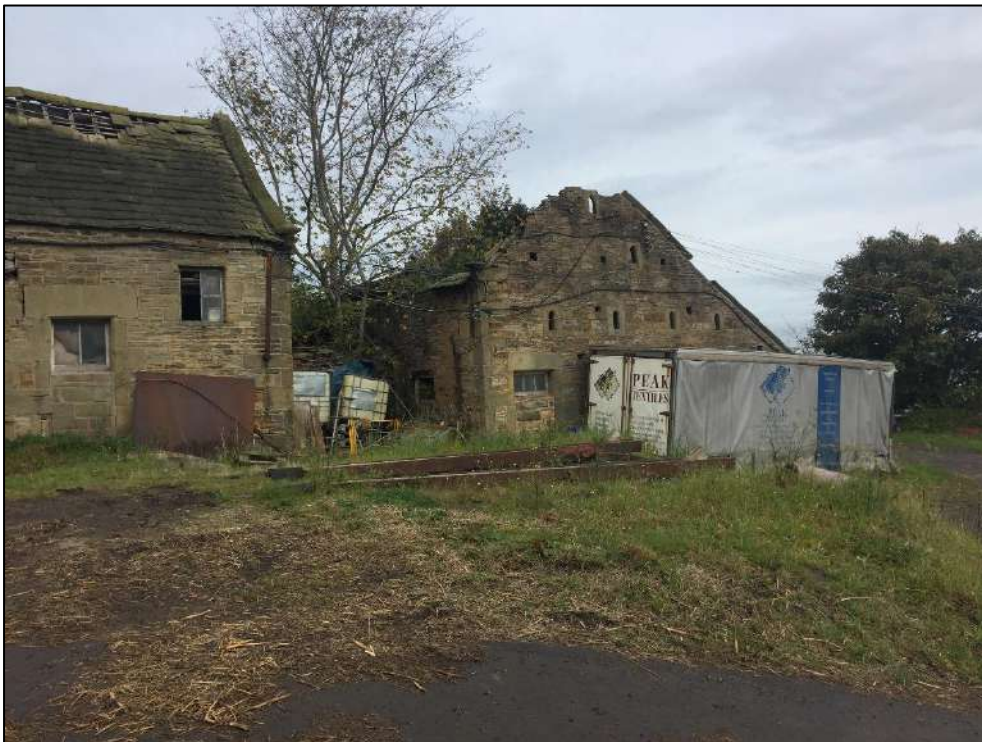
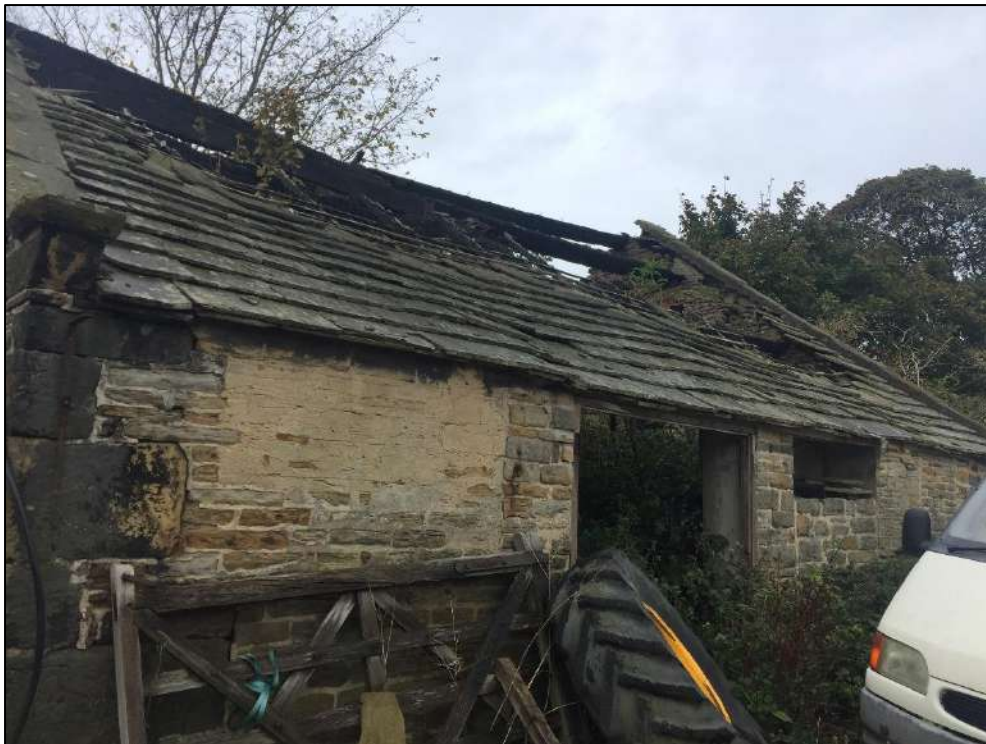
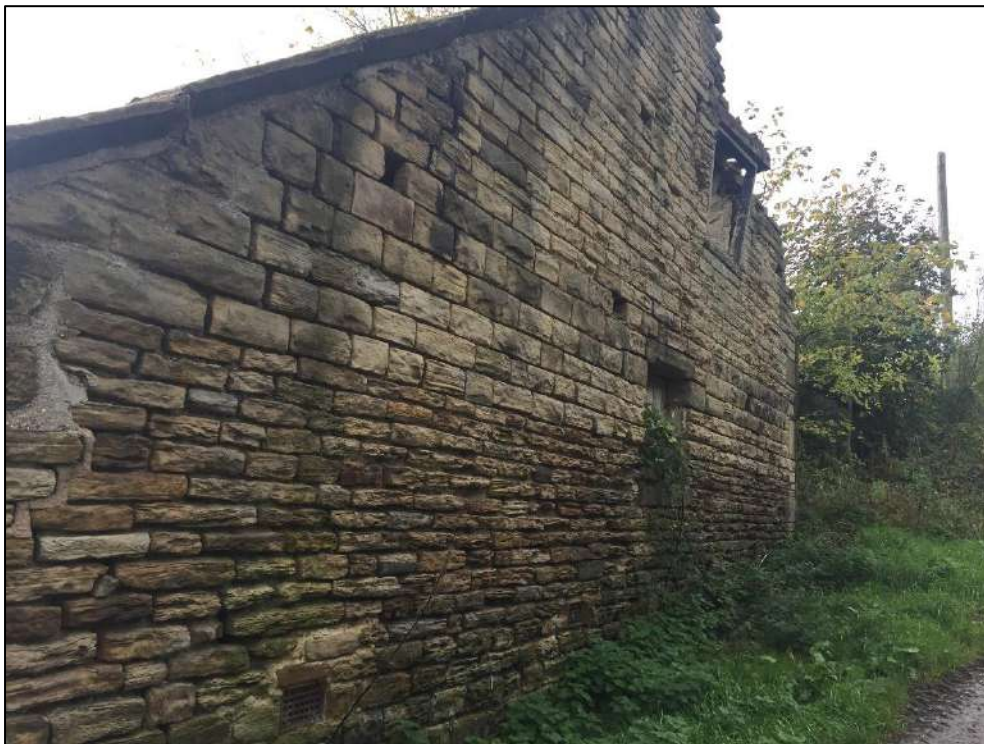
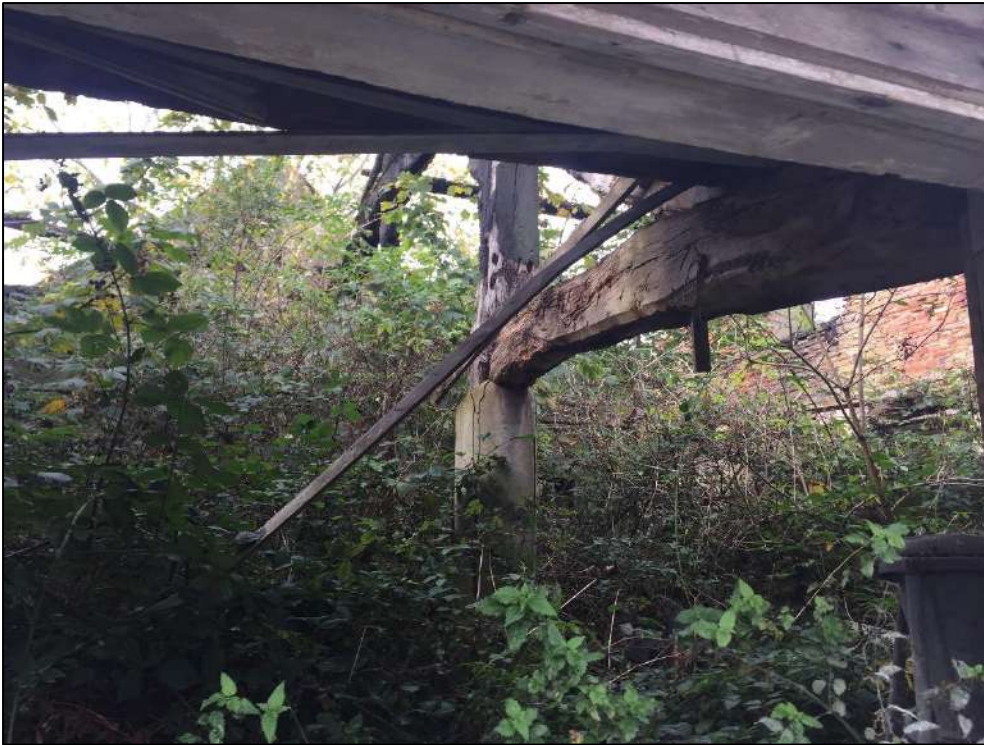
*Plate 18: South aspect of building 3*

*Plate 19: East aspect of building 3*

*Plate 20: North aspect of building 3*

*Plate 21: Interior of building 3*

| Building number | Description | Bat roost trigger index score |
|---|---|---|
| Building 3 | <p>A small stone building with a pitched English slate tile roof located towards the northeast of the site. The building was a ruin with a collapsed roof which had suffered from fire damage. The exterior stonework of the building was in good condition. The interior of the building was exposed due to the collapsed roof and thick brambles were found within. No features suitable for roosting bats were observed.</p> | 0.49<br>(negligible) |

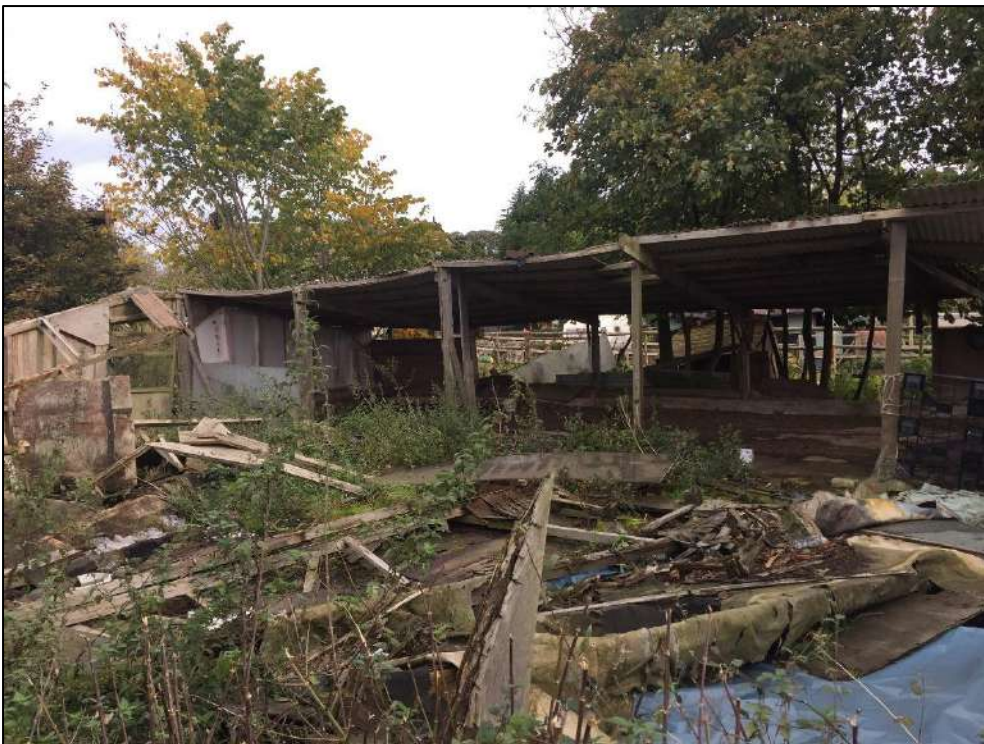
| Building number | Description | Bat roost trigger index score |
|---|---|---|
| Building 4 | <p>A disused corrugated metal shelter was located at the south of the site. This showed evidence of being previously used a kennel. The building was open sided with no roof void and no features suitable for roosting bats.</p> | 0.45<br>(negligible) |

*Plate 22: Building 4*

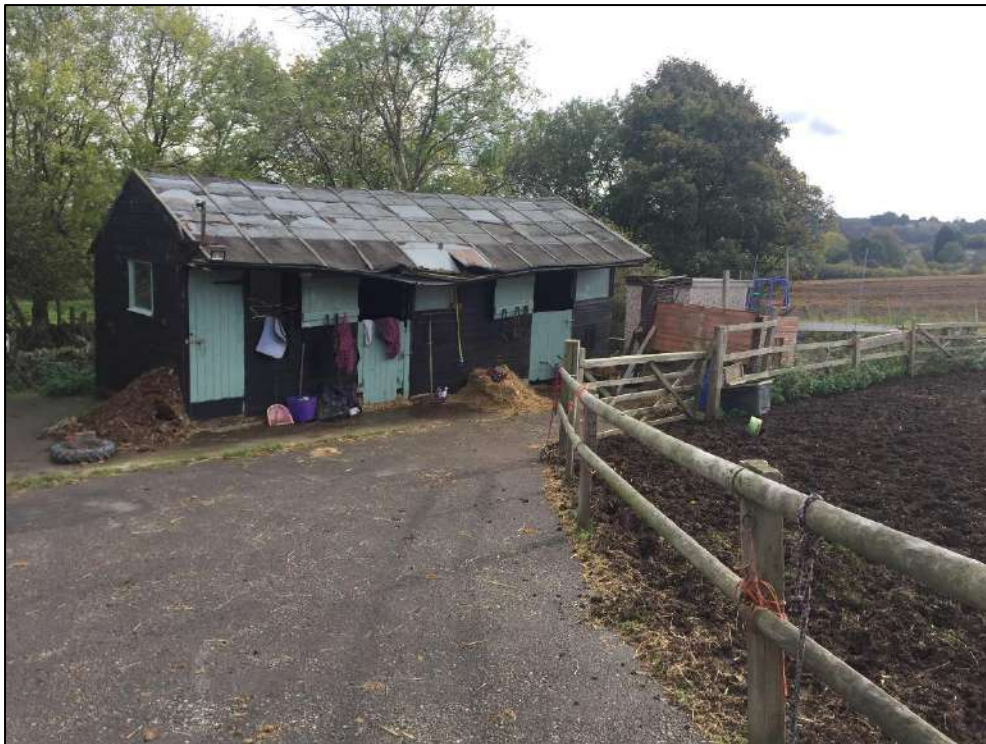
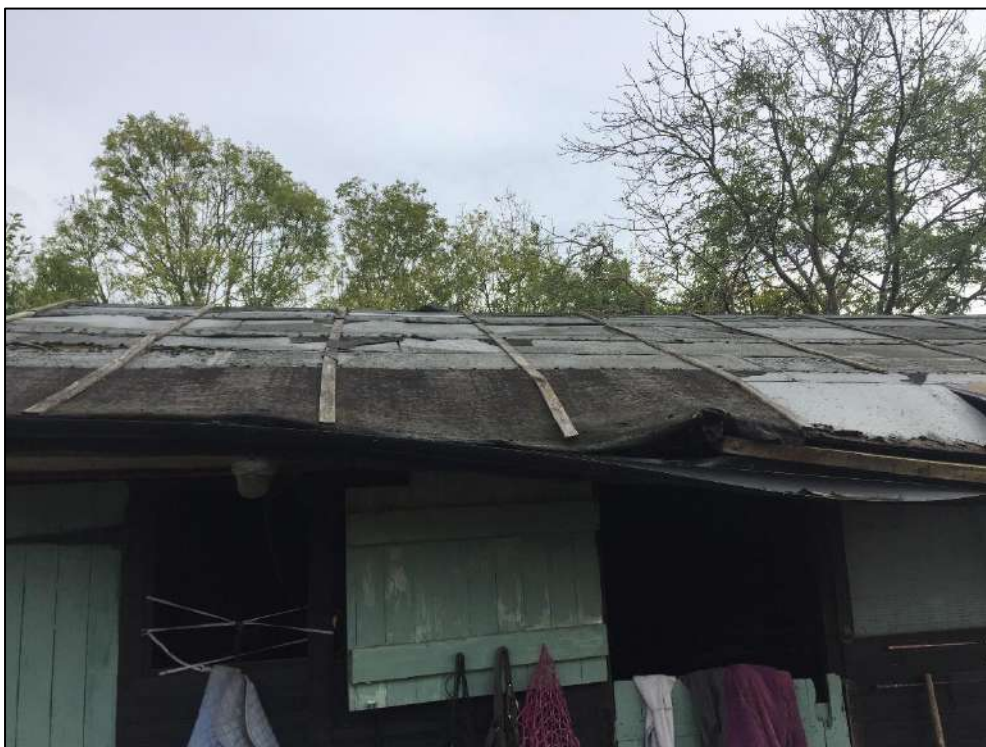
| Building number | Description | Bat roost trigger index score |
|---|---|---|
| Building 5 | <p>A stable block towards the east of the site which was divided into three stables. It had a pitched felt roof and a wooden exterior. The interior of the building had no separate roof void and no features suitable for roosting bats.</p> | 0.48<br>(negligible) |

*Plate 23: Building 5*

*Plate 24: Detail of the roof of building 5*

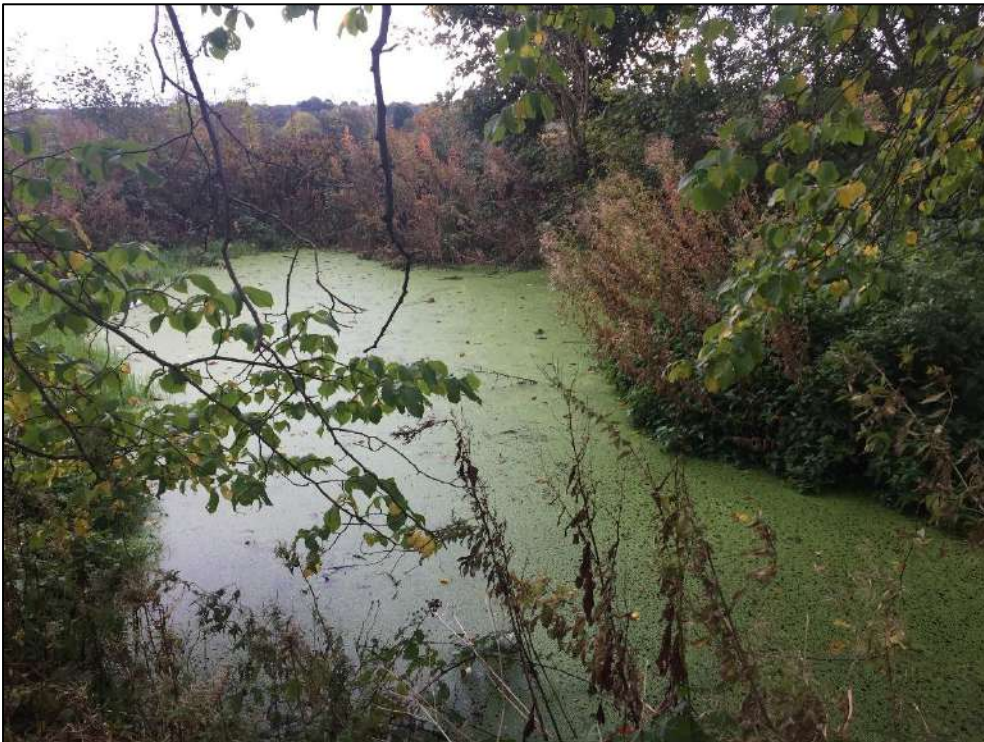
4.6.4. A search on aerial imagery (Google Earth Pro, 2017) revealed one pond within 100m of the site, located 60m southeast of the site. An assessment using the HSI found the pond to provide average habitat for great crested newts, indicating a 55% chance of great crested newts being present.

*Plate 28: Pond adjacent to the site*

- 6.1.4. To determine the presence or absence of great crested newts within the pond located 60m from the site it is recommended further surveys are undertaken. This should consist of a single Environmental DNA (eDNA) test between 15<sup>th</sup> April and 30<sup>th</sup> June, to establish presence or likely absence. Alternatively this may also be established by carrying out four surveys between mid-March and mid-June using three methods, preferably bottle-trapping, egg searching and torch surveying.
