INITIAL BAT SURVEY

SHEFFIELD ROAD, PENISTONE

A Report to The Co-Operative Group

Report Number: RT-MME-113193-02

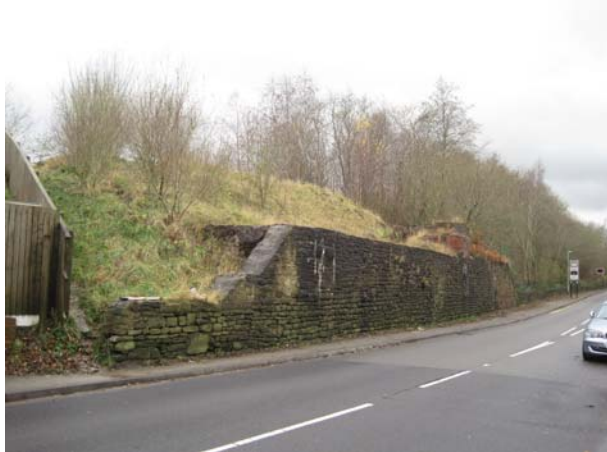
The site contained two walls; one stone wall which was located parallel to the northern boundary and one dilapidated brick wall located on the western boundary. The retaining stone wall on the northern boundary measured approximately 2 m in height and contained several areas of missing mortar and gaps (Plates 3.1 and 3.2). The gaps could be fully inspected with an endoscope and no evidence of bat activity (e.g. droppings, scratch marks, feeding remains or bats) was recorded in or around these features.

Plate 3.1: View of Stone Wall

The assessment of the stone wall identified the presence of features considered to have moderate roosting potential for bats. The features identified which bats could utilise include the areas of degraded mortar providing gaps between the stone work. No evidence of bats was found at the time of survey, but there is potential for these features to be colonised in the future.

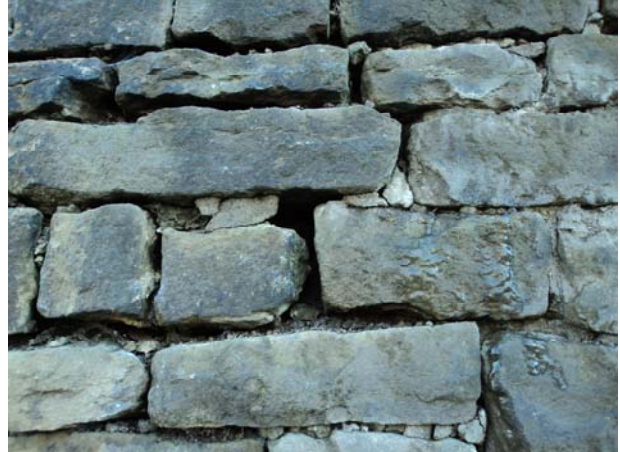
Plate 3.2: Example of missing mortar

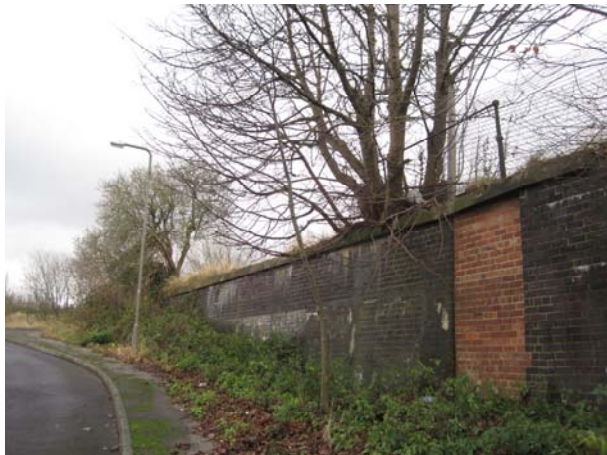
The brick wall located on the western boundary was mostly in good condition (Plate 3.3) with the exception of a short section at the southern end which was dilapidated with many areas of missing mortar (Plate 3.4). The gaps were inspected and found to be open to the elements making them largely unsuitable for roosting sites. No evidence of bat activity (e.g. droppings, scratch marks, staining, feeding remains or bats) was recorded.

Plate 3.3: View of brick wall in good condition

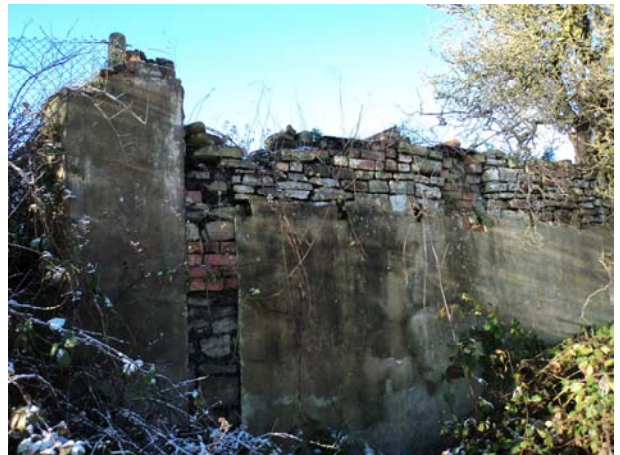
Plate 3.4: Dilapidated section of brick wall

The assessment of the brick wall identified a short section where the brick work and mortar were degraded. This was considered to have negligible potential for use by roosting bats.
