**CARR HOUSE, ROYD LANE,  
THURLSTONE.**

**BAT SURVEY.**

**Ref No:- 161111 (Rev 1).**

**Date: 8<sup>th</sup> May 2017.**

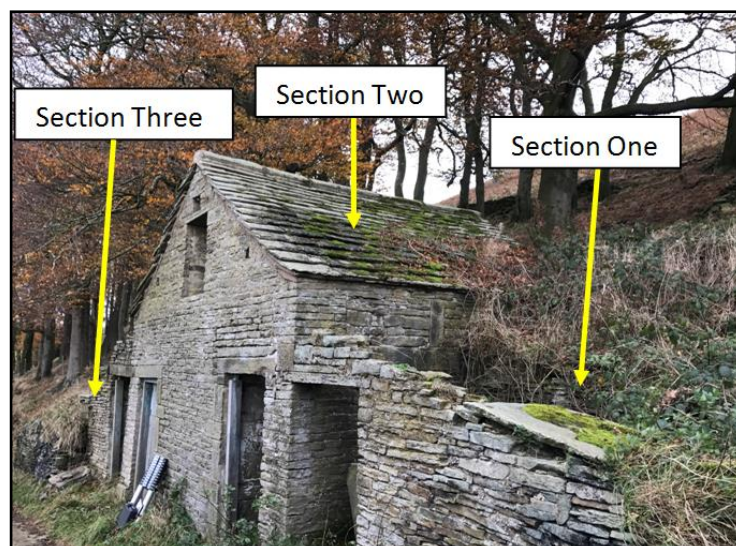
3.2.1.1. The plan below shows different sections of the surveyed building.

3.2.2. Section One is located on the eastern side of the surveyed area. Section One includes solid stone walls approximately 1m in height. This section of the building has no roof and the existing walls are in poor condition and covered in dense bramble and grasses.

3.2.3. Section Two is attached to Section One and Three by solid stone walls. Section Two is constructed from solid stone walls and a pitched stone slate roof.

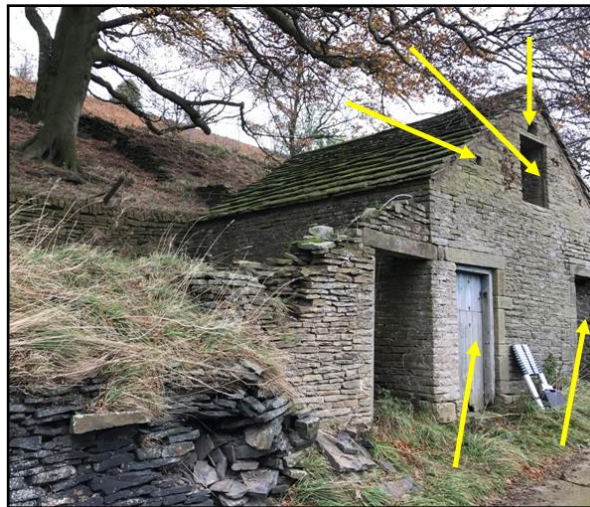
3.2.4. A number of gaps which allow access into the interior of the building are located within the northern and southern walls of Section Two. Two doors allowing access into the building are located on the southern side of the building. One of the doors includes a wooden door and the other door does not include a door structure or a door frame.

3.2.4.1. The yellow arrows on the plan below show the gaps allowing access into the interior of Section Two of the building.

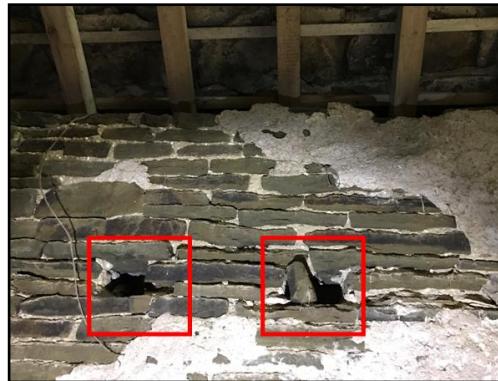
3.2.5. A number of large cracks and voids are located within both the exterior and interior side of the stone walls of Section Two of the building.

3.2.5.1. The photograph below shows some of the identified gaps and voids.

3.3.2. Section Two of the surveyed building contains a number of voids and cracks within the exterior and interior sides of the stone walls. The voids and cracks provide

suitable habitat for individual or low numbers of crevice dwelling bats although no bats or bat field signs were identified during this survey; therefore, the building has been assessed as providing low potential for roosting bats in line the Bat Conservation Trust guidelines.

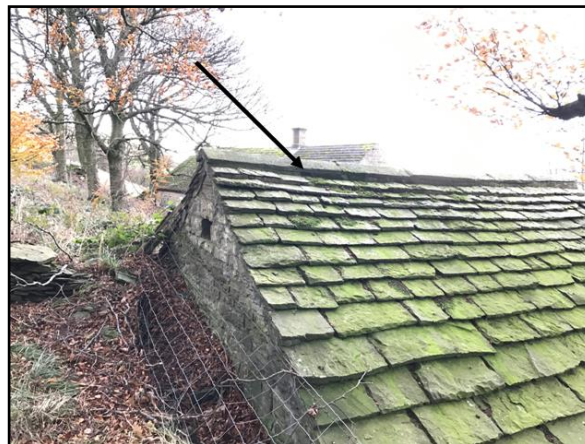
3.2.6. The exterior side of Section Two's roof includes stone slates and stone ridge tiles. The gable ends include bare stone slates and there are no fascias or guttering. The roof is in good condition with the only visible gap allowing access inside the building located underneath the ridge tile on the western side of the roof.

3.2.6.1. The photograph below shows the gap within western side of the ridge tiles.

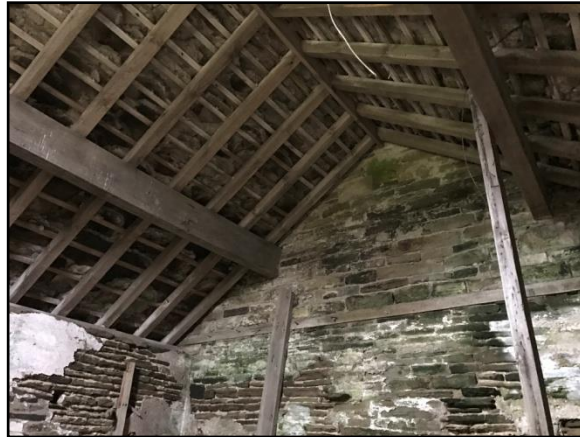
3.2.7. The roof of Section Two is supported by timber rafters, timber tie beam and two large timber joists. The roof also includes bare stone slates which are unlined.

3.2.7.1. The photograph below shows the underside of the roof.

3.3.3. The gaps between the stone slates also provide suitable habitat for individual roosting bats. No bat field signs were identified along the outside or underside of the roof during this survey and the roof is unlined; therefore, the roof is only potentially suitable for low or individual numbers of bats.

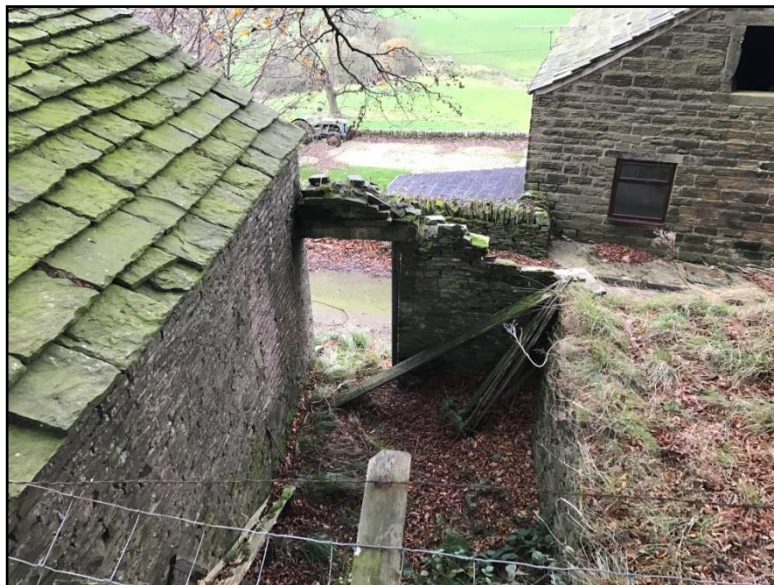
3.2.8. Section Three is located on the western side of the surveyed area. Section Three includes solid stone walls approximately 1.5m in height. This section of the building has no roof and the existing walls are in poor condition and very exposed due to the location of the building within the surrounding landscape.

3.2.8.1. The photograph below shows Section 3 of the Building.

3.3.1. Sections One and Three of the surveyed building have partly collapsed walls and no roof; therefore, these sections of the building have been assessed as unsuitable for roosting bats.

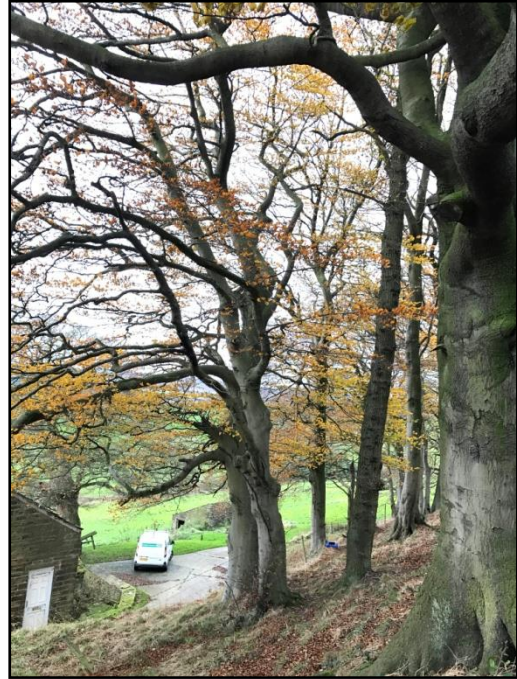
3.2.9. Mature beech trees are located approximately 6m north of building causing a number of large branches to overhang the surveyed building.

3.2.9.1. The adjacent photograph shows the mature beech trees.

3.3.4. A number of large mature beech trees are located approximately 6m north of the surveyed building. A thorough inspection of the beech trees could not be achieved from ground level although they are likely to contain cracks and voids suitable for roosting bats due the trees size and age. No cracks or voids suitable for roosting bats were identified within branches overhanging the surveyed building.

4.8. If any mature beech trees are to be felled during the works there will be potential impact on roosting bats. If the works do not involve felling but include removing the branches overhanging the surveyed building, there will be no potential impact on roosting bats.

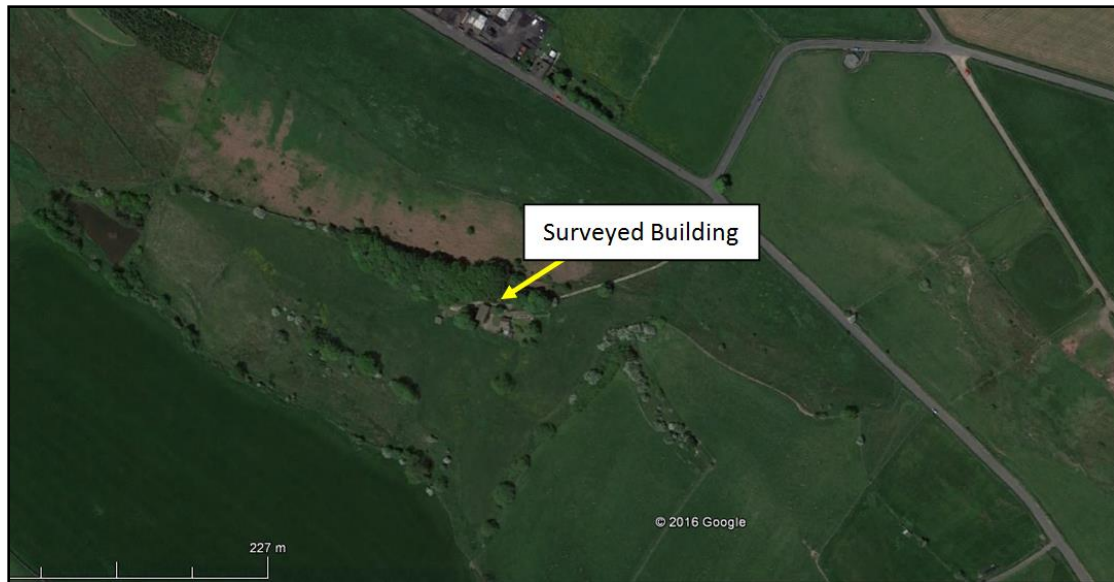
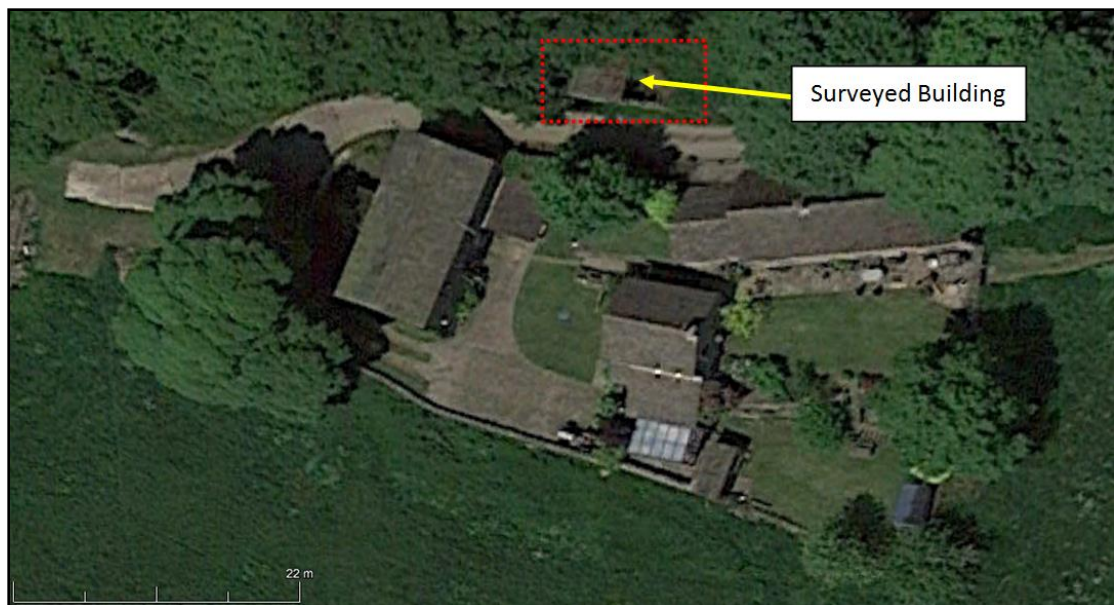
3.2.10. The surveyed building is located within an exposed area of farmland on top of a south facing hillside. The surrounding landscape includes a small area of beech woodland, open pasture farmland and scattered stone farm buildings.

3.2.10.1. The aerial plans below show the surveyed area.

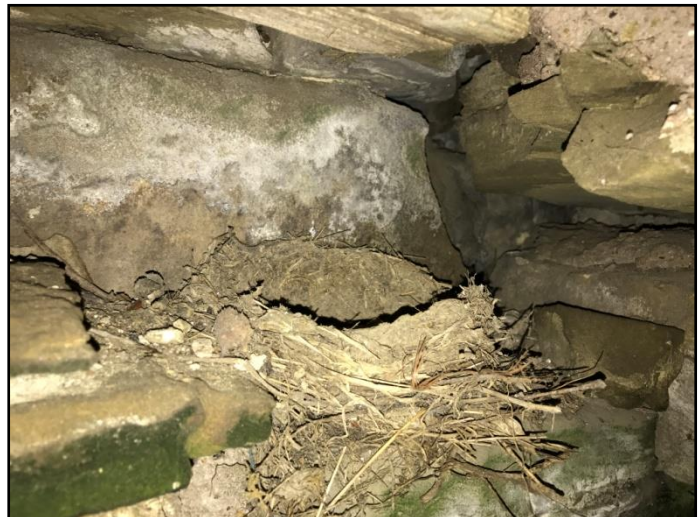
3.3.5. The surveyed building provides suitable habitat for nesting birds during the nesting bird season which extends between March and September each year. A number of old swallow nests and other bird nests likely to be pigeon are located within the interior of the building along the timber rafters and ledges on top of the stone walls.

3.3.5.1. The adjacent photograph shows one of the identified bird nests located within the building.

5.3. It is recommended any works undertaken on the building and vegetation are carried outside the nesting bird season which extends between March and September each year.

5.4. If works are to be undertaken during the nesting bird season it is recommended a nesting bird survey is undertaken prior to works by an experienced ecologist. Any active bird nests must remain undisturbed until the young have fully fledged the nest.

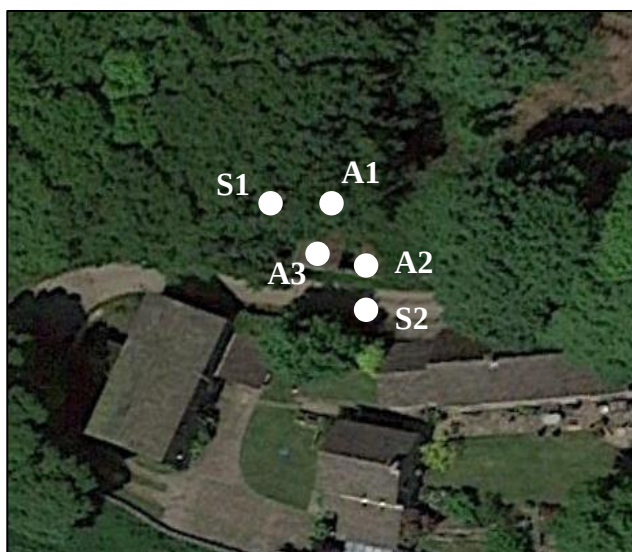
3.4.3. Surveyor 1 was equipped with an Anabat Walkabout bat detector, and Surveyor 2 with a BatBox Duet. Three static Anabat SD1/2 bat detectors were also used around the site. The location of the surveyors and static anabats can be seen on the map below where S = Surveyor, A = Anabat.

3.4.10. No bats were seen to emerge from the building during this survey. No bats were seen to forage within the building during this survey. Anabat 3 (within the building) has picked up bat calls from outside, evident from the level of noise which was recorded during these calls. The timings of these calls also tie with those recorded by the external anabats.

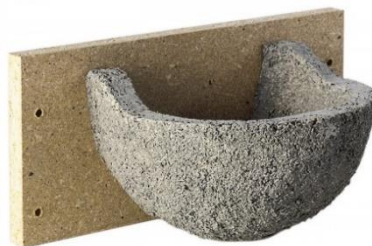
5.5.1. An example of a swallow nest cup is shown below;

5.5. It is further recommended the proposed building incorporates nesting bird habitat to compensate for the loss of nesting bird habitat within the existing building. Suitable nesting bird opportunities could include sheltered areas by incorporating overhanging eaves into the building or attaching swallow nest cups along the top of the walls.
