134 MILTON ROAD, HOYLAND.

BAT SURVEY REPORT.

Ref No: 250411/1.

Date: 22nd June 2025

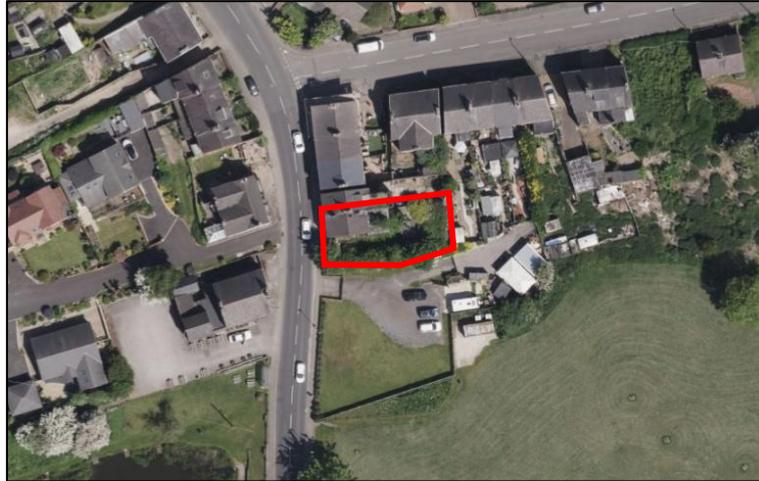
3.2.2. The survey area comprises the residential building and adjacent garden at 134 Milton Road (OS Reference: SE 3741 0019). The approximate extent of the survey area has been defined by the red line boundary in the aerial image below.

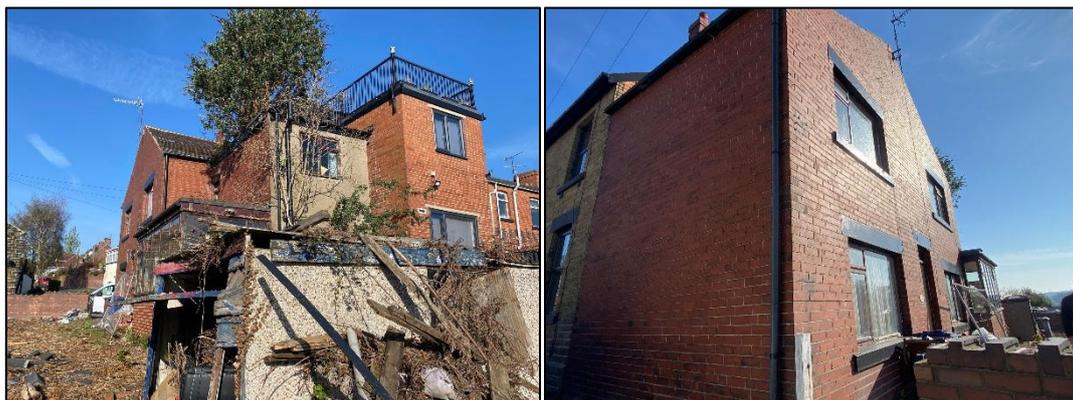
3.3.1. The building at 134 Milton Road was primarily constructed from brick and mortar, with an extension with both brick and render present to the rear of the property. The property featured a pitched roof with roofing tiles although the vast majority of the tiles were missing. The extension to the rear featured a flat felted roof with timber fascia boards. The photographs below were taken from the southeastern and southwestern aspects.

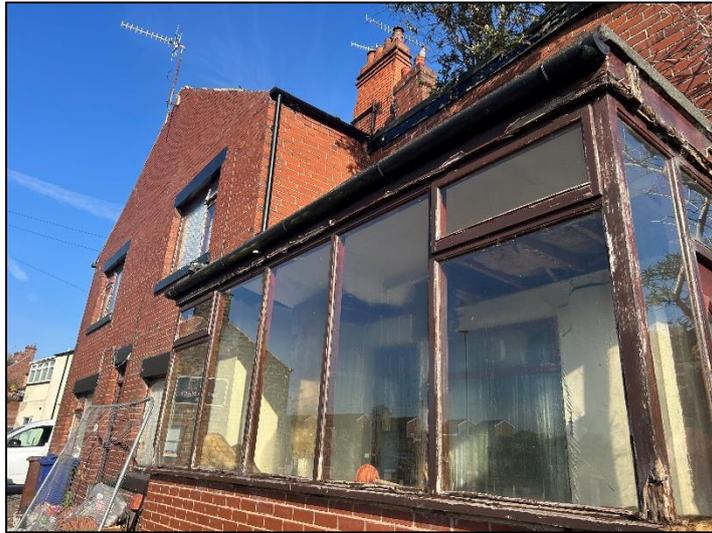
3.3.2. There was a conservatory on the southeastern aspect with a flat felted roof, a brick base and glass window and timber frame upper. The photograph below highlights this conservatory.

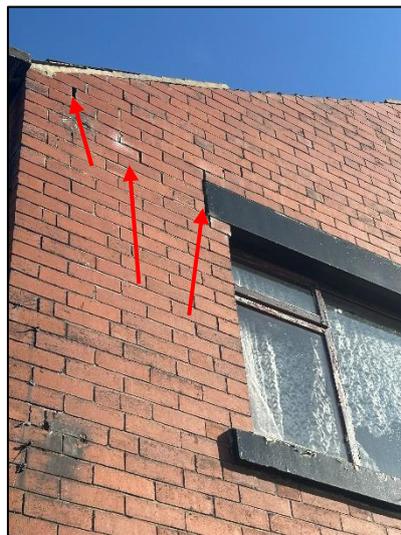
3.3.3. The brickwork itself appeared to be in relatively good condition, though several potential access features for bats were identified, including areas of missing mortar and small gaps between the brickwork and window lintels, particularly on the upper south facing wall, as shown in the photograph below.

3.3.12. The results of this survey on this building found a number of potential features in the brickwork that may provide potential access for low numbers of summer roosting bats. The previous loft space, however, provides negligible potential for roosting bats, and is in incredibly poor condition, with missing tiles throughout, with further damage caused to lower levels of the property due to exposure to the elements and lack of protective features. Furthermore, the location of the property along a relatively busy road within a residential area meaning the surrounding area is likely to be consistently lit up and therefore lowers the suitability of the property for roosting bats. Given the above factors, the building has been assessed as providing low potential overall for summer roosting bats.

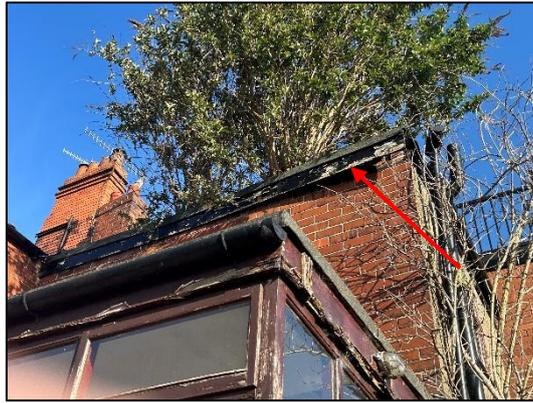
3.3.4. Timber fascia boards are present on the extension to the rear of the property. These were in poor condition which left voids between the timber board and the brickwork. A large proportion of this gap, on the southern aspect, was too open and exposed to support roosting bats although where the boarding is tighter to the brickwork, it could support individual opportunistic bats. The roof of the extension is felted and flat and therefore, it is unlikely any roosting opportunities are present beyond this initial void.

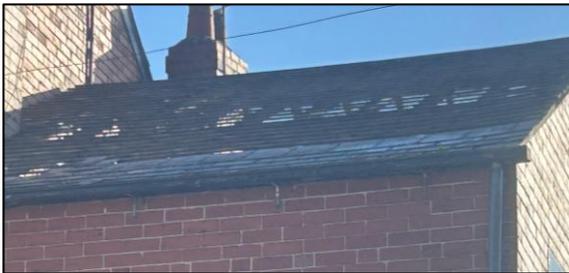
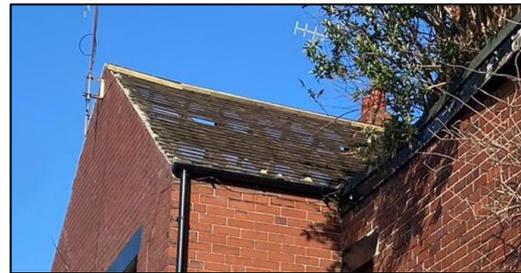
3.3.5. The main roof of the property is in poor condition. The majority of the roof has fallen through and very few tiles remain, particularly to the rear of the property, leaving the upper level of the building completely open and exposed, as such providing negligible potential for roosting bats. Images of the roof can be seen below, whilst photographs of the interior of the building are shown in section 3.3.7. There is the possibility of individuals bats utilising gaps between the remaining slates although this is considered unlikely given the few that remain and how exposed this location is.

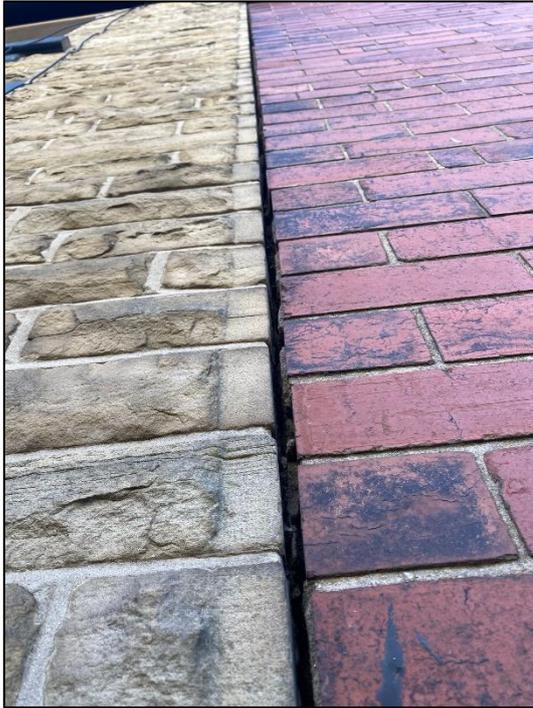
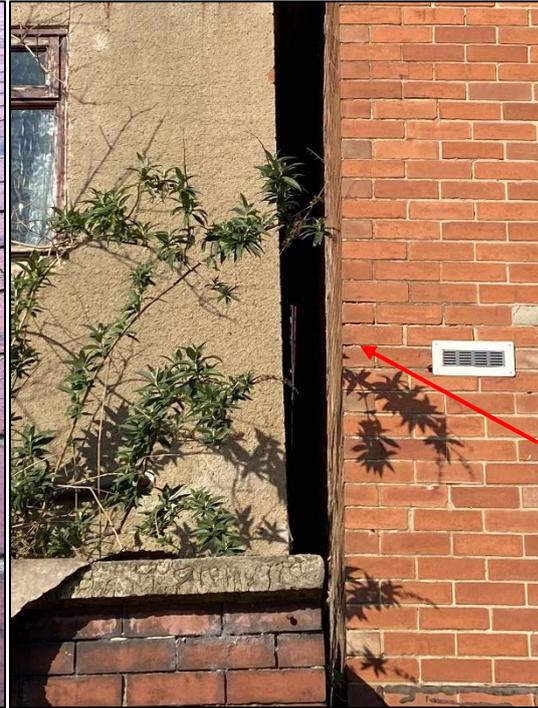
3.3.6. A gap, due to subsidence and movement within the building, has formed where the adjoining terrace meets the surveyed property, which can be seen in the photographs below. This ran from ground level, where the gap was less open, to roof level, where the gap was at its widest. It was also smaller on the front of the property and wider to the rear. This gap ranged from approximately 2cm to 25cm.

3.3.7. This gap was open and exposed to the rear which is unlikely to support roosting bats although where the gap is smaller, this could support roosting bats. The condition of the brickwork within the gap could not be accessed, and it is unknown whether there are any gaps or crevices in addition to the gap, and as such could not be assessed fully for roosting potential for bats.

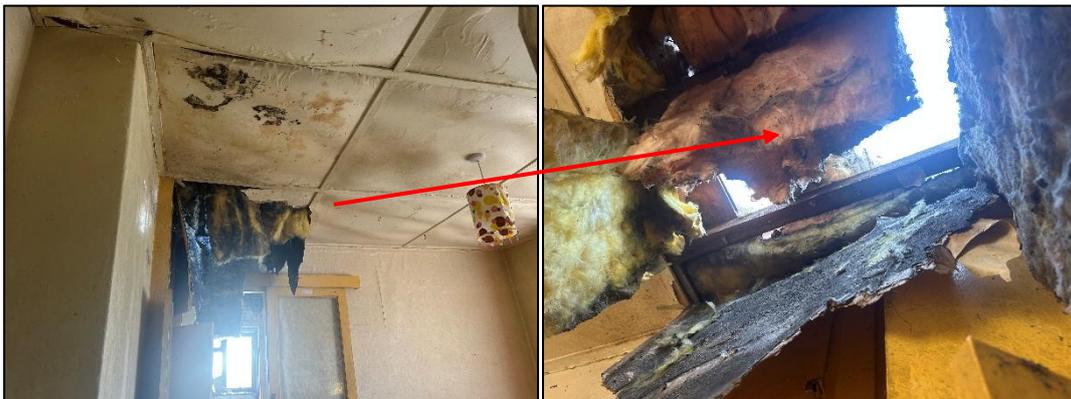
3.3.8. The interior of the property was dilapidated. An area of ceiling adjacent to the chimney wall has fallen through, as can be seen in the images below.

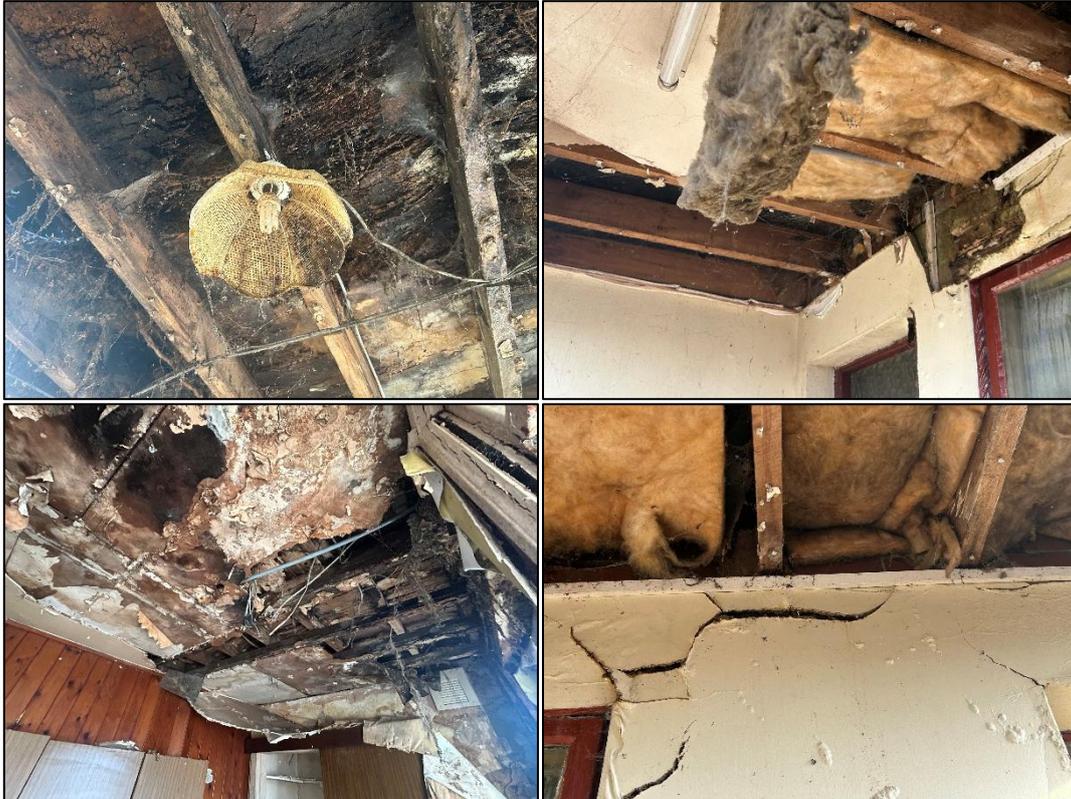
3.3.9. There is damage to the remaining ceiling panels, walls, and ceiling joists throughout the building on both the lower and upper floor, as shown in the photographs below.

3.3.10. The area which would have been a loft is fully exposed due to the poor condition of the roof meaning that this is highly unsuitable for supporting roosting bats. No access into the roof void could be gained at the time of the survey due to the poor condition of the building but as this void could be seen through an open area within the ceiling, it is not considered to be a limitation at all.

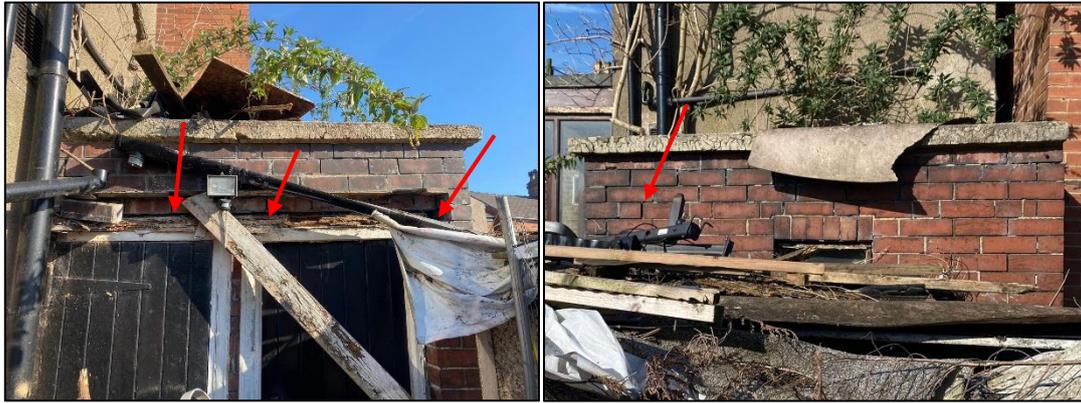
3.3.11. The adjacent outbuilding to the rear of the property, shown in the images below, was constructed from brick with a concrete flat roof. It possesses several gaps, areas of missing mortar and slipped bricks, which offers potential access points for bats. Access was not available to the interior of this small outbuilding.

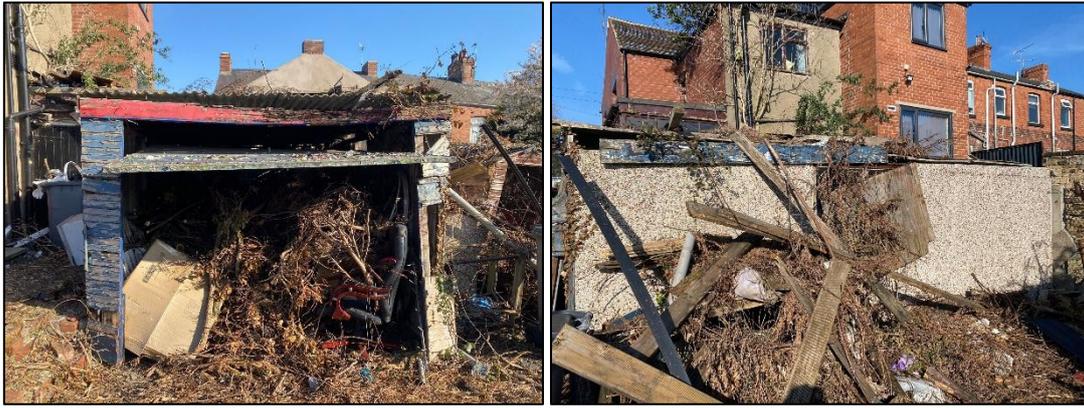
3.3.14. The detached garage, to the east of the main building, was a mixture of materials including render, timber and steel. The roof was flat with profiled metal sheets. The building was light and exposed internally with no roof void. Given the construction materials, and lack of roosting opportunities within this building, it was assessed as unsuitable for roosting bats.

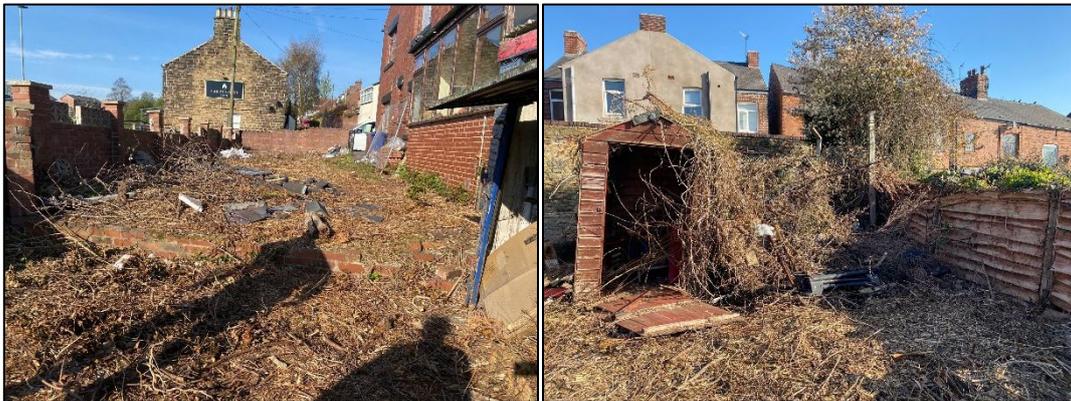
3.3.15. The garden surrounding the immediate east and west of the property had been de-vegetated prior to the site survey, though historic aerial imagery showed a densely vegetated green space.

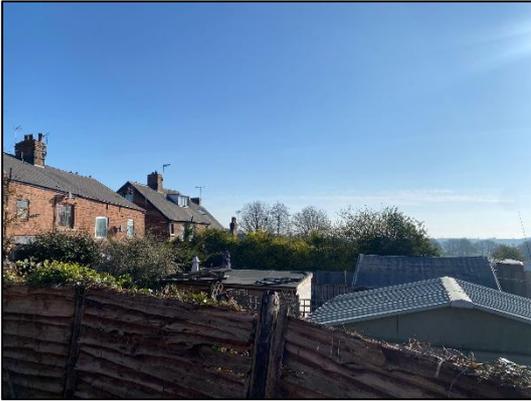
Neighbouring gardens:

3.3.16. Connectivity between the survey area and the wider landscape is also relatively poor, with little vegetation present with exception to neighbouring gardens and the wooded area to the west of Milton Ponds (forming connective corridors) that may be used by commuting and foraging bats. The property is also located along a main road, where vehicular activity is likely to be higher, with a pub and several streetlights in close vicinity. Therefore, the survey area was assessed as having low bat roosting potential with areas, however moderate foraging and commuting potential within the adjacent landscape.

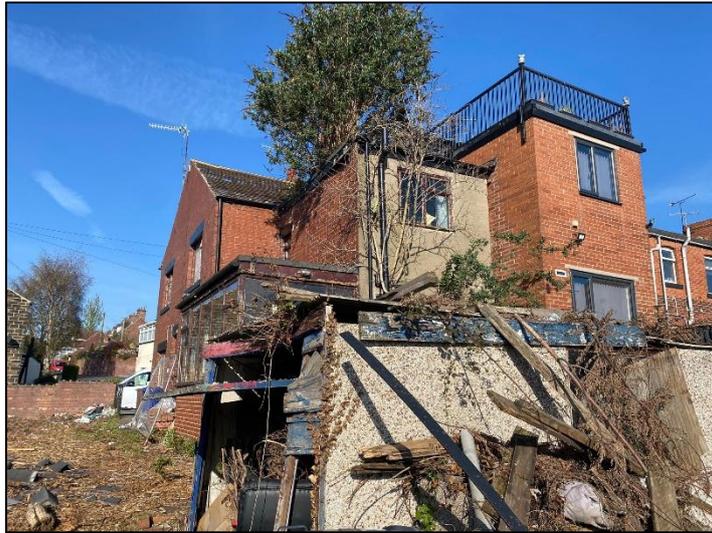
3.4.2. The remaining vegetation and brash / debris on site also provides suitable habitat for nesting birds. These areas are shown in the photograph below.

It is recommended that any (further) vegetation clearance and demolition works are carried out outside of the nesting bird season, which extends from March to August each year. Any works undertaken during the nesting season should be preceded by a nesting bird survey and any active nests identified must remain undisturbed until the young have fledged.

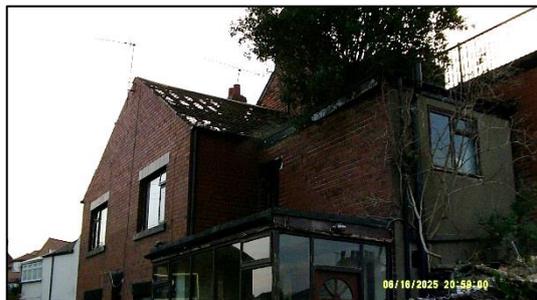
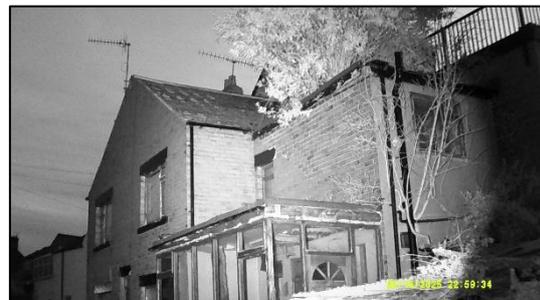
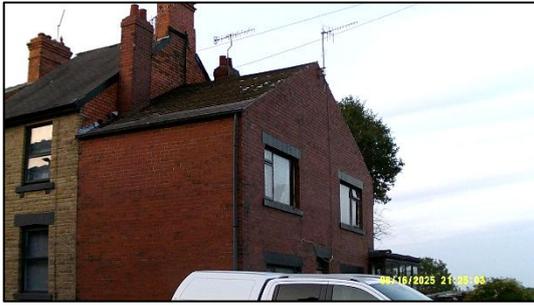
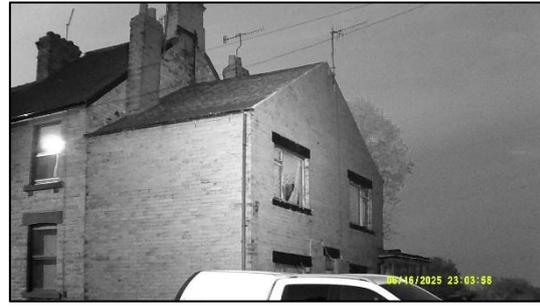
3.4.4. Two infra-red cameras and infra-red torches were also set up around the buildings, ensuring that all suitable features were covered. Shown below are photographs which show the view of each camera at both the start and end of the survey.

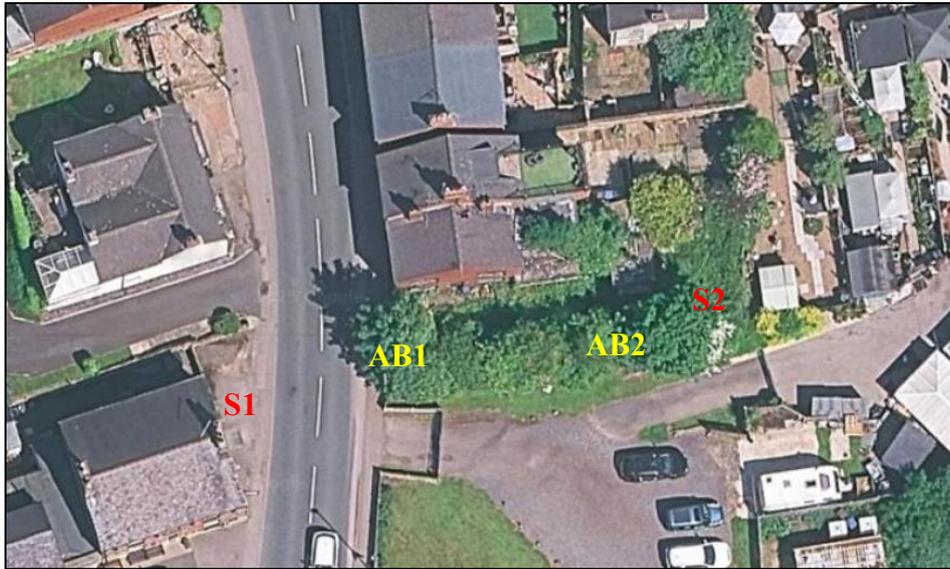
3.4.5. The aerial photograph below shows where the Surveyors (S) and Anabats (AB) were located throughout the survey.

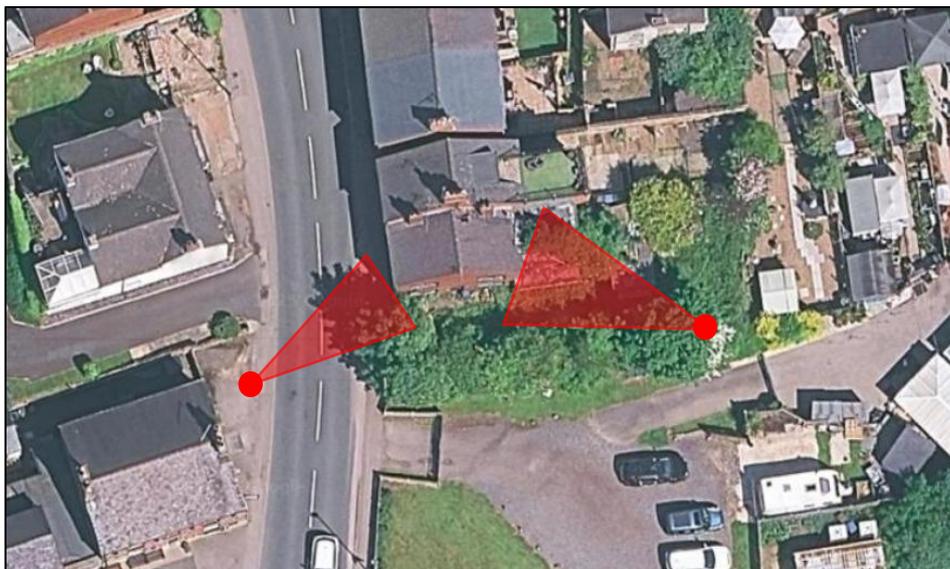
3.4.6. The aerial photograph below shows where the cameras were positioned along with their approximate field of view.
