GEOENVIRONMENTAL DESK STUDY REPORT

Barnsley West

4848-JPG-XX-XX-RP-G-0604-S2-P05

July 2019

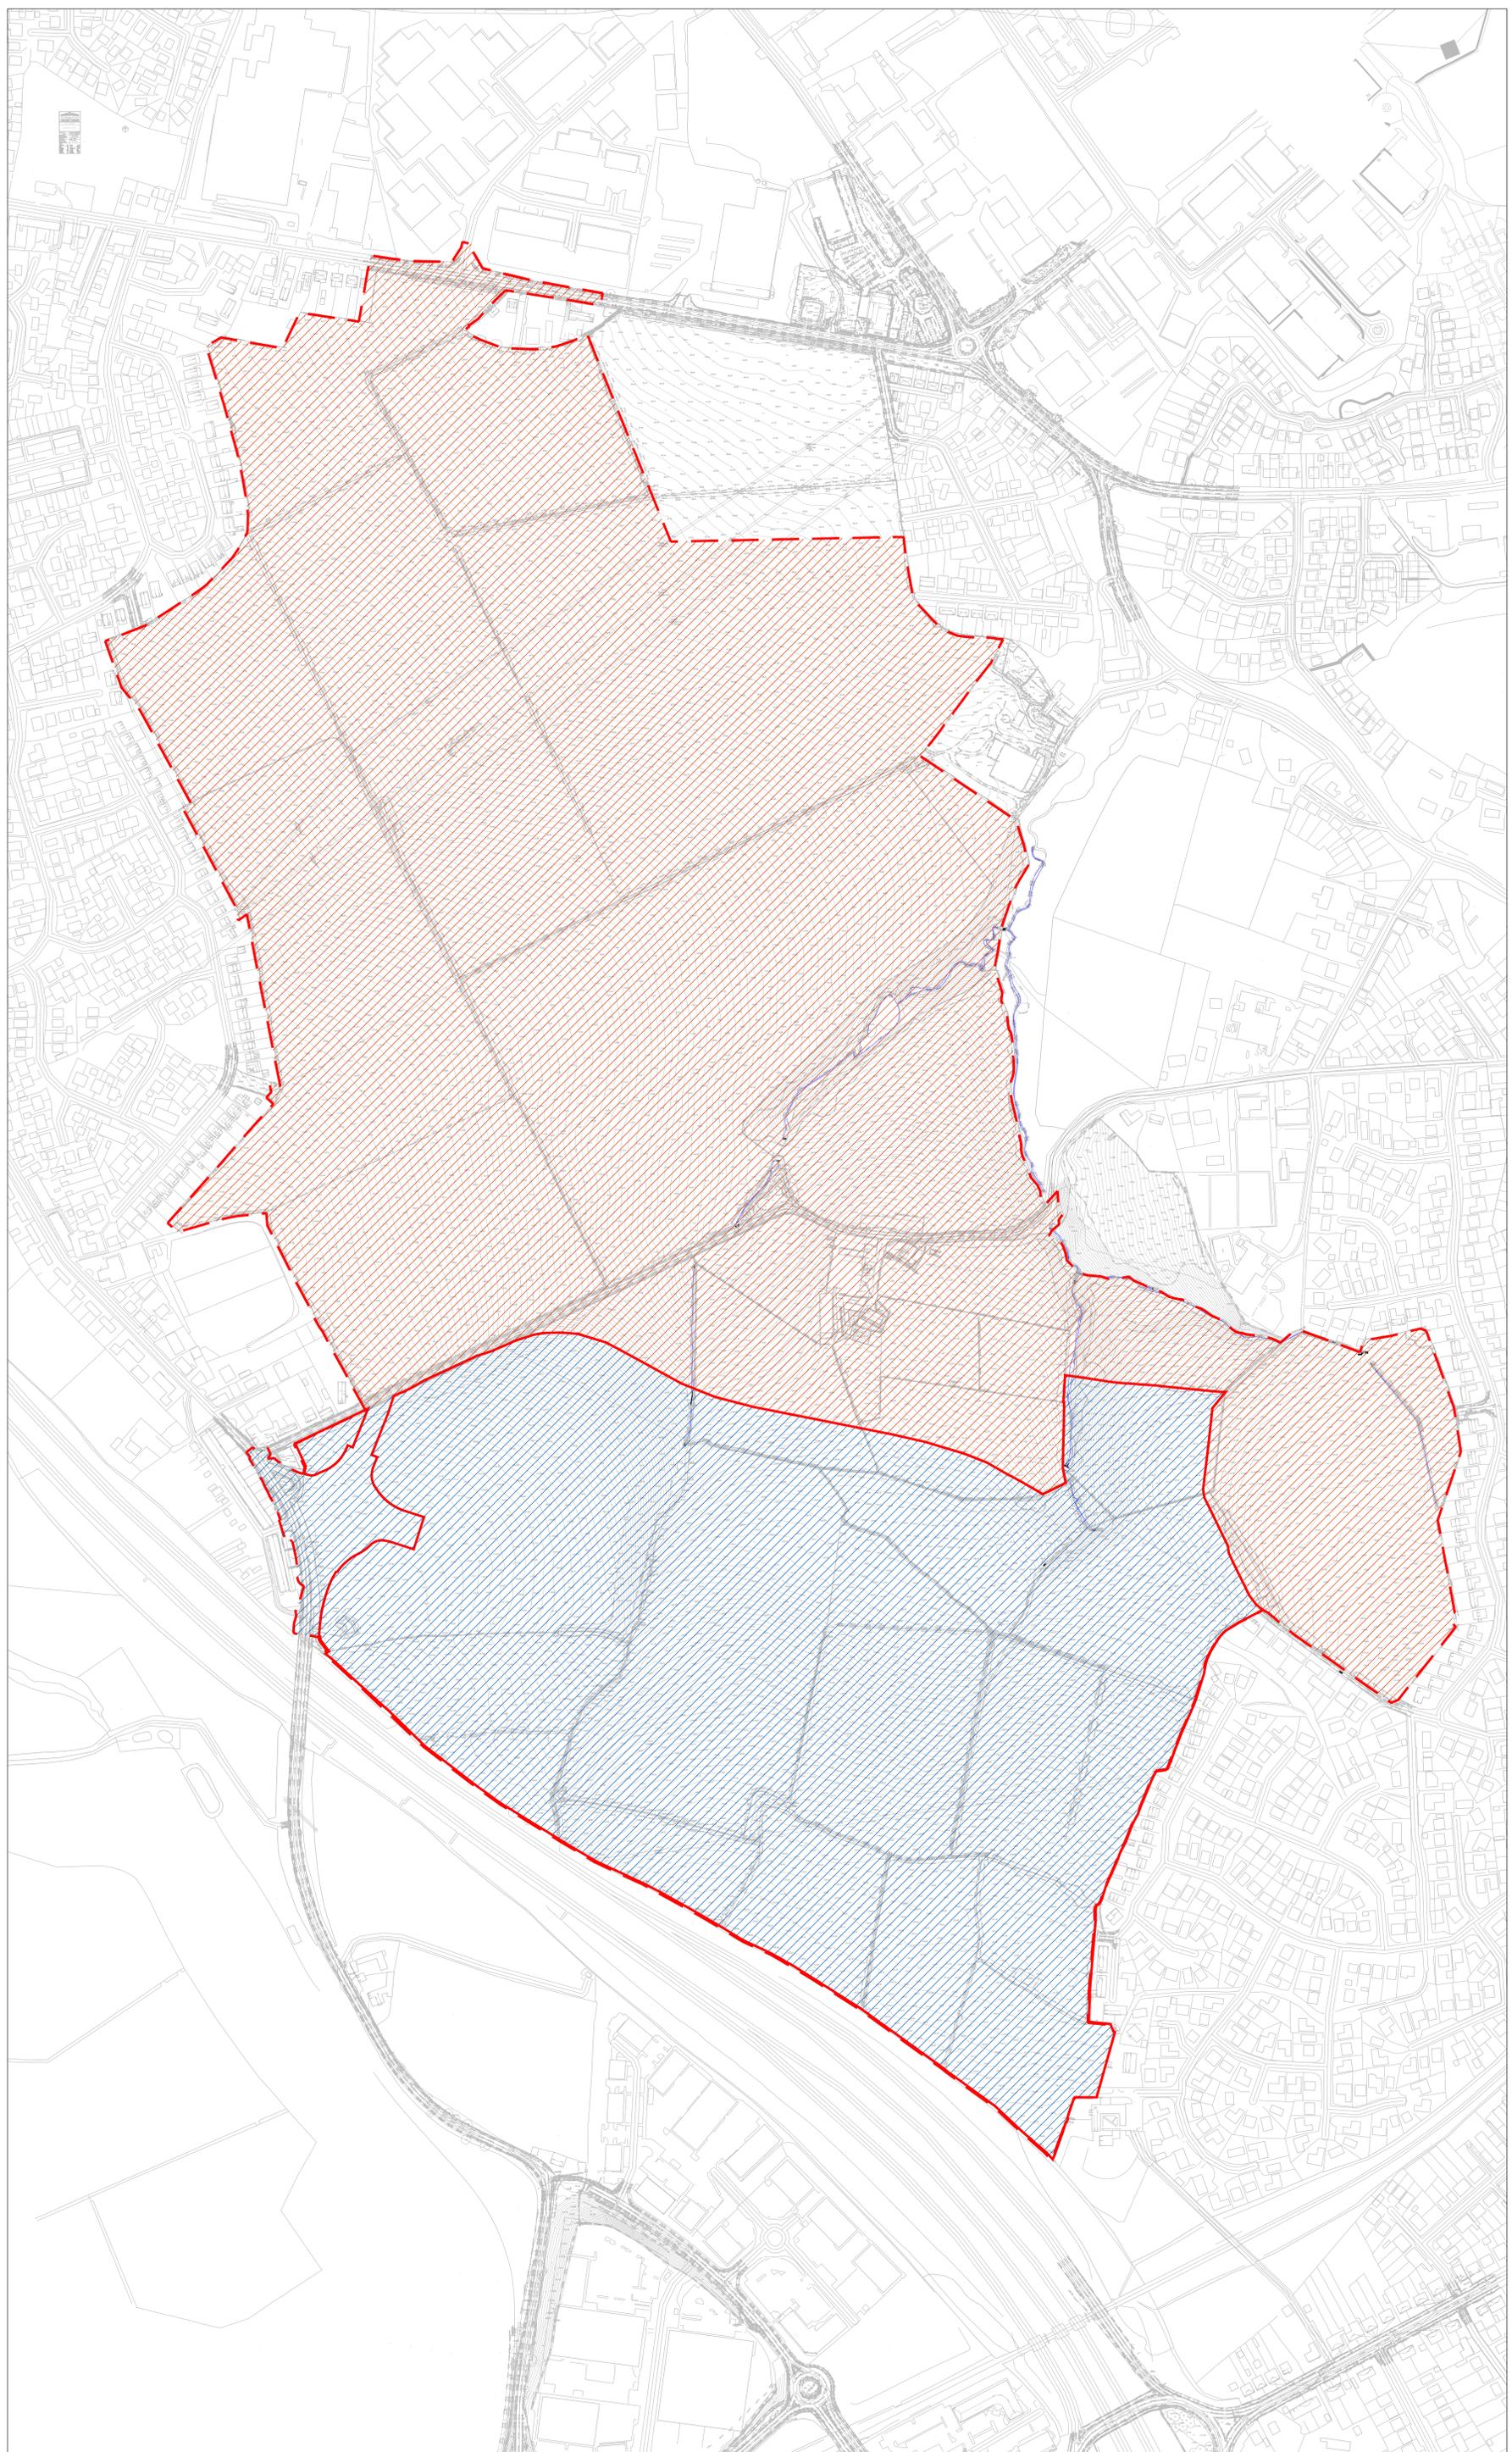
RESIDENTIAL BOUNDARY

It is proposed to develop the northern part of the site for residential end use and the southern part of the site for commercial end use. A plan outlining the separate zones is referenced below and provided in Appendix A.

- JPG Leeds Limited. Site Zoning Plan. Barnsley West. Drawing Reference: 4848-JPG-ZZ-ZZ-DR-C-1000-S2-P02. Dated March 2023.
