**PHASE I CONTAMINATION AUDIT FOR THE SITE AT 243 BURTON ROAD,  
MONK BRETTON, BARNSLEY, SOUTH YORKSHIRE**

**ON BEHALF OF  
MR W CONWAY**

**NOVEMBER 2008**

## **PHASE I CONTAMINATION AUDIT FOR 243 BURTON ROAD, MONK BRETTON**

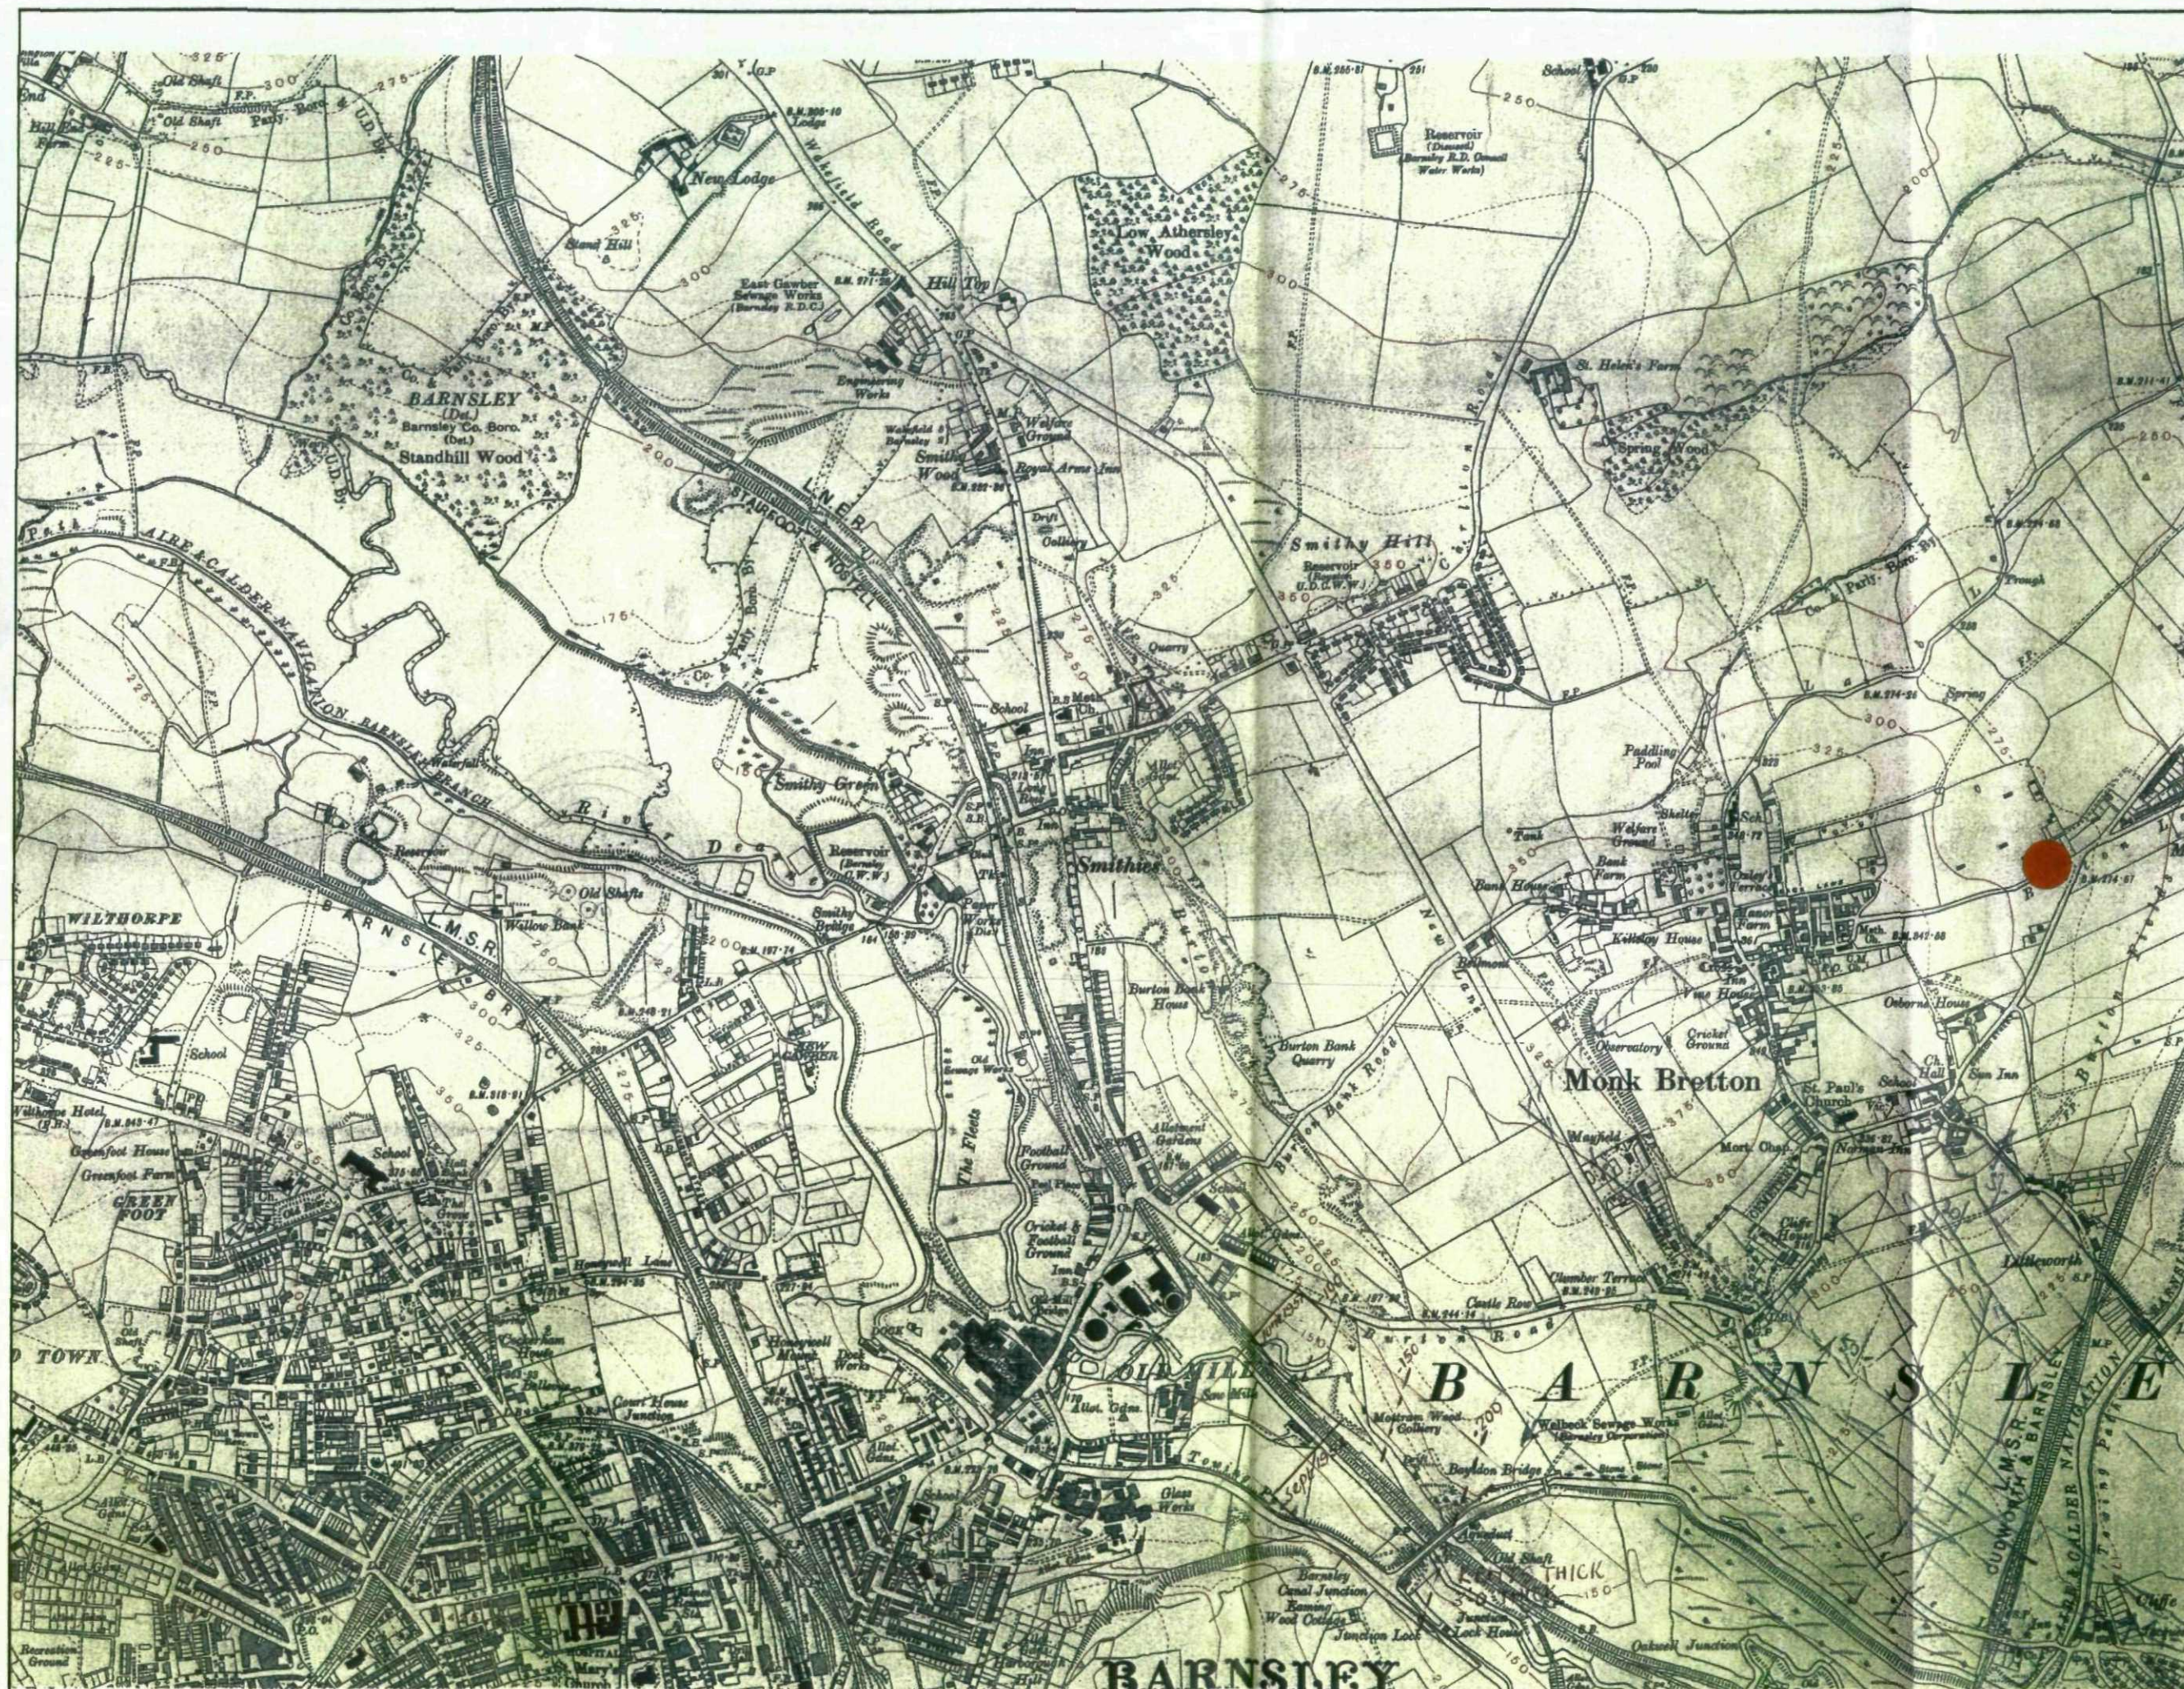
Dwg. No.  
**1832 HISTORICAL PLAN**

- 7.3 1872 – At this point in time, the subject site is currently agricultural land and labelled as part of 'Burton Fields' which are adjacent to Burton Lane. To the east and south of the site is predominantly agricultural land. Monk Bretton is quite undeveloped at this time, apart from in the west and south west of the site. Within the town is a Methodist Chapel and associated Sunday School, these are approximately 470m from the site itself. Further west of the town, are what appear to be residential dwellings, a burial ground and 450m south west of the site is St Peter's Church. To the north west of Monk Bretton, it is also undeveloped as Smithy's Wood and Athersley are evident with no other activity evident.

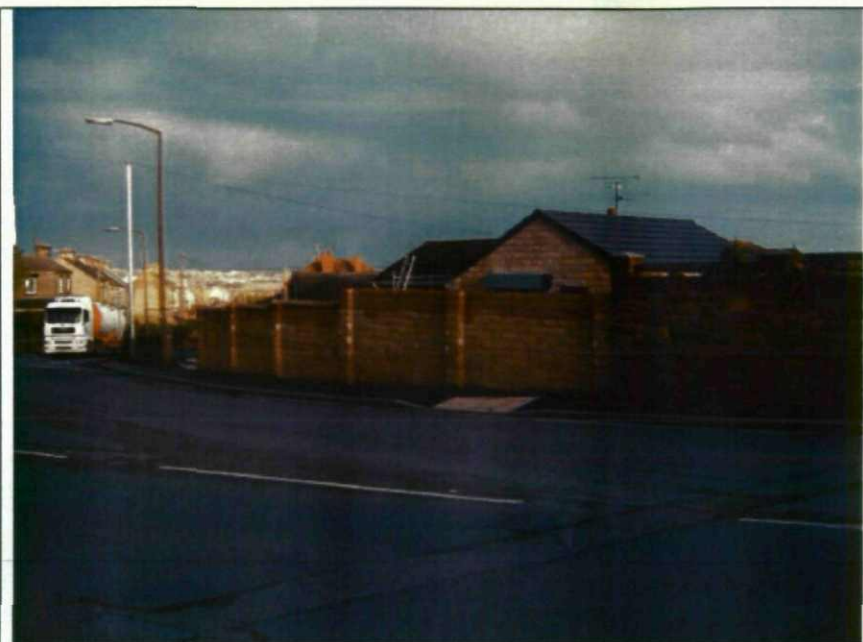
Photograph 1 – The above shows Burton Road in the foreground and part of the boundary wall to the existing property.

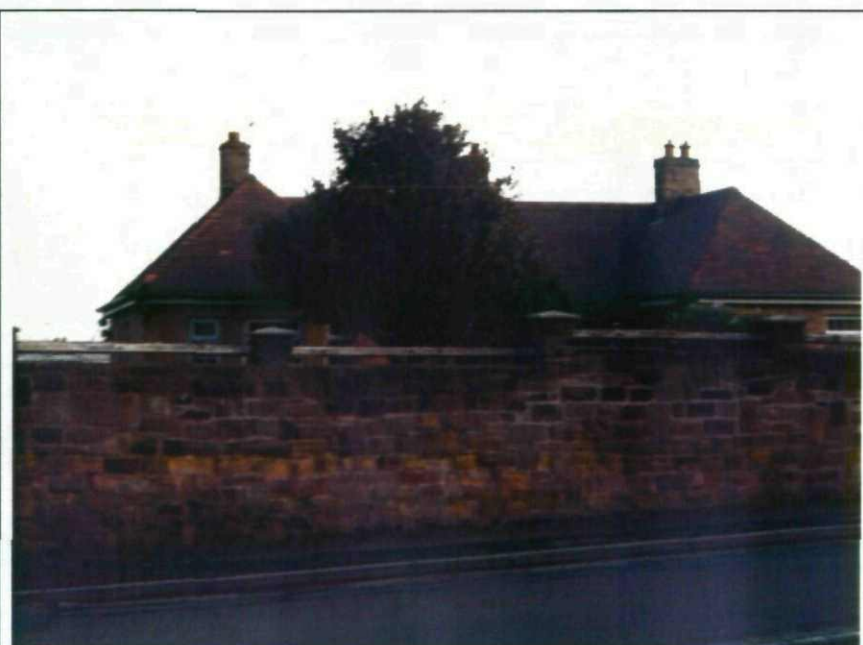
Photograph 2 – Again, the photograph shows the boundary of the site in the foreground and in the background what can be seen of the existing property.

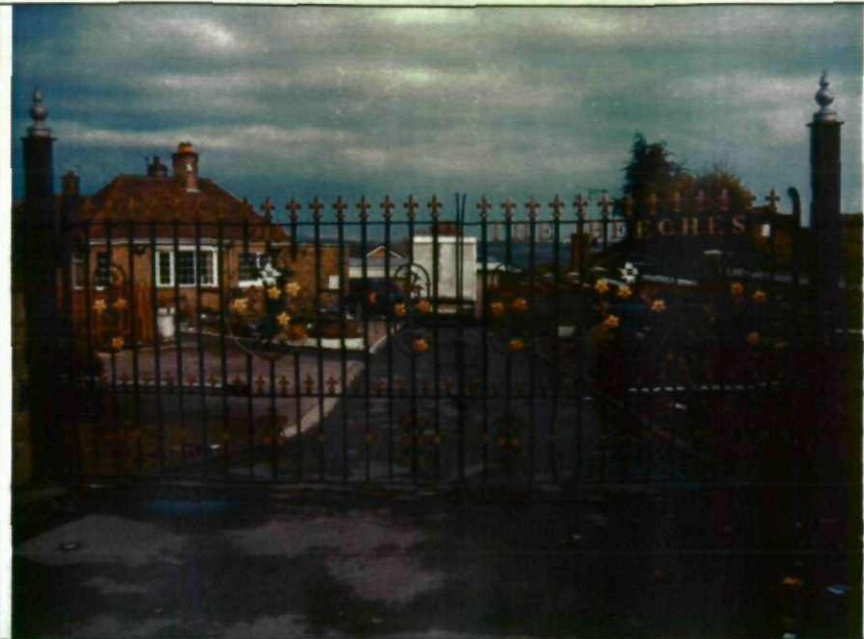
Photograph 3 – The above shows the existing tarmacadam driveway which leads to the house from the gates.

- 11.4 Upon accessing the site, as said previously the surface of the driveway is sealed and drained concrete. To the left hand side of the access gate is a small resurfaced concrete area which could also be used for additional parking and adjacent to this is a conifer hedging with shale and pebble on the topsoil.

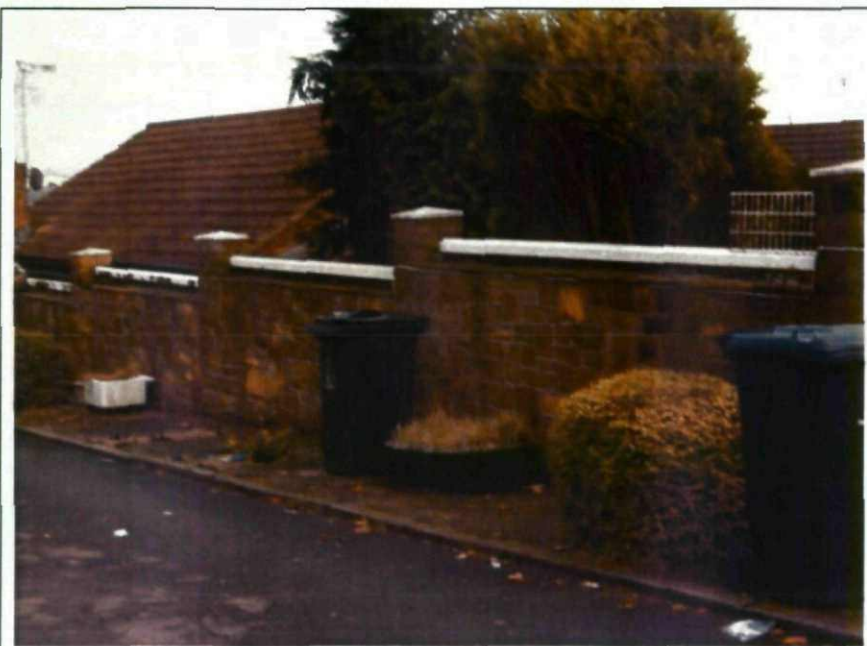
Photograph 4 – The boundary wall to the right hand side of the entrance upon entering the site.

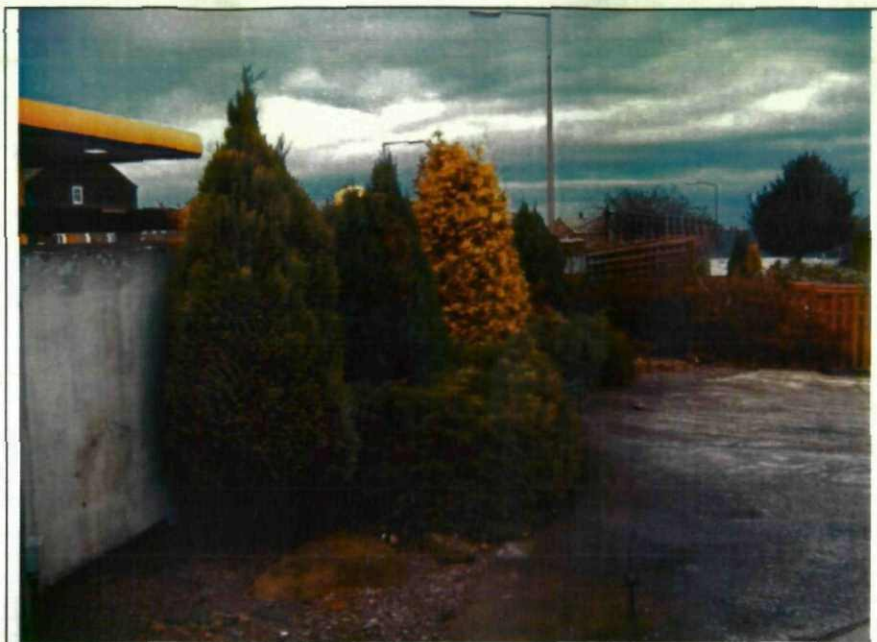
Photograph 5 – The boundary wall to the left hand side of the entrance upon entering the site. This boundary is adjacent to Burton Road.

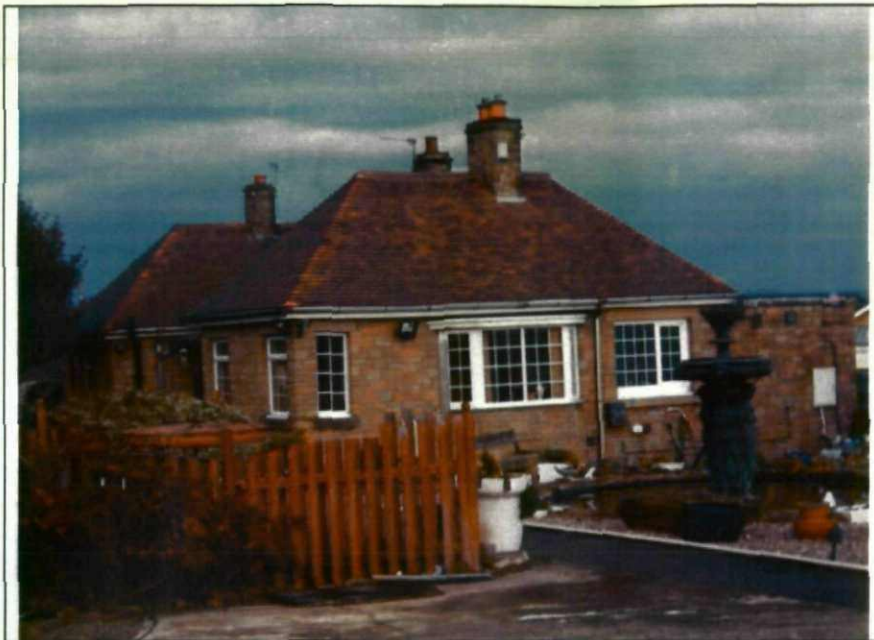
Photograph 7 – Above is the existing property which is on site, which is proposed for demolition once redevelopment takes place.

- 11.2 The site currently consists of a stone built one storey-detached bungalow with associated landscaped gardens and parking facilities on site. The existing property and garden areas are proposed for demolition if Planning Permission is granted for the redevelopment of the site for the construction of four detached residential dwellings with associated hardstanding and soft landscaping.

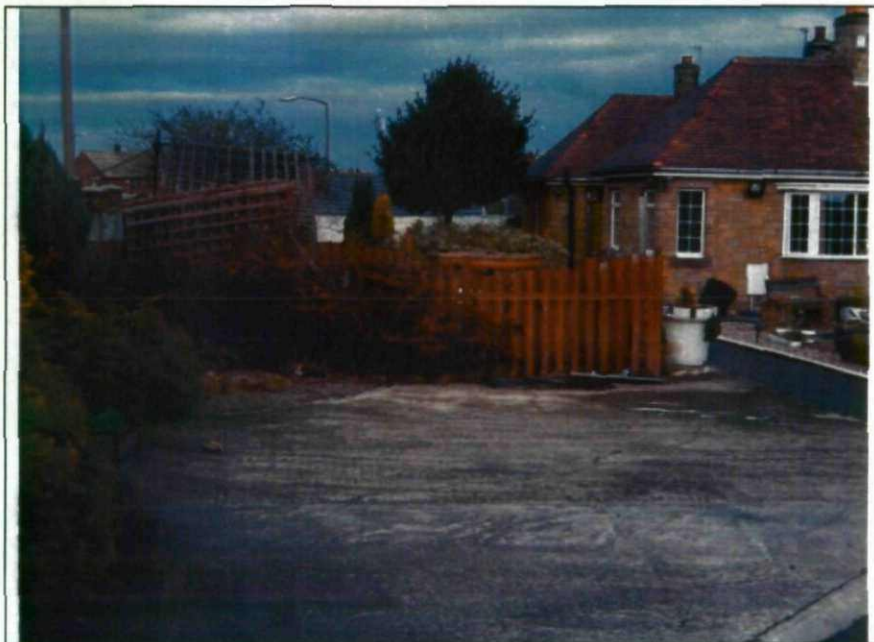
Photograph 8 – Showing a more detailed view of the small-concreted area on site to the left of the access.

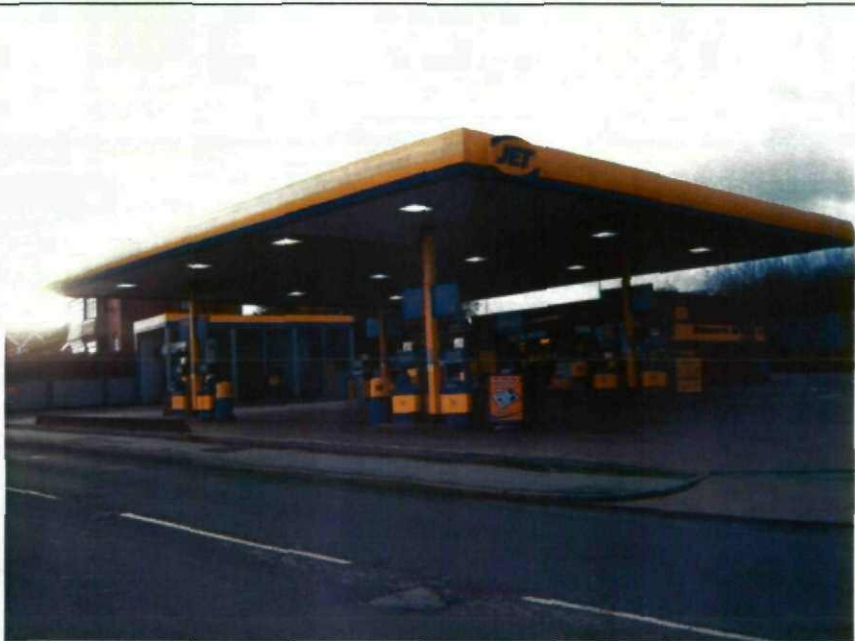
Photograph 12 – The above shows a fuel station adjacent to the existing site located on Burton Road.

- 2.2 The site is located on Burton Road and adjacent to the existing property is a fuel station. The location of the site is in the west of Monk Bretton and is on the junction of a large roundabout, which leads to town of Barnsley from Royston and Carlton.

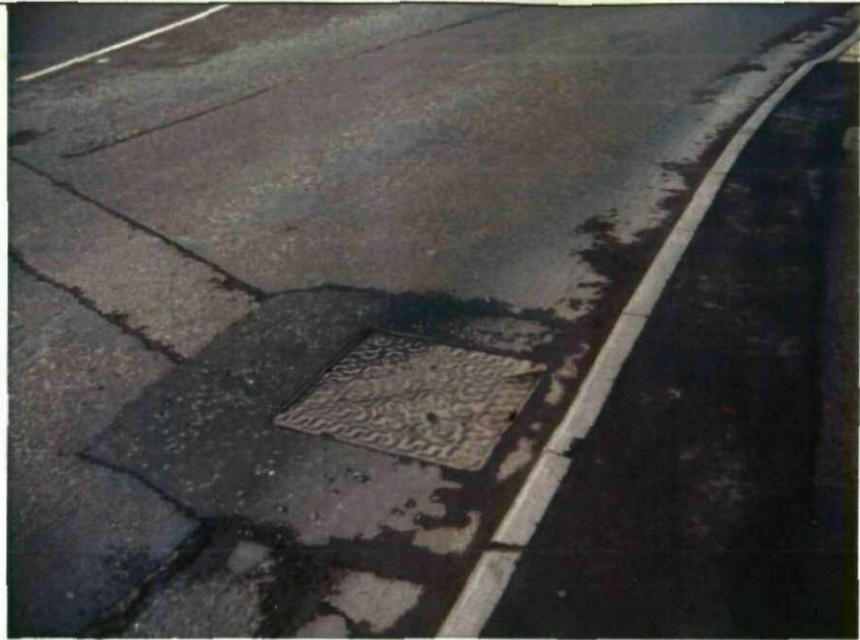
Photograph 13 – Outside the north west boundary of the site on Burton Road was a manhole which indicates existing drainage channels.

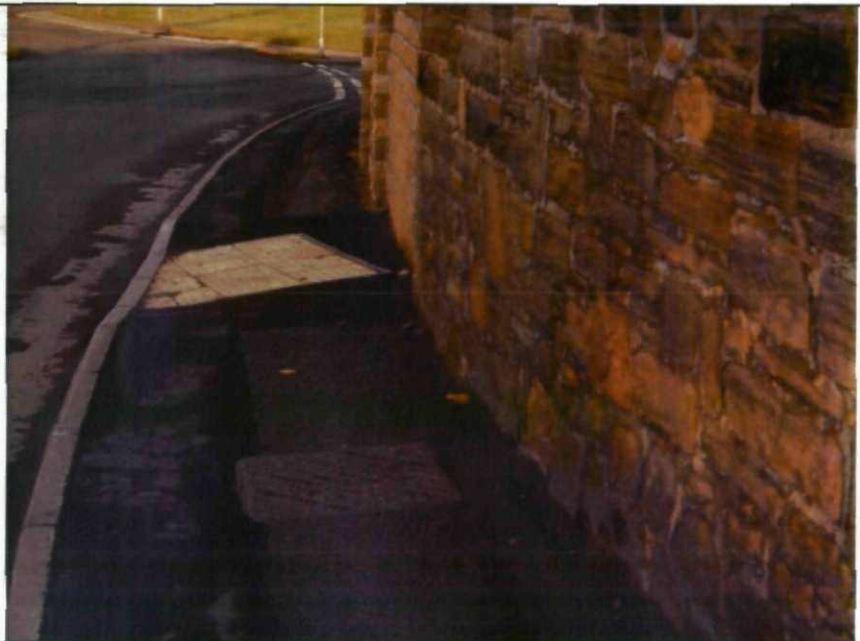
Photograph 14 – Again, outside the north west boundary of the site on the pavement adjacent to Burton Road was another manhole.
