Ref C220/02/GS

**Ref: Preliminary Intrusive Mining Investigation on land off Bismarck Street, Worsbrough Common, Barnsley.**

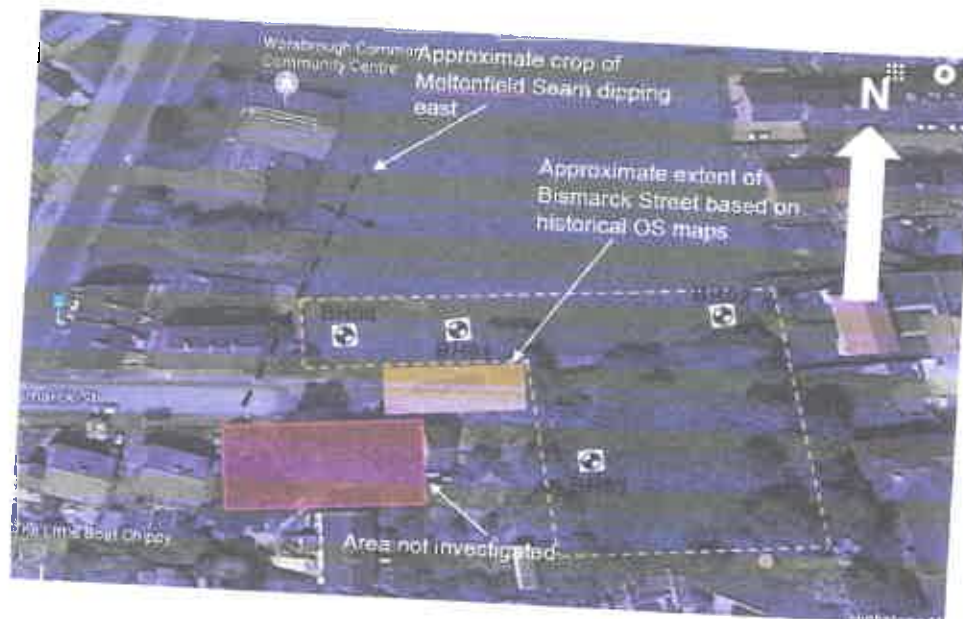
The site is located in Worsbrough Common, approximately 1km south of Barnsley town centre, South Yorkshire. The site is accessed off Bismarck Street, which runs adjacent to the western boundary of the site, as shown below.

It is understood that the plot of land highlighted in red, shown below, will be subject to a separate planning application and was consequently not investigated as part of this current work.

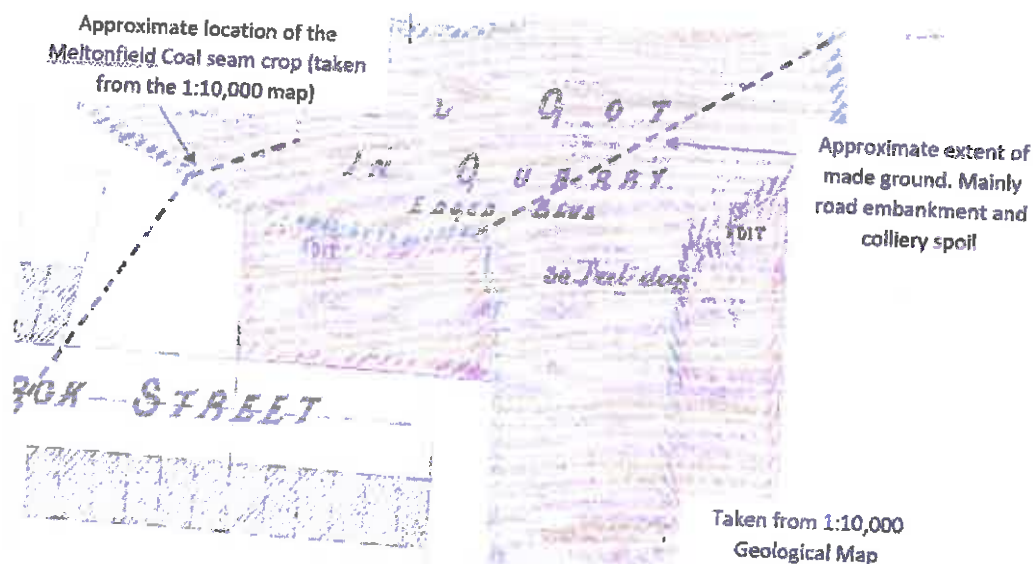
An examination of the geological map (1:10,000 SE30NW) appears to support this assumption; this shows the quarry encroaching onto the northern boundary of the site; shown approximately on the drawing below.

Information kindly supplied by the CA, included an abandonment plan (Ref 5002), which appears to indicate that in fact the brickpit/quarry extended further onto the site than was anticipated (see below), extending past the line of houses along Bismarck Street (now partially demolished), towards the southern boundary of the site. It is understood that the blue hatching indicates where coal was removed from the quarry face and that the red hatching possibly indicates shallow workings.

The 1:10,000 geological map indicates that the Meltonfield Coal seam crops in the north west edge of the site (shown above) and dips, probably at a shallow angle towards the east; i.e. beneath the site. The stratigraphic column of the map shows the Meltonfield seam (recorded as between 0.69m to 0.89m in thickness) to be underlain by the Two-Foot coal (between 0.56 to 0.63m in thickness), approximately 12m below; which is itself underlain by the Winter or Abdy seam (between 1.22m to 1.42m in thickness), approximately a further 16m below.

The boreholes were located to assess various features identified on the CA abandonment plan Ref 5002.

The abandonment plan included within this report shows the potential locations of two adits, likely to have been driven from the face of the quarry/brick pit. Based on the results of boreholes BH1 and BH2 it is considered possible that these entrances may have been removed, at the locations drilled, as part of the historical quarrying. These adits were presumably driven into the face following the outcrop of the Meltonfield seam. It is not considered likely that these entrances were driven down to the deeper Two-Foot seam, as the abandonment plan does not appear to show any shallow working beneath the base of the quarry, linking the two areas of mining, either side of the quarry high-wall. All of the boreholes showed, with

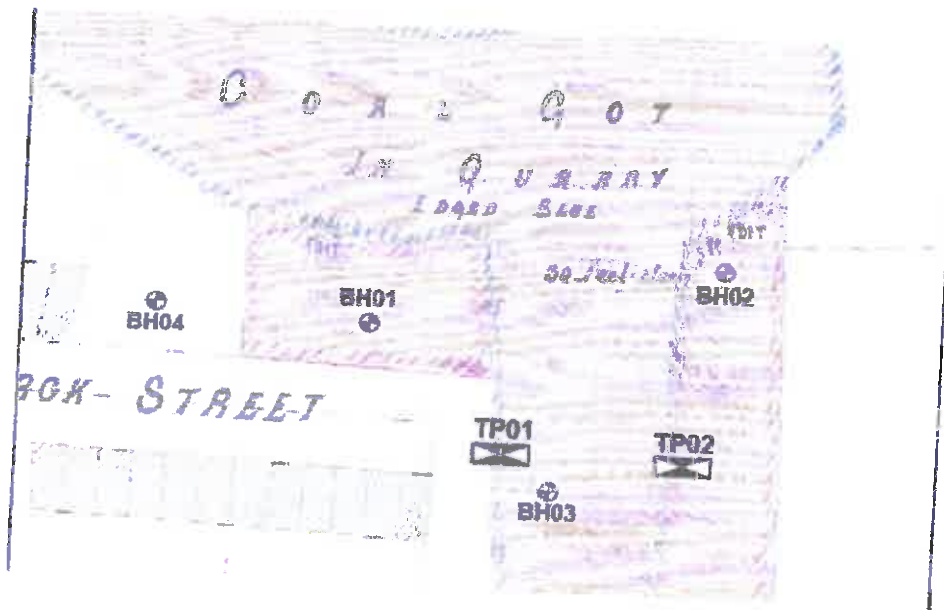
A plan showing the exploratory hole locations is shown below. Each hole was located to assess particular features identified by the abandonment plan.

Borehole BH4 was located in the area of the abandonment plan which indicated that coal had neither been extracted from the quarry or by shallow mining. Two intact coal seams were encountered within this hole. The Meltonfield seam, encountered at 6.5m bgl and the Two-Foot seam, encountered at 21m bgl, with intervening mudstone bedrock of 13.5m in thickness. This is consistent with the separation between the two seams shown on the stratigraphic column of the geological map, which is indicated to be approximately 12m.

Borehole BH3 confirmed that the base of the quarry extended further onto the site, than indicated on the geological map, which accords with the CA abandonment plan.

Borehole BH1 was drilled in the area shown as shallow workings in the north western part of the site. The made ground encountered at this location extended below the anticipated depth that the Meltonfield coal would be present based on the depth it had been encountered in BH4. The only coal encountered was assessed as the Two-Foot coal, which appeared to have been worked at this point; the driller recorded a void between 22.5 m and 23.4 m bgl. It is possible that the shallow Meltonfield seam may have been extracted as part of the quarrying process, which extends closer to the line of Bismarck Street than is indicated on the abandonment plan.

Borehole BH2 was also drilled in an area indicated as shallow mining, again the depth of made ground was such that it appears that the Meltonfield, at this borehole location, may have been extracted by quarrying, or the overlying bedrock removed after extraction, as part of the quarrying operation.
