**GEOTECHNICAL AND GEO-ENVIRONMENTAL  
SITE INVESTIGATION REPORT**

**BLYTHE STREET, WOMBWELL**

**GLEESON DEVELOPMENTS LTD**

38506-001

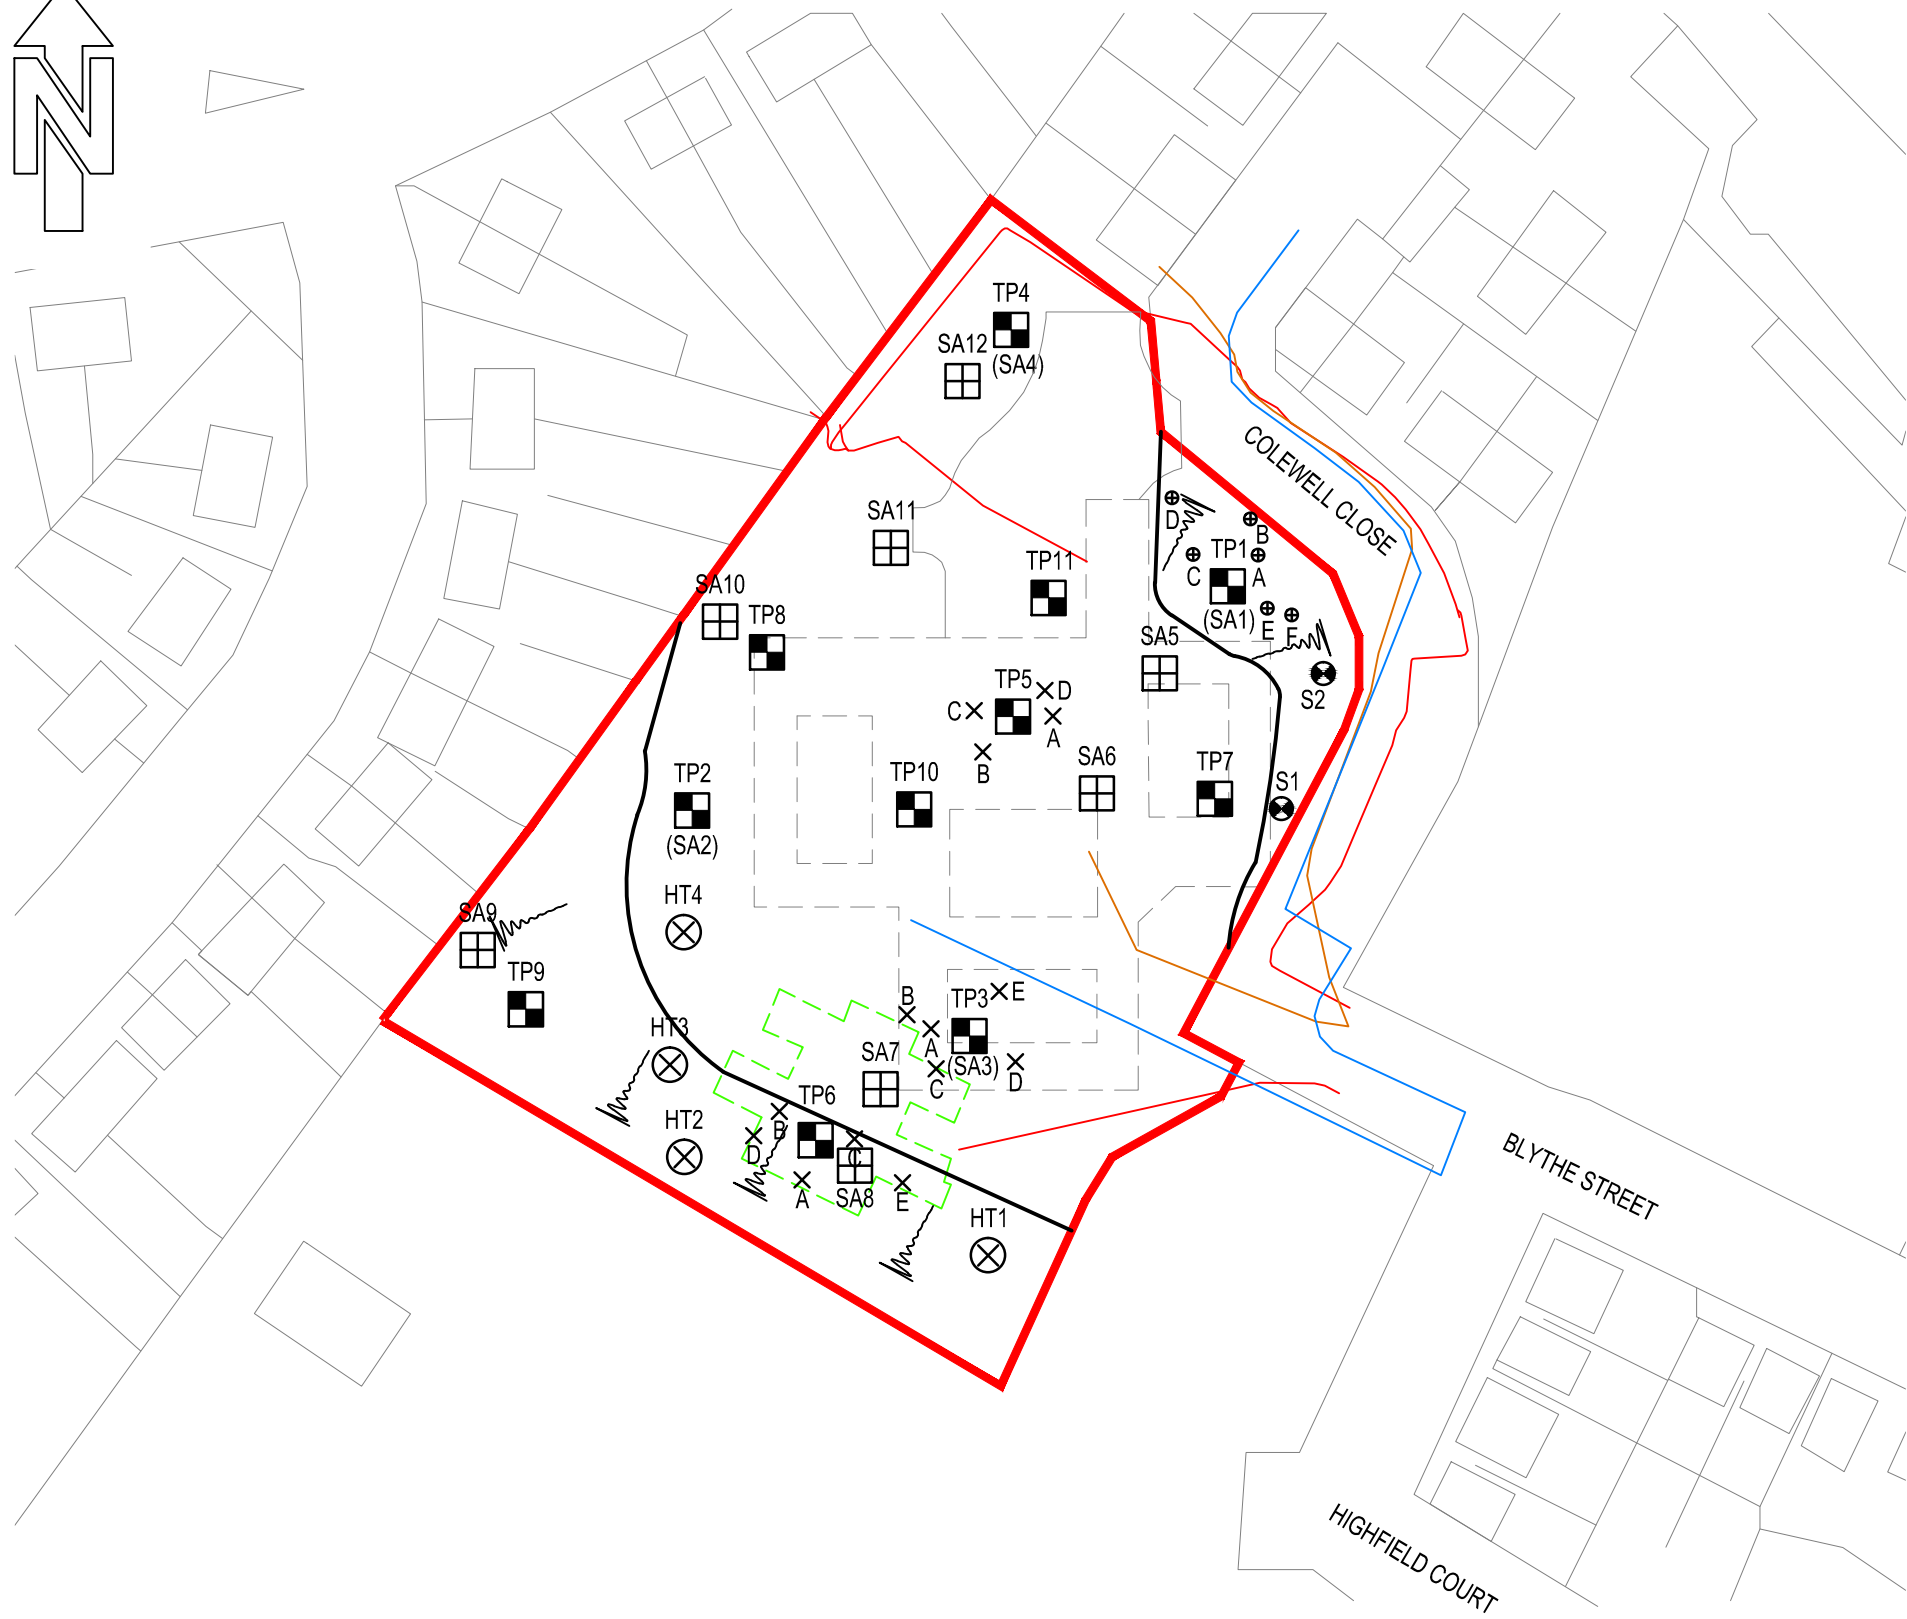
*'Exploratory Hole Location Plan'*, Drawing Number 38506/001B  
Photographs

The '*Exploratory Hole Location Plan*', drawing 38506/001/B in Appendix 1, shows the features described. Some photographs are also provided in Appendix 1.
