# Land off Moor Lane, Lundwood

## Bat Survey Report

27<sup>th</sup> August 2019

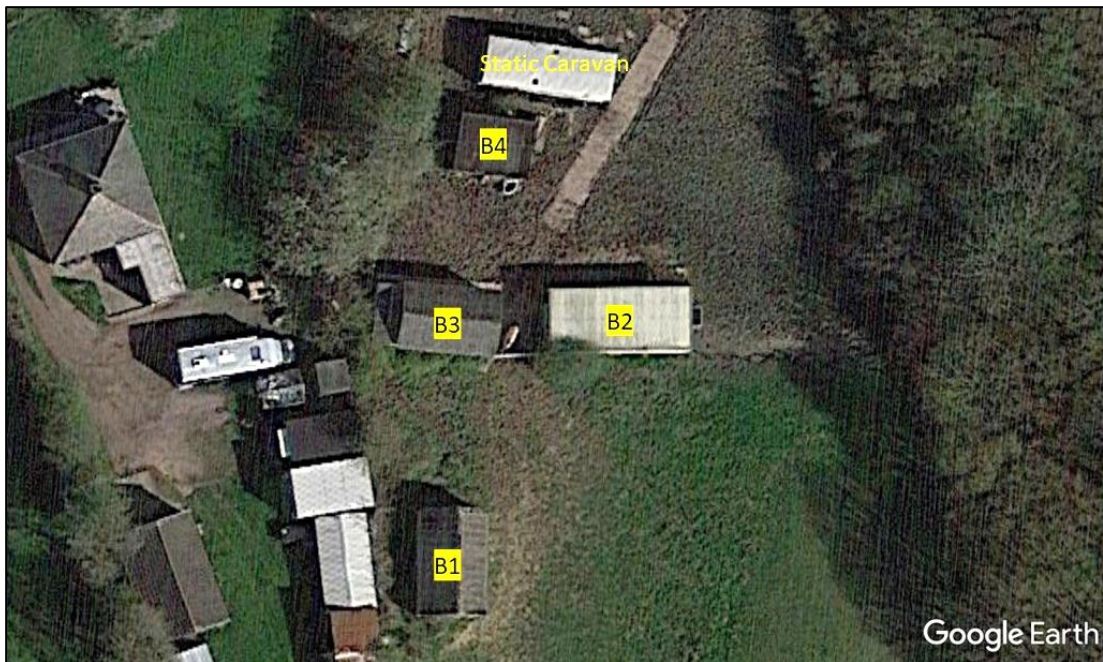
**Figure 2. Site Plan**

5.2.2 The surveyed structures comprise three concrete block-built stables and a wooden shed (see Figure 2 and Plates 1 to 4). Building 1 (B1) and Building 3 (B3) have single skin concrete block external walls beneath a pitched corrugated asbestos cement roof, whilst Building 2 (B2) is also built of single skin concrete blocks, this structure has a shallow mono pitched sheet metal roof. There is wood sarking beneath the asbestos sheets on B1 and B3. Building 4 (B4) comprises a square shaped wooden shed with a flat bitumen felt roof.

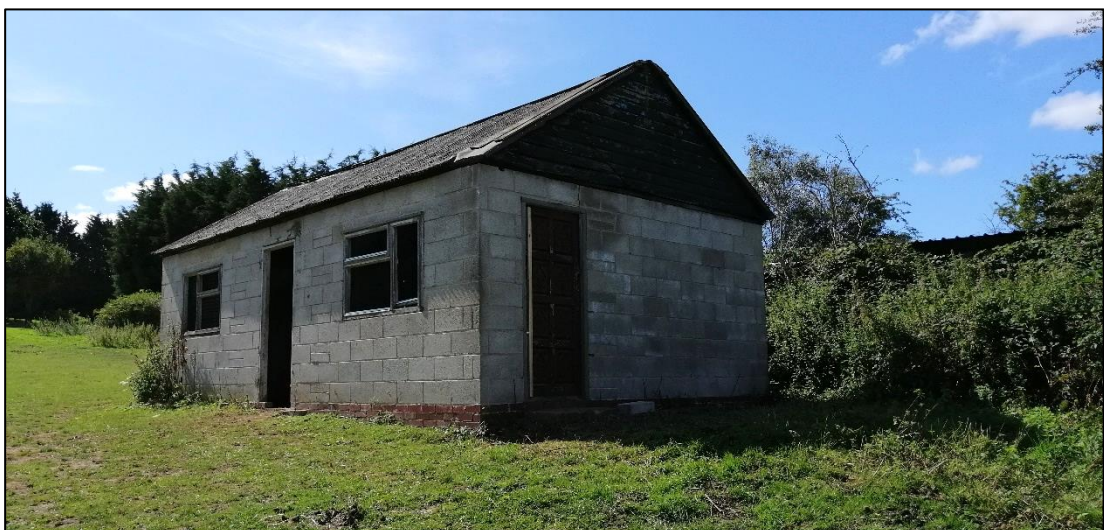
**Plate 1. Building 1**

- 5.2.3 With the exception of gaps beneath the corrugations of the asbestos roof sheets on B1 and B3, all structures lack features with potential to accommodate roosting bats. External walls on B1, B2, B3 & B4 (including wood cladding on the gables of B1 & B3) are all single skin and therefore there are no voids, crevices or other features with potential to support roosting bats. The corrugations of the asbestos roof sheets on B3 are large and considered unlikely to be used by roosting bats, this feature was easily inspected with the aid of a high-powered lamp and the gaps were found to be 'cobwebby' and no signs of bats were found. Whilst the gaps beneath the corrugation on B1 are more suitable for crevice dwelling bats, the gaps were found to be very 'cobwebby' and again no signs of bats were found.

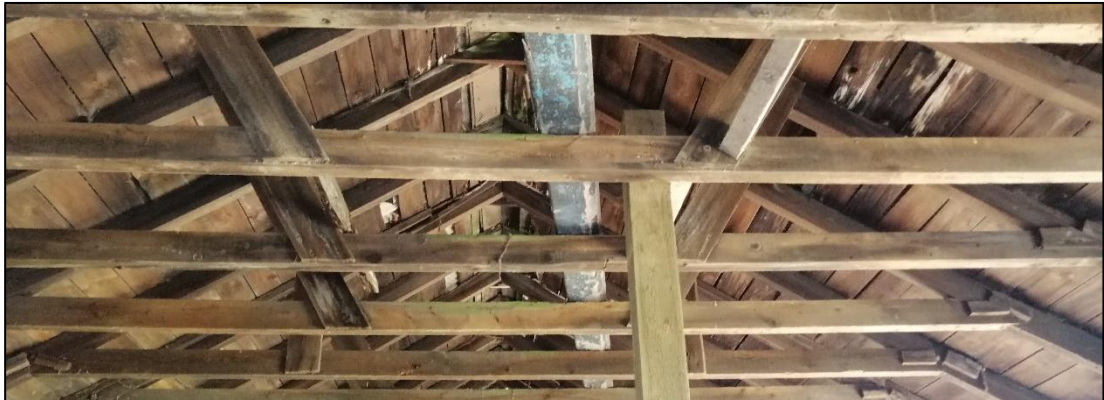
**Plate 5. Inside of B1**

- 5.2.4 There are no roof-voids in any of the buildings. There is wood sarking beneath the asbestos sheets on B1 & B3 with 5-10mm gaps between the planks (see Plate 5). No signs of bats were found but several defunct swallow *Hirundo rustica* nests were located.

- 6.3.2 Consideration should also be given to the provision of a lean-to structure such as a carport, log store or other open sided structure that can provide continued nesting opportunities on site for swallow.
