Report No: C398 Rev A Date: September 2022

LAND OFF PADDOCK ROAD, STAINCROSS, BARNSLEY, SOUTH YORKSHIRE MINING INVESTIGATION REPORT

REPORT NUMBER:	C398	REPORT STATUS:	Final – Rev A
REPORT TYPE:	Mining investigation Report		
REPORT DATE:	September 2022		
SITE:	Land off Paddock Road, Staincross Barnsley, South Yorkshire		
PREPARED FOR:	Andrew Bailey Architects		
PREPARED BY:	A Swinbourne BSc. (Hons), MIEnvSc, FGS, ACIEH.		
REVIEWED BY:	G Swinbourne BSc. (Hons), MSc., DIC, FGS

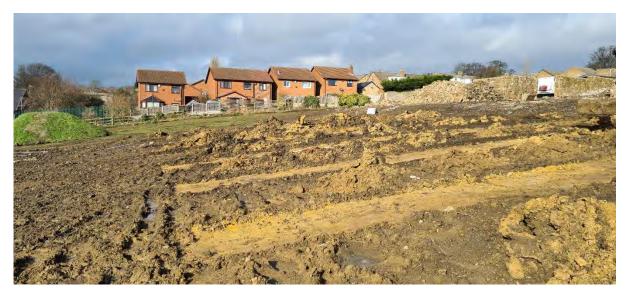
Figure 1 - Site Strip 1 looking east to west

A localised site scrape was undertaken using a 6-tonne tracked excavator to a maximum depth of 0.15 m using a ditching bucket to scrap away the topsoil and subsoil to expose the upper surface of the weathered rock (weathered mantle material) to determine if there was any discolouration which could be indicative of shallow mine workings such as bell pits or open cast / crop workings. The extent of this scrape is shown on the Trial Pit and Site Strip Location Plan (drawing number C398/CM/01) presented in Appendix A of this report:

No evidence of historical mining was encountered during the investigation. Where coal was encountered in the boreholes and trial pits it was intact. No loss of flush, broken ground or voids were recorded in the boreholes. The trial site scrape did not encounter any evidence of surface workings, either bell pits or backfilled open cast.
