**SITE INVESTIGATION REPORT**

**LAND OFF BARNBURGH ROAD, GOLDTHORPE**

**GLEESON HOMES AND REGENERATION**

**34041-005**

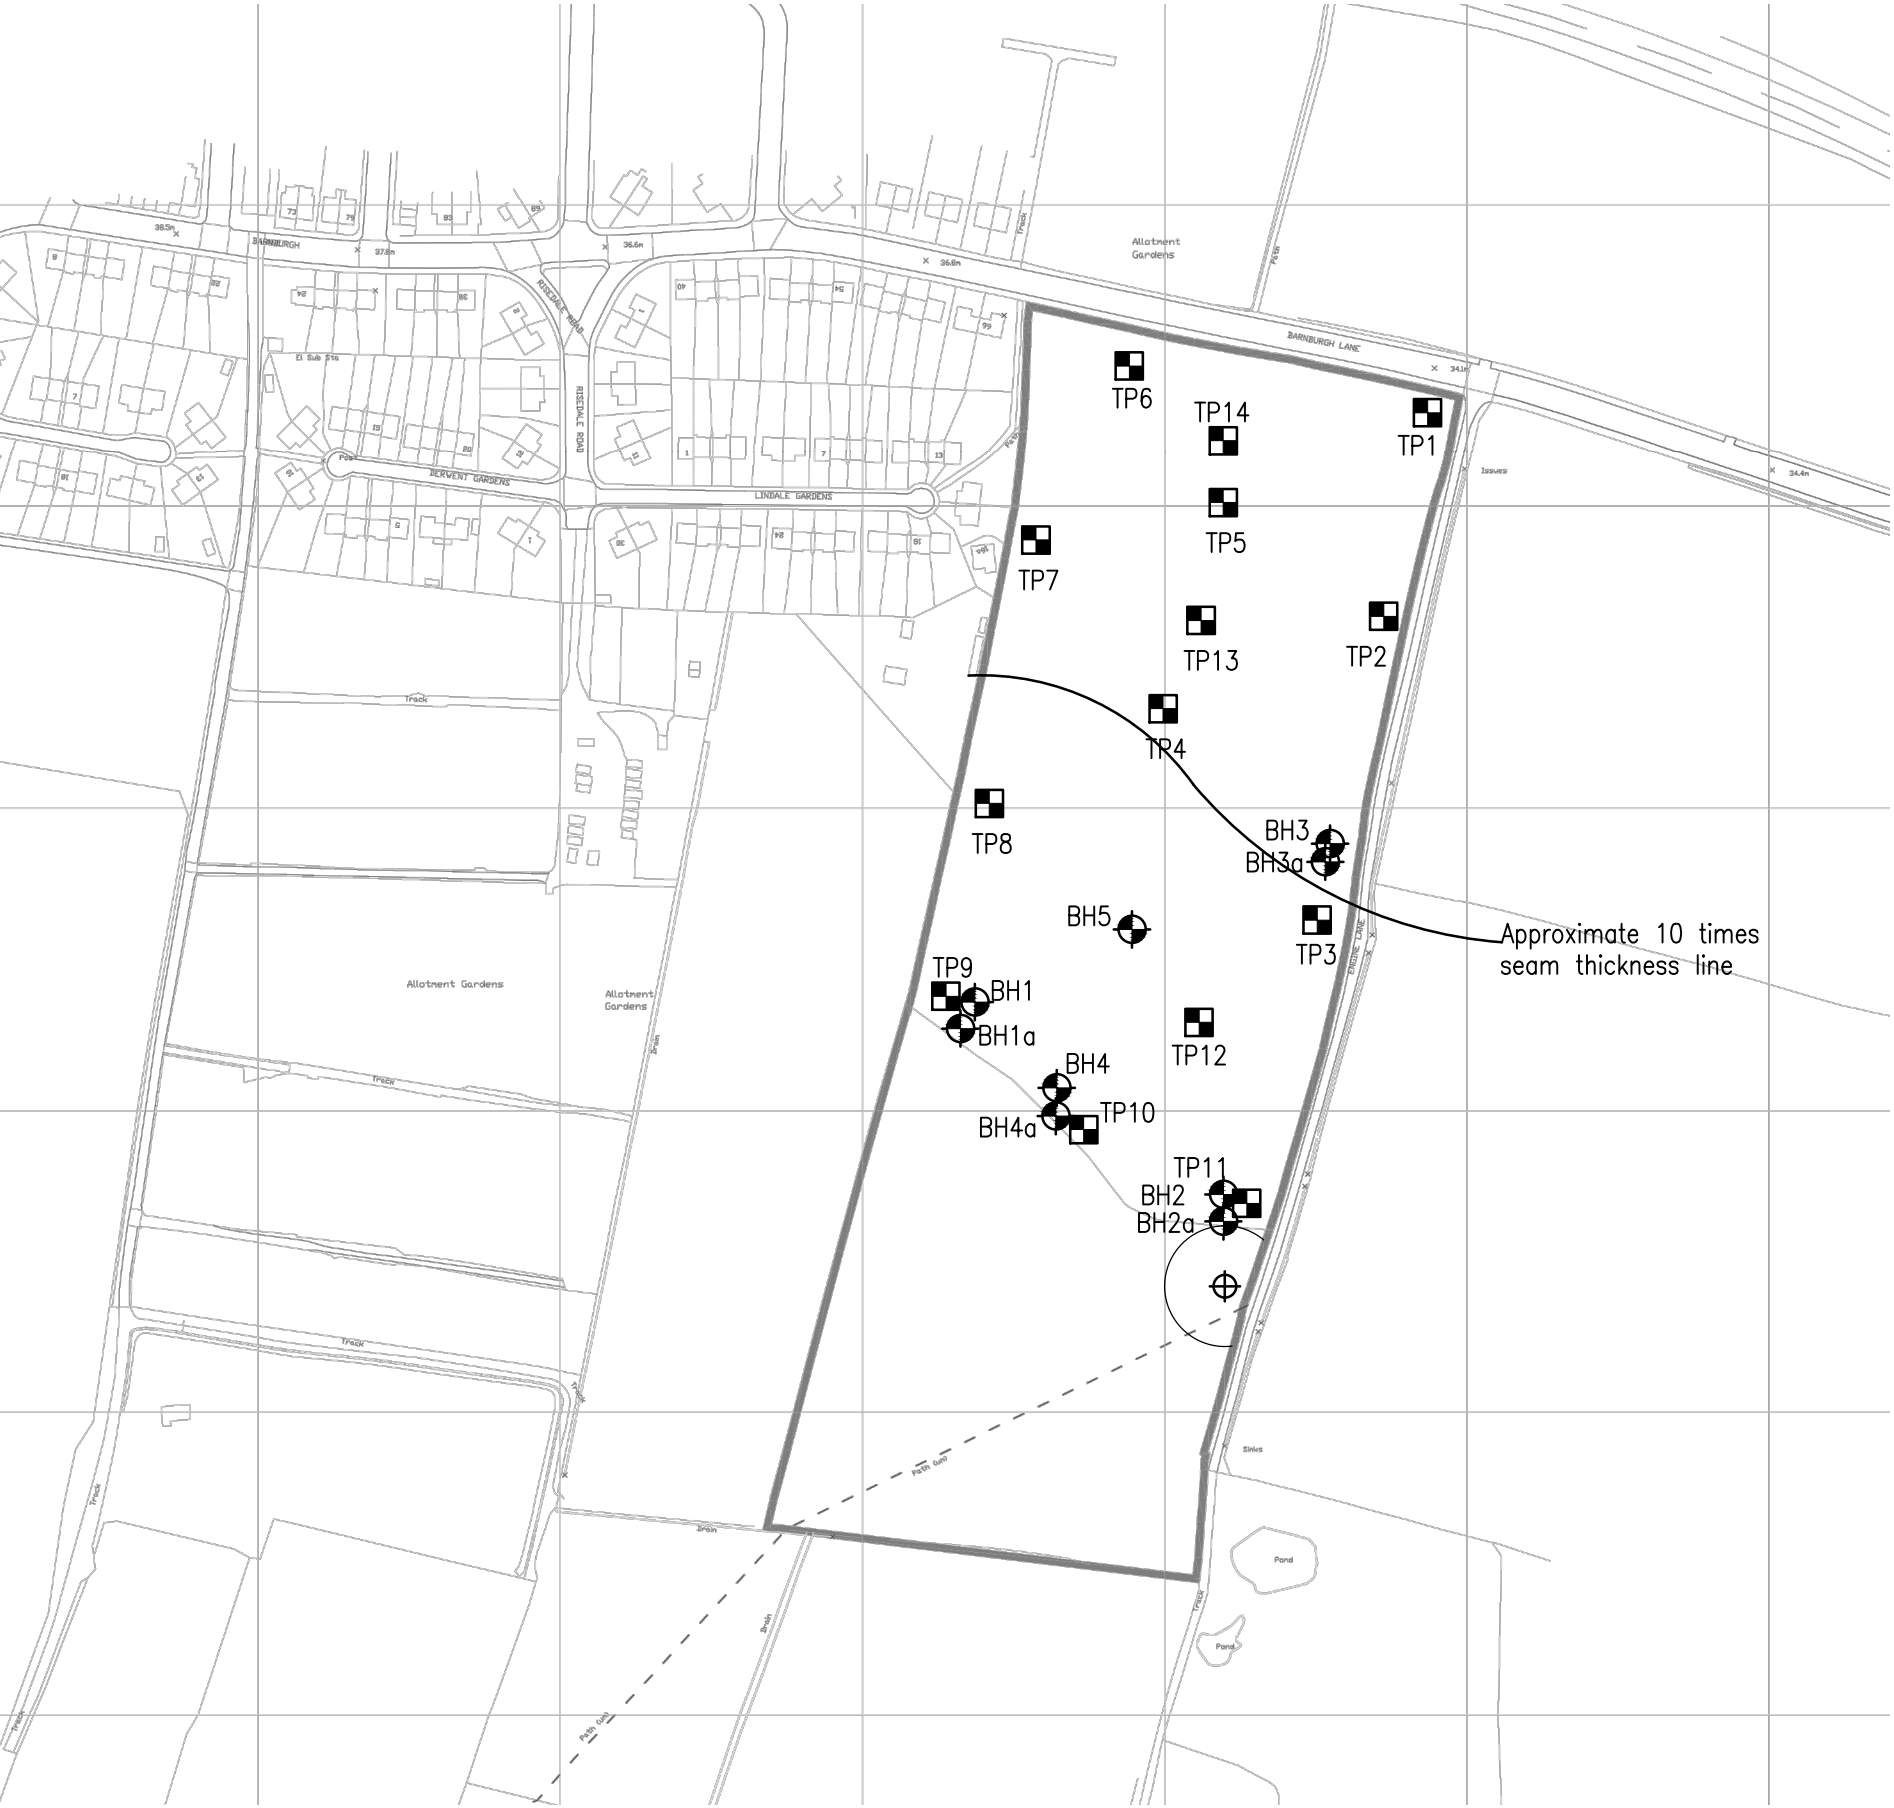
34041/002      Exploratory Hole Location Plan

- Approximate trial pit location.
- Approximate borehole location.
- Approximate location of mineshaft.  
(Ref: 446403-021).
- Approximately 20 m buffer from mineshaft location.

There is one recorded mine entry within the site. The mineshaft (ref: 446403-021) is on the site just south of the centre near the eastern boundary. It has been filled to an unknown specification and its position is shown on the Exploratory Hole Location Plan.

Copies of the trial pit and borehole logs are presented in Appendix 2, and their locations are plotted on the Exploratory Hole Location Plan, Drawing number 34041/002 revision A in appendix 1.
