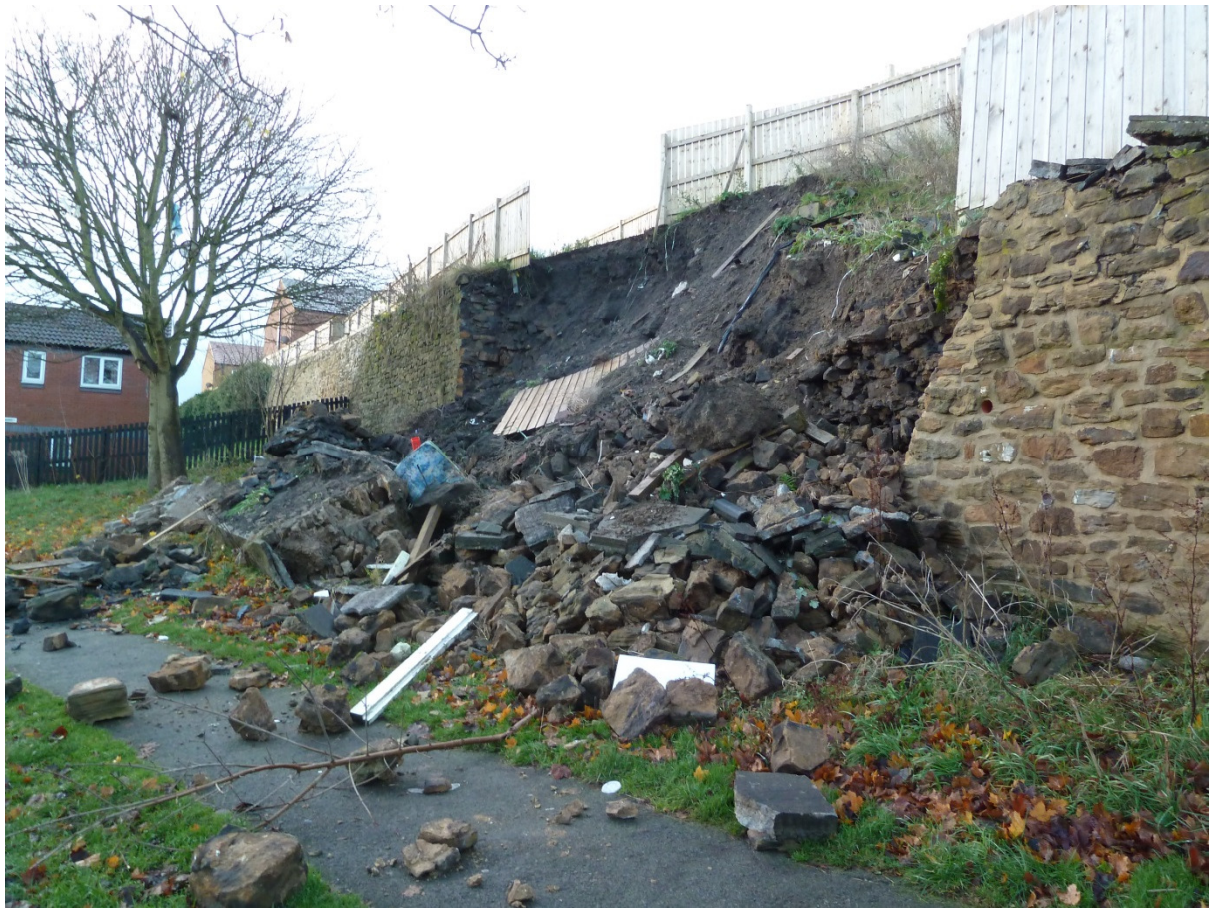
Existing landscaping:

As shown in the above photo, the existing landscaping (prior to collapse) consists of a stone masonry retaining wall with a grassed slope behind it. The area was also fenced off by wood panel fencing so that the grass slope was not accessible.

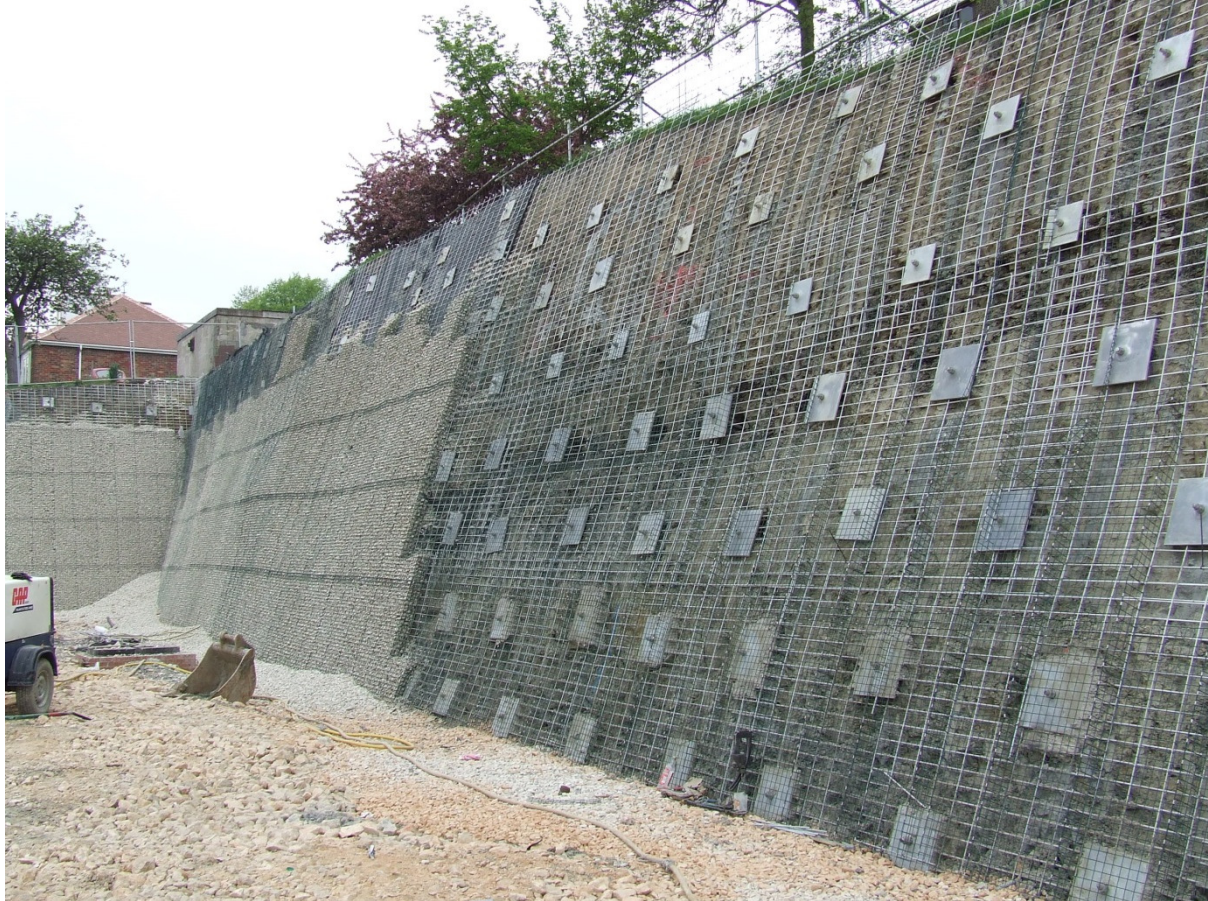
Proposed landscaping:

The Gabion Wall itself will consist of 9m soil nails, which will then be extended at the front of the existing wall so that the 150mm thick gabion structure can be attached and stone filled. The construction of a typical wall of this type is shown in the above photo.

The proposed work includes the repairing of the existing, partially collapsed stone retaining wall, and the rebuilding of the collapsed section of retaining wall in the form of a Gabion Wall.

The construction of the new Gabion Wall will involve lowering the height of the partially collapsed stone wall at the toe of the structure, grading slope back to a uniform profile and nailing the new gabions to the graded bank.

The upper part of the slope will be covered with a growth promoting geogrid and a plastic coated galvanised mesh which can be top soiled.
