Trial Pit Logs, TP01 to TP24  
Rotary Borehole Logs, BH01 to BH03  
Site Investigation Photographs

Project Name Manor Farm	Project No. 48417	Co-ords: 442839.00 - 406917.00 Level: 62.60	Date 30/08/2023
Location: Great Houghton, South Yorkshire		Dimensions: <span style="border: 1px solid black; display: inline-block; width: 100px; height: 20px; vertical-align: middle;"></span> m	Scale 1:20
Client: Avant Homes		Depth: 2.00m	Logged DN

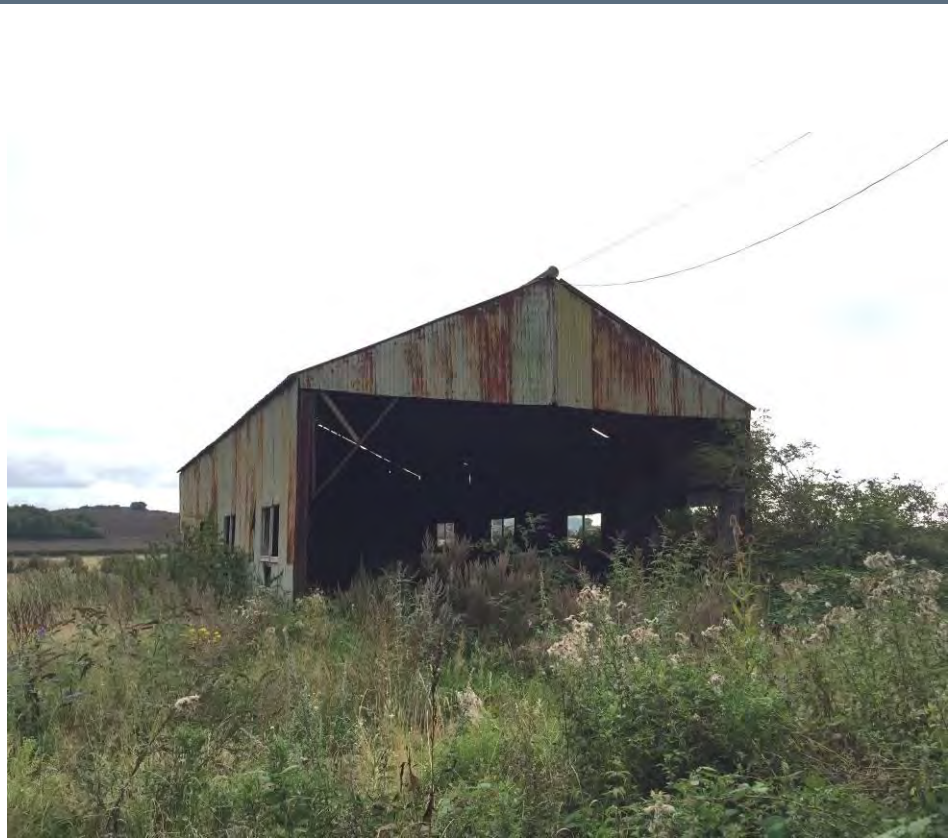
Old shed in north of farm yard

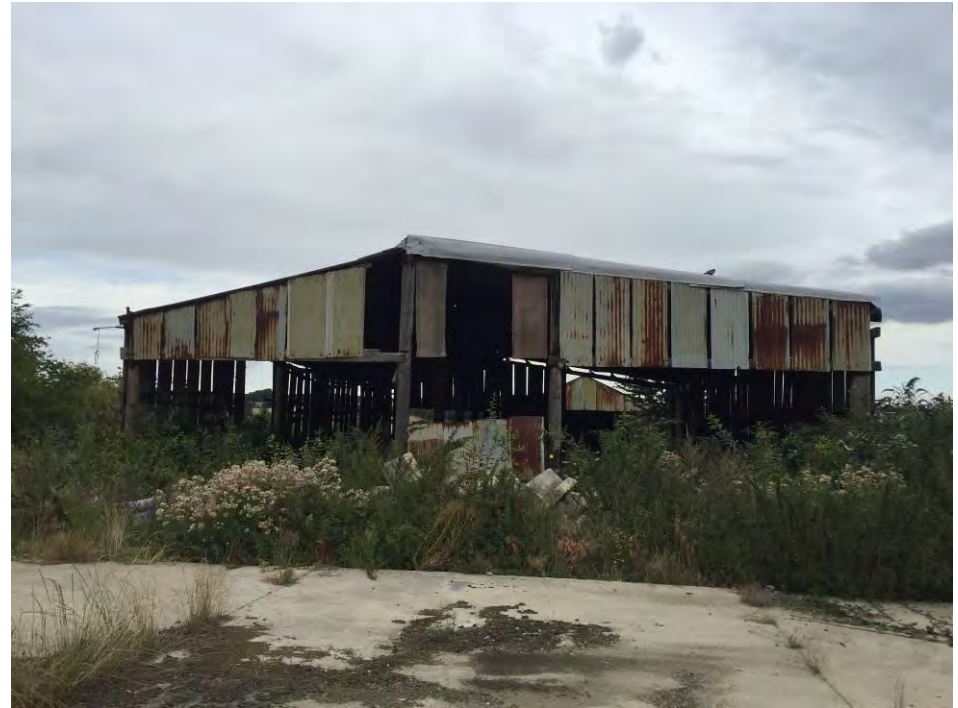
Old shed in south of farm yard

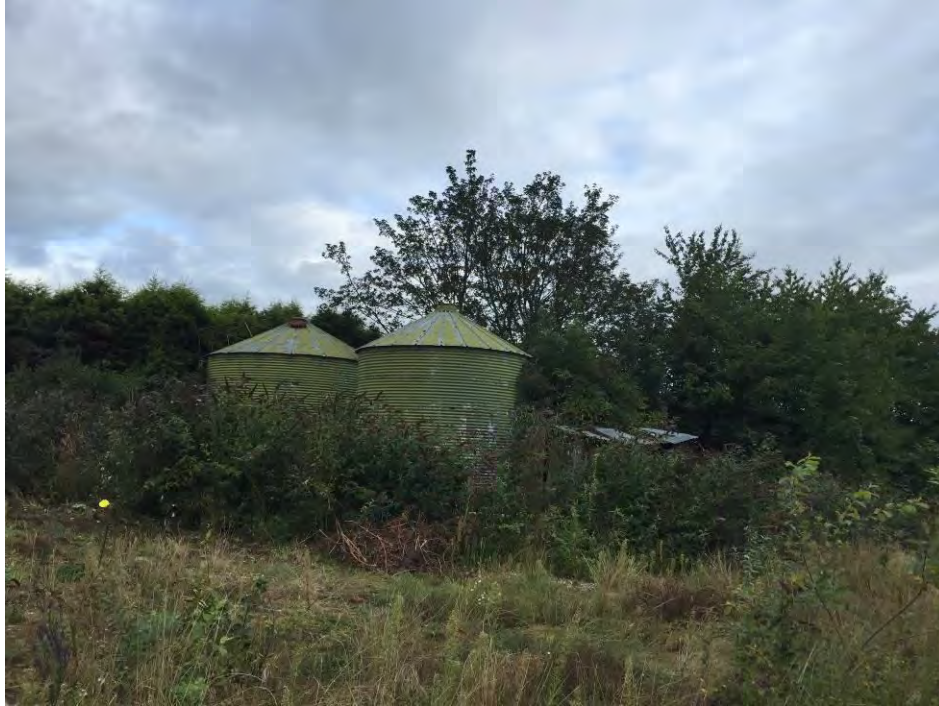
Old silos in south of farm yard

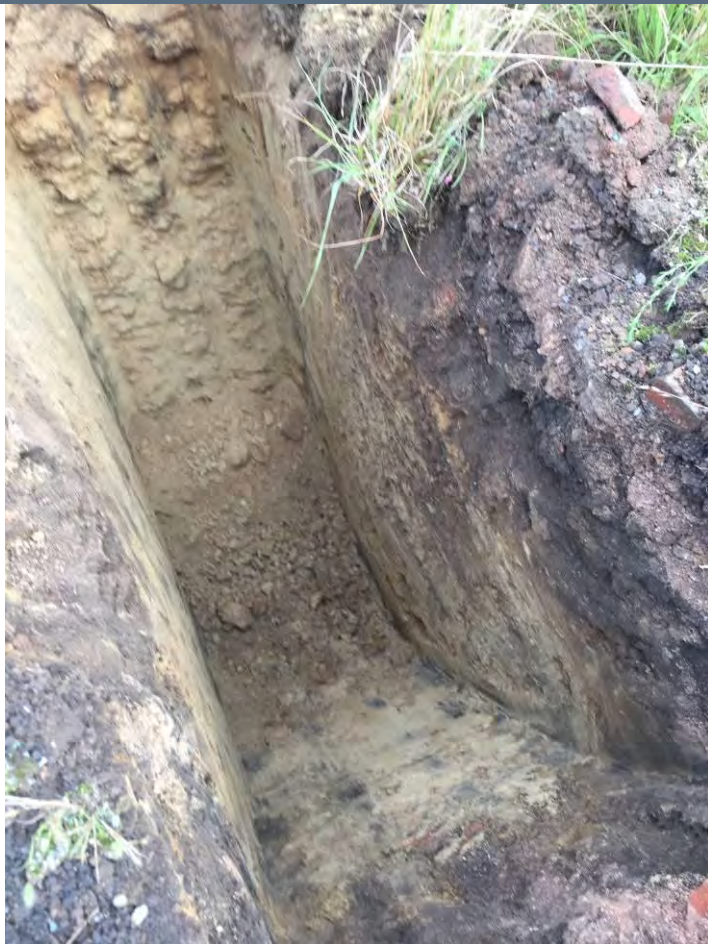
TP01

MADE GROUND: Brown very gravelly SAND. Gravel is fine to coarse angular of sandstone, concrete, brick, clinker, and rare glass and coal.
			0.35	62.25

MADE GROUND: Dark brown slightly gravelly SAND. Gravel is fine to coarse angular of brick.
0.60	ES

Brown slightly gravelly silty fine to medium SAND. Gravel is fine to coarse angular of sandstone. <i>Redundant cable encountered at 0.45m.</i>
			1.10	61.50

Very weak light brown medium-grained SANDSTONE recovered as very sandy fine to coarse angular gravel. Slow progress at base. <i>Recovered with low cobble content below 1.6m.</i>
			2.00	60.60		Trialpit Complete at 2.000m

Remarks: Pit terminated at 2.0m due to slow progress. Groundwater not encountered. Backfilled with arisings.

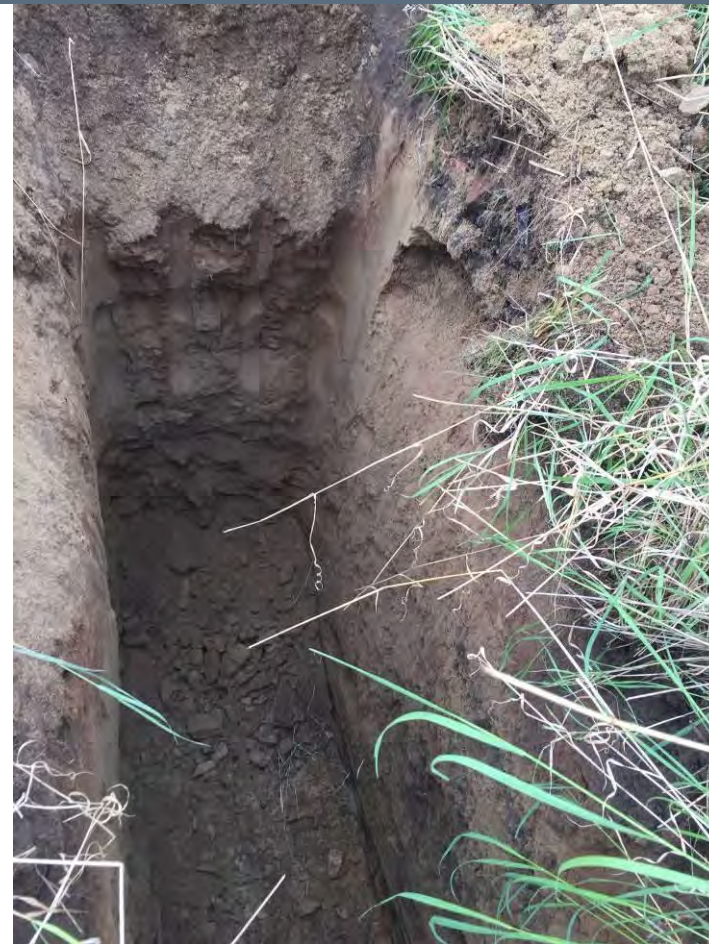
TP02

MADE GROUND: Brown very sandy GRAVEL with high cobble content. Gravel and cobbles of brick, concrete and sandstone.
			0.50	61.10

Light brown very sandy GRAVEL. Gravel is fine to coarse angular of sandstone.
0.90	ES

Extremely weak light brown medium-grained SANDSTONE recovered as very sandy fine to coarse angular gravel. Slow progress at base.
			1.50	60.10

<i>Below 1.7m: Very weak and recovered with low cobble content.</i>
			1.90	59.70		Trialpit Complete at 1.900m

Remarks: Pit terminated at 1.9m due to slow progress. Groundwater not encountered. Backfilled with arisings.

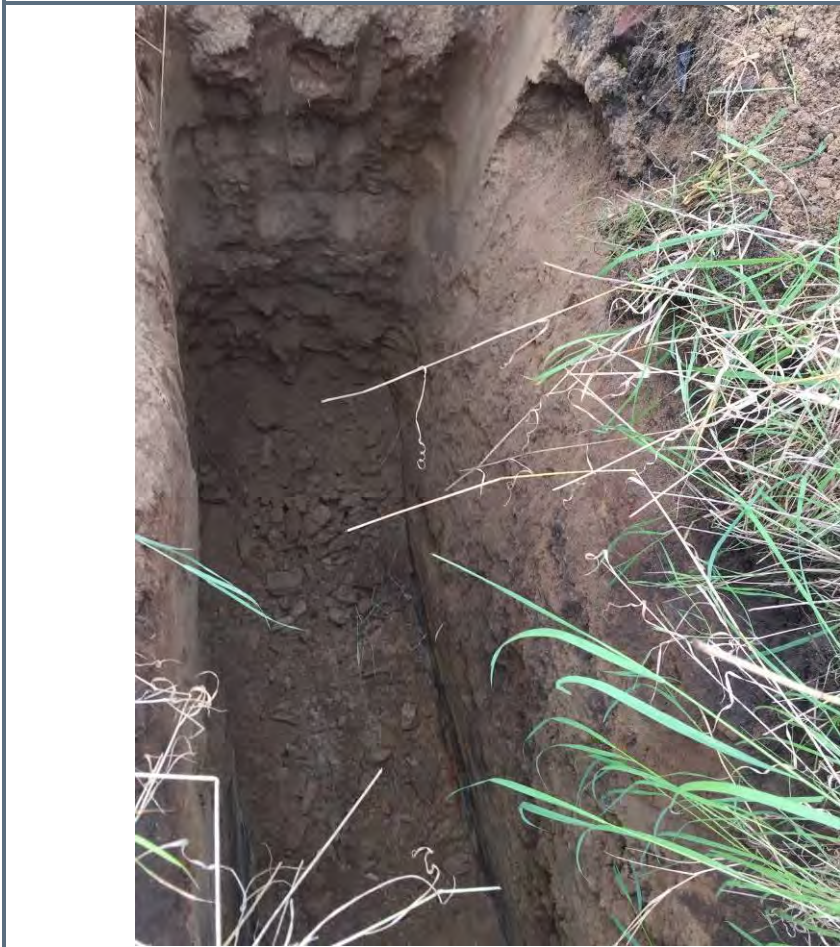
TP03

TOPSOIL: Dark brown silty very gravelly SAND with medium cobble content. Gravel is fine to coarse angular of sandstone and brick fragments. Cobbles of brick.
0.50	ES

Light brown gravelly fine to coarse SAND. Gravel is fine to coarse angular of sandstone.
			1.50	59.10

Extremely weak light brown medium-grained SANDSTONE recovered as very sandy fine to coarse angular gravel. Slow progress at base.
			2.00	58.60

Below 1.7m: Very weak and recovered with low cobble content.
Trialpit Complete at 2.000m

Remarks: Pit terminated at 2.0m due to slow progress. Groundwater not encountered. Backfilled with arisings.

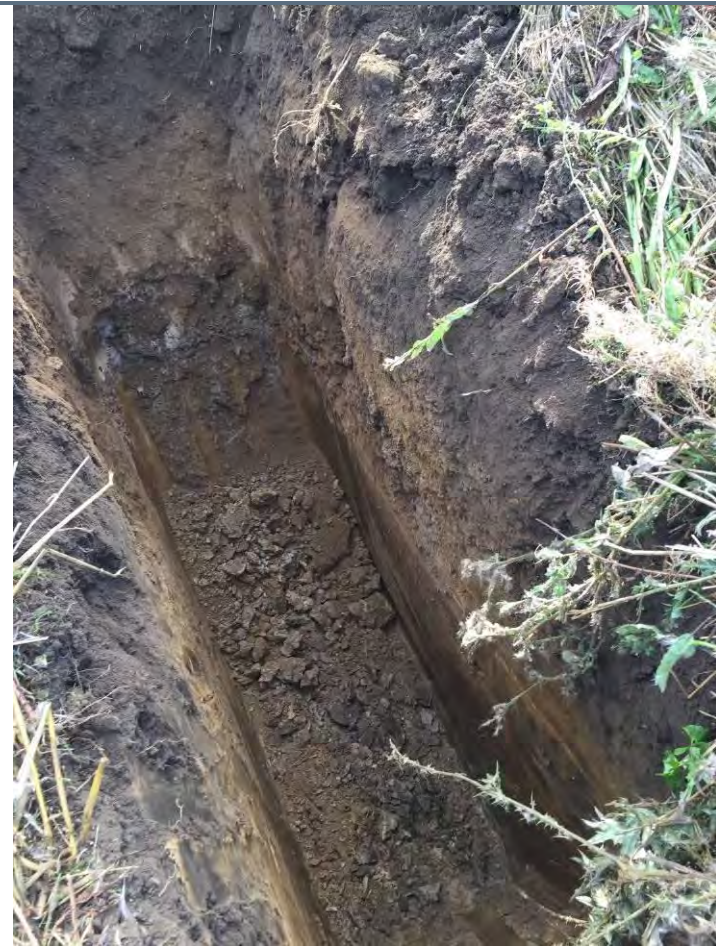
TP04

TOPSOIL: Dark brown slightly gravelly very silty SAND. Gravel is fine to coarse angular of sandstone.
0.80 0.80	D	HVP=115

Stiff grey mottled brown CLAY.
			1.70	57.85

Very weak brown fine-grained SANDSTONE recovered as slightly sandy fine to coarse angular platy gravel. Slow progress at base.
			1.90	57.65		Trialpit Complete at 1.900m

Remarks: Pit terminated at 1.9m due to slow progress. Groundwater not encountered. Backfilled with arisings. HVP = Average hand shear vane reading in kN/m2.
