**Cliffe House Farm, Cubley**  
**Bat and Barn Owl Survey Report**  
**15<sup>th</sup> June 2018**

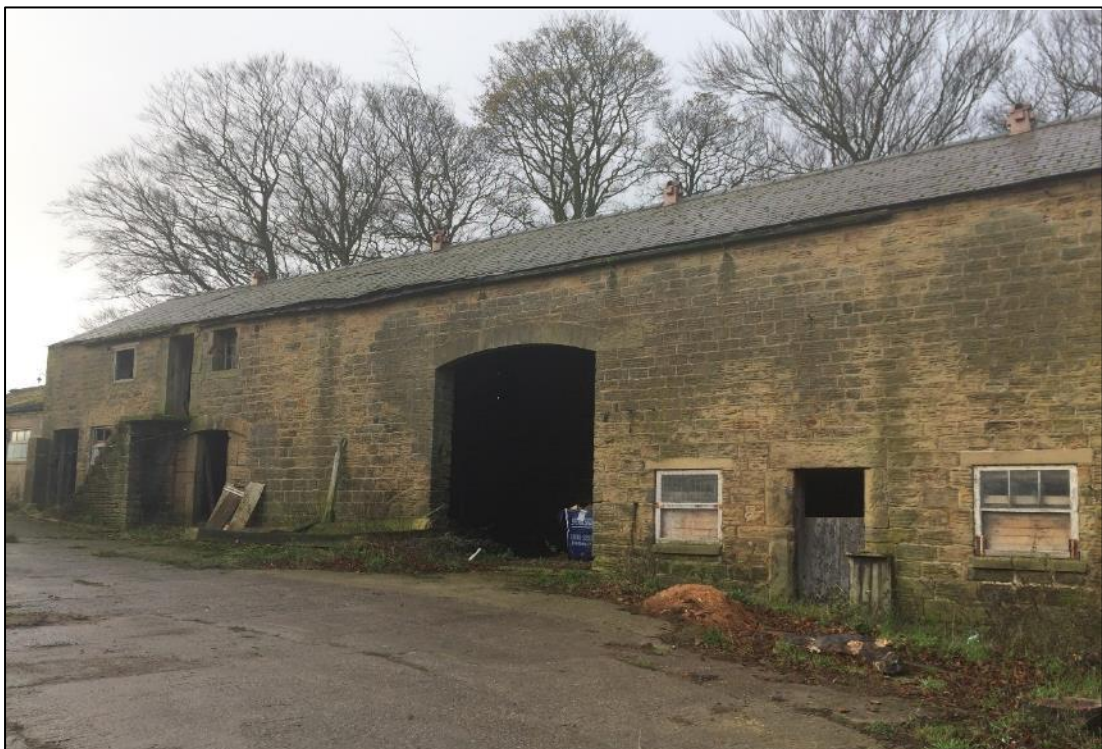
**Plate 1. Main barn (Building 1)**

- 5.2.2 The surveyed buildings comprise a large rectangular stone built two storey barn on a North-South axis (Building 1) together with an adjoining single storey stone built east wing (Building 2). Building 1 has a pitched Welsh slate roof supported by king-post roof timbers; a large central opening leads to a section that is open to the underside of the roof covering and either side of this the building comprises several compartments at both ground level and first floor level (see Plate 1). At the south end of this building is a modern single storey concrete block extension which has a metal framed pitched corrugated asbestos cement sheet roof (see Plate 3). The single storey adjoining wing (Building 2) is again built of stone beneath a pitched York stone/grey slate roof (see Plate 2).

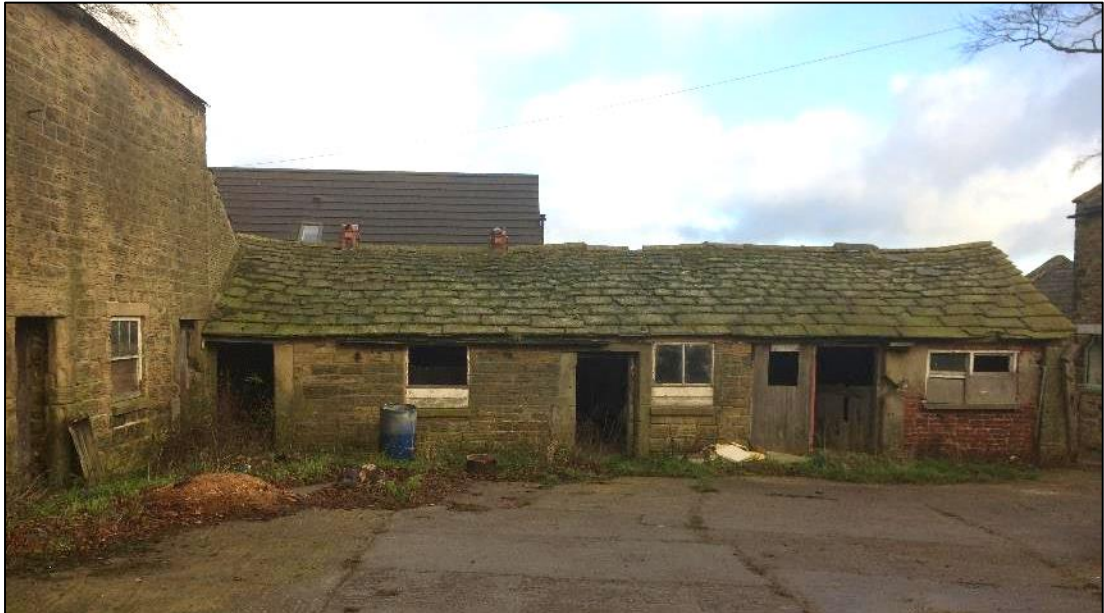
**Plate 2. Adjoining east wing (Building 2)**

- 5.2.3 The east facing external wall of Building 1 has been maintained and potential bat roosting opportunities are limited to a few small holes. However, the western elevation of this building has a relatively large number of crevices in mortar joints leading to the rubble filled core of the walls. The inside walls also display bat roost features with both large and small holes present. The York stone slates of Building 2 contain an abundance of gaps beneath slates. Gaps between lintels above doorways on building 1 also provide good potential roost features.

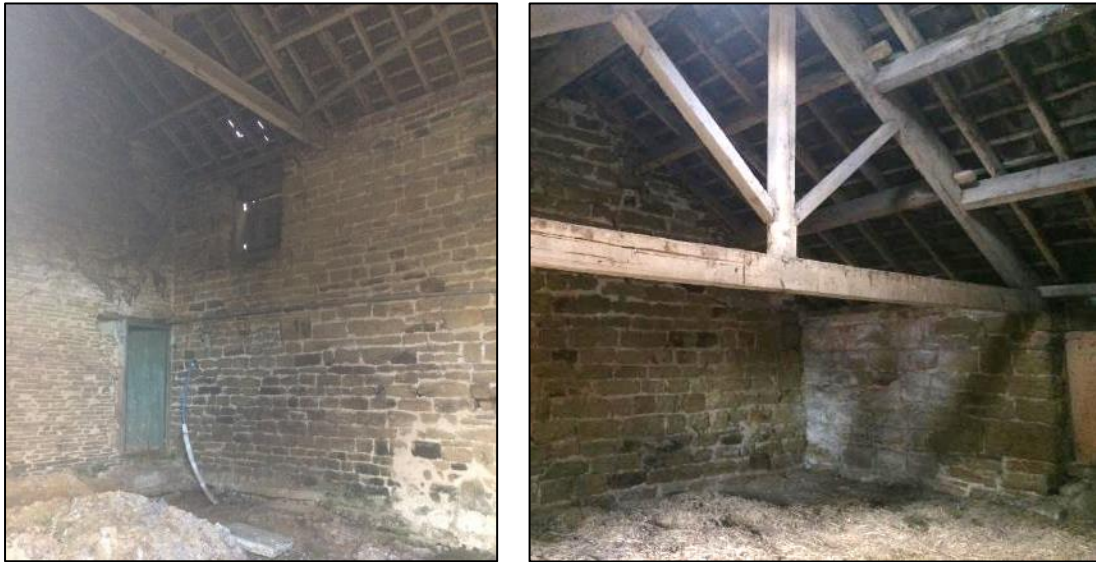
**Plate 4. Inside of central section of Building 1 and a first floor compartment within the same building**

- 5.2.4 There is no membrane beneath the roof slates throughout any section of either building. Crevices between floor timbers and wall stonework, and gaps between the ridge beam and ridge tiles ridge were mainly filled with detritus and 'cobwebs'.
- 5.2.5 More than 20 defunct swallow *Hirundo rusitca* nests at various locations were located within the main barn (Building 1). Other defunct nests of blackbird *Turdus merula* and wren *Troglodytes troglodytes* were also found recorded within the building.

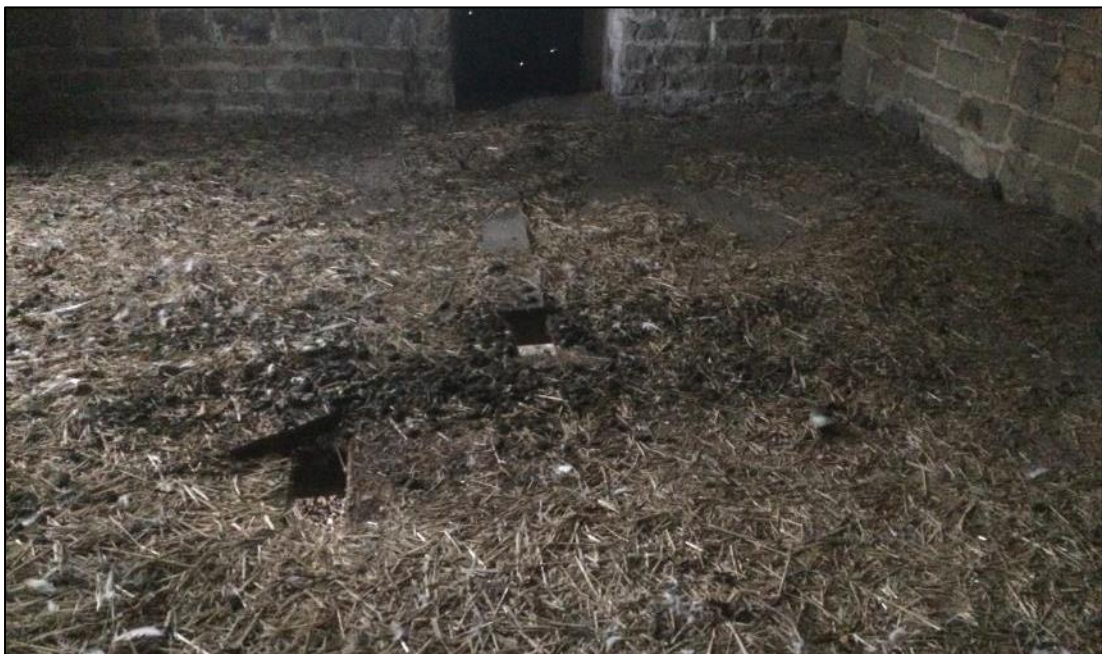
**Plate 5. Barn owl pellets on upper floor of main barn (Building 1)**

- 5.2.6 Accumulations of barn owl pellets were located in the central section of the main barn (Building 1). The amount of pellets (c300) was considered indicative of long-term use by a breeding pair (see Plate 5). Inspection of the wall top with the aid of a ladder revealed previous nesting locations in the centre of the western wall top (see Plates 6 & 7), with two adult barn owls flushed from this area of wall top. The nest location was evidenced by thick accumulations of pellet debris including small mammal bones on the wall top, where pellets have been crushed by the movement of birds. During the field survey, a previous owner of the barn commented that barn owl had bred within the barn for the past four years following a period of absence, with barn owl usage of the barn going back at least 70 years. On the basis of survey information gathered during the survey, it is considered that the barn can be classified as an Occupied Breeding Site (OBS) for barn owl (Schawyer, 2011).

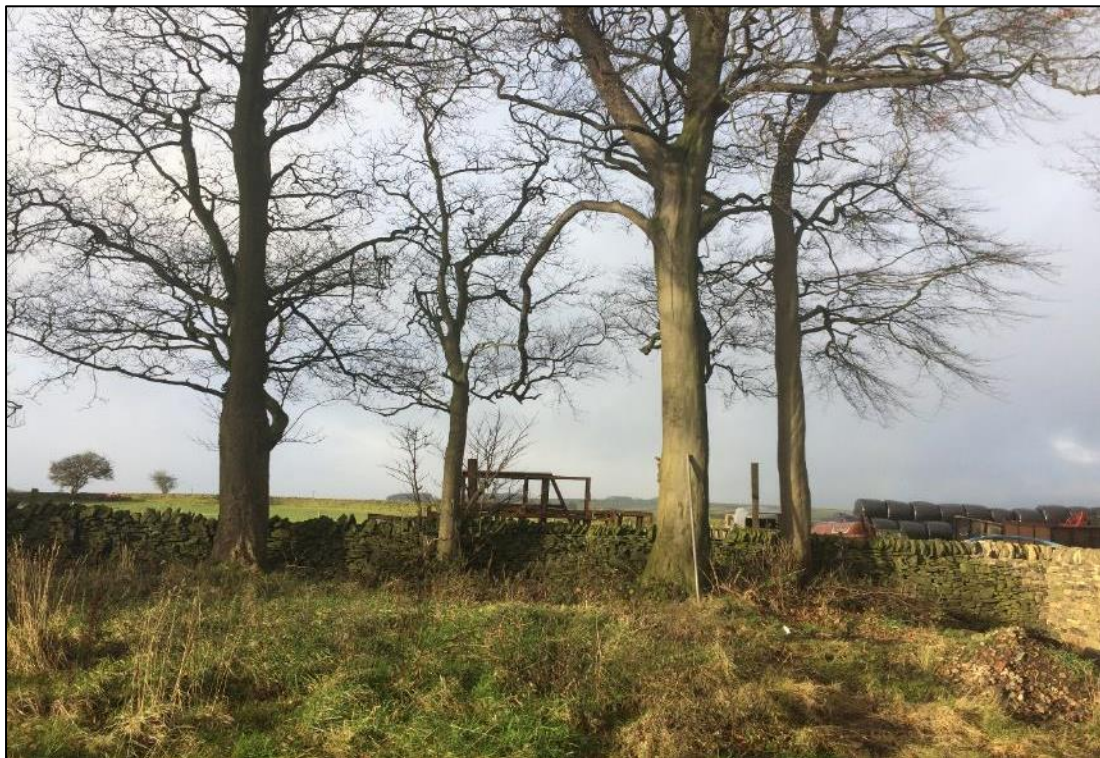
**Plate 8. Area proposed for construction of sewage treatment unit (top left on Figure 2)**

- 5.2.8 None of the trees likely to be impacted by the works display features with potential to accommodate roosting bats (see Plate 8). With the exception of the trees, the habitats are of low ecological value. Works for the sewage treatment unit will not result in impacts of greater than site level importance to nature conservation.

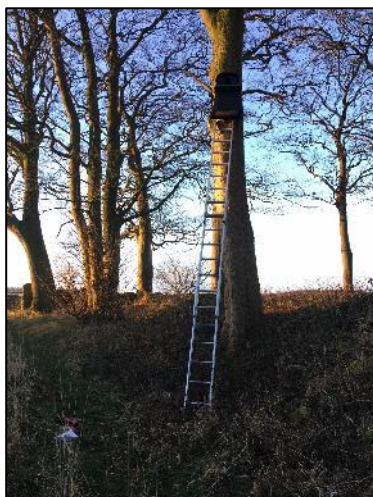
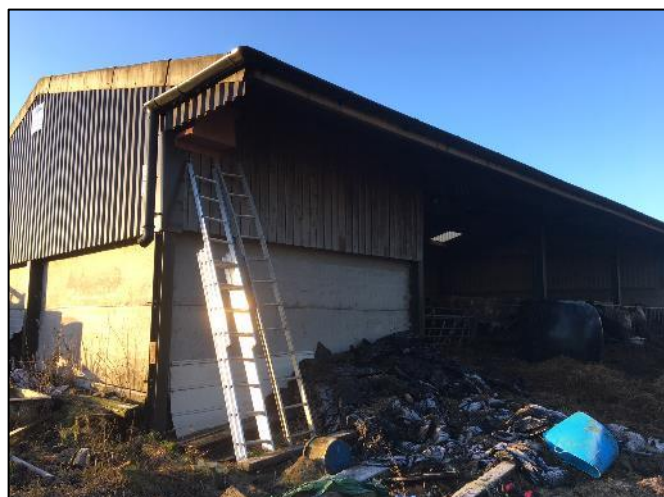
**Plates 11 and 12. Installed barn owl boxes**

6.3.4 In the short term, two barn owl boxes were installed close to the surveyed buildings in December 2017. Fitted barn owl boxes include one Eco Barn Owl Box installed on a beech tree to the west of the barn (Plate 11) and one Wooden Barn Owl Nest Box installed with the local farmer's consent on a modern barn approximately 25m east of Building 1 (Plate 12). Despite the presence of these boxes through 2018, the barn owls remained using their historic nest site within Building 1 during the nocturnal surveys.
