**SITE NAME:** Bank House

**LOCATION:** Bank House Farm, A628, Silkstone, Barnsley, S75 4FZ

**SCOPE:** This report is a supplementary statement to consider the heritage significance of the gable wall at Bank House. The site is a Grade II Listed building (NHLE:1193251). It should be read in conjunction with a previously submitted heritage statement in July 2021 (TJC 2021.73v1).

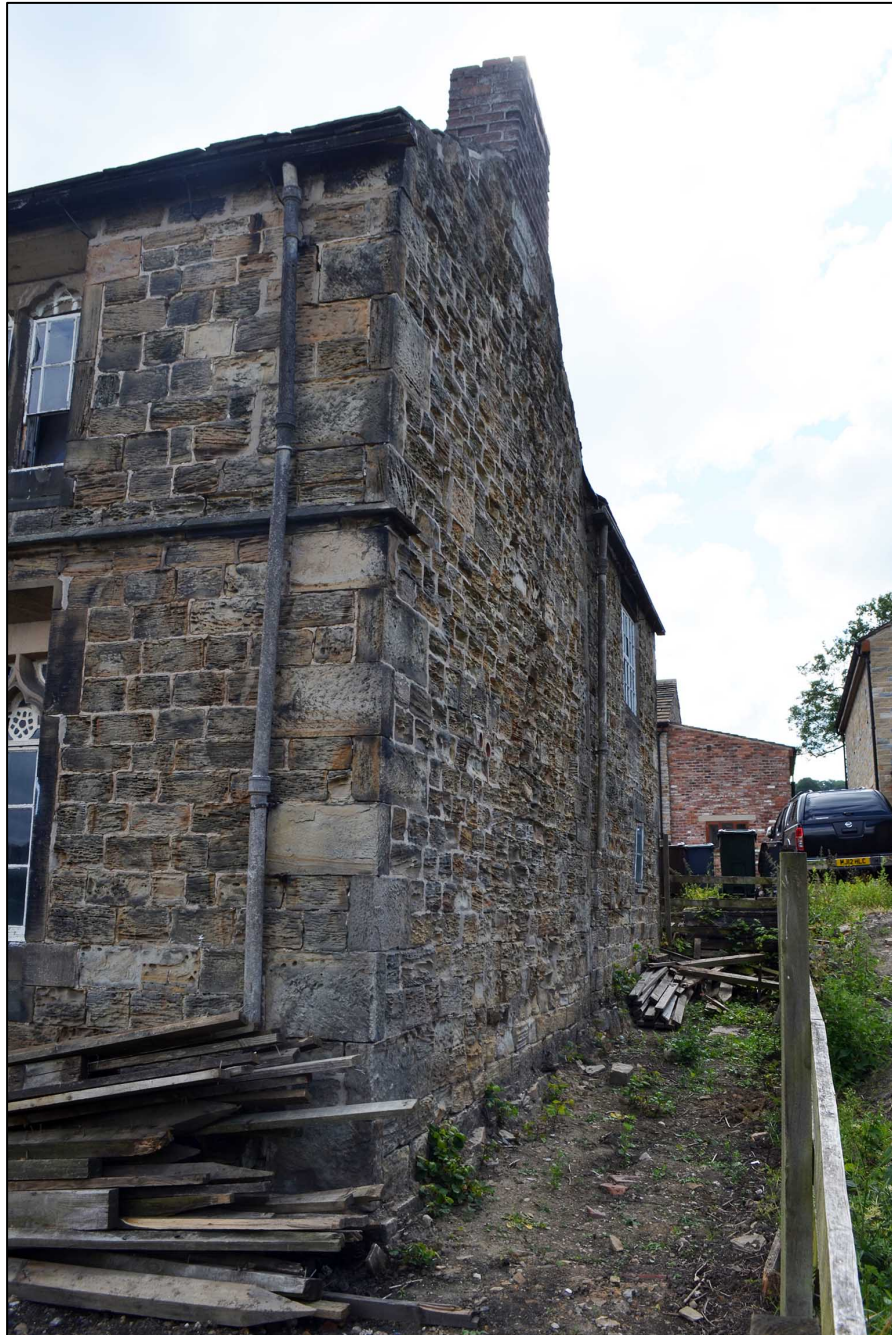
**Figure 1:** North-west elevation of Bank House

coat of arms above, and bays either side of deeply splayed mullioned windows with tracery and decorative leaded lights. The north-west gable of this range is blind (**Figure 1**), as too was the south-east gable (**Figure 2**) prior to the insertion of door and window, in the late 20<sup>th</sup> Century.

the north-west and south-east gables of the frontage range are dismantled and rebuilt, thus ensuring their long term structural stability.

- Historic wall fabric should will be reused where possible and make use of new stone which compliments the existing coursing and external appearance of the building – thus ensuring that its overall historic character can be retained.
- The gable stacks should be rebuilt, with consideration to replace the north-west stack (**Figure 1**) which has been replaced in brick, with stone to match the stack on the south-east (**Figure 2**) and thus provided a degree of enhancement to the principal façade.
