**PHOENIX PARK**  
**THURNSCOE**  
**ARBORICULTURAL IMPACT ASSESSMENT**  
**JULY 2024**

Title  
Arboricultural Impact Assessment [BASELINE]

Title  
Arboricultural Impact Assessment [EFFECTS]

Title  
Arboricultural Impact Assessment [MITIGATION]

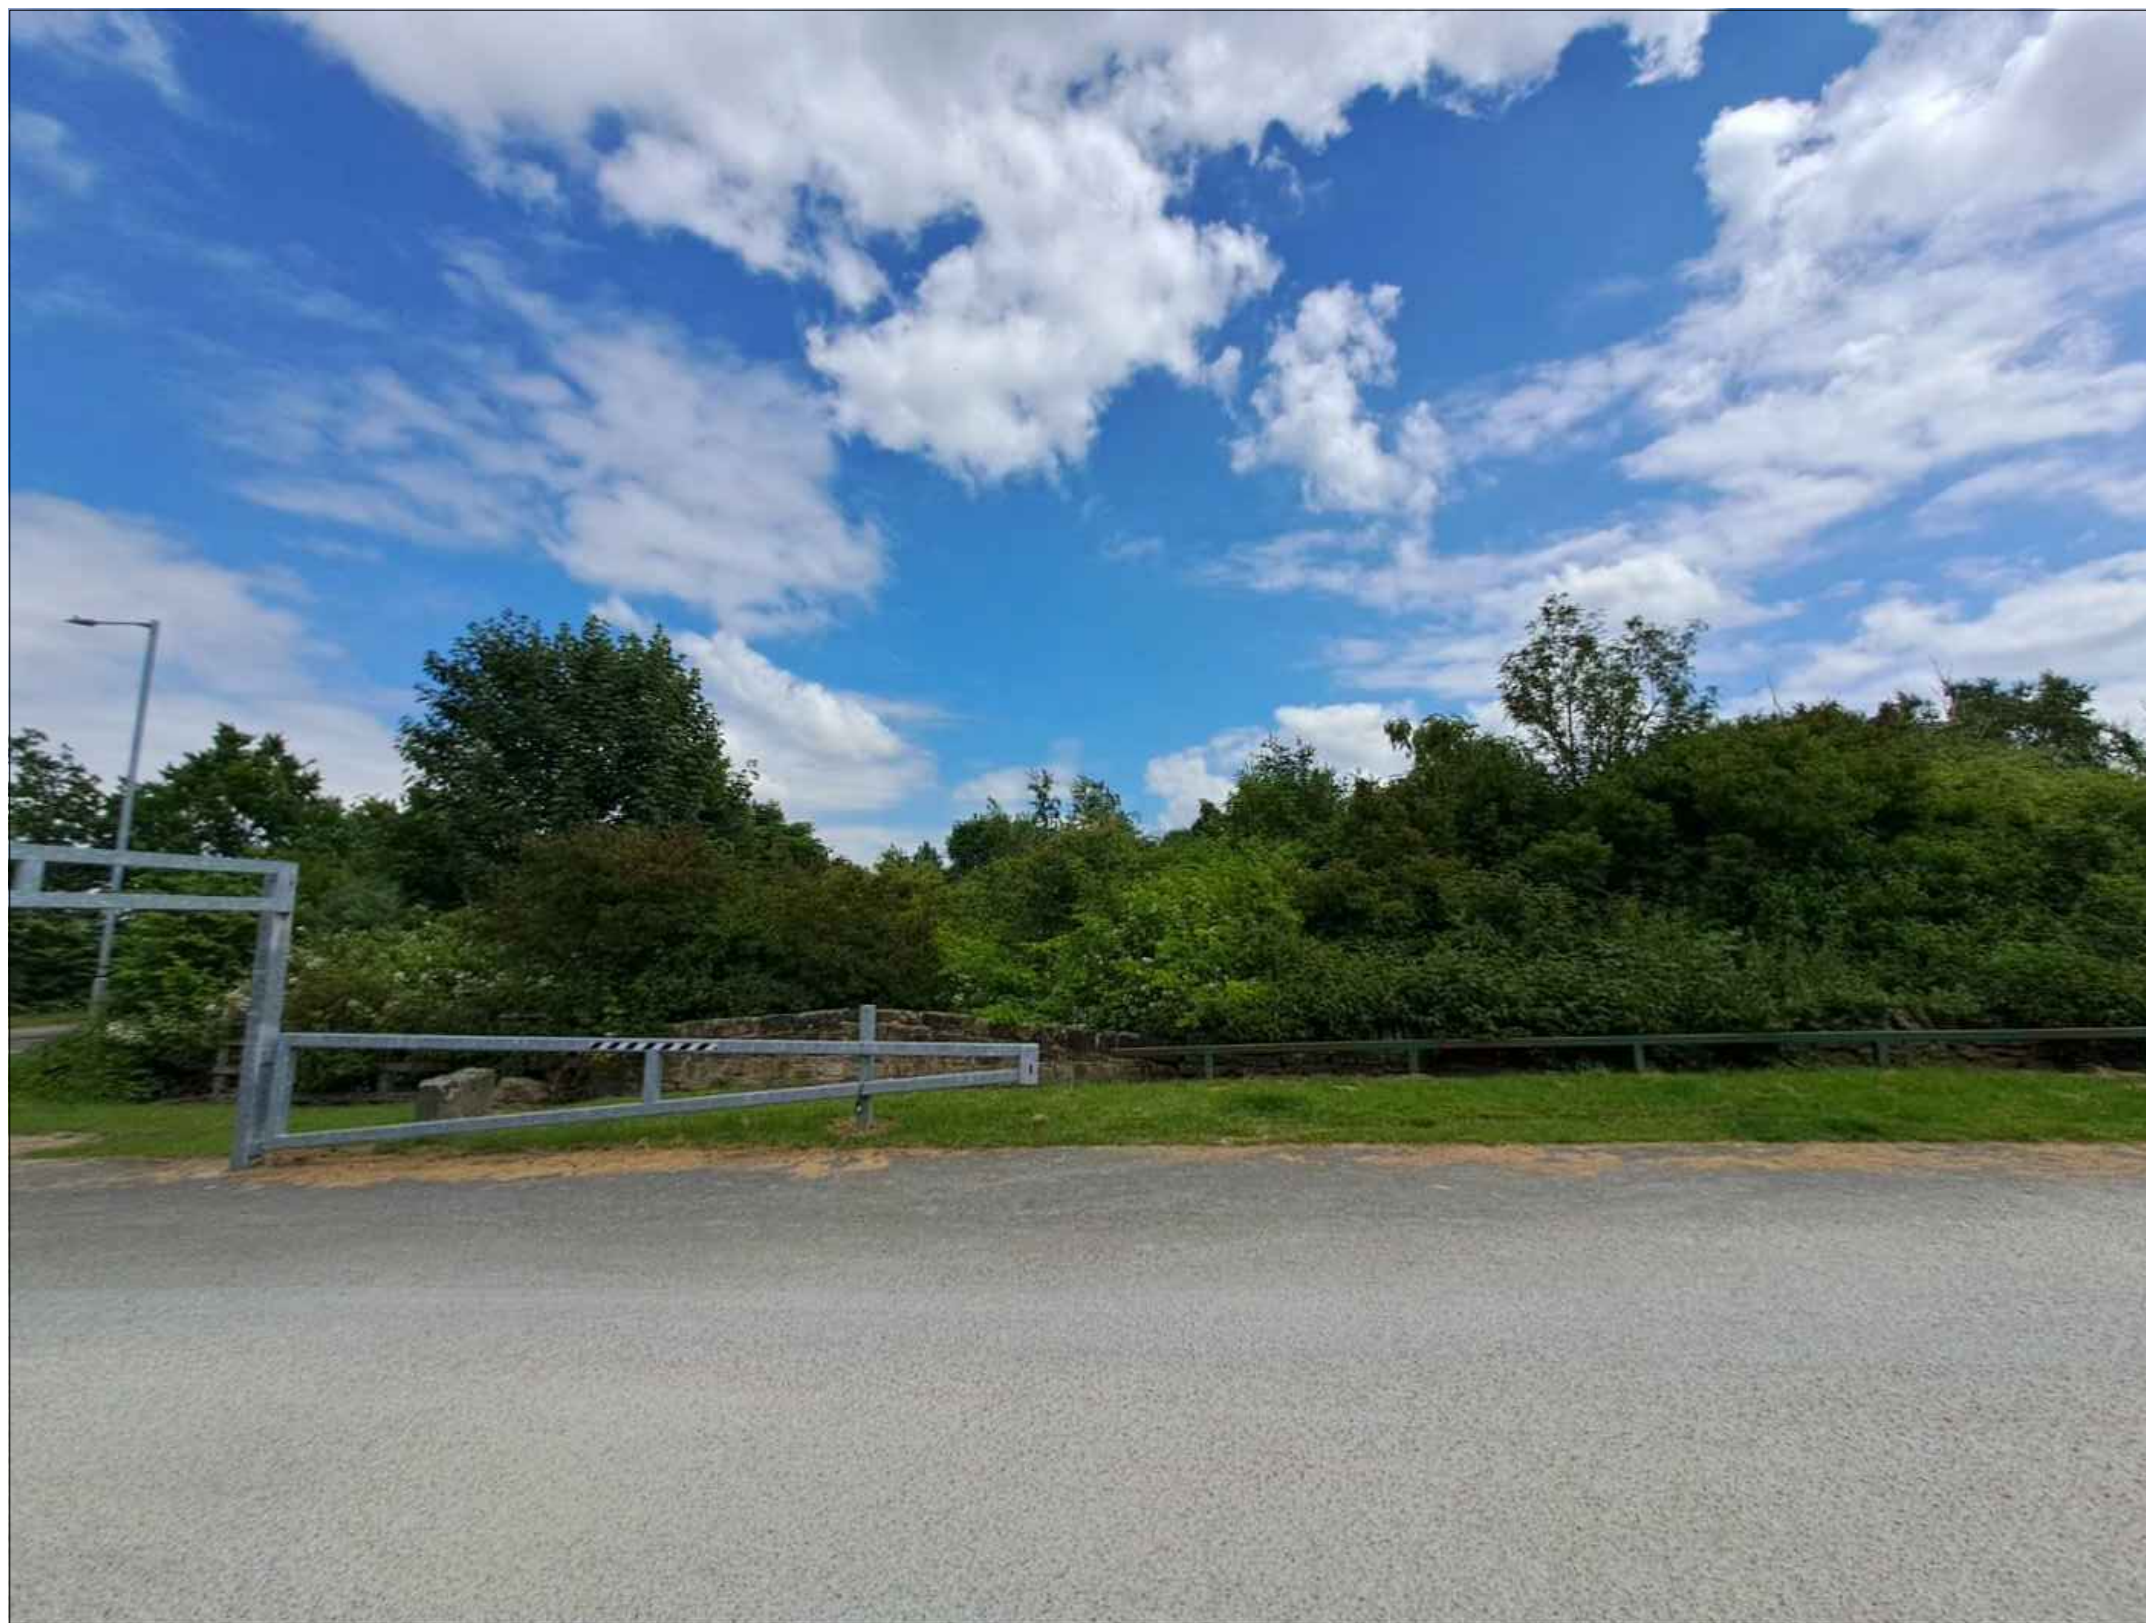
**G3: Small trees to be cut back and location of watching  
brief for service corridor excavation (left of frame)**

- 4.15. Two sections of excavation for services will be completed under an **Arboricultural Watching Brief** (see **pink cross hatch** opposite).
- 4.15.1. Excavation of a shared service corridor containing drainage, electricity and water connections to the east of the access off Barrowfield Road (adjacent to G3) will be supervised by an arboriculturist. There is no existing boundary wall in this section to protect the trees, but an existing post and rail fence will be maintained. The supervising arboriculturist will ensure that the working area is minimised and/or to the western side of the trench only, and will identify and prune any major roots that are uncovered.

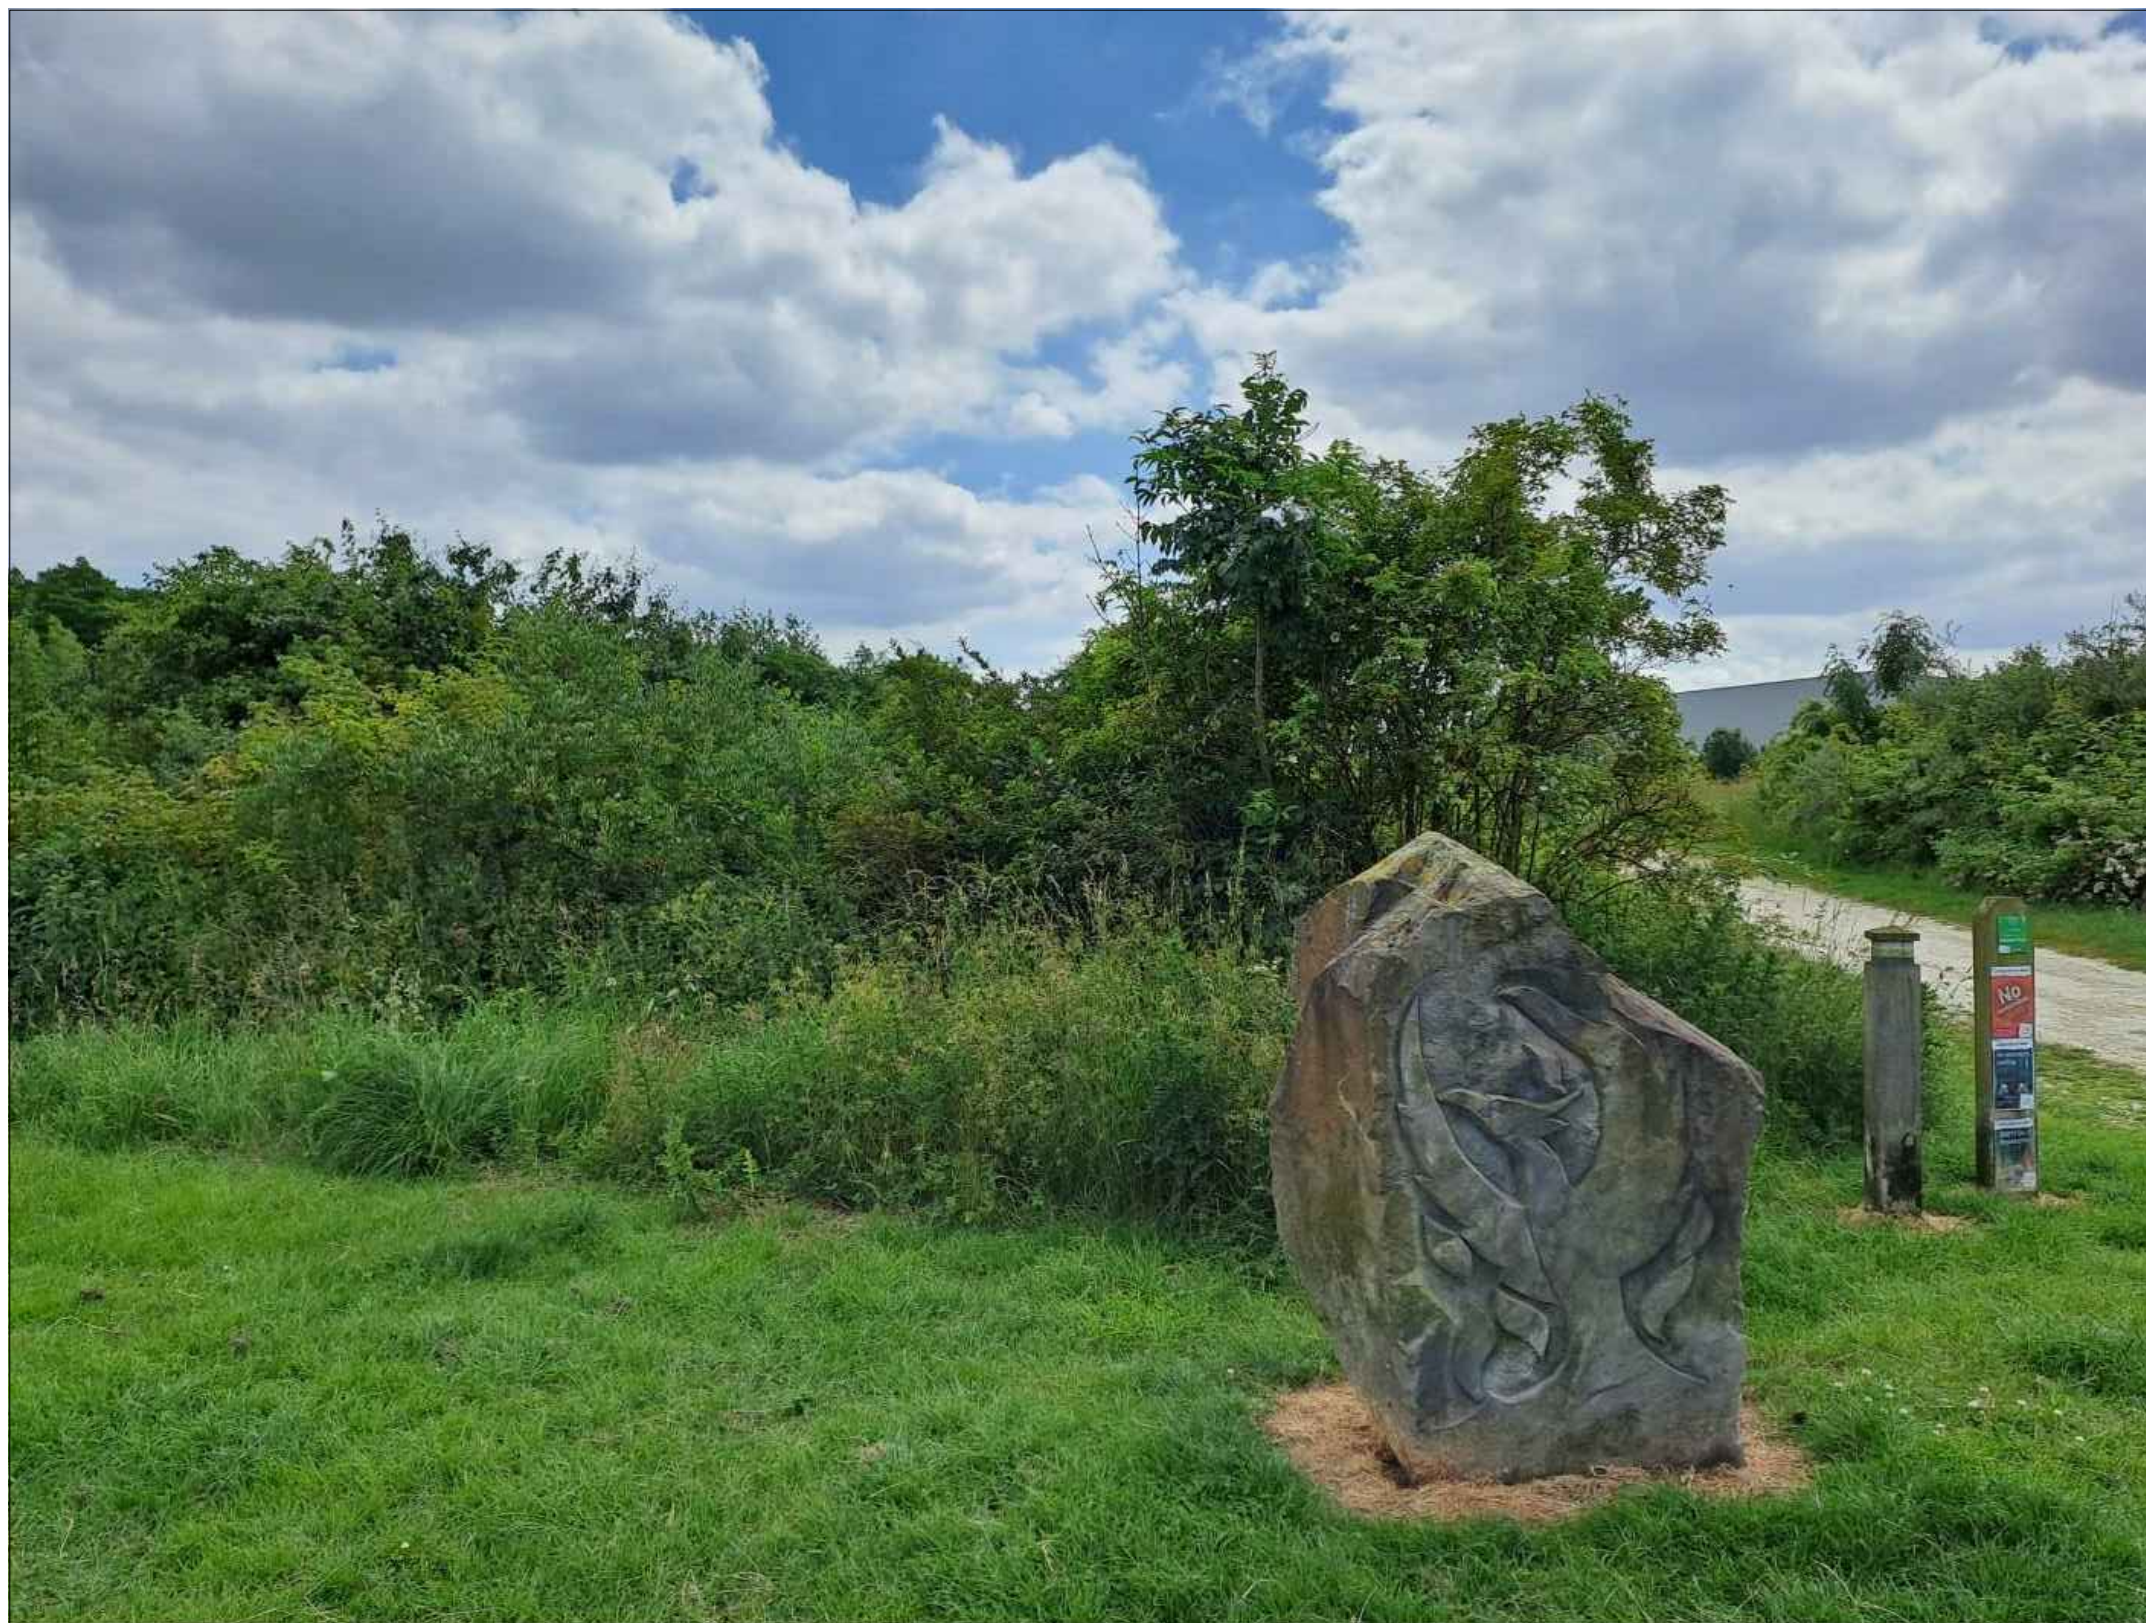
#### G4: Location of supervised excavation for surface water drain between trees and track (right of frame)

- 4.15.2. Excavation and installation of a surface water drain and outfall and around the western end of G4 will be supervised by an arboriculturist. The supervising arboriculturist will ensure that the working area and tree removal are minimised, and will identify and prune any major roots that are uncovered.

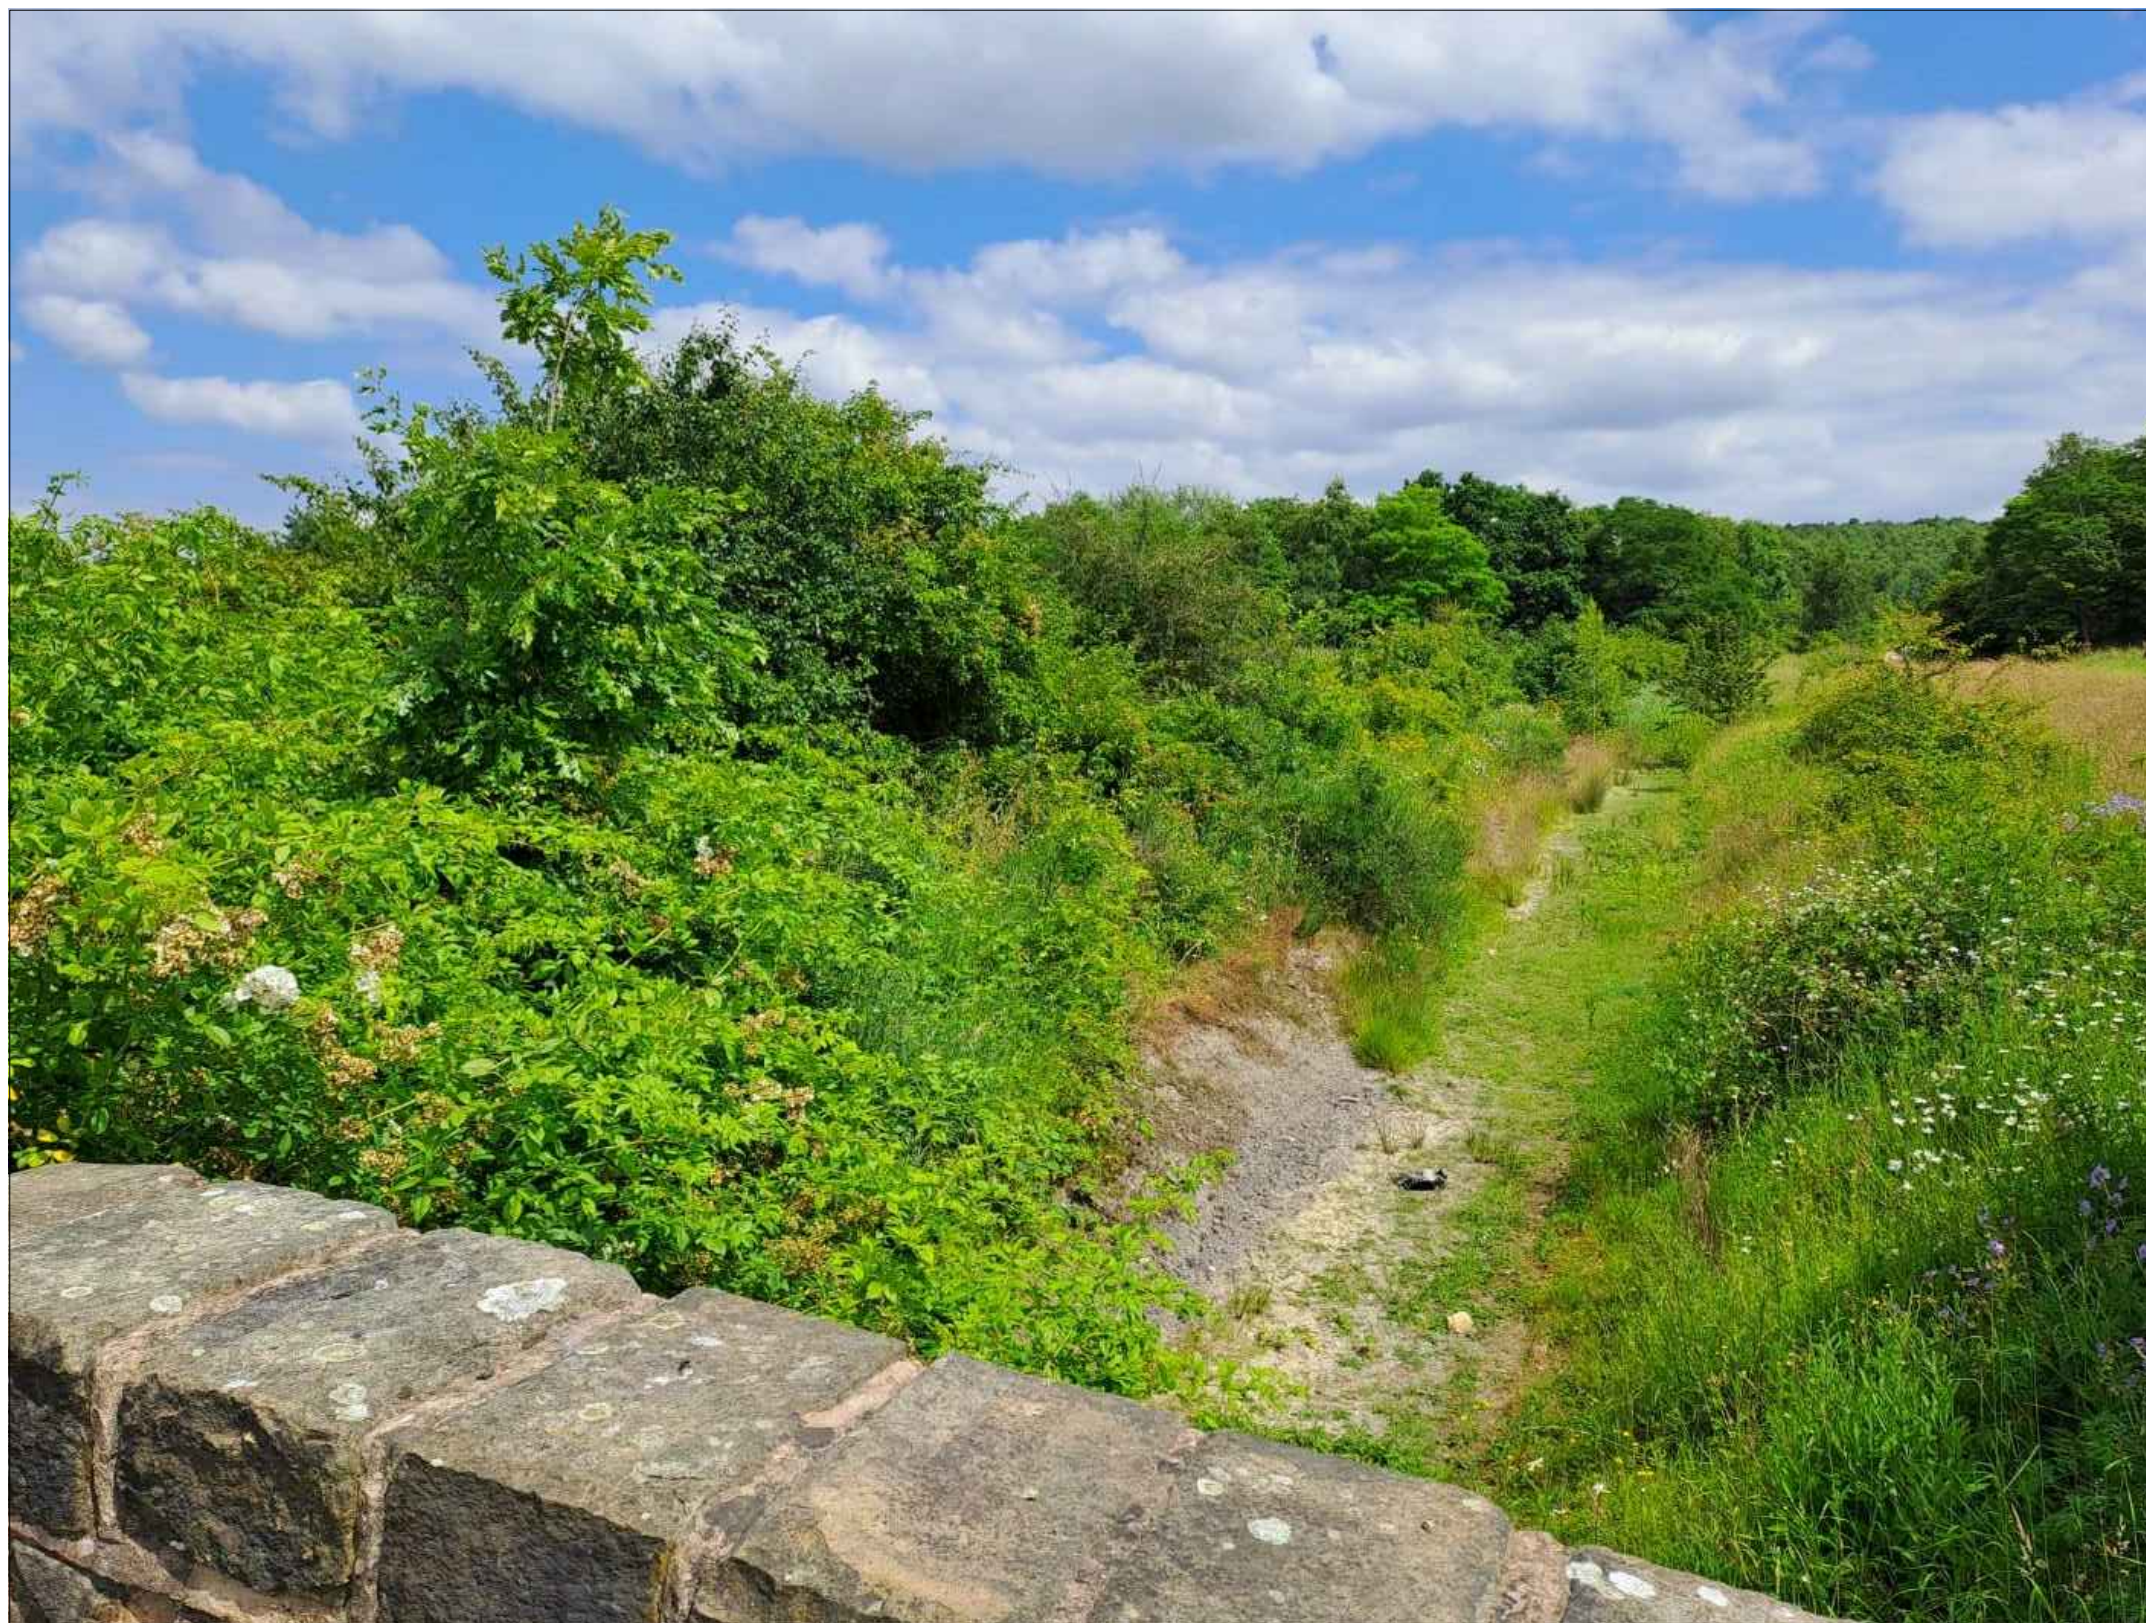
**G4: View west from bridge at location of proposed surface water outfall**  
**Vegetation removal and excavation (to left of frame) to be supervised**

- 3.7. The surface water drainage outfall in the south west corner would connect to an existing ditch. Small trees grow along the bank top in G4 up to a bridge that crosses the ditch. In order to install a drain, it will be necessary to remove a small part of this group. The drain would be adjacent to the bridge, which will minimise the impact. The tree removal would be limited to one or two small trees. A photograph of the location is included at Appendix D.
