## Bat Emergence and Re-Entry Surveys (BERS)

New Inn, Bridge Street, Penistone, S36 7AH

*Conversion of Derelict Out-Building(s) including Construction of Extension into Guest Accommodation & to be used in-conjunction with the existing public house.*

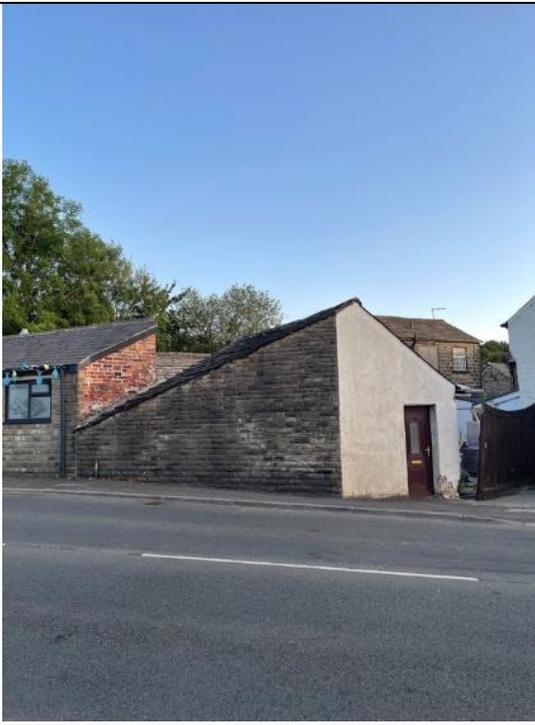
<p><i>IR position 1</i>  <i>Nightfox Whisker</i>  <i>Nightfox XB5 PRO</i></p>	<p>Camera position 1: observing northeastern elevation of B1  <b>Emergences observed: No</b></p> <p>The footage was in line with the observation of surveyor 1. No further bat activity was captured on the footage.</p>

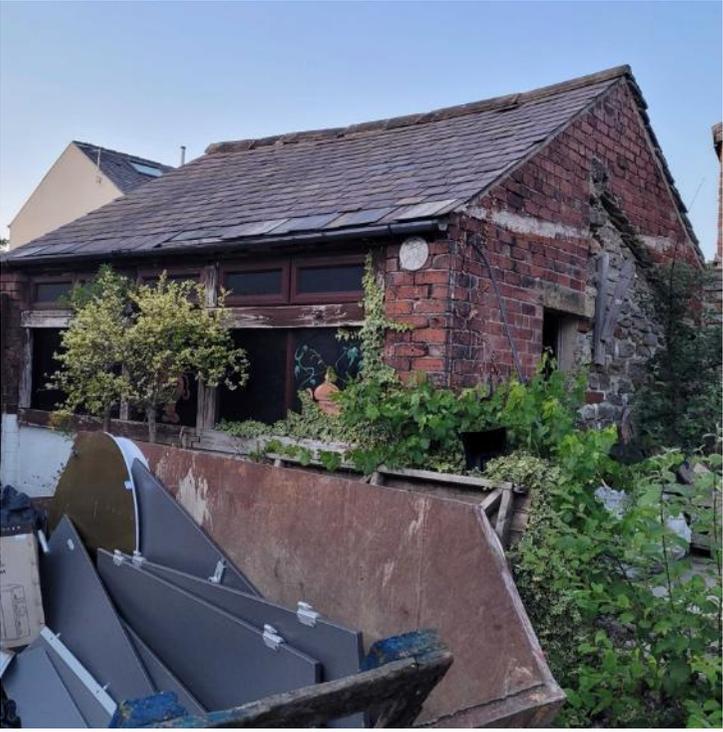
<p><i>IR position 2</i>  <i>Nightfox Whisker</i>  <i>Nightfox XB5 PRO</i></p>	<p>Camera position 2: observing southwestern elevation of B1  <b>Emergences observed: No</b></p> <p>The footage was in line with the observation of surveyor 2.                  No further bat activity was captured on the footage.</p>

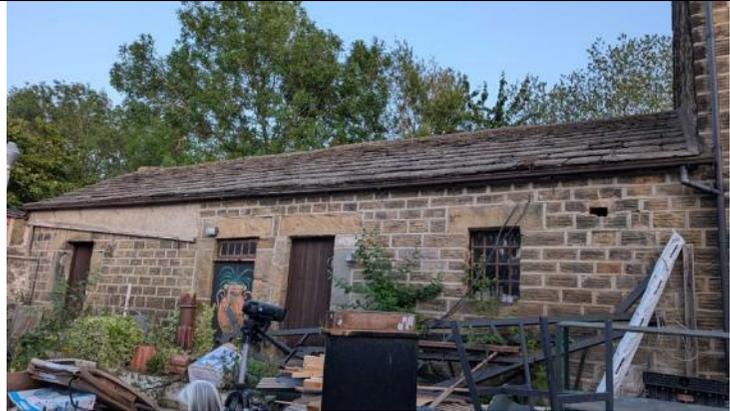
<p><i>IR position 3</i>  <i>Nightfox Whisker</i>  <i>Nightfox XB5 PRO</i></p>	<p>Camera position 3: observing northwestern elevation of B2  <b>Emergences observed: No</b></p> <p>The footage was in line with the observation of surveyor 3. No further bat activity was captured on the footage.</p>

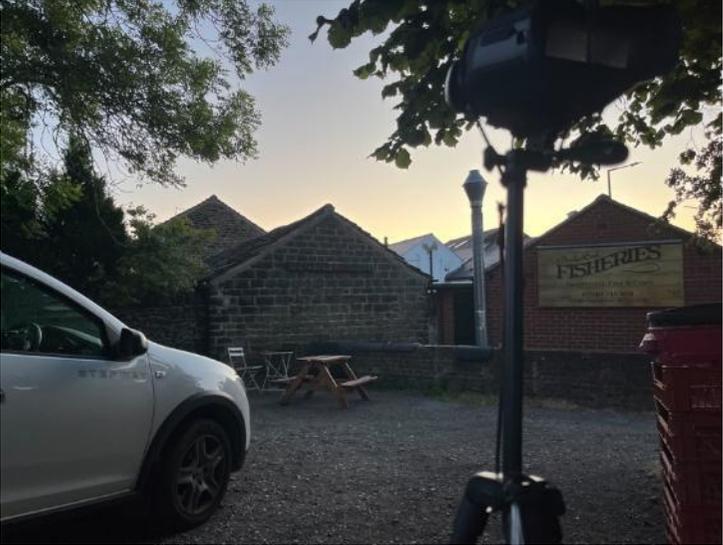
<p><i>IR position 4</i>  <i>Nightfox Whisker</i>  <i>Nightfox XB5 PRO</i></p>	<p>Camera position 4: observing eastern elevation of B2</p> <p><b>Emergences observed: No</b></p> <p>The footage was in line with the observation of surveyor 4. No further bat activity was captured on the footage.</p>

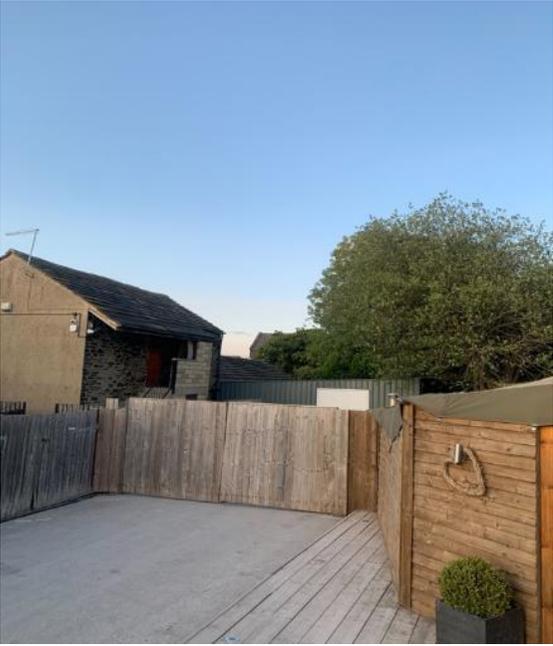
<p><i>IR position 5</i>  <i>Nightfox Whisker</i>  <i>Nightfox XB5 PRO</i></p>	<p>Camera position 5: observing southwestern elevation of B2  <b>Emergences observed: No</b></p> <p>The footage was in line with the observation of surveyor 5 with the addition of an unknown bat foraging in the trees behind the eastern elevation at 22:53 .</p>

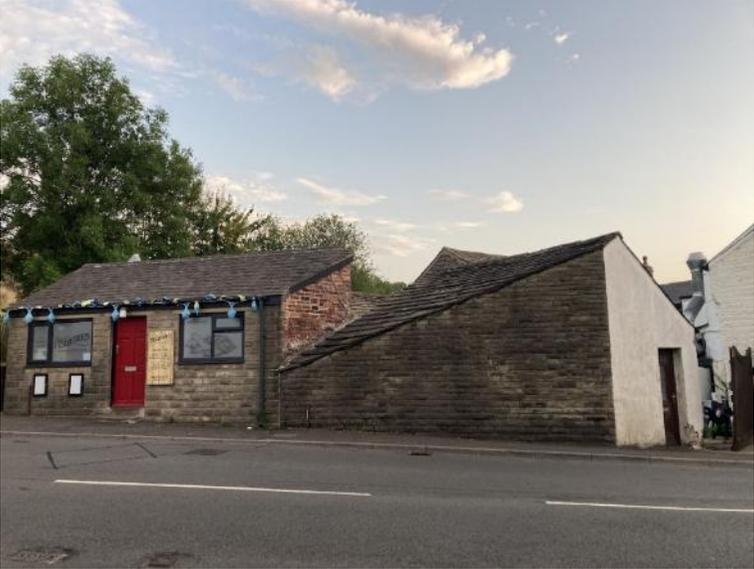
<p><i>IR position 1</i>  <i>Nightfox Whisker</i>  <i>Nightfox XB5 PRO</i></p>	<p>Camera position 1: observing northeastern elevation of B1  <b>Emergences observed: No</b></p> <p>The footage was in line with the observation of surveyor 1. No further bat activity was captured on the footage.</p>

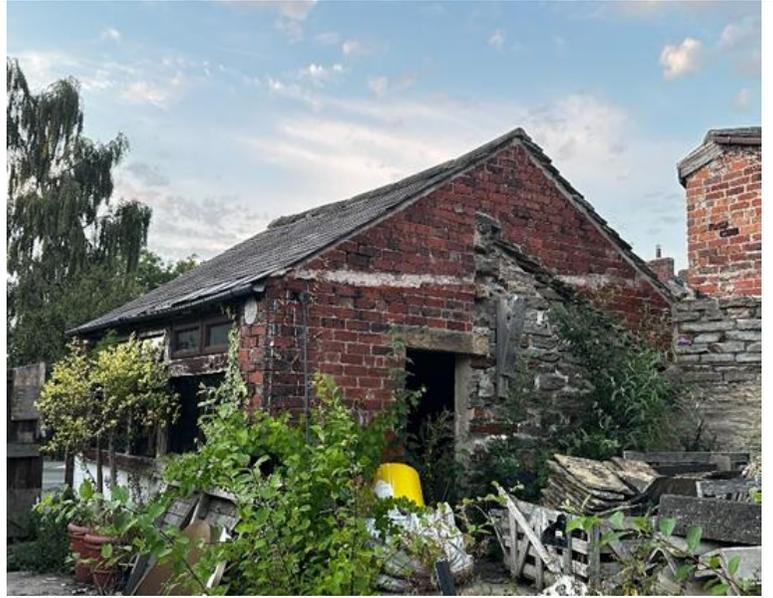
<p><i>IR position 2</i>  <i>Nightfox Whisker</i>  <i>Nightfox XB5 PRO</i></p>	<p>Camera position 2: observing southwestern elevation of B1  <b>Emergences observed: No</b></p> <p>The footage was in line with the observation of surveyor 2.                  No further bat activity was captured on the footage.</p>

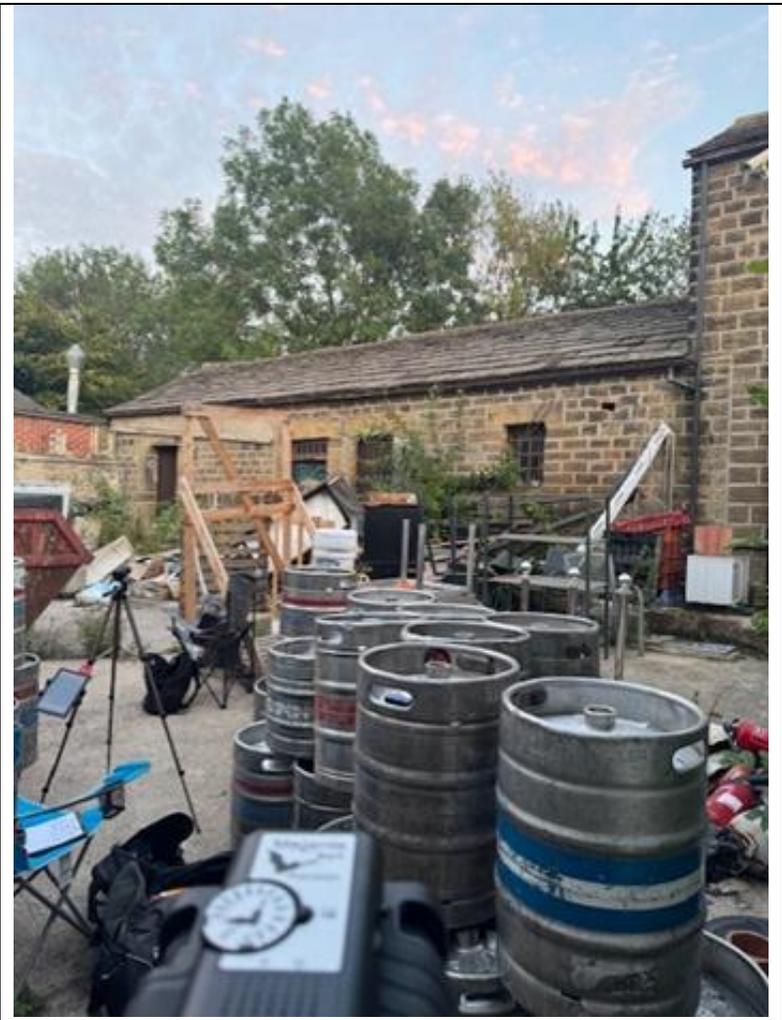
<p><i>IR position 3</i> <i>Nightfox Whisker</i> <i>Nightfox XB5 PRO</i></p>	<p>Camera position 3: observing northwestern elevation of B2 <b>Emergences observed: No</b></p> <p>The footage was in line with the observation of surveyor 3. No further bat activity was captured on the footage.</p>

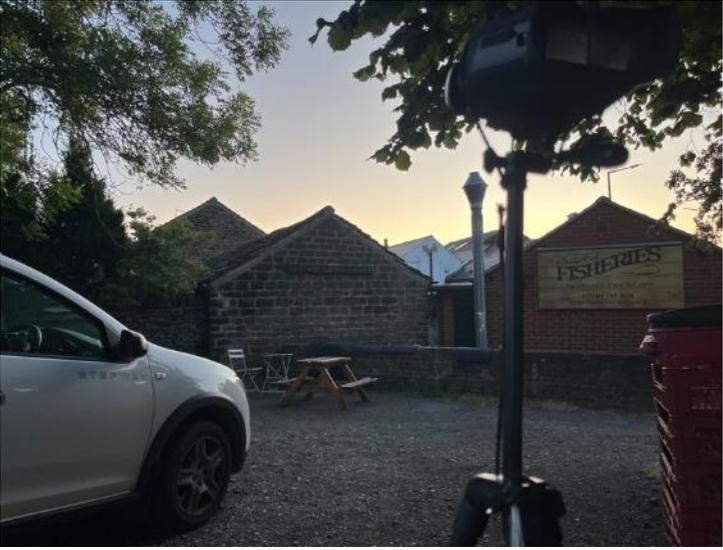
<p><i>IR position 4</i> <i>Nightfox Whisker</i> <i>Nightfox XB5 PRO</i></p>	<p>Camera position 4: observing eastern elevation of B2 <b>Emergences observed: No</b></p> <p>The footage was in line with the observation of surveyor 4. No further bat activity was captured on the footage.</p>

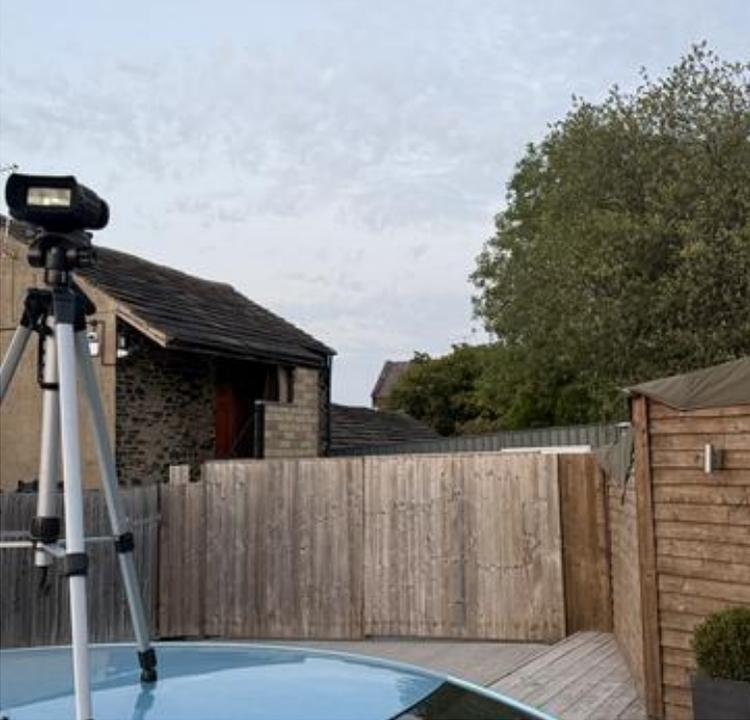
<p><i>IR position 5</i> <i>Nightfox Whisker</i> <i>Nightfox XB5 PRO</i></p>	<p>Camera position 5: observing southwestern elevation of B2 <b>Emergences observed: No</b></p> <p>The footage was in line with the observation of surveyor 5. No further bat activity was captured on the footage.</p>

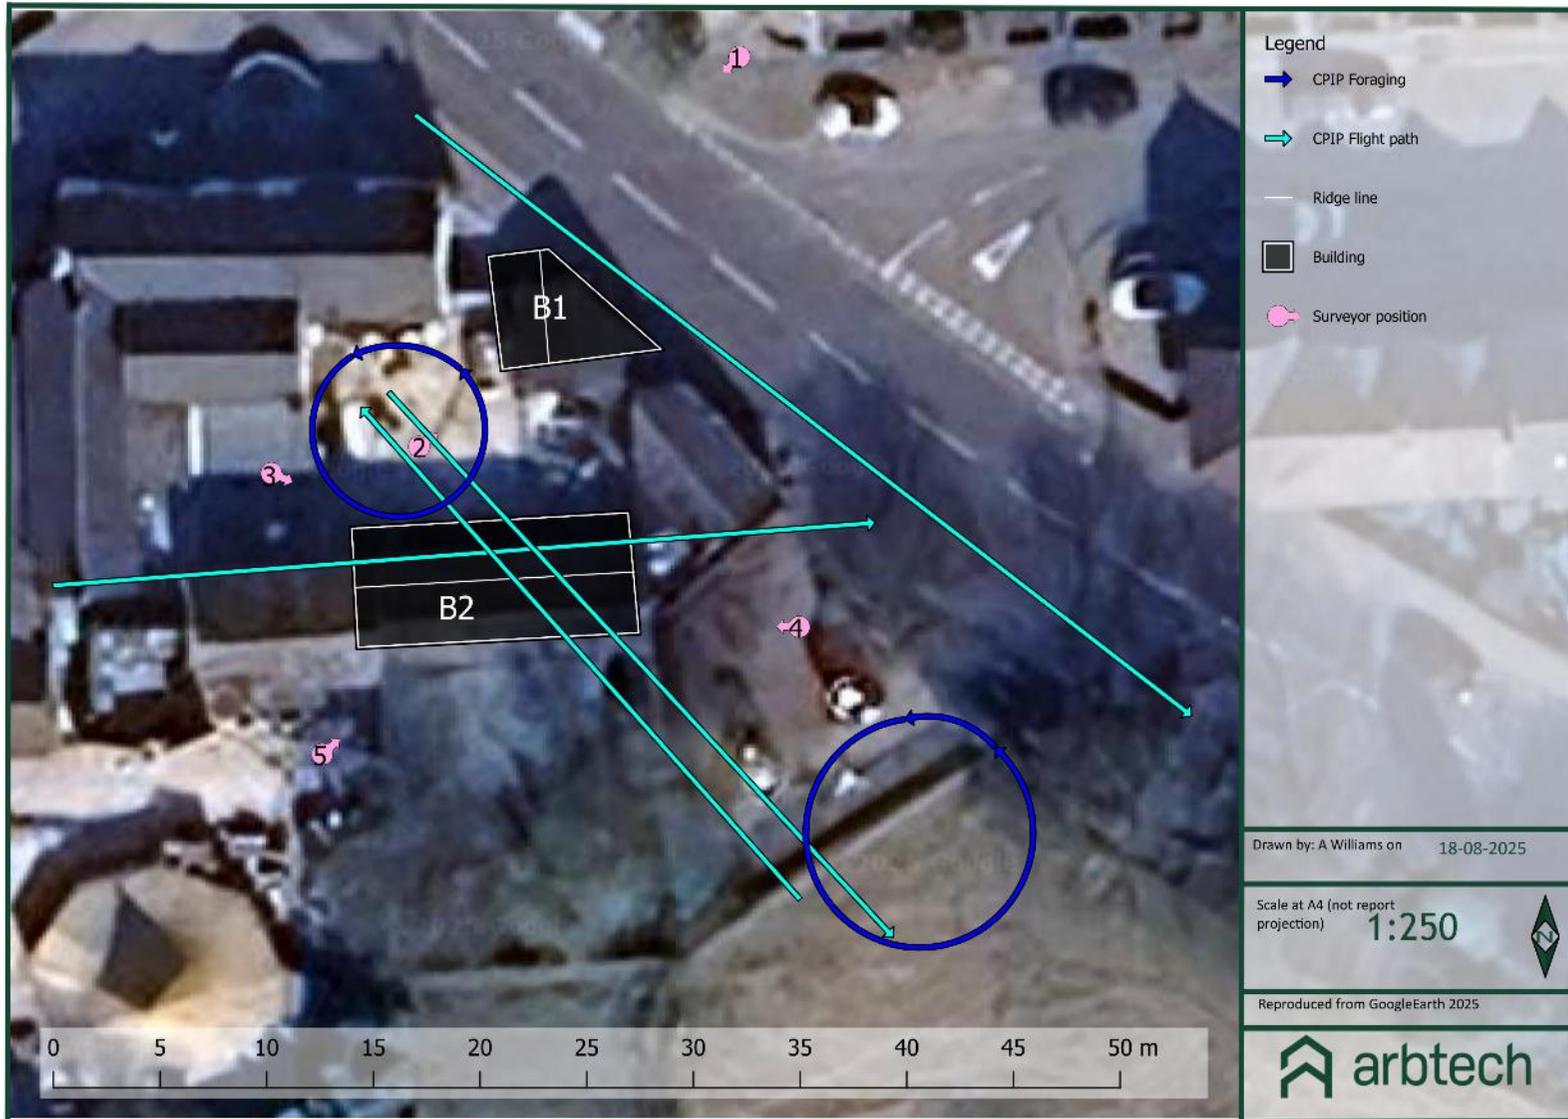
Appendix 1: BERS plan

See surveyor locations in the BERS plan in Appendix 1, proposed plan in Appendix 2.					
<i>Limitations</i>	The western elevation of B2 could not be observed due to B2 adjoining onto a neighbouring building at this elevation. Surveyor 5 was situated in the best possible position to observe the southwest of B2. Surveyors utilised radios to distinguish commuting and foraging bats from emerging bats. As B2 is single storey and the adjoining building is two -storey, there are no connecting roof tiles which could result in the building being functionally linked. Furthermore, no crevices within B2 were identified on the walls adjoining the neighbouring building to the western elevation of B2. Therefore, it was reasonable to discount the neighbouring buildings from further survey effort as impacts to B1 and B2 will not effect any bats potentially roosting within neighbouring structures.				
<b>Field Survey</b>

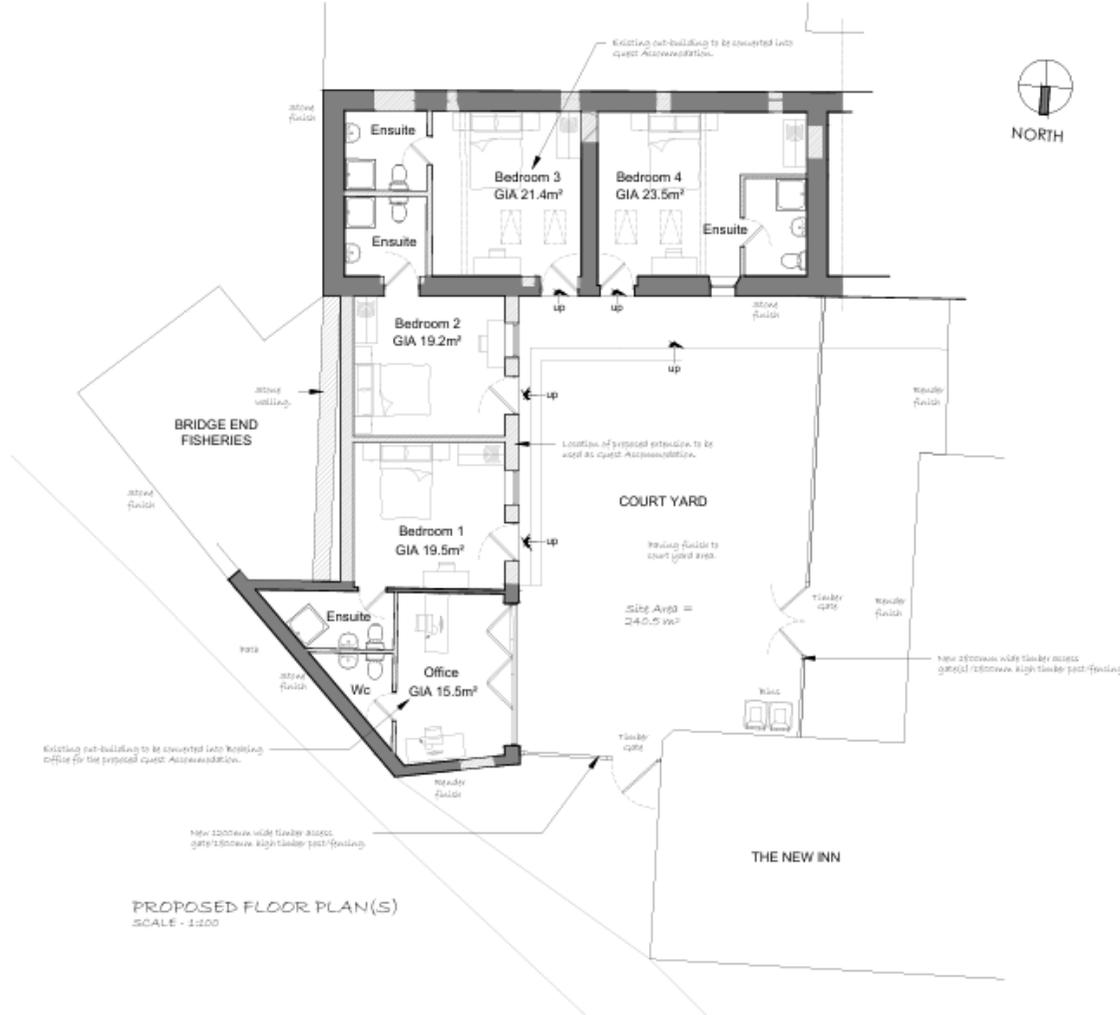
PROPOSED FLOOR PLAN(S)  
SCALE - 1:200

- Walls - construction of above, finish to plaster ready finish to exterior.
- Doors - Timber framed doors, Powder coated aluminium framed bi-folding doors.
- Windows - Timber framed glass units.
- Roof - New slate/stone roof/ slate roofing finish.
- Finish/ cladding - vinyl guttering fixed to brackets and downpipes to suit.
