**WATH ROAD, ELSECAR.**

**BAT SURVEY.**

**Ref No: 200123/Rev 1.**

**Date: 5<sup>th</sup> September 2020.**

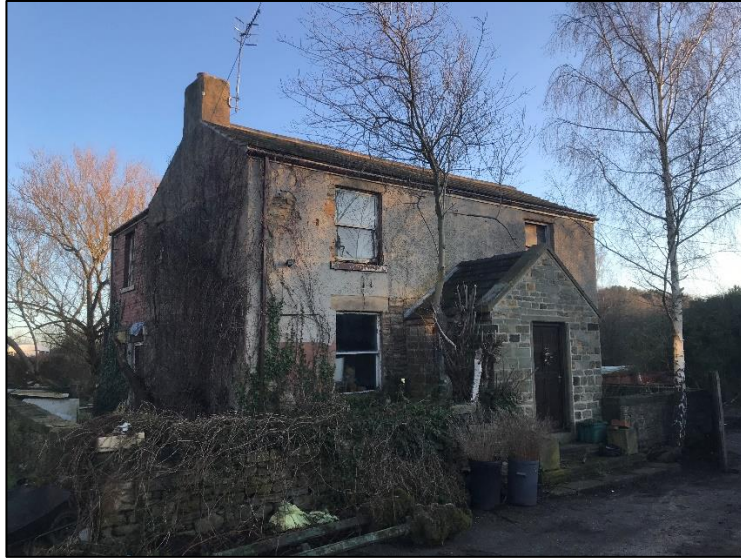
3.3.1.1.1. The first part is the original house, shown in the photograph below with a newer, single storey stone porch on the front. The main house is a stone building that has been rendered. That rendering has deteriorated and there are large patches of render missing exposing the stone walls beneath.

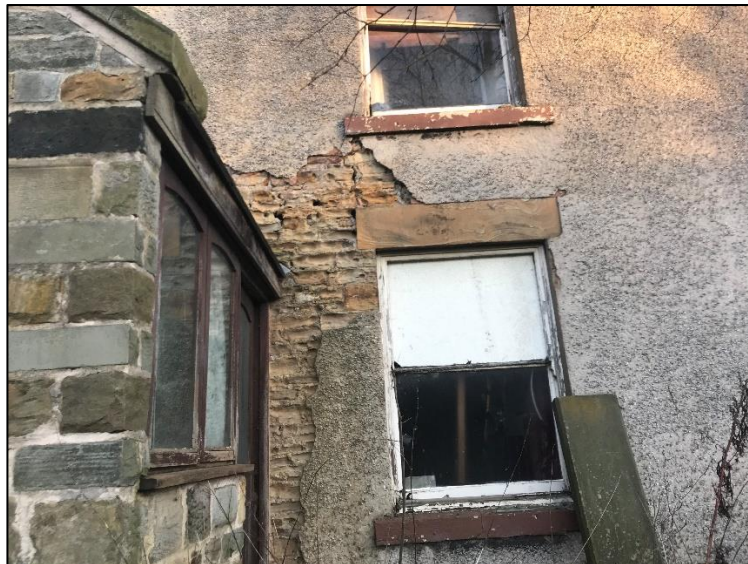
3.3.1.1.2. The timber window and door frames have all rotted leaving gaps around the frames and there are gaps in the stonework that provide opportunities for roosting bats and nesting birds.

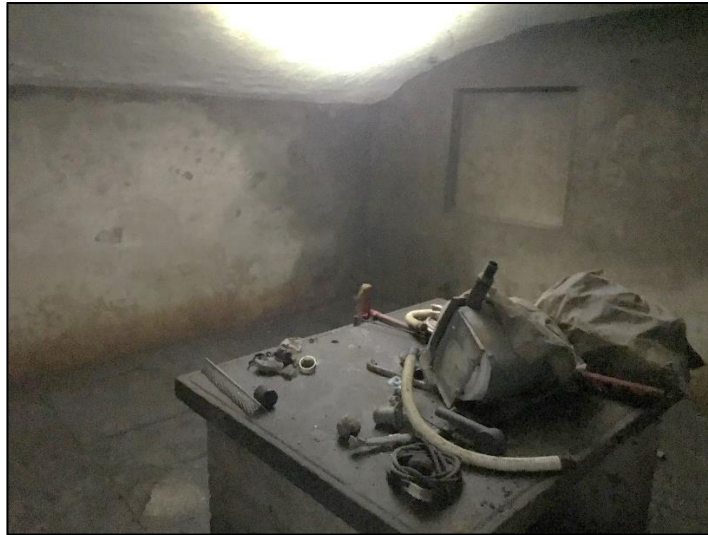
3.3.1.1.5. Underneath this section of the house there is a cellar. This is well lined, clean and in good condition and provides no access for bats or birds.

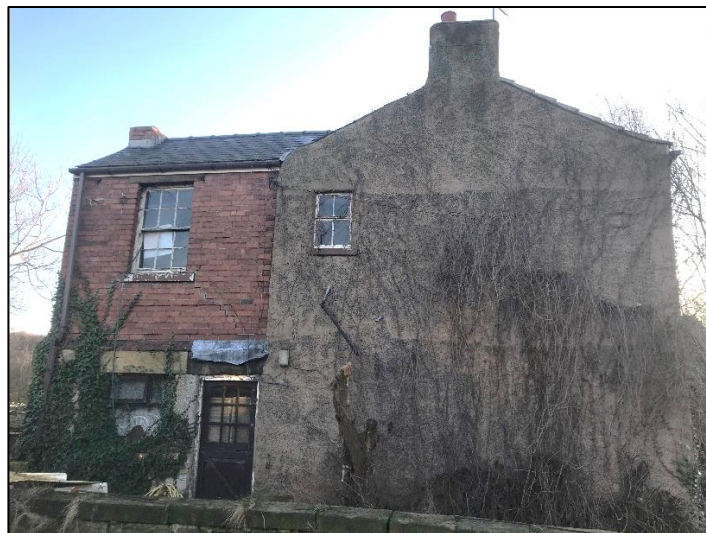
3.3.1.2.1. At the rear of the original house there is a two-storey extension built with stone first storey walls with solid brick walls above and a pitched, slate covered roof. The photograph below shows the western elevation.

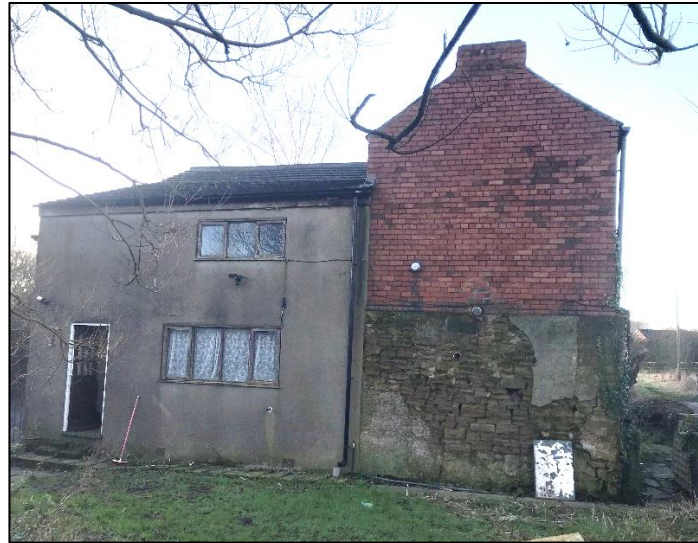
3.3.1.2.2. The photograph below shows the northern elevation

3.3.1.2.5. There is a crack in the external wall that may provide an opportunity for roosting bats and there are gaps behind the fascia board. This section of the building was assessed to have a low potential for roosting bats.

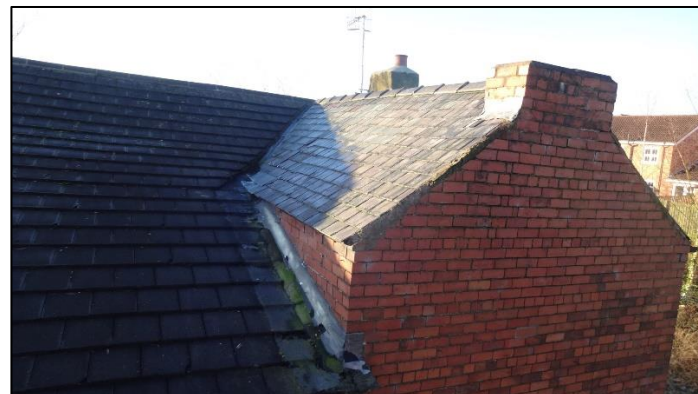
3.3.1.2.3. The photograph below shows the slate covered roof.

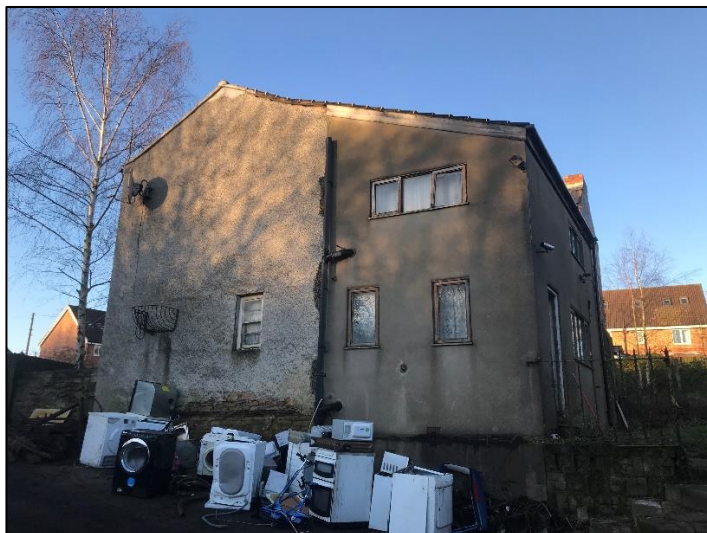
3.3.1.3.1. Finally, in the northeast corner of the building, there is the latest of the extensions. This is a completely rendered extension with a mono-pitched roof covered with interlocking concrete slates.

3.3.1.3.2. This section of the building was assessed to have negligible potential for roosting bats.

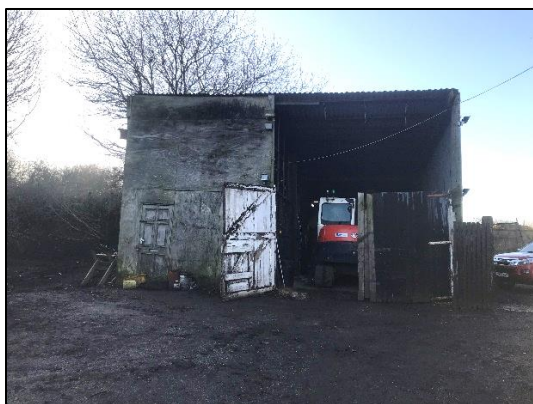
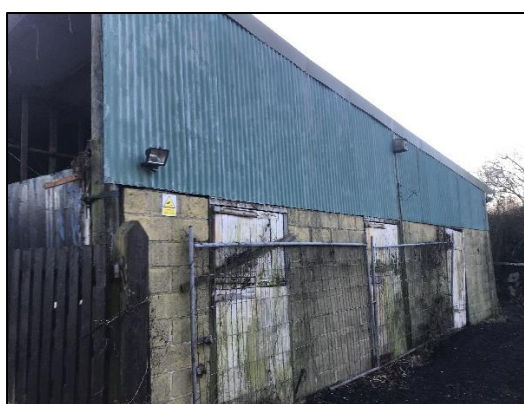
3.3.2.1. Building B is a steel framed, agricultural building with concrete block lower walls topped by steel cladding to the upper walls and roof, shown in the two photographs below.

3.3.2.2. This building has no potential for roosting bats.

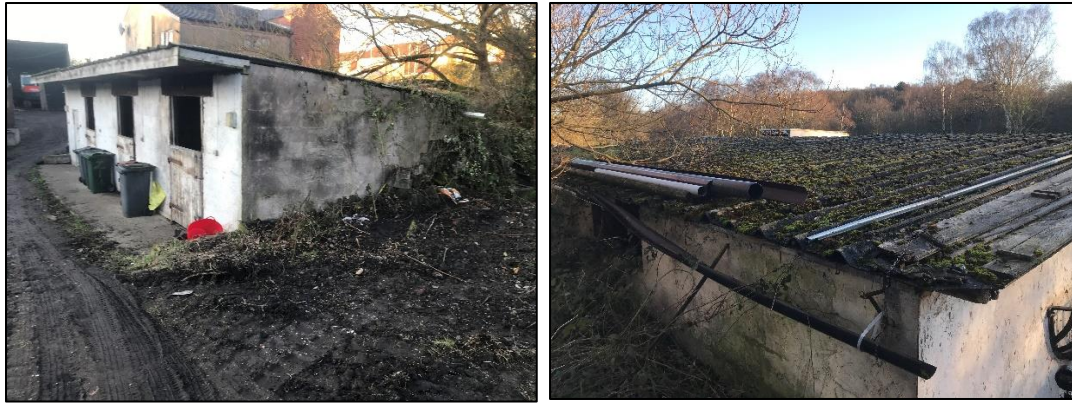
3.3.3.1. Building C is a stable block with painted concrete block walls and with a mono-pitched roof covered with corrugated cement sheets, shown in the two photographs below.

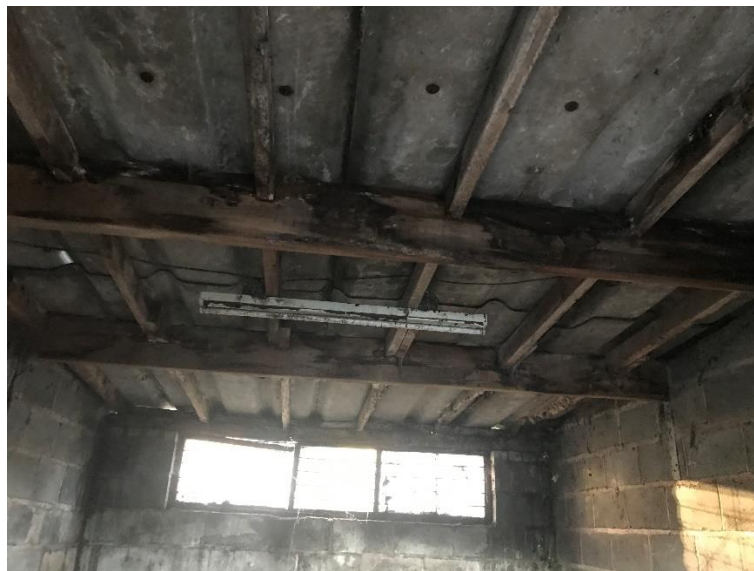
3.3.3.2. The photograph below looks inside one of the stables.

3.3.3.3. No bats or bat field signs were found inside or outside this building and the building is assessed to have negligible potential for roosting bats.

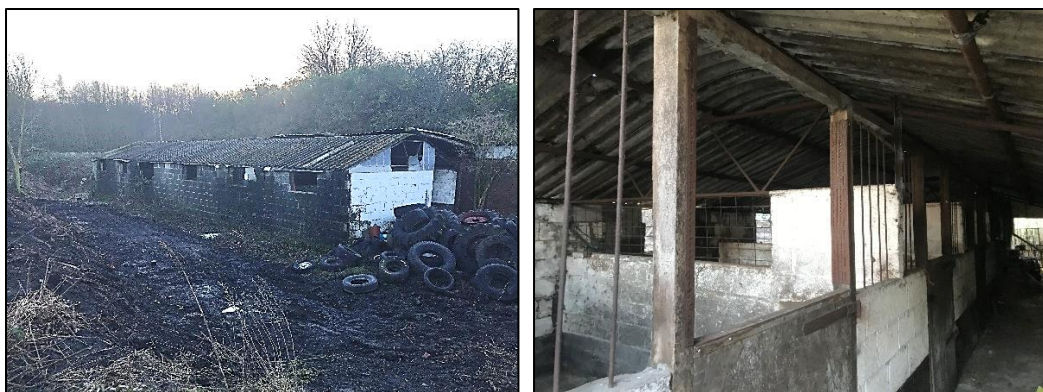
3.3.4.1. Building D is a second stable block, constructed with solid concrete block walls and partitions with a corrugated concrete roof above.

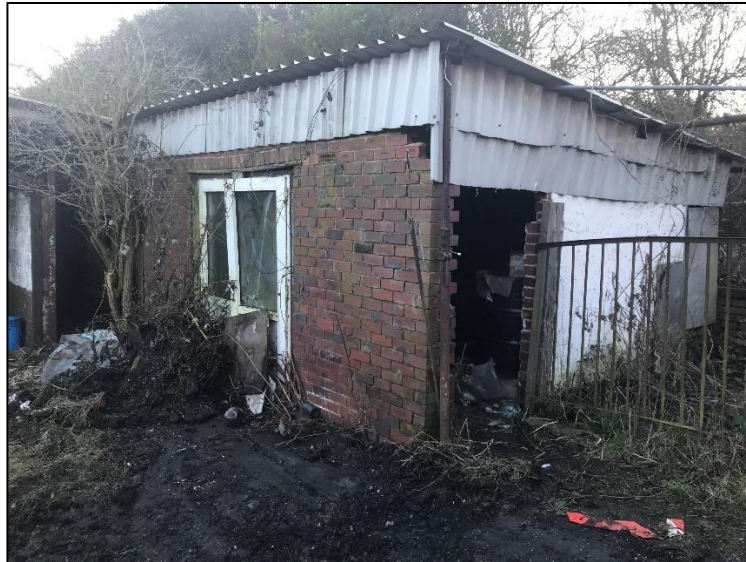
3.3.4.2. Adjacent to this block there is a store constructed with a single skin brick wall topped with corrugated metal sheets and with a mono-pitched metal sheet covered roof.

3.3.4.3. Neither of these buildings are suitable for roosting bats.

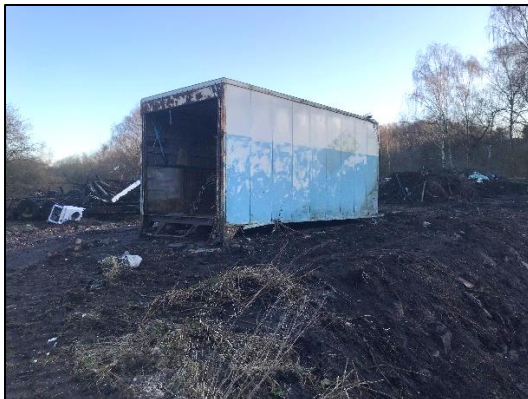
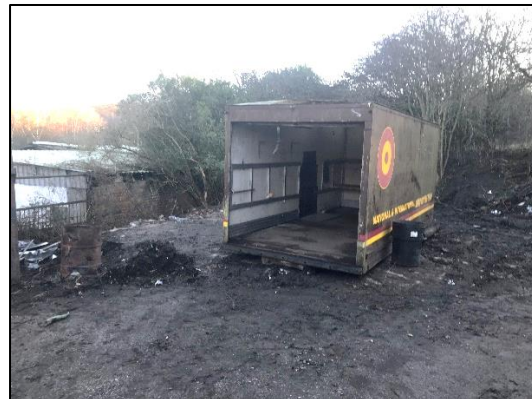
There are lorry containers in the yard, as shown below and these are unsuitable for roosting bats.

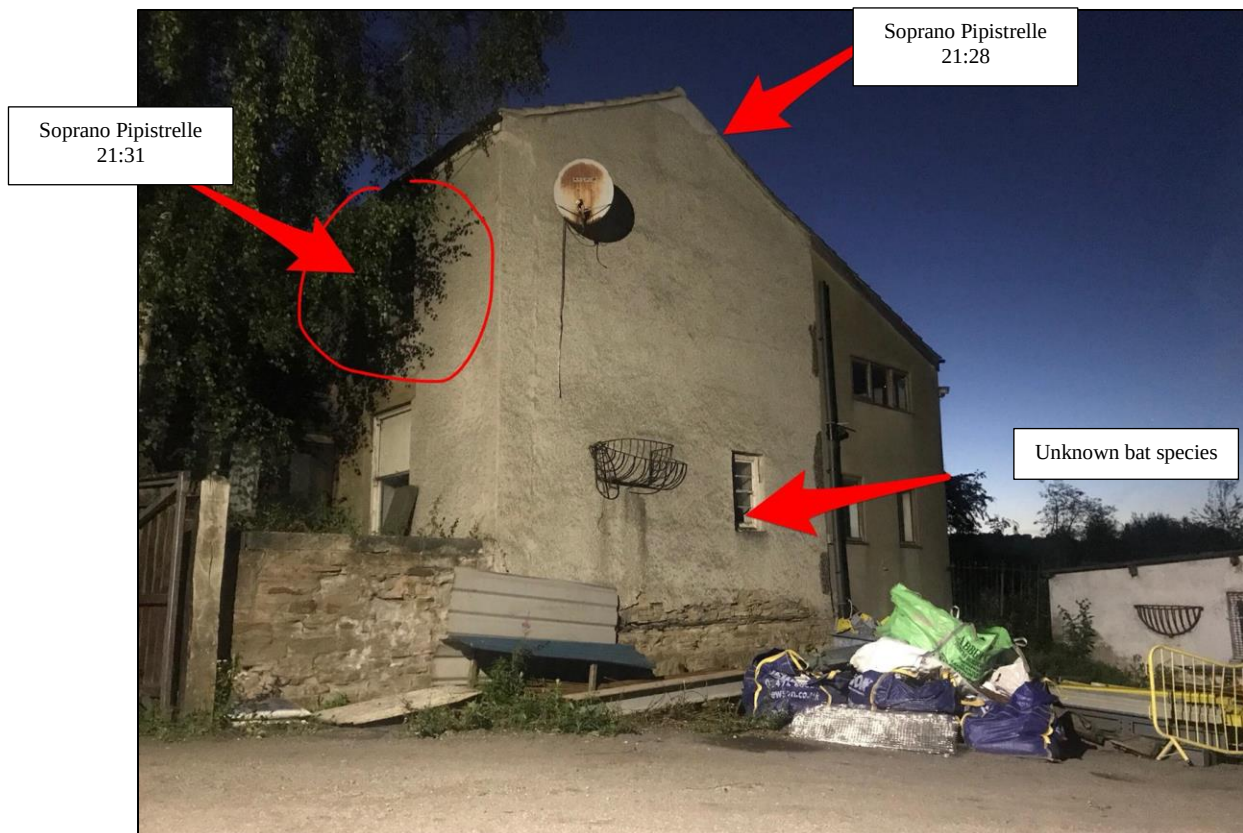
3.4.5. During the survey Surveyor 2 had two Soprano Pipistrelle bats emerge from the building and one bat fly out of a ground floor window and back in a few times before flying out and leaving site. This bat was not echolocating and is presumed to have emerged inside the building.

3.4.7. The photograph below shows the locations the two Soprano Pipistrelle emerged from and the window the bat flew out of.

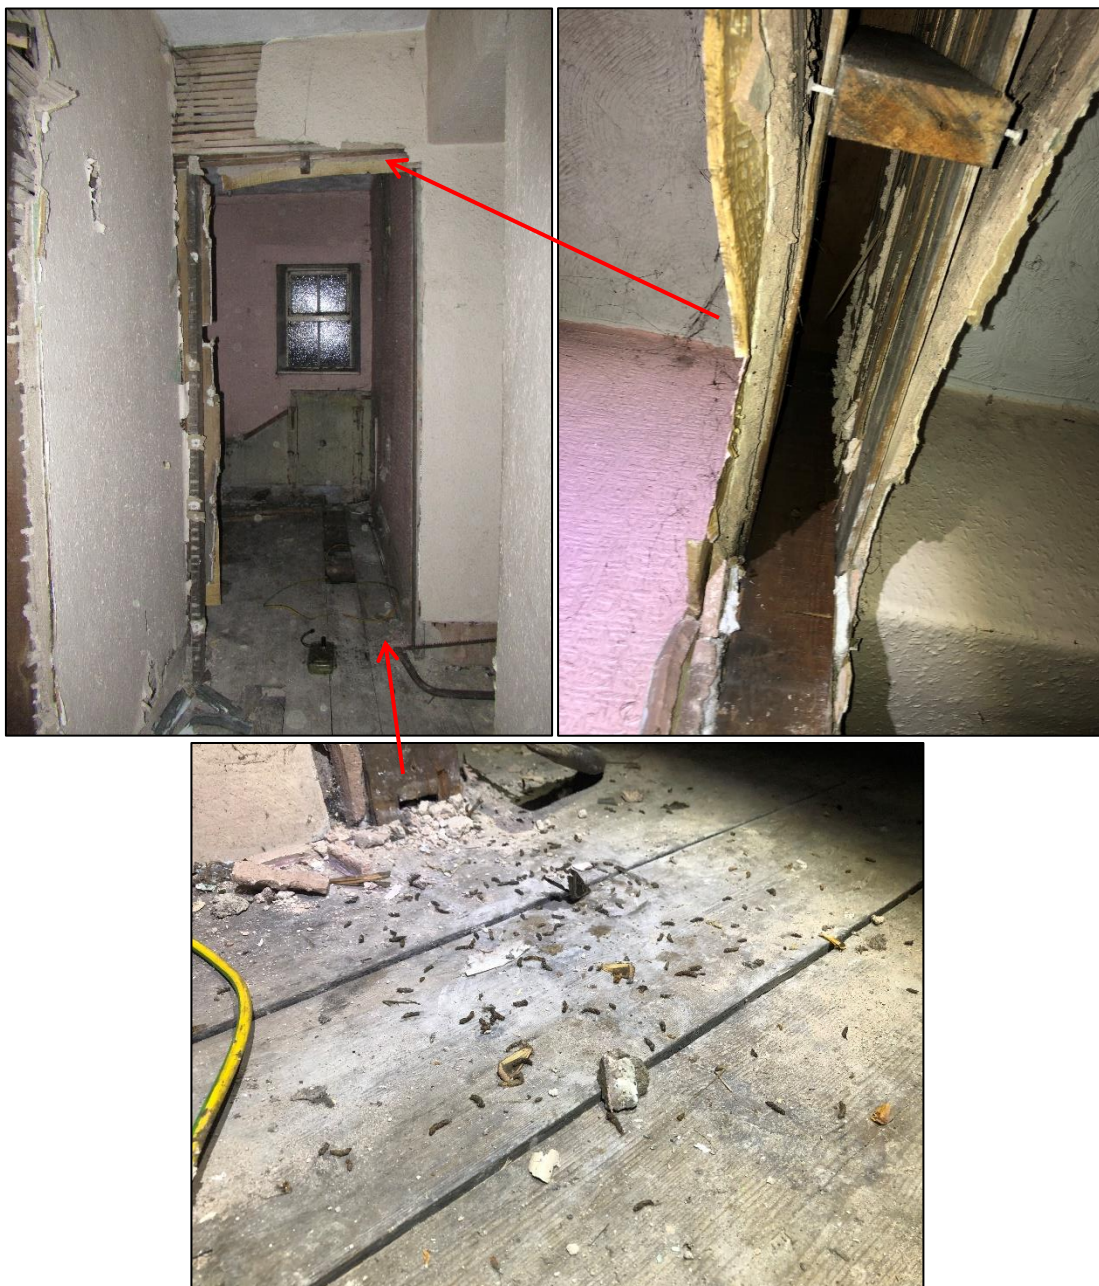
3.5.1. The building was searched for bat field signs. On the first floor of the building a concentration of approximately 50 fresh bat droppings with some moth wings was identified. This was located under a doorway between two rooms where the frame has been removed leaving a gap above the top of the doorway. No bat was present in the gap before or after the survey.

3.5.2. The photographs below show the doorway, the gap above and the droppings on the floor.

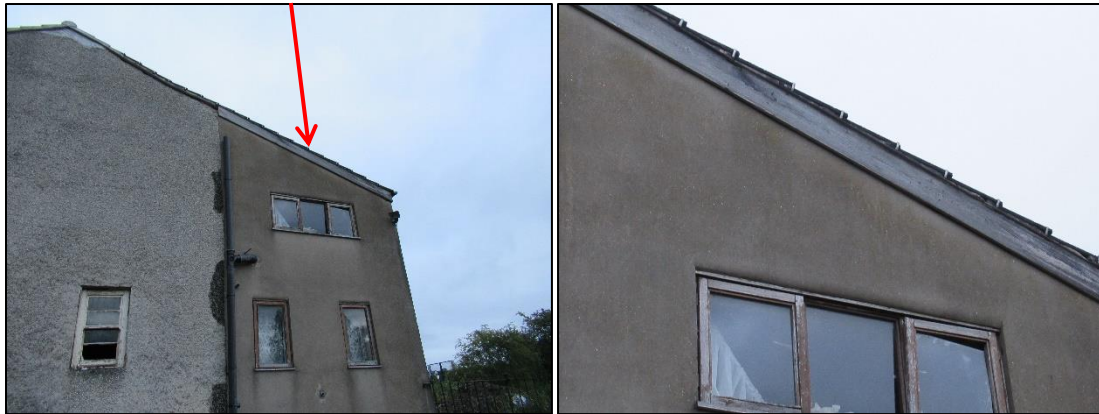
3.6.6. During the survey Surveyor 2 had three Soprano Pipistrelle bats enter a roost on the eastern side of the building under the fascia board at 05:00, 05:07 and 05:08.

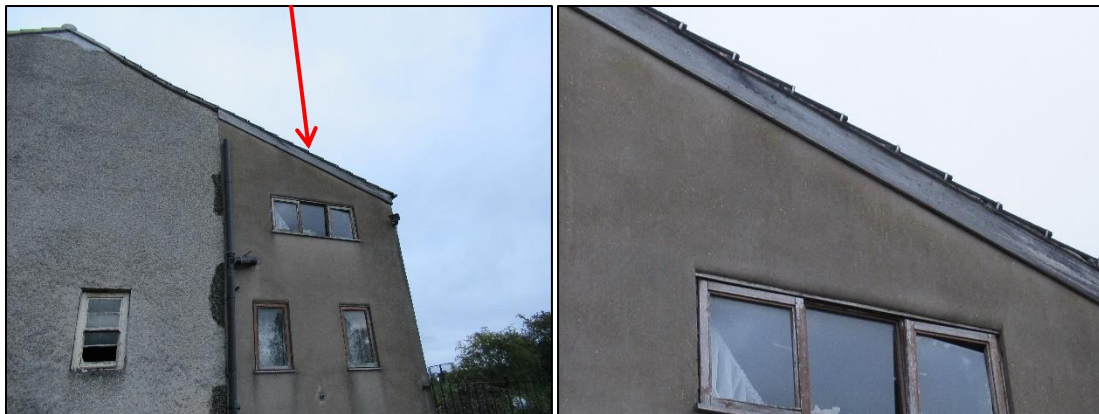
3.7.5. During the survey Surveyor 2 saw two Soprano Pipistrelle bats emerge from behind the fascia board on the east side of the house at 20:08 and 20:27.

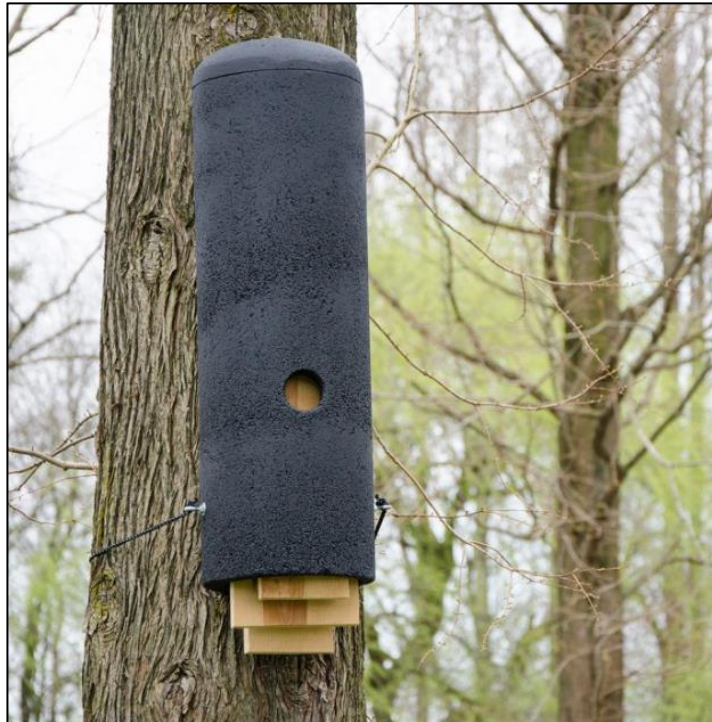
A1.2. Before any demolition works commence on the existing building, a Miramare bat box or equivalent will be erected on a tree or pole at the site. The location will be agreed with the ecologist.

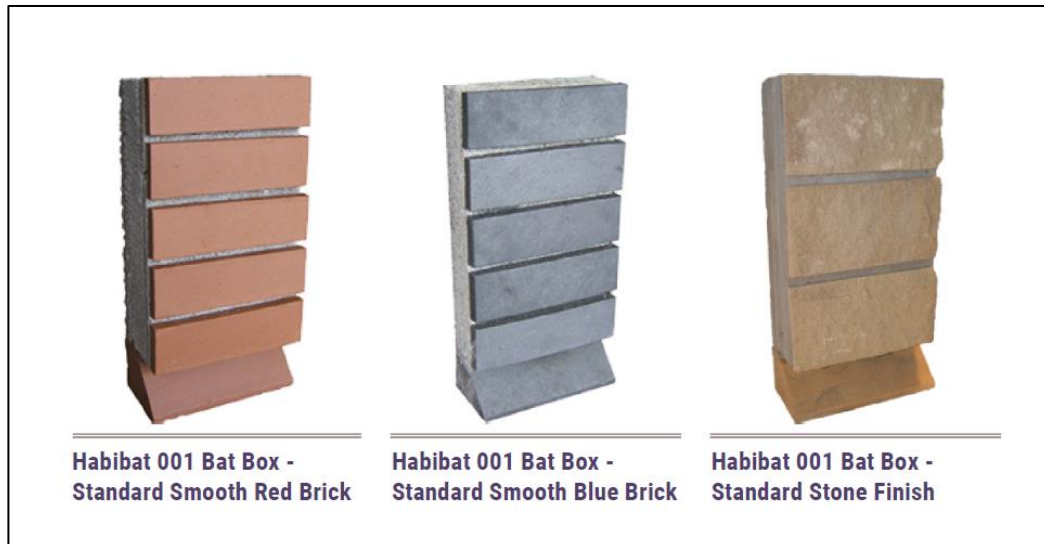
C1.3.1. One integrated bat brick will be installed in the external walls of the new dwelling. A Habibat brick as shown below, or equivalent, will be installed to match the external finish of the walls.
