GEO-ENVIRONMENTAL REPORT

| job number | C4503/24/E/6885 | date | 21.03.2025 |
| site address | Royd Moor House Farm, Thurlstone, Sheffield, South Yorkshire, S36 7RD | | |

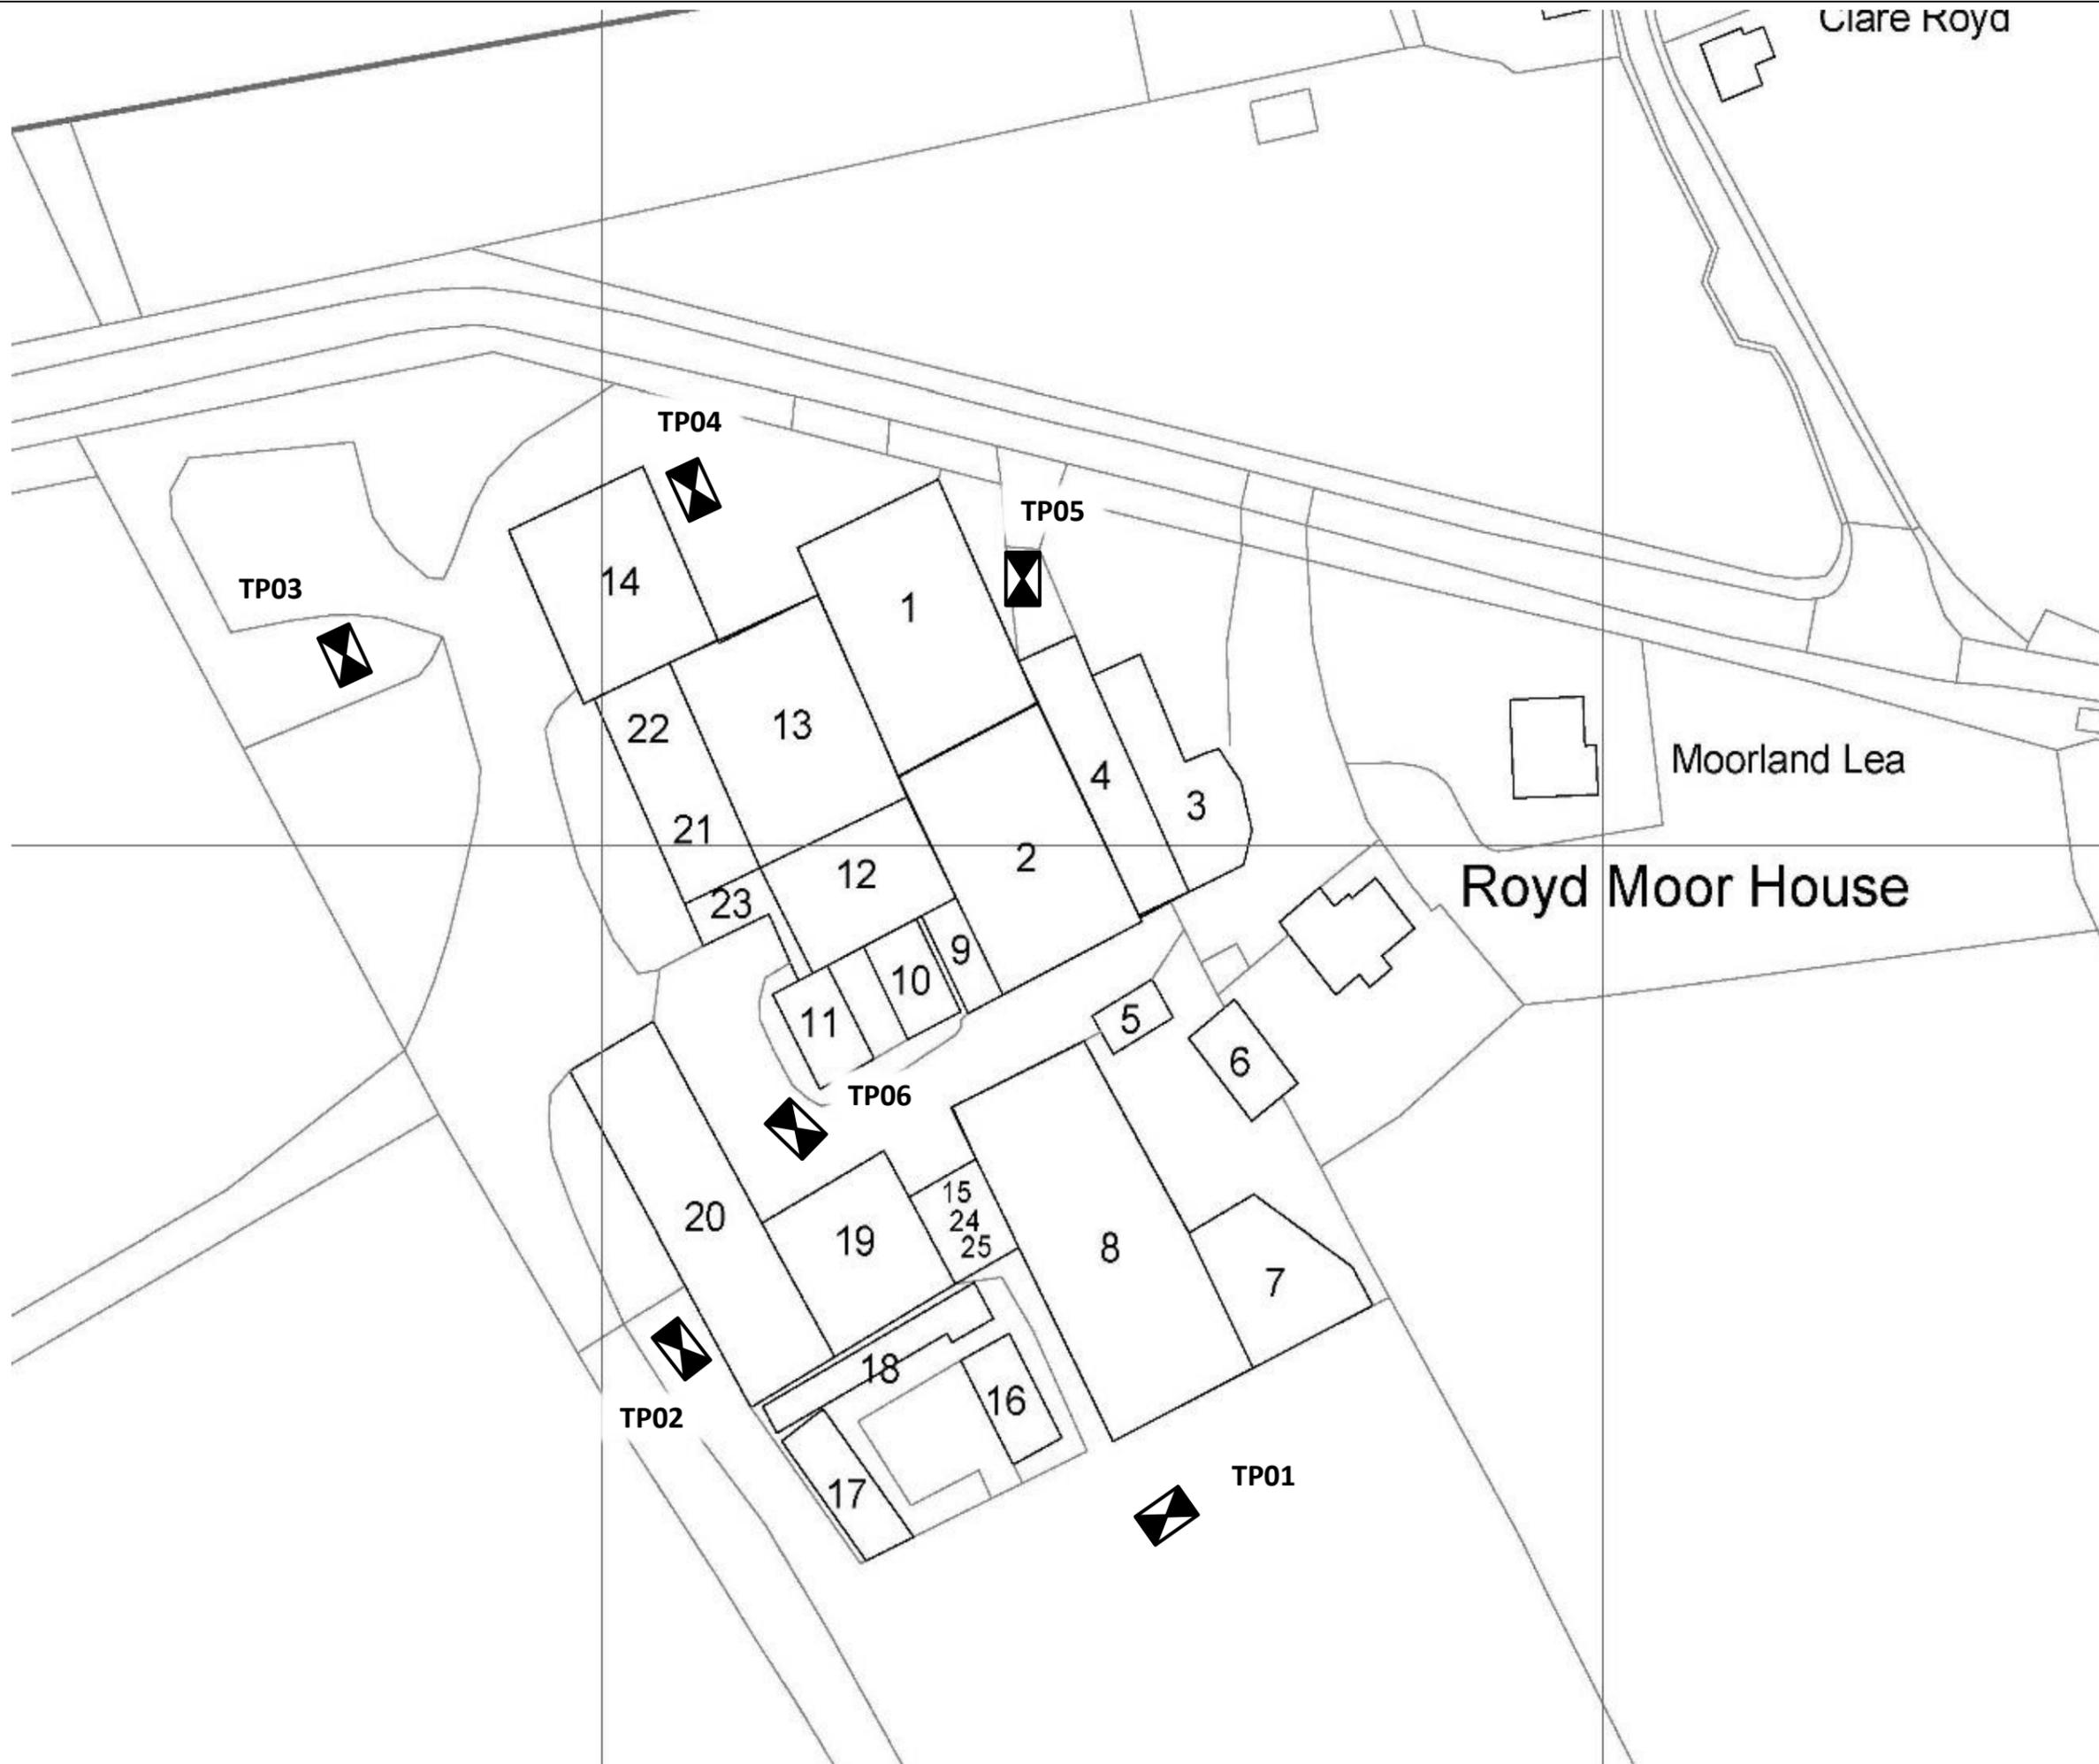
Site Plan

The fieldworks were undertaken on the 10th February 2025 and included six machine excavated trial pits. The investigatory locations are shown on the site plan which is presented in Appendix 1 to this report.

Notes:
Investigation positions approximated from site operative's notes.

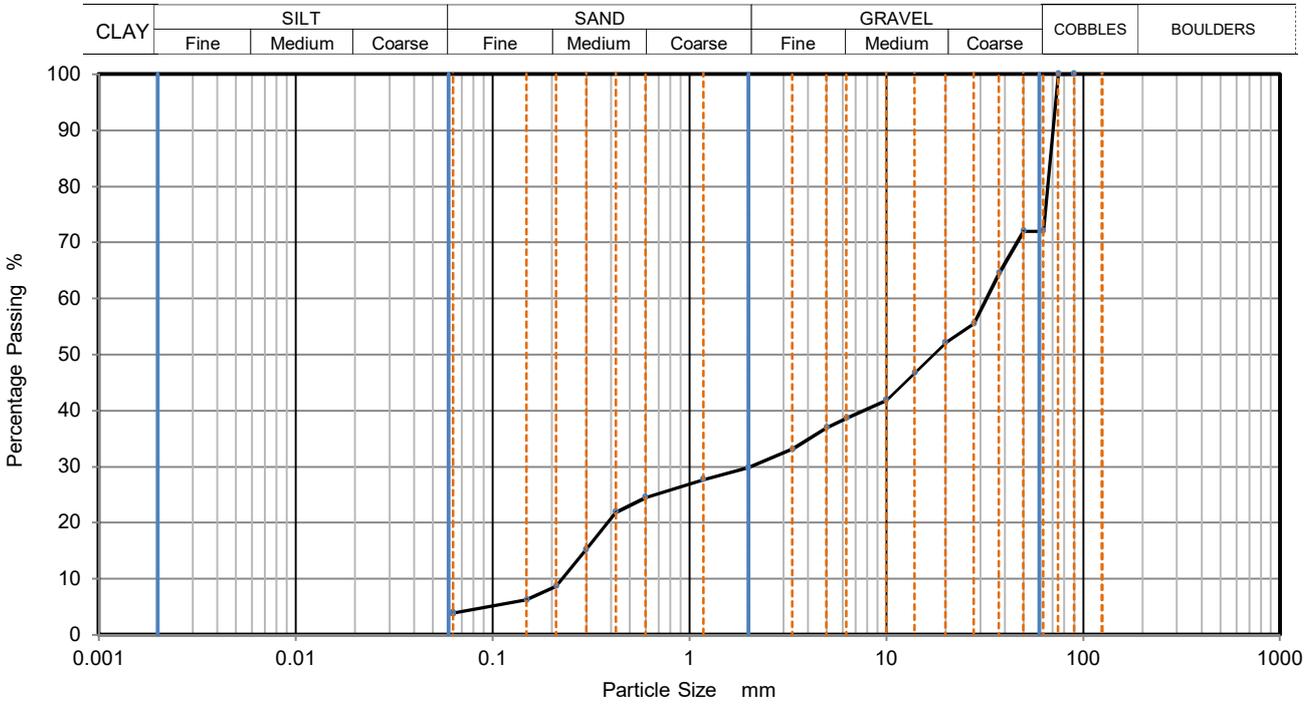
| Specimen Reference | 1 | Specimen Depth | 0.8 m |

| Test Method | ISO 17892 -4, by sieving on pre-dried or dry sample | | |

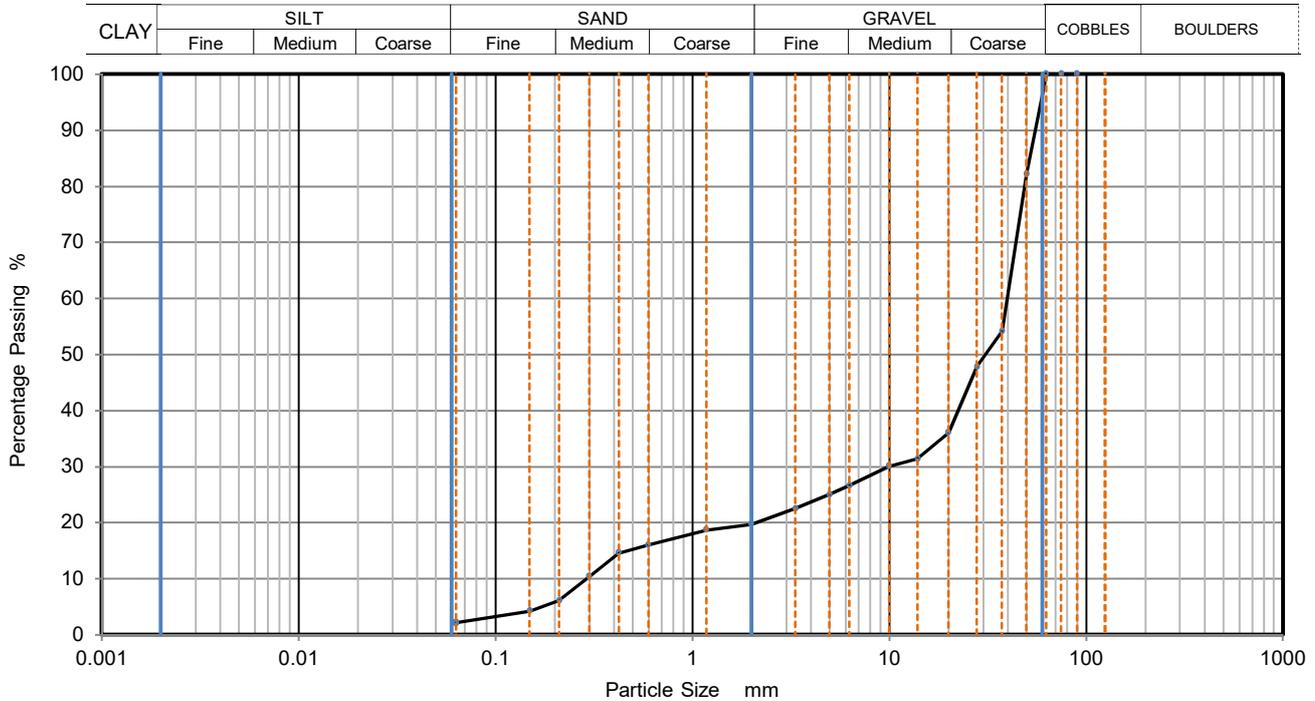
KeyLAB ID RGS_202502145

Test Method ISO 17892 -4, by sieving on pre-dried or dry sample
