Bat Scoping Survey to  
the mistle  
Hollin Royd Farm  
Lane Head Raod  
Cawthorne  
S75 4AU

6<sup>th</sup> March 2020

# 1. Summary

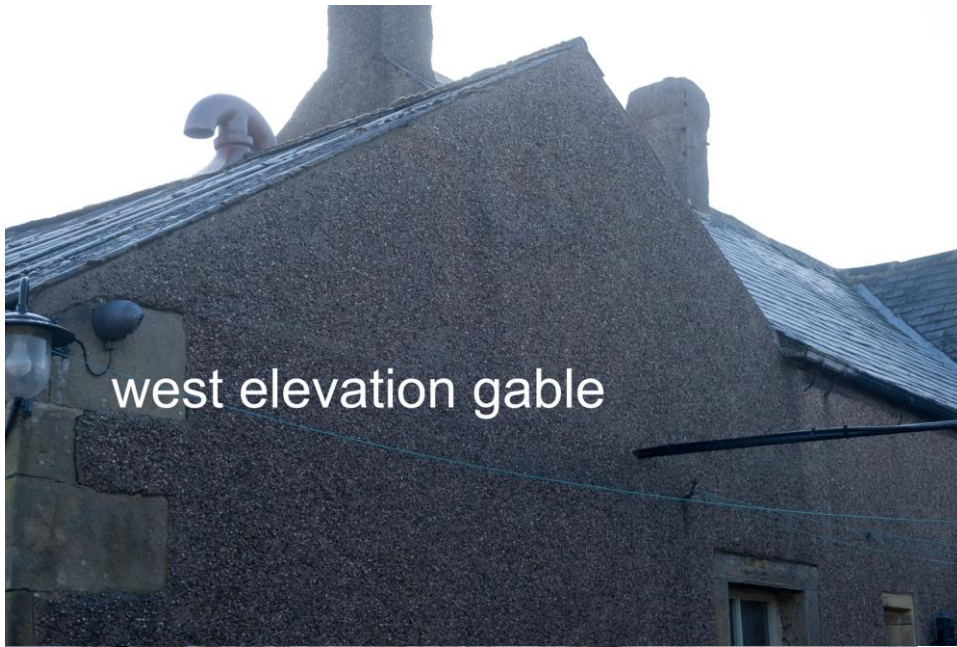
The building runs east west with the east end being joined at right angles to the large barn (converted to residential) and therefore only has a single gable wall at the west elevation. The west gable has a render of pebbledash and has no value or interest to bats as the wall is sealed fully right to the edge of the roof sheets. Internally, the building is open to the rafters and the ridge section is clearly visible. The original roof covering has been stripped many years ago and, although the rafters are original, the ridge section is now just a thin plank and is very heavily covered with cobwebs. There is no evidence to suggest any use by bats and the construction is unlikely to support ridge dwelling species. There is a small upper section at the east end of the building and a close inspection of the floor did not reveal any droppings or scattered prey remains. The partition wall had a heavy build up of cobwebs and no droppings adhered to the blockwork. There was no evidence to suggest use by bats or barn owls.

west elevation gable

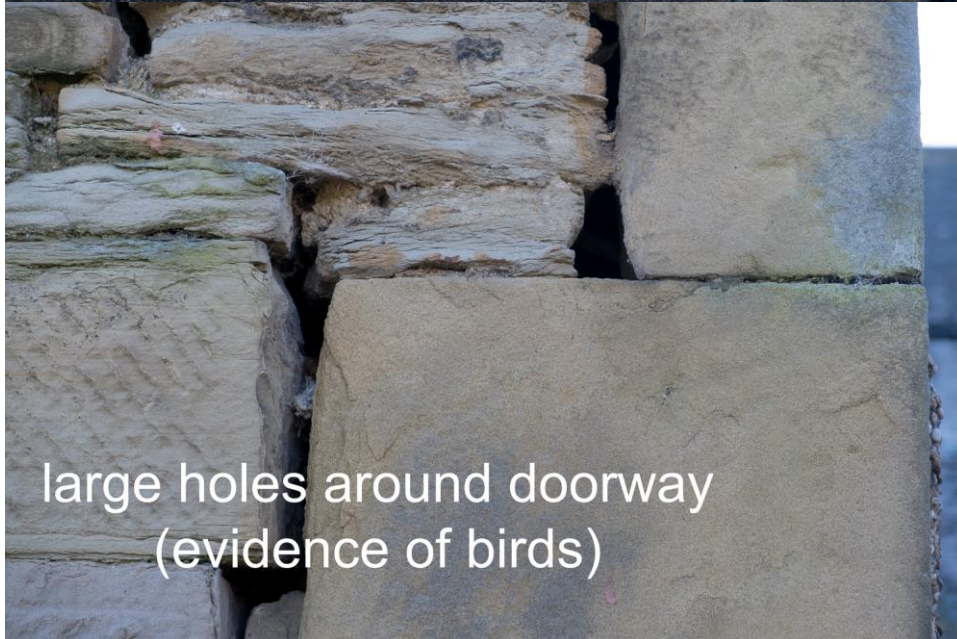
The walls are built of stone and appear to be rubble filled. The pointing is generally good but there are some holes just around the door but these are quite large and unlikely to be used by bats as they are accessible to birds and it appears as if blue tits or sparrow have used this area. There are no gutter boards or other fascia that bats might hide behind though there is opportunity for bats to sit on the wall tops. The south elevation walls are the same construction and condition as the north elevation. Some sections on the south elevation are obscured by an upright yew tree and thorny climbing vegetation and will prevent bats from gaining access to the wall tops. Internally, the walls are sound and are all limewashed.

large holes around doorway  
(evidence of birds)

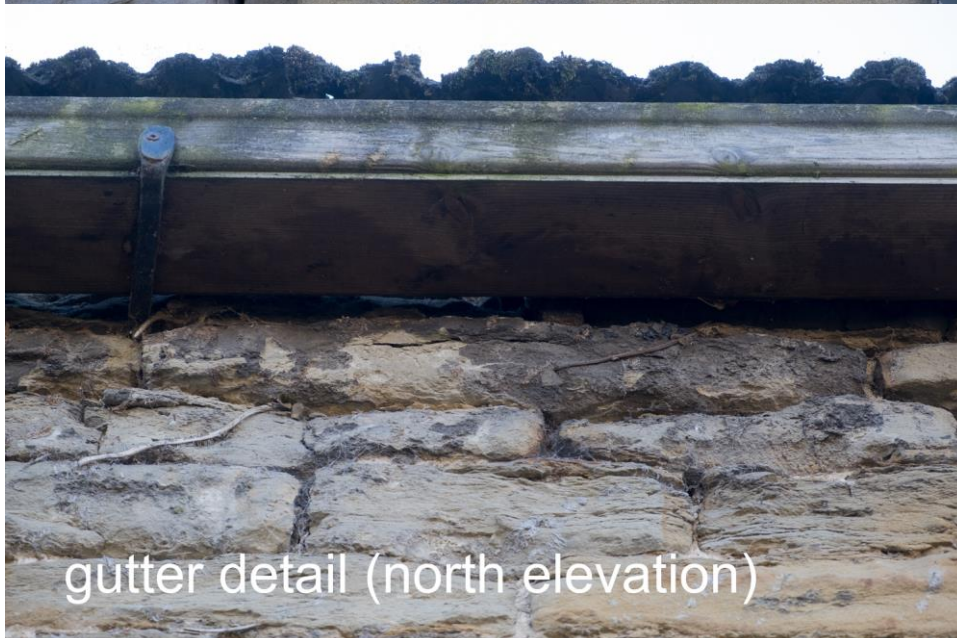
gutter detail (north elevation)

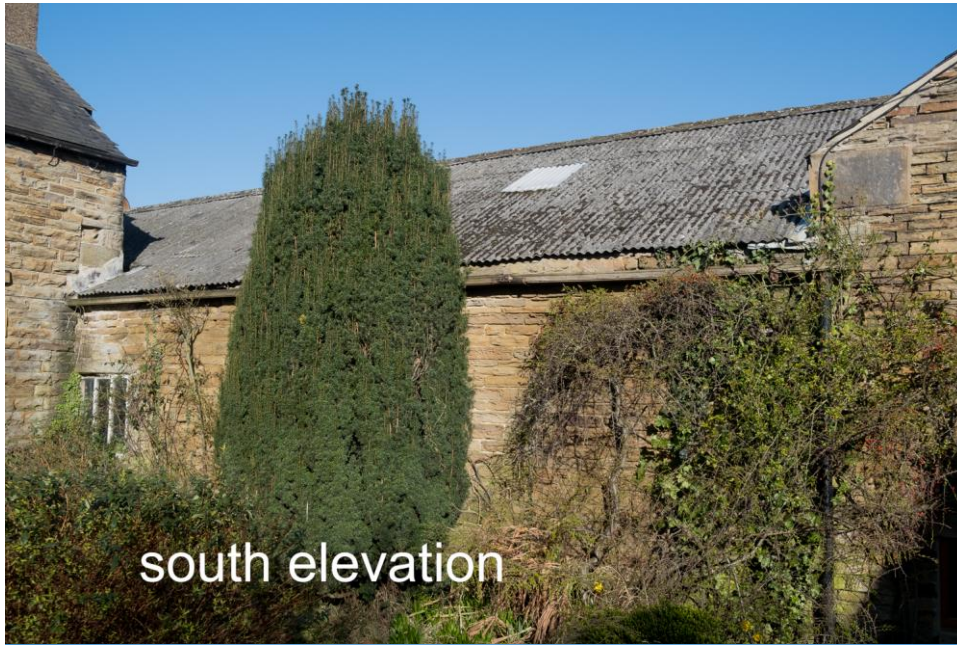
9.1 The building has limited potential to be of interest to bats mainly as the roof is a single thickness asbestos sheet which has no cavities that bats could use. The gable wall has a render which effectively prevents bats from being able to gain access to wall cavities or wall tops. The ridges are all very heavily covered in cobwebs and show no signs of use by bats and there were no droppings or scattered prey remains anywhere in the building. The south elevation is much the same as the north elevation but access to the wall tops is obscured by

an upright yew and thorny climbing plants. Overall, the building is considered to be of negligible interest to bats. The original farmhouse and converted barn are likely to offer greater roost potential having lined, blue slate roofs.

south elevation

- A permanent roosting feature should be incorporated into the south elevation of the converted building or. Alternatively, on the south elevation of the agricultural building on the approach driveway. Artificial roosts should be located high up (above 4m) and away from windows if on a residential dwelling. Ideally, this should be a Schwegler IFQ bat house or good quality commercial bat boxes. Bat boxes can also be erected on the south or west side of trees within the footprint of the site.
- Consideration should be given to the siting of a sparrow nesting terrace on the north elevation the agricultural building adjacent to the driveway. This building already has a barn owl box but sparrow terraces would be very beneficial.

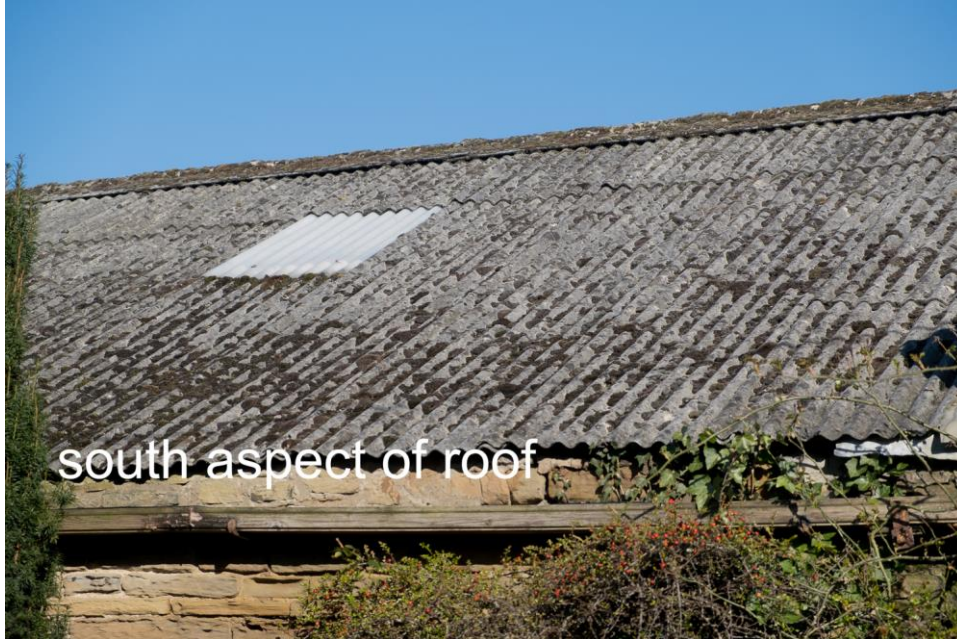
south aspect of roof
