**STRATA STERLING BARNSELY WEST LTD**

**BARNSELY WEST**

**OTTER AND WATER VOLE SURVEY**

**OCTOBER 2023**

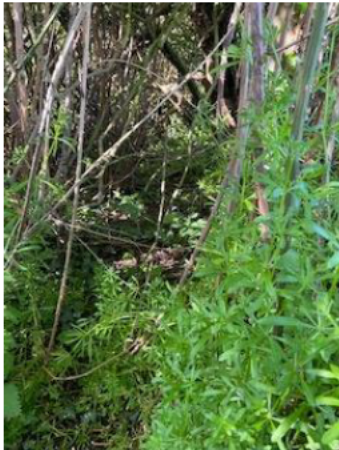
| Watercourse ID Number | Description | Photo | Suitability |
|---|---|---|---|
| D1 | Field boundary ditch with mature hedge above. Ditch is partially dry becoming wet with shallow water 0.02m max depth. Channel is approximately 1m wide with and predominantly bare earth due to heavy shading from hedge above. No emergent or aquatic vegetation is present. Banks are 0.5m high with limited sparse vegetation comprising ivy Hedra helix and common nettle. | | Negligible |

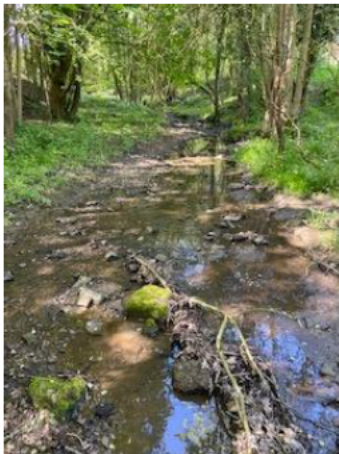
| Watercourse ID Number | Description | Photo | Suitability |
|---|---|---|---|
| D2 | <p>Stream (western leg). Banks are shallow almost flat in places and support woodland flora and ruderal species to include common nettle, creeping buttercup <i>Ranunculus repens</i>, cleavers <i>Galium aparine</i>, broadleaved dock <i>Rumex obtusifolius</i>, Ramsons <i>Allium ursinum</i> and lesser celandine <i>Ranunculus ficaria</i>. To the south the banks become steep greater than 45° and undercut in places. The channel is various widths ranging from 0.5m-1m wide with a slow flow. No aquatic or emergent vegetation is present in this area. The water flows south to north</p> | | Poor but Suitable |

- 4.1.1 Otters are very mobile species and can cover large territories extending approximately 40km. Given that otters were recorded by the desk study within 2km of the site boundary it is recommended that as a precaution a 10m buffer from the larger streams namely D2 and D3 is retained to provide a sheltered undisturbed corridor for commuting. This buffer should be fenced to ensure breaches by construction vehicles during the construction period is avoided.
- 4.1.2 As no evidence of otter or water vole was recorded from Site they are considered likely to be absent as resident species.

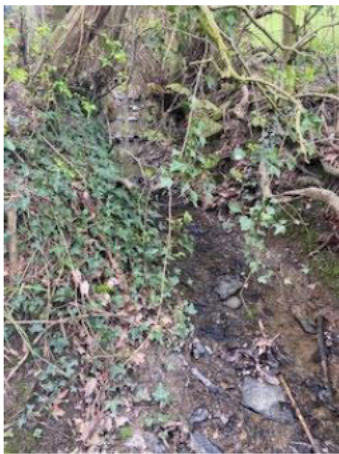
| Watercourse ID Number | Description | Photo | Suitability |
|---|---|---|---|
| D3 | <p>Stream through Craven wood (Eastern leg). Here the banks are steep sided and vertical and in places undercut. Banks extended to approximately 3m high in places. Channel sides are bare due to heavy shading from Craven wood. The channel is 1m-1.5m wide with slow to moderate flow. No aquatic vegetation or emergent vegetation was present in this section of the stream.</p> <p>The stream continues beyond Hermit Lane to the South along the edge of Craven Wood. Banks are steep and variable in height steep and greater than 45° or vertical and undercut. Banks are also variable in height.</p> | | Poor but Suitable |

| Watercourse ID Number | Description | Photo | Suitability |
|---|---|---|---|
| | Water flows in a south to north direction and merges with the Stream listed as D2. | | |

- 3.3.2 No water vole field signs to include burrows, latrines, droppings, feeding stations or pathways were recorded during the survey of watercourses on site.
- 3.3.3 Several rat burrows were recorded along D3. Burrows were larger in diameter, and some had a fan of spoil outside the entrance.

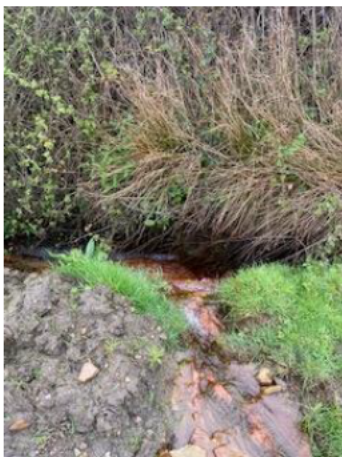
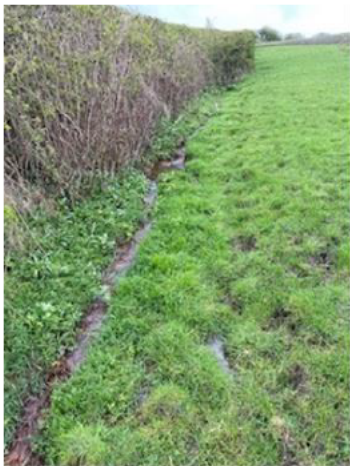
| Watercourse ID Number | Description | Photo | Suitability |
|---|---|---|---|
| D4 | <p>Partially culverted drain. Break in pipe exposes water run-off which seeps into field and meets a natural spring in the centre of the field. Here some aquatic vegetation is present such as floating sweet-grass <i>Glyceria fluitans</i> and brooklime <i>Veronica beccabunga</i>. The water collects in a half culvert along the base of a hedgerow and scrub. Here the flow is of moderate speed. No aquatic/emergent are present in this area. The water flows from the culvert into the natural watercourse along the base of the hedge. The channel here is very narrow only 0.2m wide but the water varies in depth between 0.02-0.1m. Banks along the natural section of the water course are also variable in gradient, being almost flat and poached to the west as its unfenced to the field. The east side supports a mature but managed hedge and a steeper bank. The ditch terminates at the field gate to the north, at this point the ditch is culverted beneath Hermit Lane and adjoins Craven Wood Stream (D2)</p> | | Negligible |

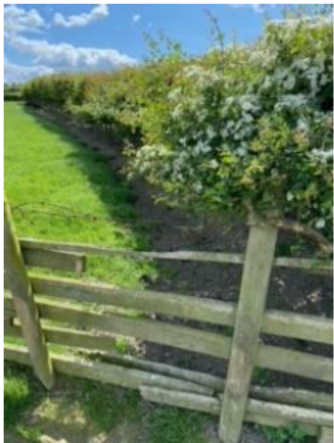
| Watercourse ID Number | Description | Photo | Suitability |
|---|---|---|---|
| D5 | A small section of ditch along an internal hedge that is no longer present. No evidence to suggest the area become wet or holds water during periods of high rain fall. | | Negligible |

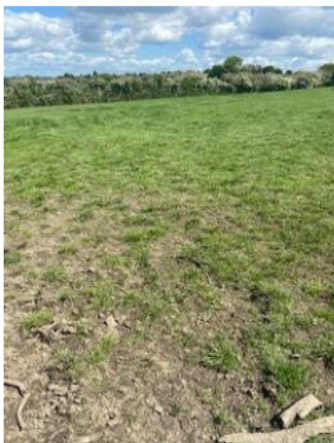
| Watercourse ID Number | Description | Photo | Suitability |
|---|---|---|---|
| D6 | Field drain is no longer present. No depressions or waterlogging within areas mapped. | | Negligible |

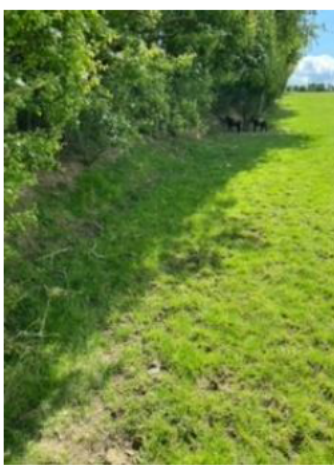
| Watercourse ID Number | Description | Photo | Suitability |
|---|---|---|---|
| D7 | Dry internal field drain. Depression present along the base of hedge but no evidence of it ever supporting water. Dry ditch is narrow and meandering in nature. The ditch is predominantly bare dry earth and heavily horse poached as it is currently unfenced from the field. | | Negligible |

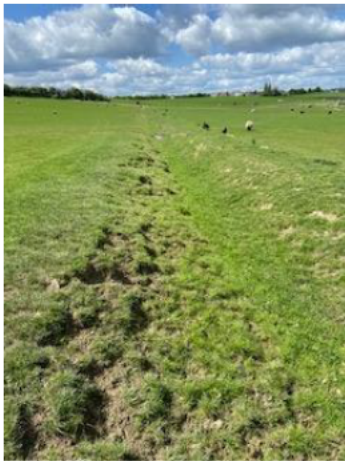
| Watercourse ID Number | Description | Photo | Suitability |
|---|---|---|---|
| D8 | Wet/Damp man-made drain through field. Drain is approximately 1m wide and supports damp ground and shallow water max depth 0.04m, and supports annual meadow grass <i>Poa annua</i> , creeping bent <i>Agrostis stolonifera</i> and where the drain is wetter floating sweet-grass. The banks are approximately 45° and covered in short grazed grassland which extends from adjacent field. Drain is unfenced and sheep grazed. | | Negligible |

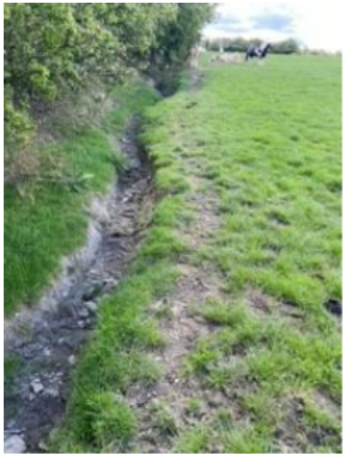
| Watercourse ID Number | Description | Photo | Suitability |
|---|---|---|---|
| D9 | Dry ditch, no visible signs the ditch has been wet over recent years. | | Negligible |

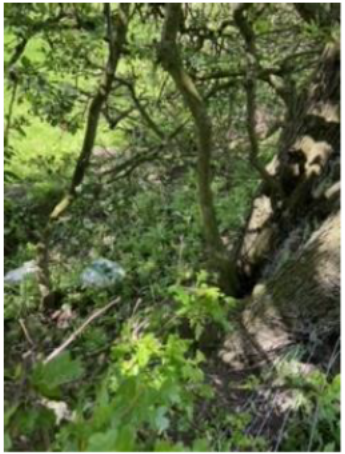
| Watercourse ID Number | Description | Photo | Suitability |
|---|---|---|---|
| D10 | Dry ditch present along internal field boundary hedge. Dry channel is approximately 0.5m wide with shallow banks <0.5m high. Banks support common nettle, creeping thistle and cleavers. | | Negligible |
