## **GEOENVIRONMENTAL DESK STUDY REPORT**

### **WENTWORTH PARK ESTATE TANKERSLEY S75 3BG**

**MT/DS/4776.v2**

**February 2016**

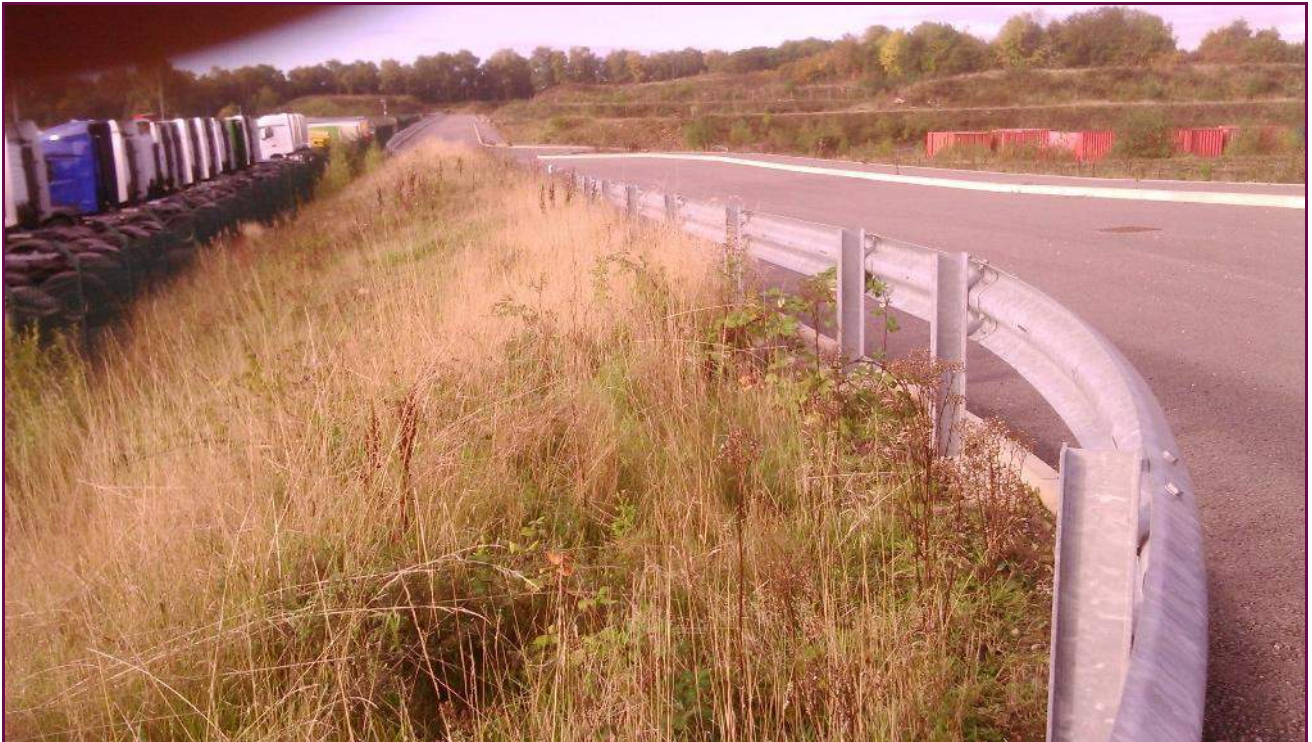
**Photograph 1: View looking west across the entrance road through the site**

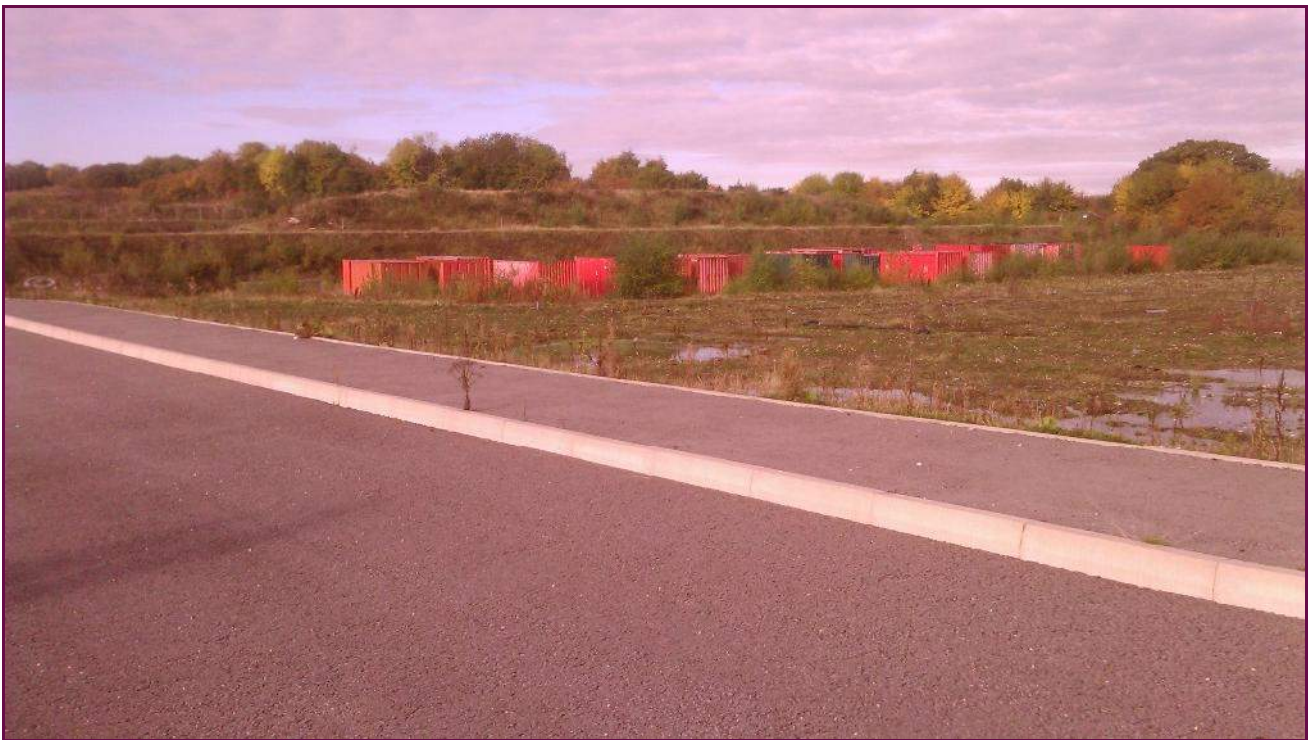
**Photograph 2: View looking north west from the east part of the site**

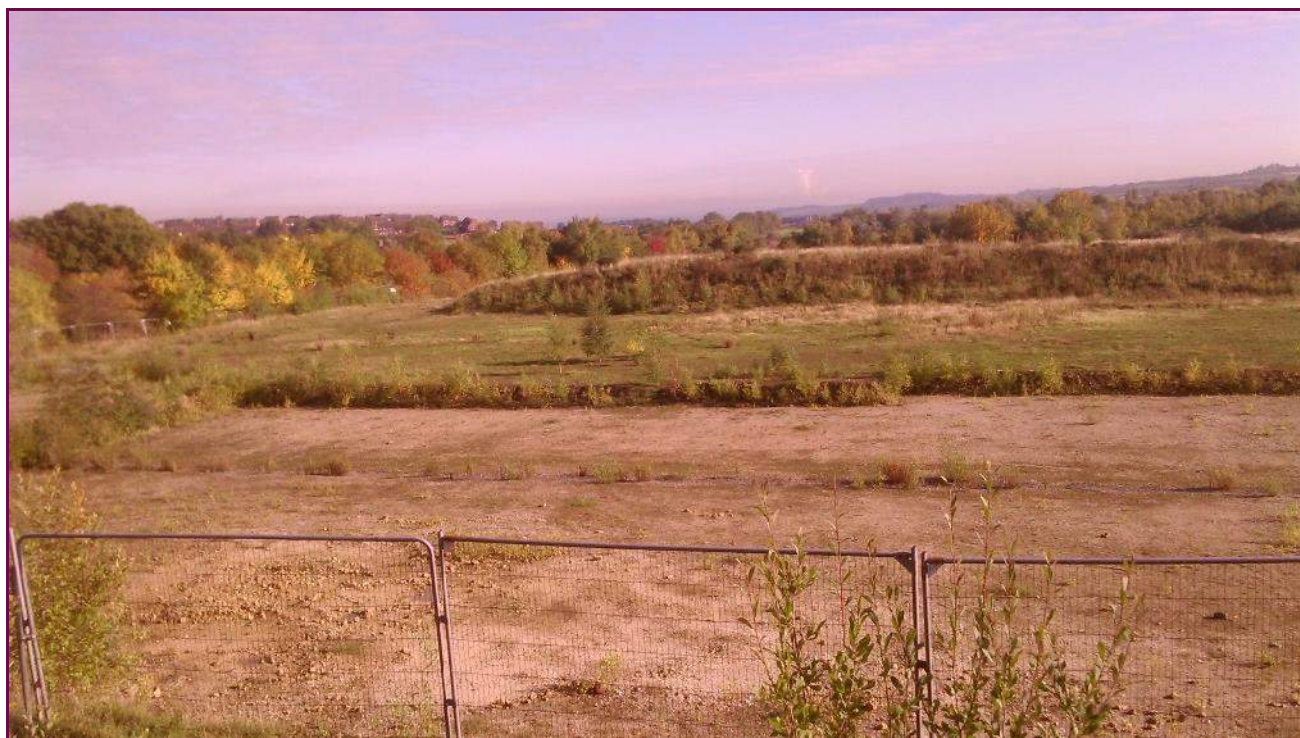
**Photograph 3: View looking to the north east across the eastern part of the site**

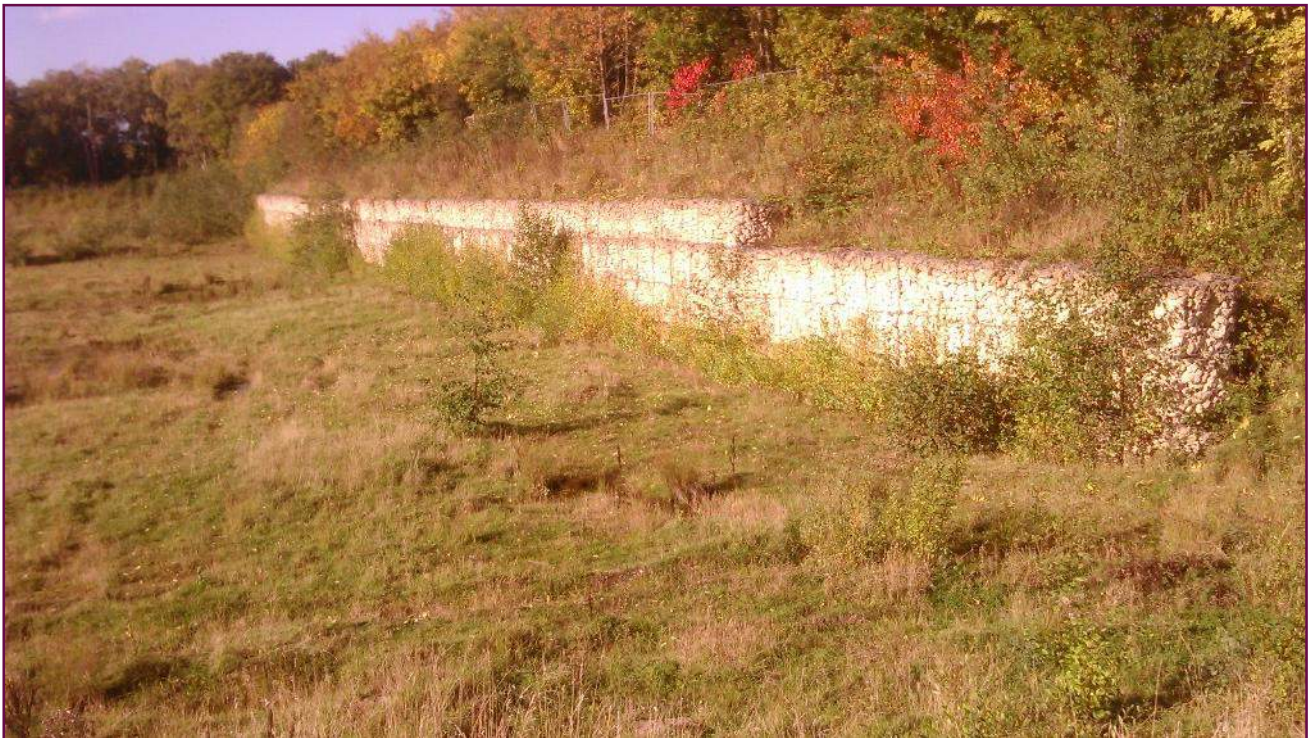
**Photograph 5: View towards the north west boundary from the central area of the site**

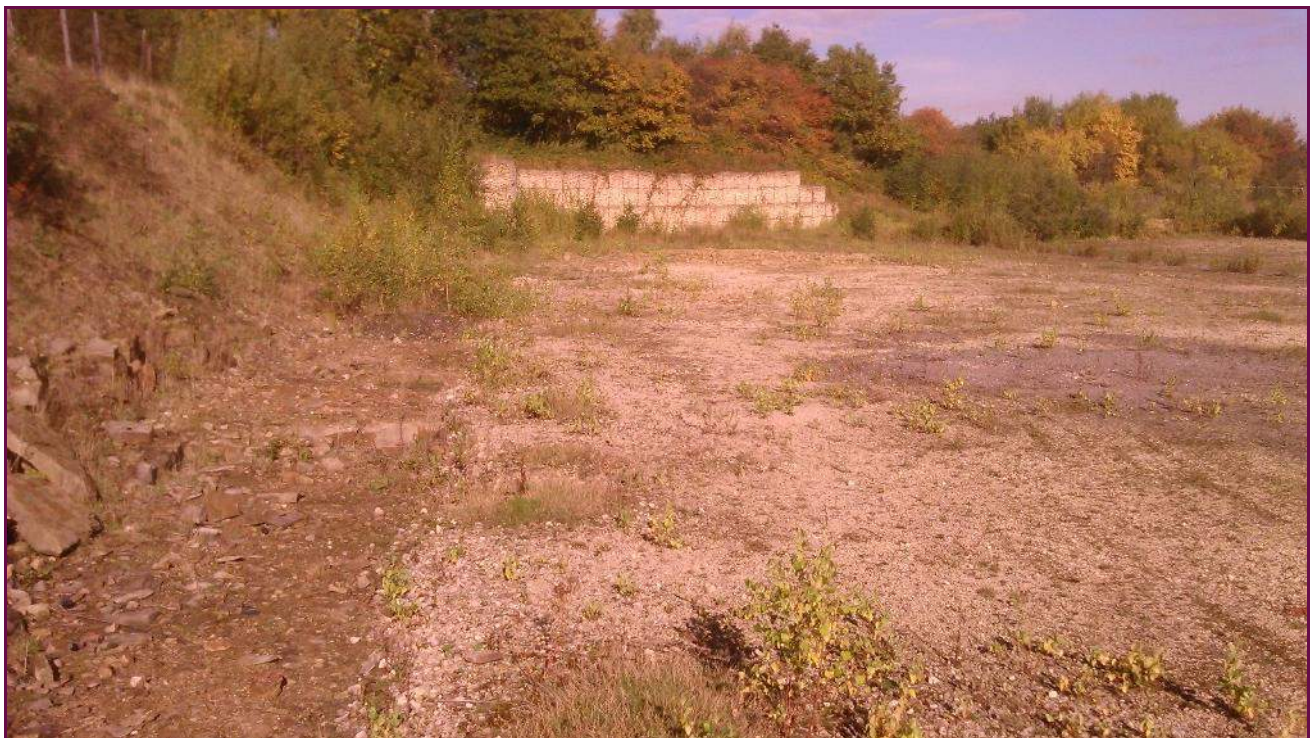
**Photograph 6 View to the north from the central area of the site**

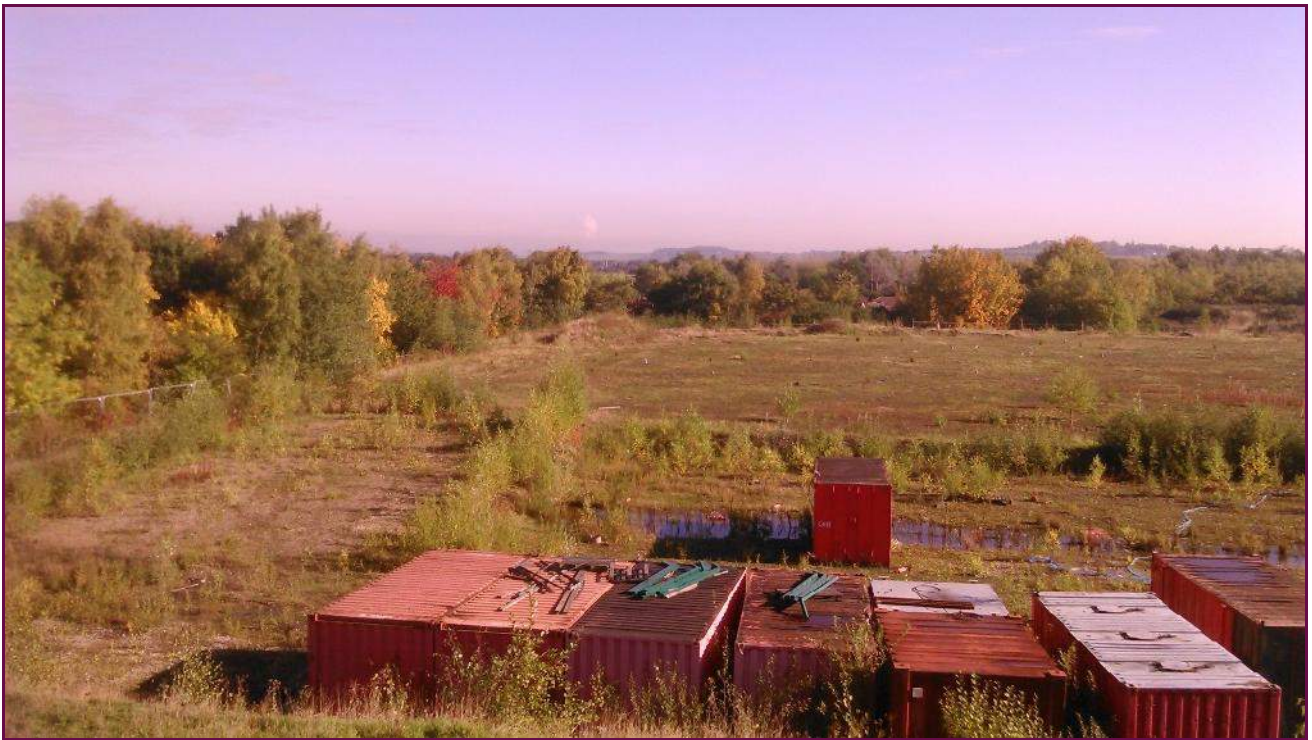
**Photograph 7 View to the east from the central area of the site**
