Geo-environmental Ground Investigation Report

PROPOSED RESIDENTIAL DEVELOPMENT

DONCASTER ROAD, DARFIELD

E18/7309/R002

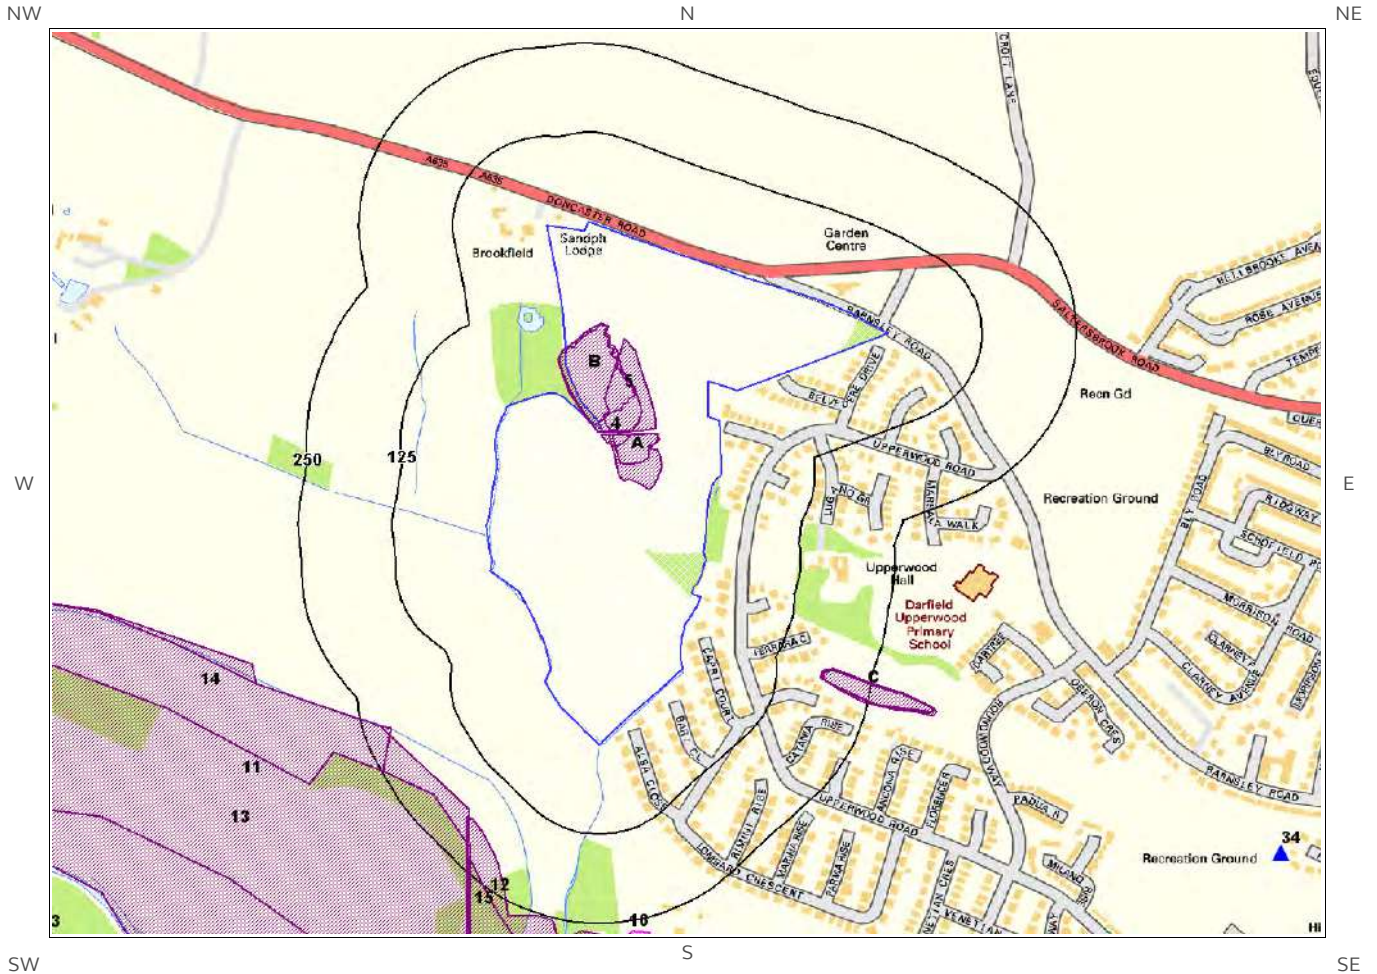
4 Ground Workings map

ID	Distance (m)	Direction	Name	Commodity	Assessment of likelihood
1	0.0	On Site	Not available	Iron Ore (Bedded)	Localised small scale underground mining may have occurred. Potential for difficult ground conditions are unlikely or localised and are at a level where they need not be considered
2	0.0	On Site	Sheffield Area	Iron Ore	Localised small scale underground mining may have occurred. Potential for difficult ground conditions are unlikely or localised and are at a level where they need not be considered
3	0.0	On Site	Not available	Iron Ore (Bedded)	Localised small scale underground mining may have occurred. Potential for difficult ground conditions are unlikely or localised and are at a level where they need not be considered
4	0.0	On Site	Sheffield Area	Iron Ore	Localised small scale underground mining may have occurred. Potential for difficult ground conditions are unlikely or localised and are at a level where they need not be considered
