# Land off Cooper Lane, Hoylandswaine

## Bat and Bird Survey Report

8<sup>th</sup> July 2022

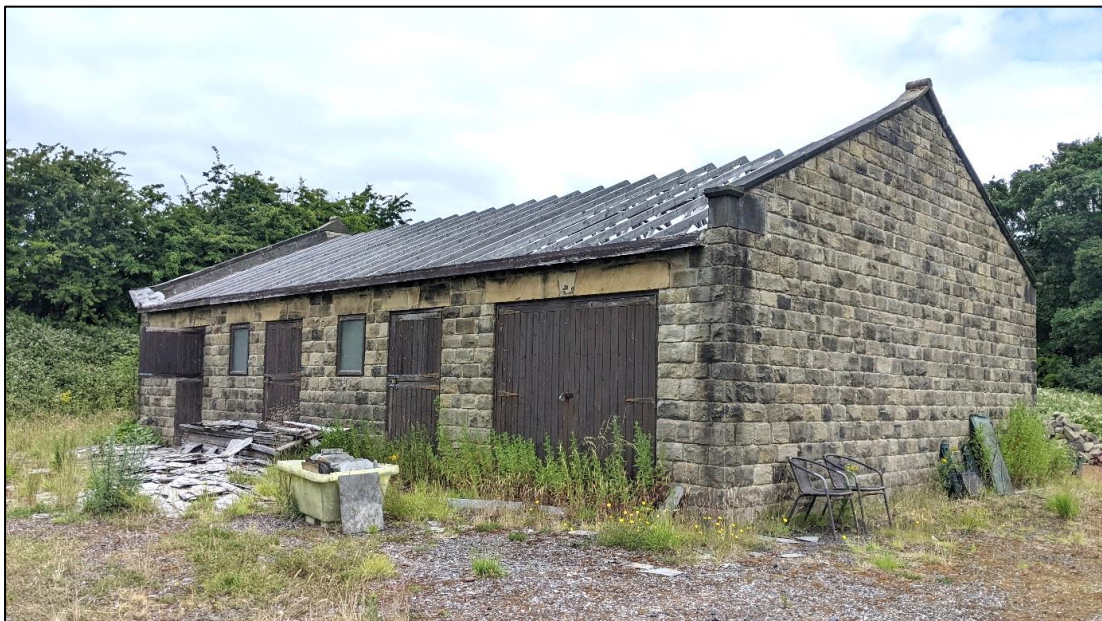
**Plate 1. Southeast corner of former stables**

5.2.2 The site building comprises a relatively modern detached stone and concrete block built former stables with stone copings on the gables (Plates 1 & 2). The former pitched roof was stripped in 2014, following the previous bat survey, exposing the pre-

fabricated roof trusses. Three wooden stable doors, one set of double doors and three single-paned wood-framed window are present in the south elevation with three stable doors and four single-paned wood-framed windows in the north elevation. Wooden soffits, which are open at the top, are present along both the north and south elevations.

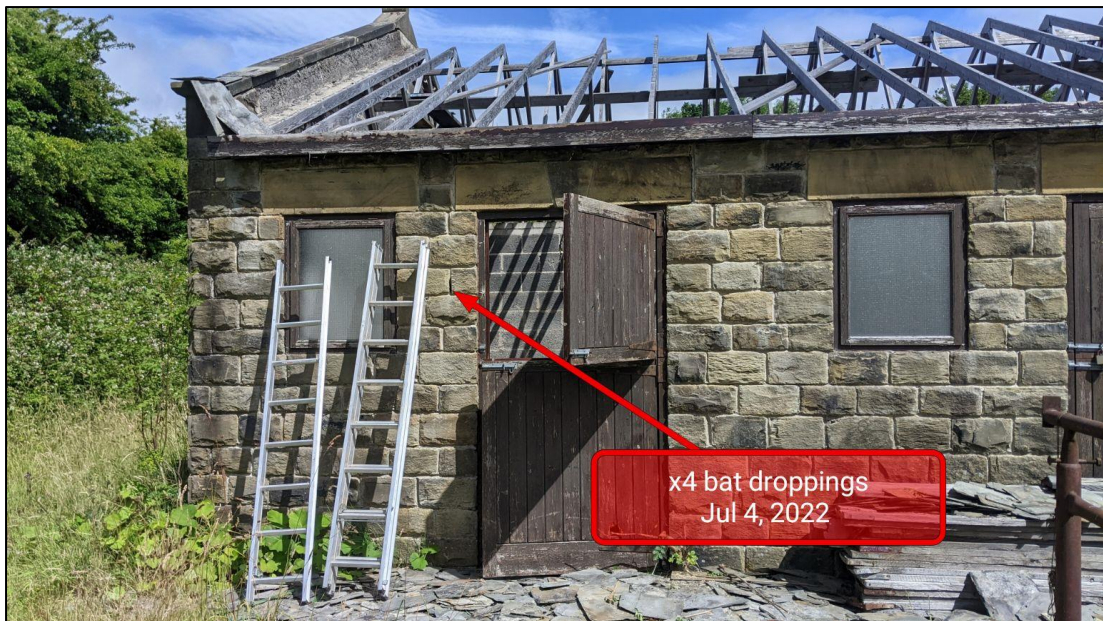
**Plate 3. Evidence of bat roost recorded from south elevation of former stables**

5.2.1 Evidence of a single bat roost was recorded in the south elevation of the former stables. This roost is expected to comprise a pipistrelle day roost. The stables were considered to display a low level of bat roost suitability.

- 5.2.3 The exterior of the former stables is mainly well sealed. One open joint, 15mm in width and at a height of 1.9m on the south elevation, leads to crevices between stone blocks in the outer skin of the wall and also possibly into the crevice between the inner and outer skin of the wall (Plate 3). A cluster of four fairly recently deposited bat droppings was present at the base of this open joint, within the wall, indicating the presence of a roost in the wall. On the basis of morphology and roost location, the droppings are considered likely to originate from a pipistrelle *Pipistrellus* species, with the roost likely to comprise a day roost. A sample of these droppings was taken for subsequent DNA analysis to species, if required. A low number of mainly superficial additional open joints were present across the external walls, but all were thoroughly inspected from a ladder and no further signs of bats were found.

6.3.1 In accordance with the accepted bat survey guidelines (Collins, 2016) two further nocturnal surveys of the former stables should be undertaken to determine bat roost presence/absence. These surveys should comprise dusk emergence and/or dawn return surveys, to be led by a licensed bat worker, with survey visits to be separated by at least 14 days.

6.3.2 The need for bat mitigation licensing and roost mitigation/compensation will be confirmed following nocturnal survey works. Some form of bat mitigation licence will however need to be obtained following the grant of planning permission.

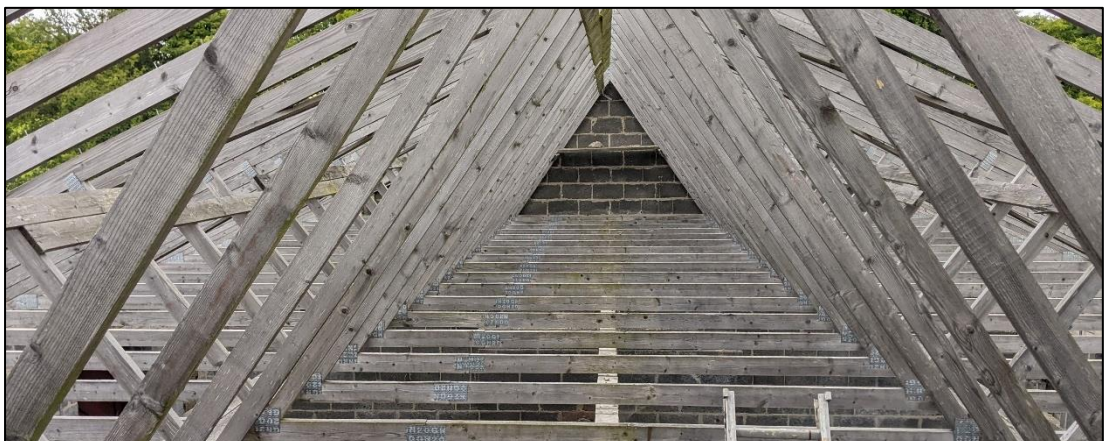
**Plate 4. Pre-formed trusses in roof structure of former stables**

- 5.2.4 The roof covering is missing with the prefabricated roof trusses remaining. The walls of the stable comprise the exposed inner face of the concrete blockwork.
- 5.2.5 There are numerous openings into the cavity between the concrete blockwork inner skin and the stone outer skin of the walls, including openings along wall tops and around doors. Several cracks are also present in the inner face of the block walls, with these cracks up to 15mm in width. However, No signs of bats were recorded from the interior of the former stable block.
- 5.2.6 The former stable block is considered to display a low level of bat roost suitability.
